# Northern Arc - Freek's Farm & Maple Drive

Ground Investigation Report

Homes England

Project number: 60578790

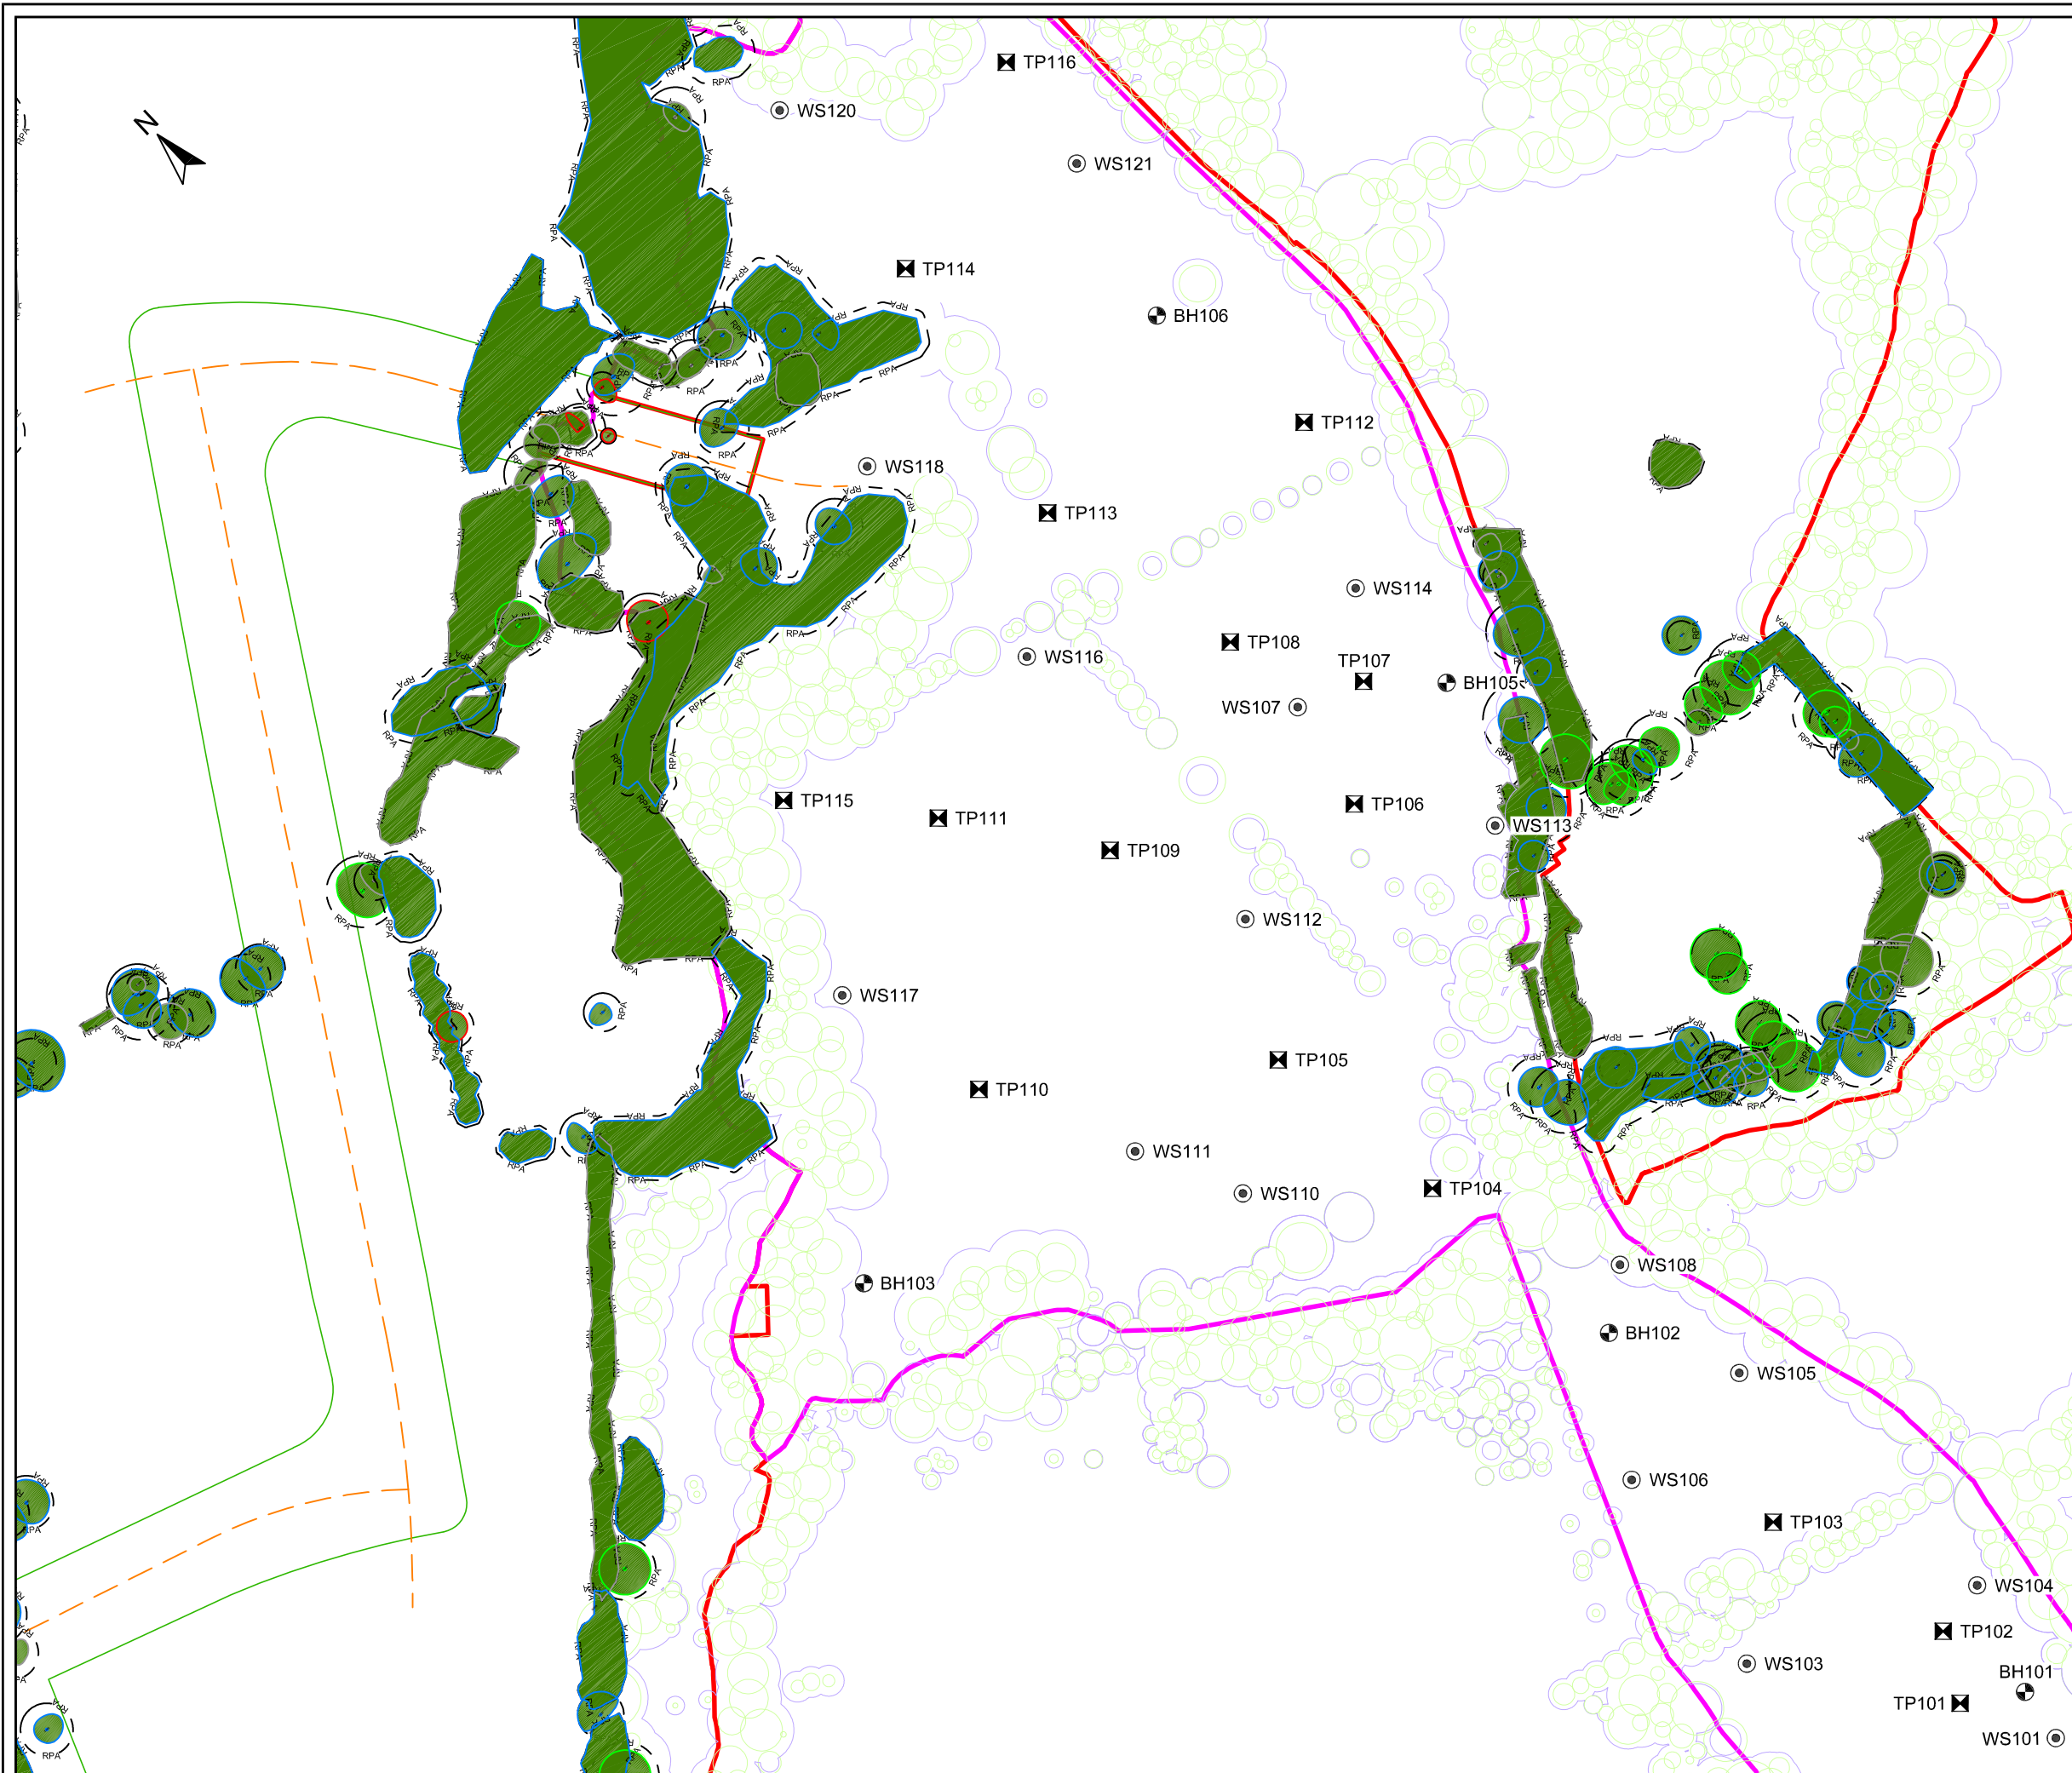
- Trial Pit Location
- Borehole Location
- Window Sample Location
