| Contract:<br>HE Northern Arc, Burgess Hill - Freeks Farm & Link Road GI | | Client:<br>Homes England | | Window Sample:<br>WS108 |

# STRUCTURAL SOILS

# WINDOW SAMPLE LOG

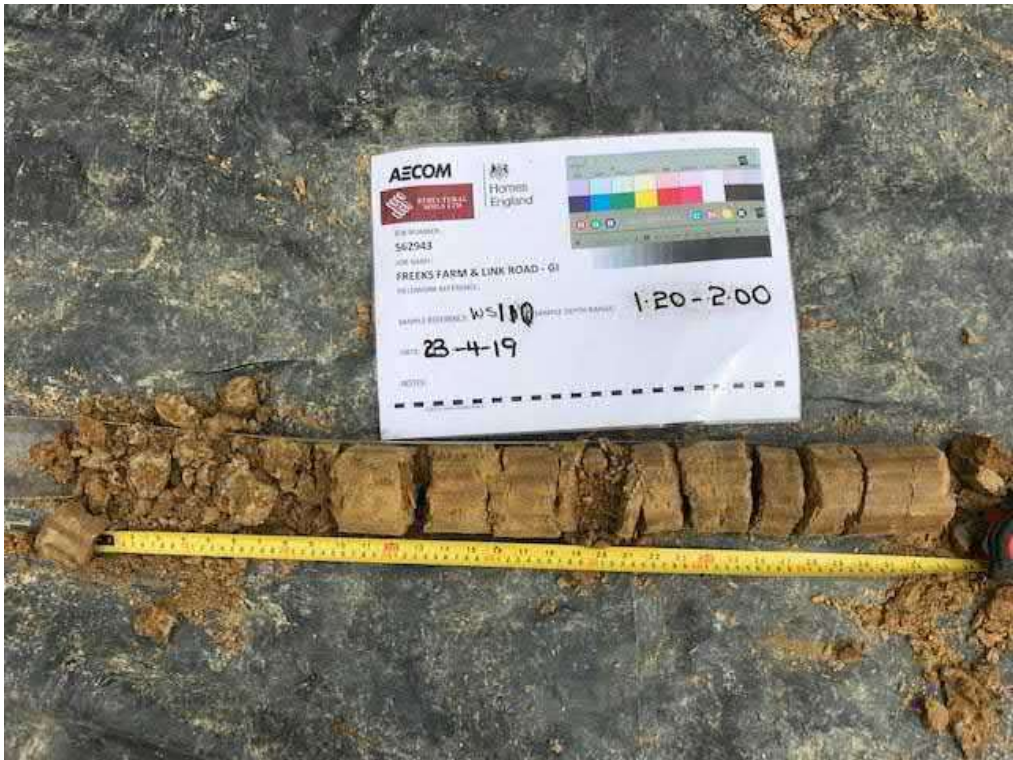
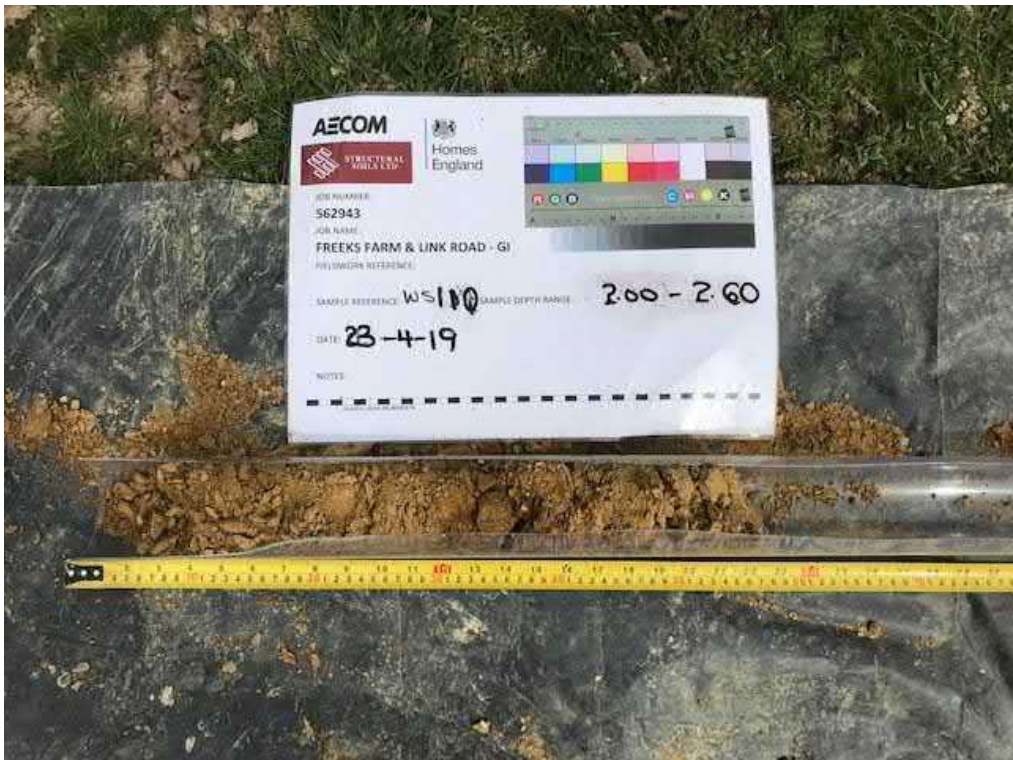
WS110: 1.20m-2.00m

WS110: 2.00-2.60m
