## 2 SITE DESCRIPTION

### 2.1 Location and Topography

The site is located approximately 1.5km North of Burgess Hill Town Centre in West Sussex (see Site Location Map in Appendix A). The British National Grid Reference (NGR) of the site is centred on NGR TQ310209.

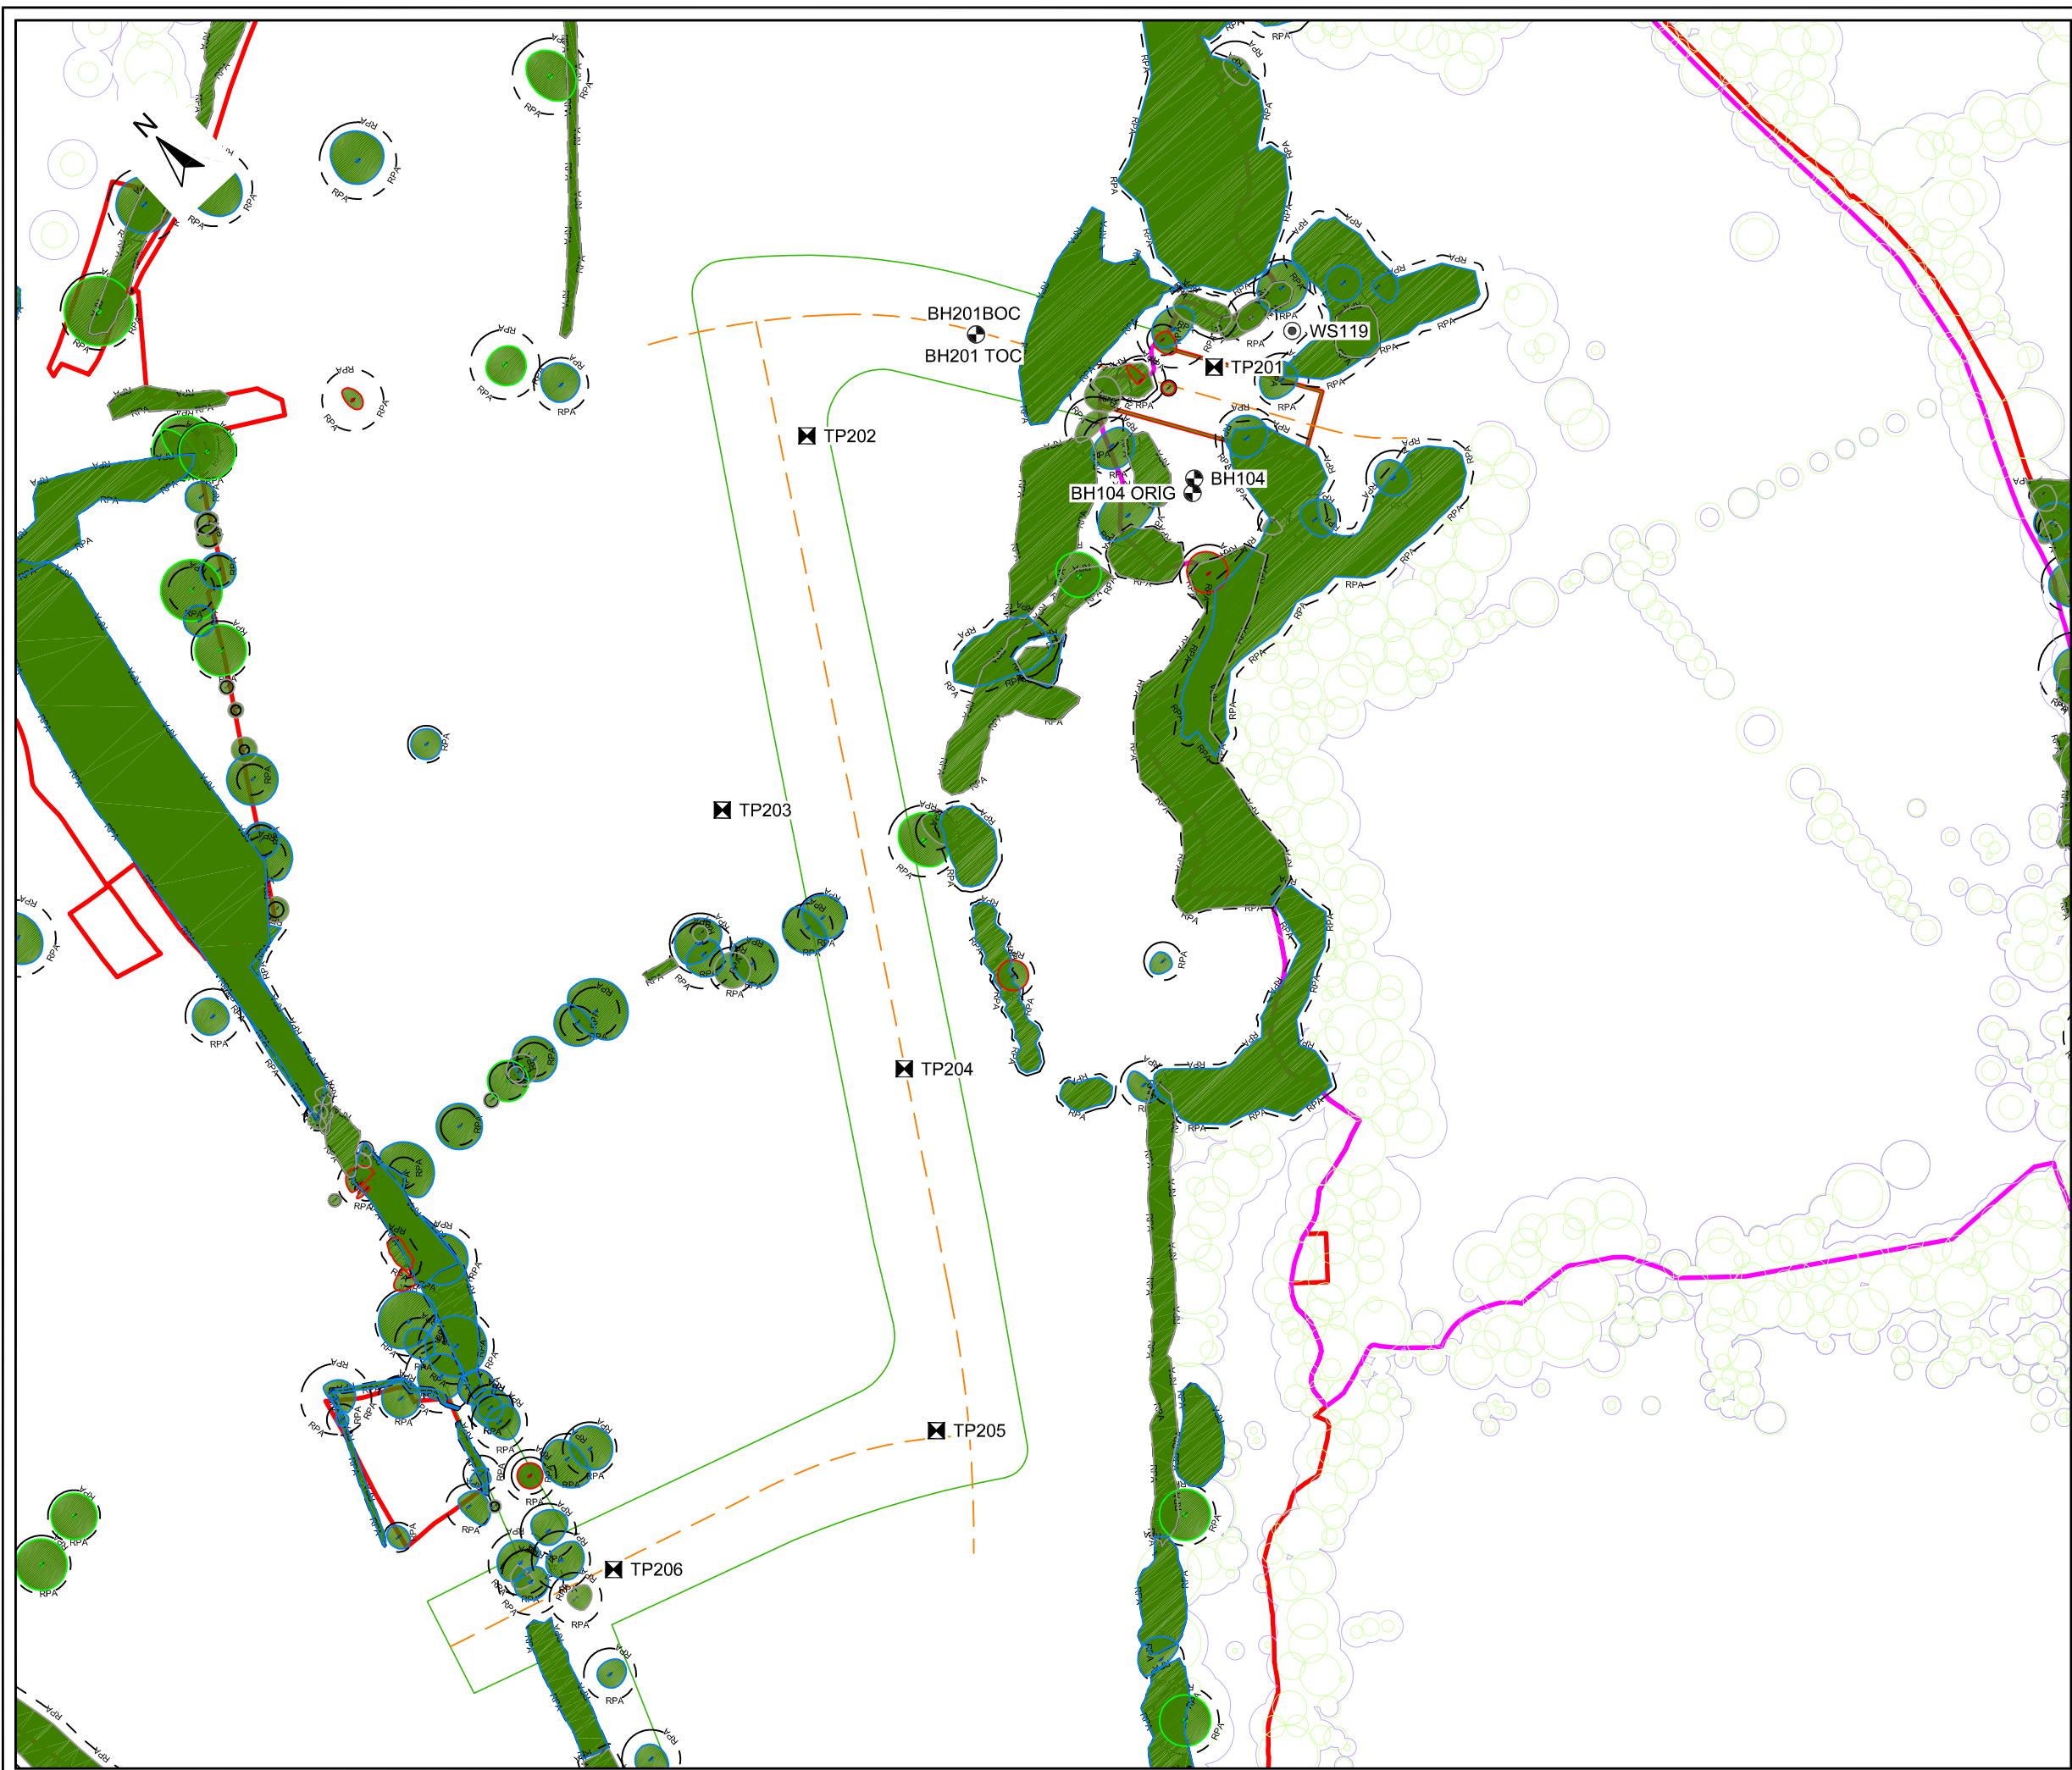
- (i) Site Location Plan
- (ii) Exploratory Hole Location Plan

- Trial Pit Location
- Borehole Location
- Window Sample Location

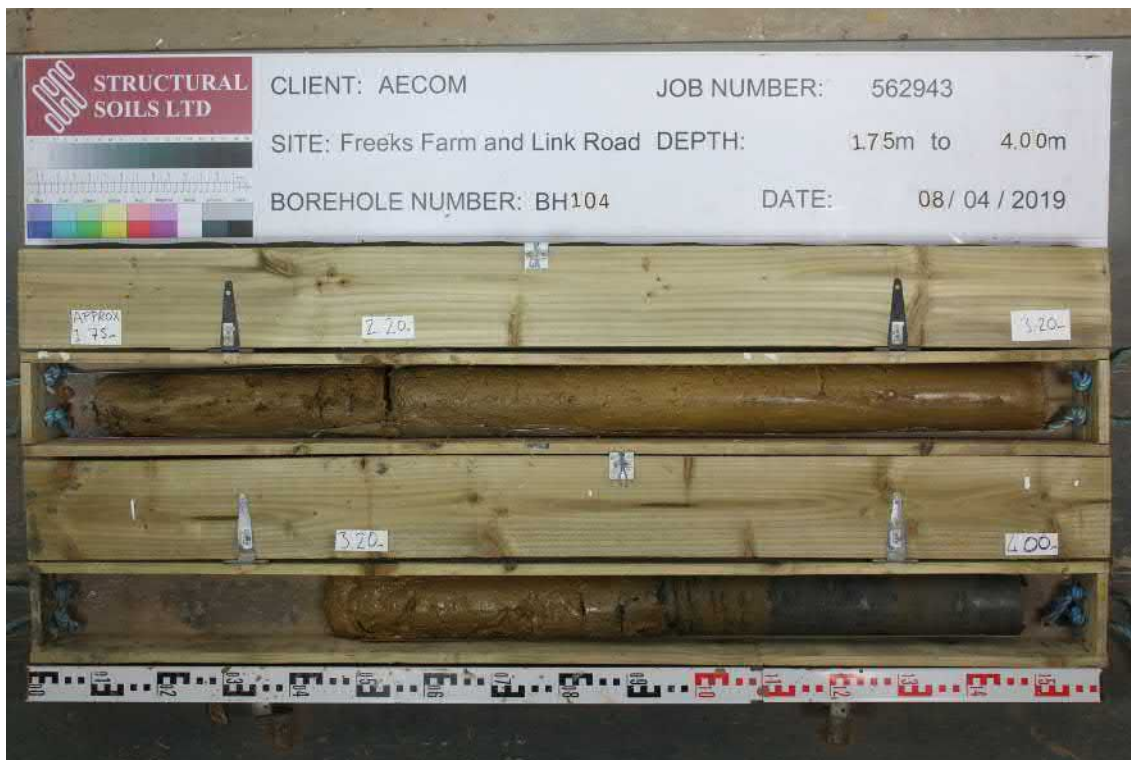
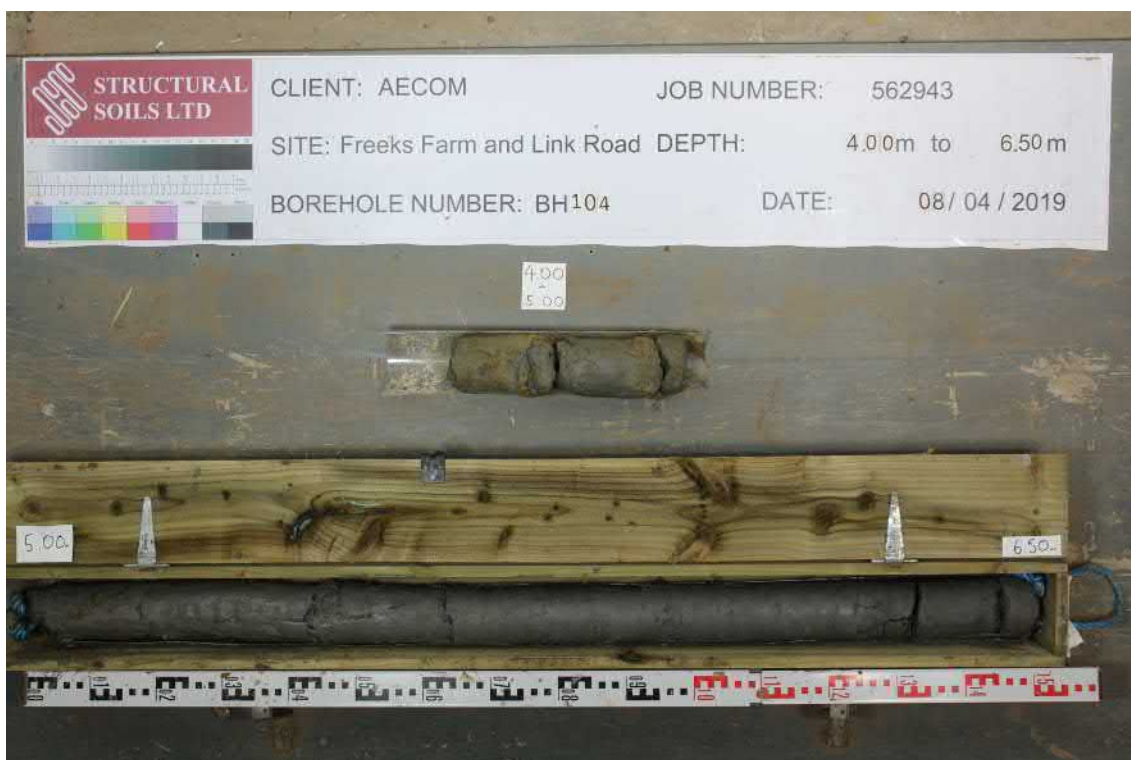
BH104 1.75m-4.00m

| Mechanical Log | | | | If (mm) | Flush Returns & Details | Samples & Testing | | | Backfill | Water | Description of Strata | Depth (Thickness) | Material Graphic Legend |
|---|---|---|---|---|---|---|---|---|---|---|---|---|---|
| 3.20-4.00 | | | | | | 3 | SPT | N=35 | | | Stiff to very stiff thinly to thickly laminated orangish brown mottled grey slightly sandy slightly gravelly CLAY. Sand is fine to coarse. Gravel is fine to medium of mudstone. Discontinuities are stained reddish brown. (Completely weathered WEALD CLAY FORMATION) | 3.40 | |
| 5.00-6.50 | | | | | | 5 | SPT | N=55 | | | Firm to stiff orangish brown mottled grey CLAY with frequent orange stained mudstone lithorelicts (up to 40mm). (Completely weathered WEALD CLAY FORMATION) | 5.00 | |
