## **Bat Survey Report**

### **The Old Woodyard**

**Slaugham Lane  
Staplefield  
West Sussex  
RH17 6AP**

24-096  
November 2024

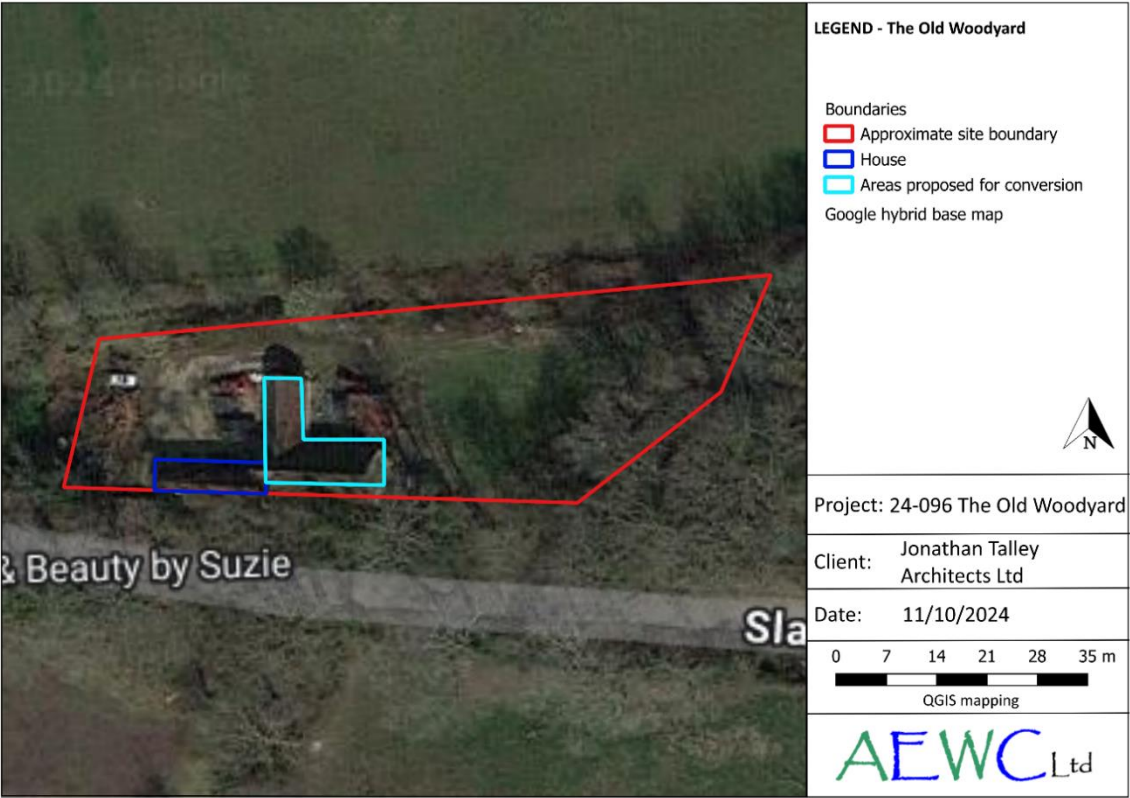
FIGURE 2: SHOWING THE BUILDING SUBJECT TO SURVEY.

1.9 The site contains a T-shaped building situated within an amenity garden. The western wing was previously converted to a 1.5-storey residential dwelling. The northern and the eastern wings subject to survey are currently used as storage.

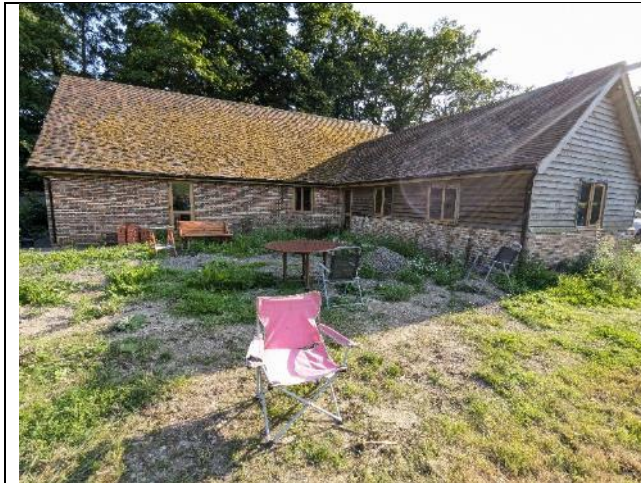
**Photograph 1:** North and east wings of the barn.

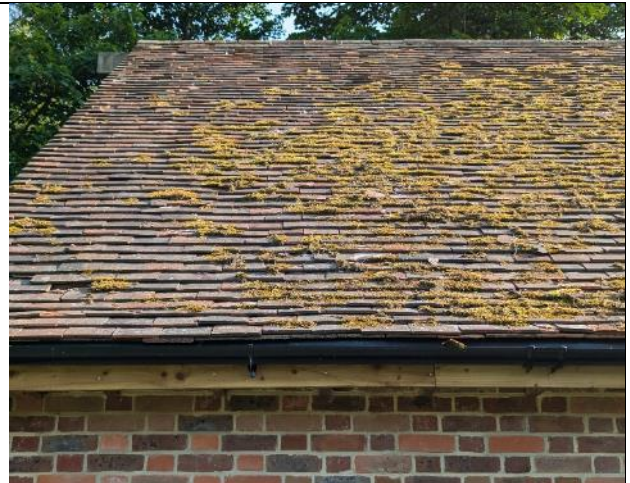
- 4.6 The roof was noted to have several lifted, slipped, and broken tiles on both wings. The weatherboarding was found to be lifted in several places, with a broken panel present on the eastern elevation on the north wing, providing access into the batten spaces. Small-sized bat droppings typical of *Pipistrellus spp.* bats were visible on the weatherboarding and the window of the northern gable. Further small bat droppings were identified in a gap below the windowsill of the same window. Gaps were also present above the ground floor door and the eastern gable hayloft door, which provide access directly into the interior space for bats.

**Photograph 2:** Missing and lifted tiles on the north elevation of the east wing.

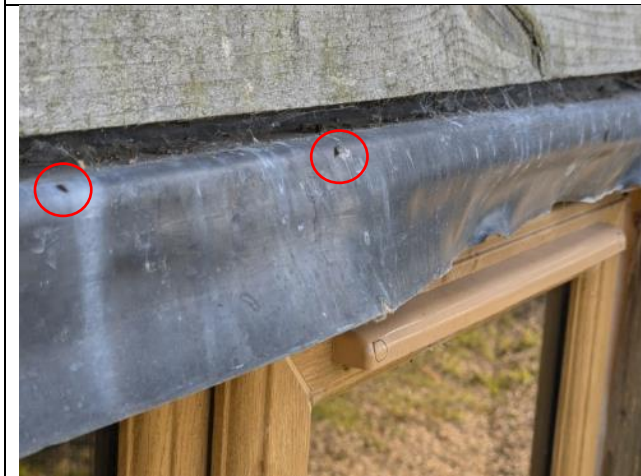
**Photograph 3:** Small bat droppings below the weatherboarding on the northern gable end.

- 5.5 Bat droppings identified externally were characteristic of small bats such as *Pipistrellus spp.* Whilst only low numbers of droppings were identified, evidence of crevice-dwelling species can remain trapped within batten spaces and undetected. Pipistrelles are considered to be early breeding species, with maternity roosts often beginning to disband from late July, however, the emergence surveys were conducted in August. Therefore, the potential presence of a maternity colony of crevice-dwelling bats cannot be ruled out.
- 5.6 The proposed works to convert the building into a residential dwelling will lead to the loss of both identified roosts.

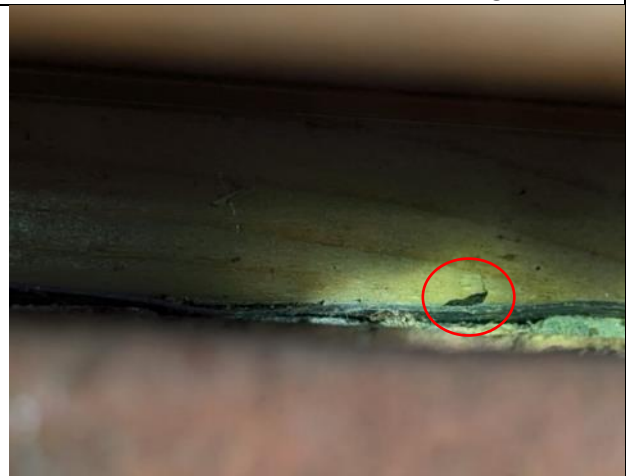
**Photograph 4:** Small bat droppings in the crevice below the window on the northern gable end.

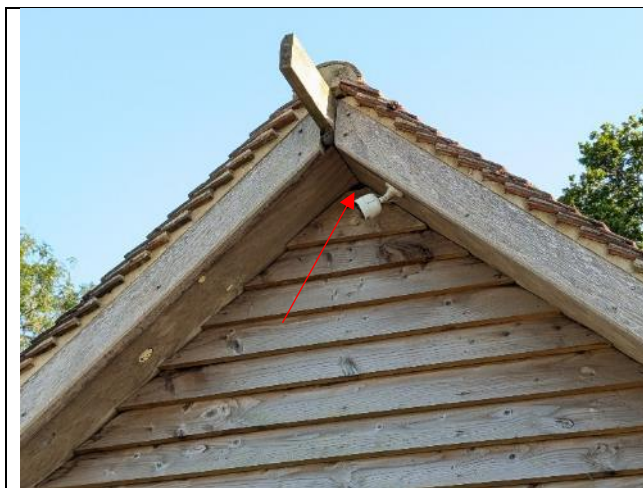
**Photograph 5:** Gap at apex on the northern gable end.

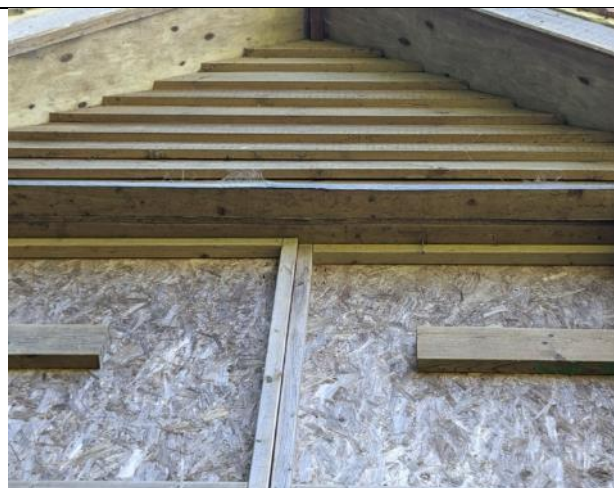
**Photograph 6:** Gaps in the weatherboarding on the eastern gable hayloft door.

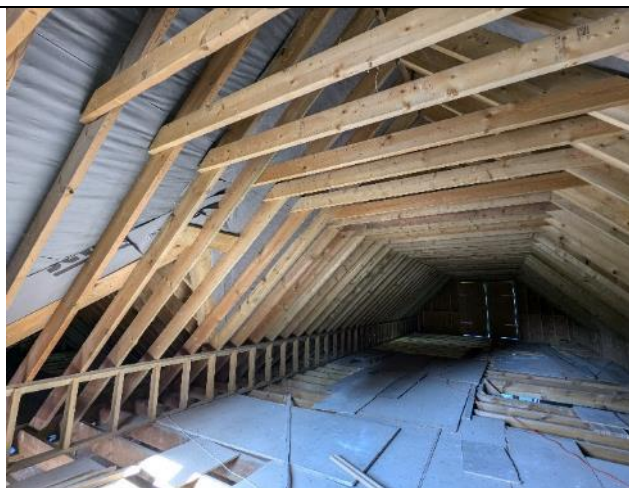
**Photograph 7:** Internal 1<sup>st</sup> floor of the east wing.

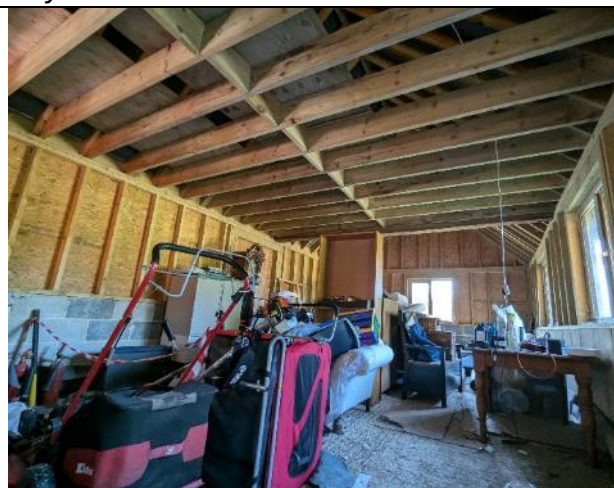
**Photograph 8:** Internal ground floor of the north wing.

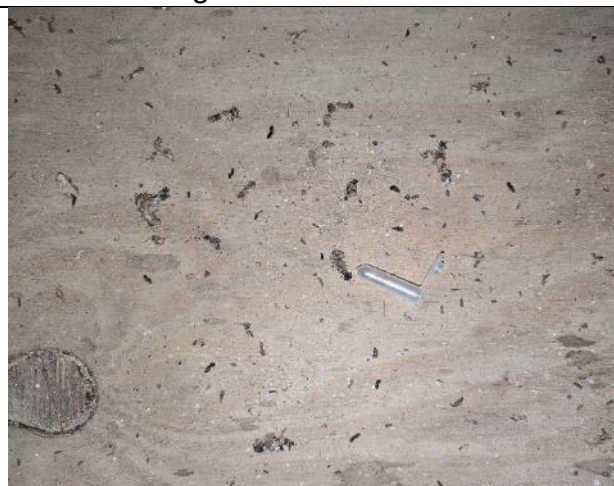
- 4.8 Small accumulations of medium-sized bat droppings typical of long-eared bats were identified within the northern intersecting wing, both on stored items at ground floor

level, and on temporary joist boarding within the roof space, with further droppings scattered throughout other areas of the building. Feeding remains were also found present within the ground floor area of the northern wing.

**Photograph 10:** Small accumulation of medium-sized bat droppings on the temporary boarding at the joist level.

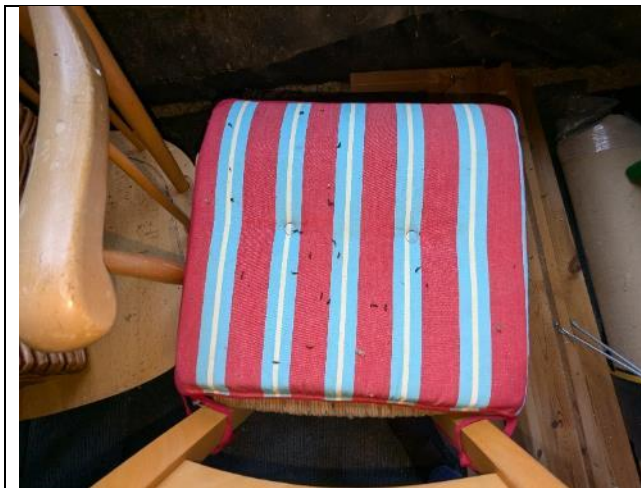
**Photograph 11:** Small accumulation of medium-sized bat droppings.

- 5.4 The size, shape and scatter pattern of the droppings and feeding remains observed within the building are typical of long-eared bats, with the size and flight behaviour of the bat recorded internally considered consistent with this genus. Long-eared bats

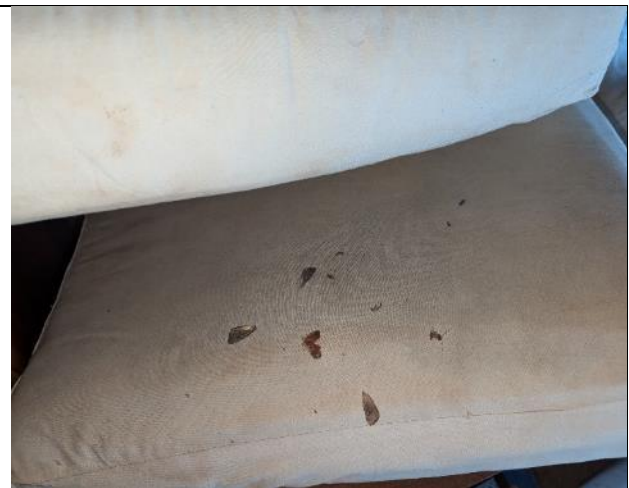
**Photograph 12:** Moth wings within the building.
