notes + revisions						client + project	title	scale	number
						Telbridge Properties	Existing Front + Side Elevations	1 : 50 @ A3	2337.S07
					Twineham Court Garage	date		status	
					Bob Lane, Twineham	09.06.2023		SURVEY

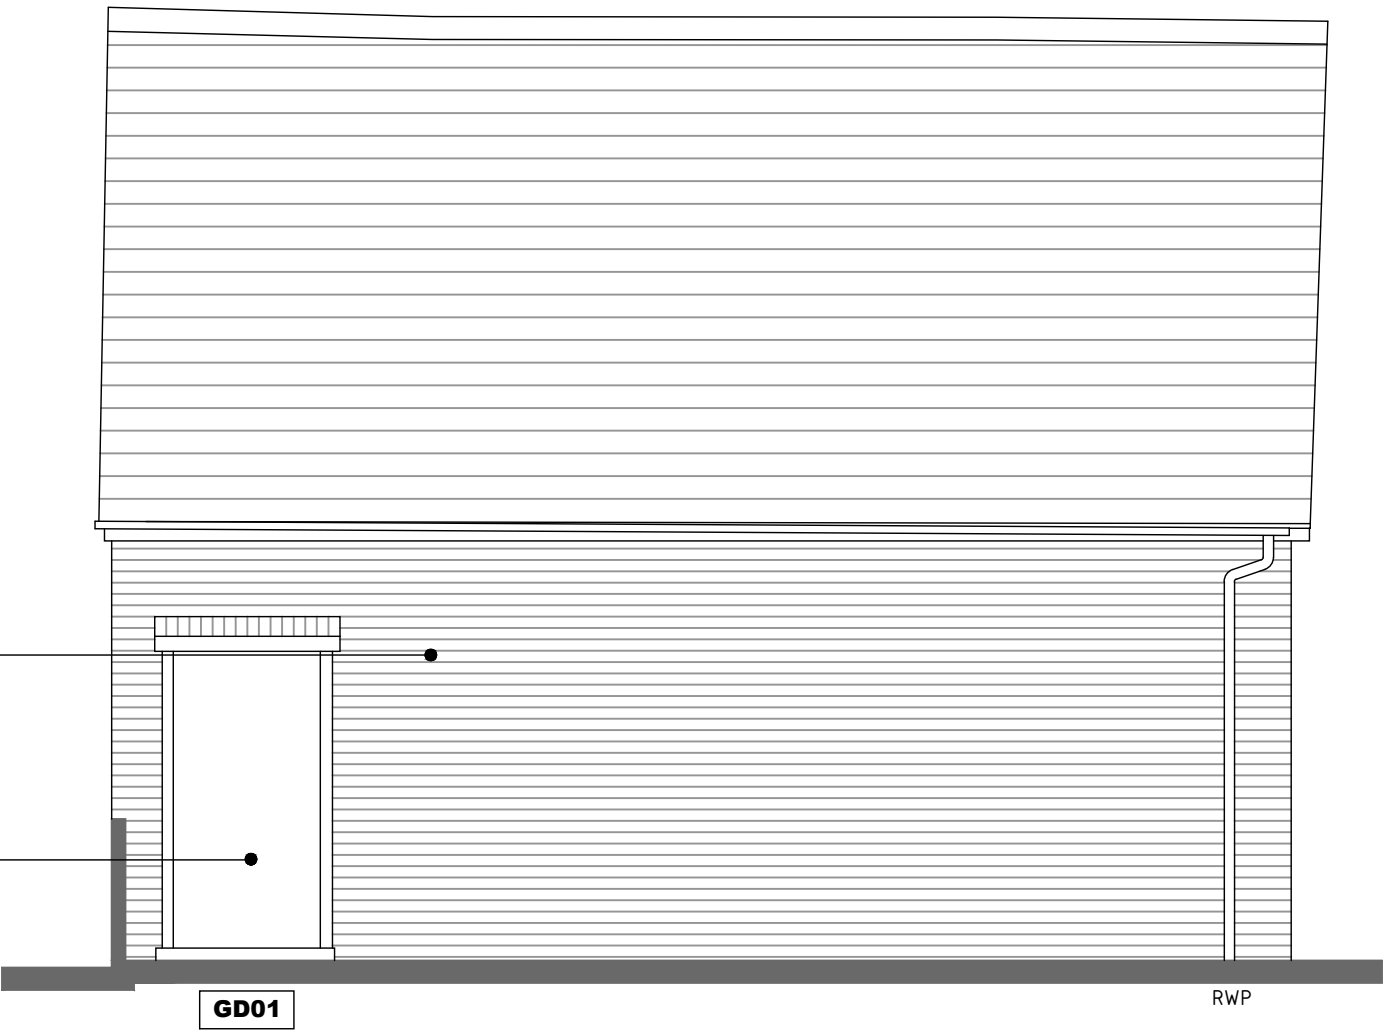
side elevation  
west

Doors  
GD01 Garage No original door, plywood temporary door for security
