Keymer Road, Hassocks

784-B049054

Bat Roost Assessment and Bat Survey Report

November 2023

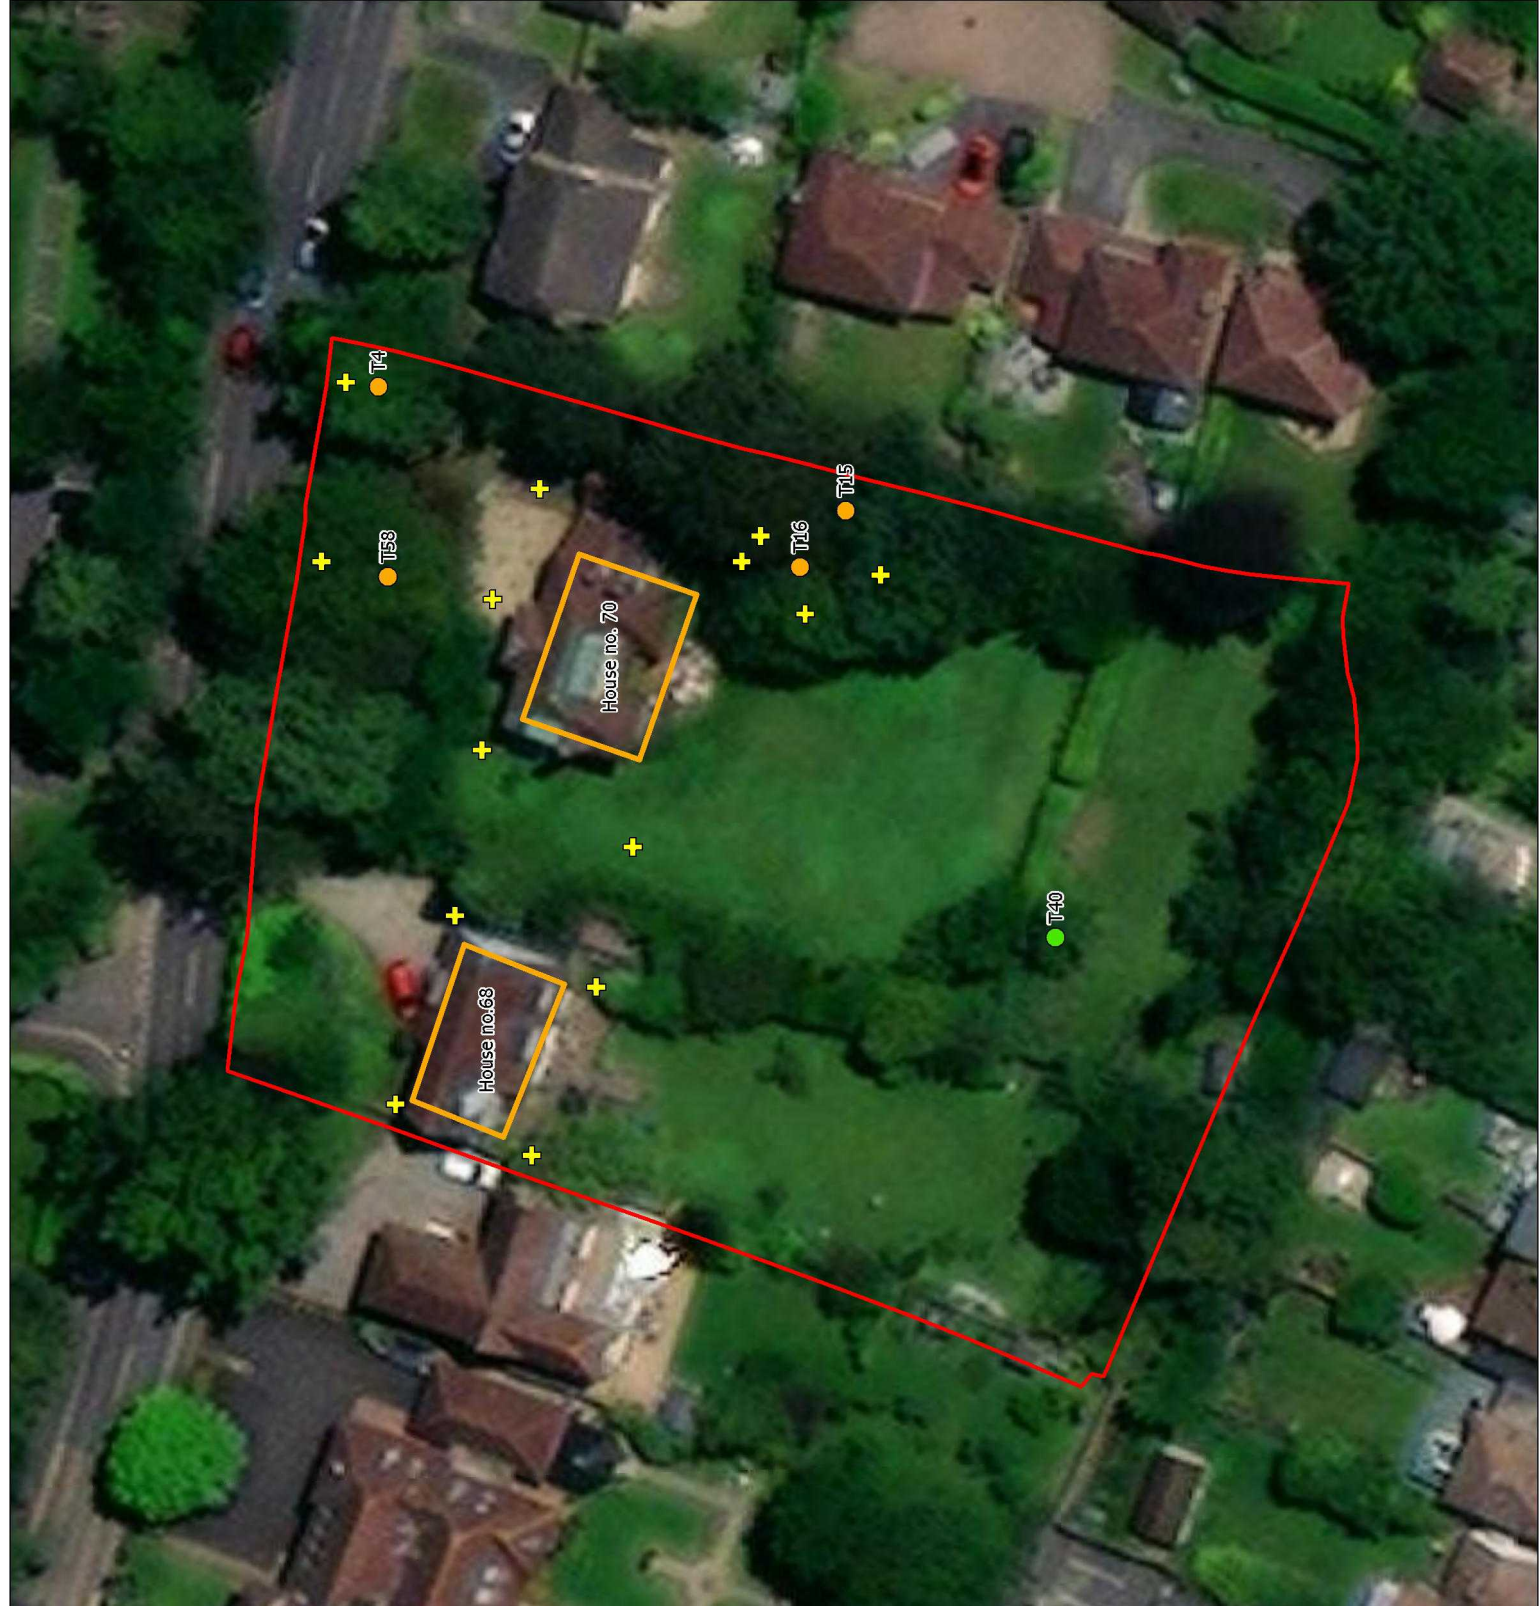
FIGURE 2: BUILDING / TREE LOCATIONS AND SURVEYOR LOCATION PLAN

Building/Tree Locations and Surveyor Location Plan

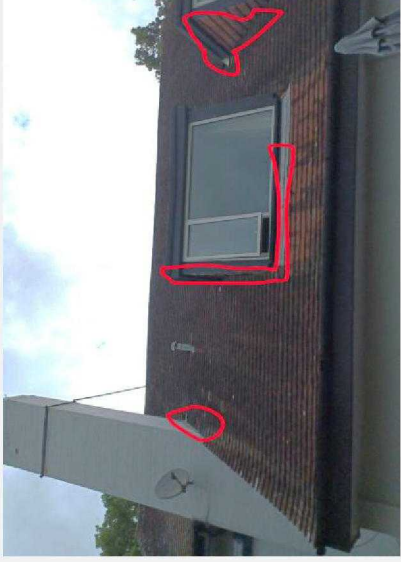
Building Name/Number	PRF	Location of PRF(s)	Photograph
House no. 68	<ul style="list-style-type: none">• Lifted lead flashing;• Gaps behind barge boards;• Gaps under tiles; and• Hanging tiles.	Southern aspect

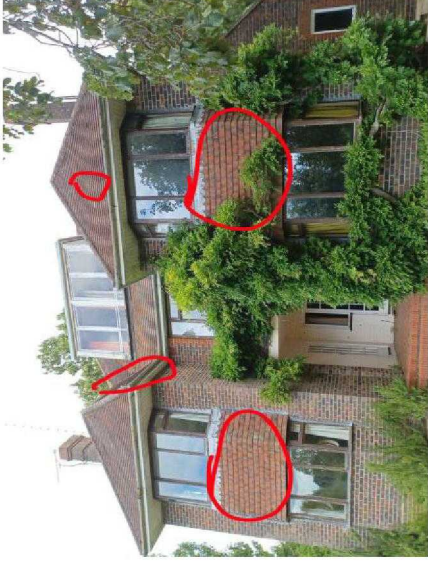
House no. 70	<ul style="list-style-type: none">• Hanging tiles; and• Slipped tiles.	Southern aspect

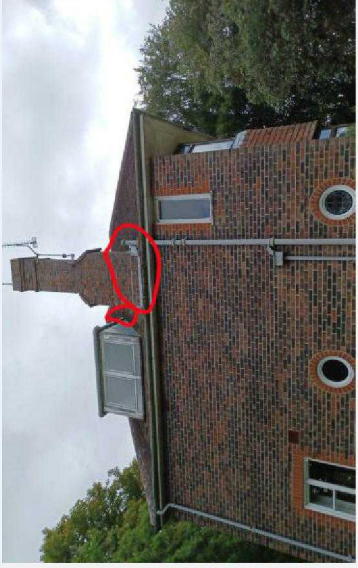
Building Name/Number	PRF	Location of PRF(s)	Photograph
	<ul style="list-style-type: none"> • Lifted lead flashing around chimney; and • Slipped tile. 	Western aspect

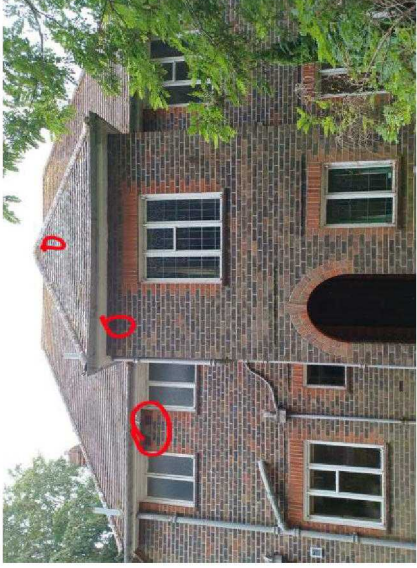
<ul style="list-style-type: none"> • Air vents; and • Slipped tile. 	Northern aspect

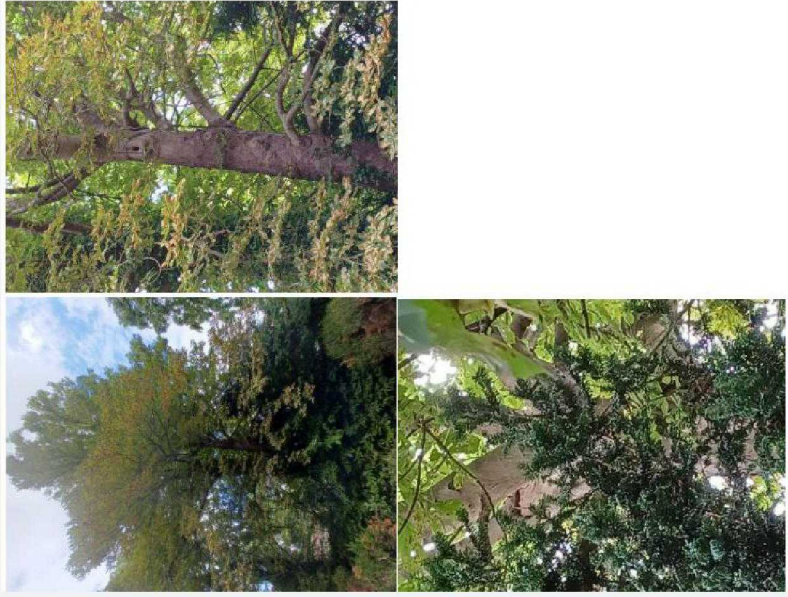
Tree No.	Species	Grid Reference	Potential Roosting Features with height and orientation	Tree / PRF Photograph
T58	Horse chestnut <i>Aesculus hippocastanum</i>	TQ30977 15420	<ul style="list-style-type: none"> • A knot hole on the stem, located on the southern aspect, approximately 7 m high and 6 cm wide; and • Pruning cuts on the stem, located on the northern aspect, approximately 7 m high and 3 cm wide. <p>These PRFs provide moderate suitability for roosting bats.</p>

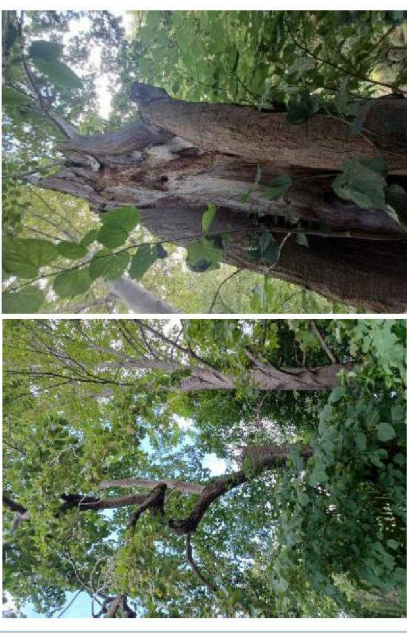
Tree No.	Species	Grid Reference	Potential Roosting Features with height and orientation	Tree / PRF Photograph
T4	Broad leaved lime <i>Tilia platyphyllos</i>	TQ30997 15418	<p>A transverse snap with ram horns and four knot holes on the stem, located on the northern aspect and approximately 2 m high.</p> <p>This PRF provides moderate suitability for roosting bats.</p>

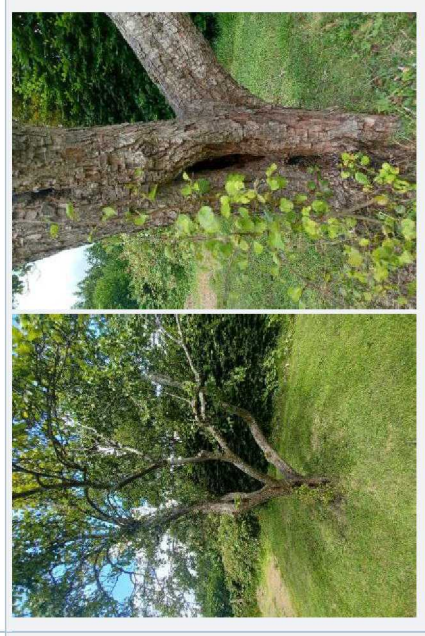
T40	Pear <i>Pyrus</i> sp.	TQ30952 15365	<p>A tear out on the stem, located on the southeastern aspect approximately 4 x 6 x 40 cm.</p> <p>This PRF provides low suitability for roosting bats.</p>

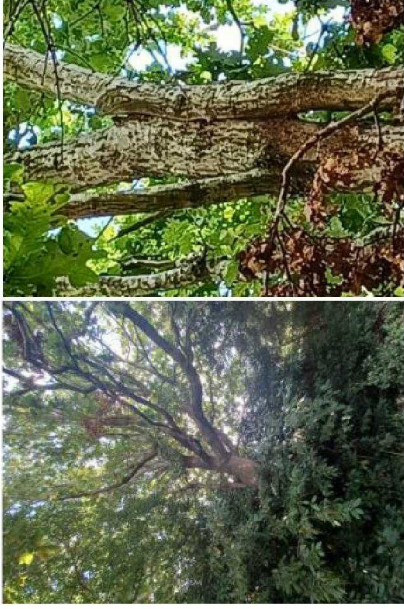
Tree No.	Species	Grid Reference	Potential Roosting Features with height and orientation	Tree / PRF Photograph
T15	Oak <i>Quercus</i> sp.	TQ 30994 15388	<p>Welds on the stem, located approximately 5 m high on the western aspect.</p> <p>This PRF provides moderate suitability for roosting bats.</p>

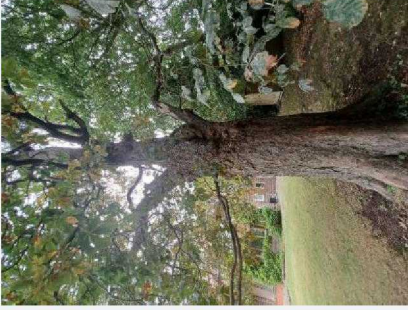
T16	Horse chestnut <i>Aesculus hippocastanum</i>	TQ 30985 15388	<ul style="list-style-type: none"> • A tear out full of water on the stem, located on the southern aspect, approximately 2 m high; • A knot hole on the stem, located on the southwestern aspect, approximately 2.5 m high and 5 cm wide; • A transverse snap on a limb, located approximately 6 m high on the northern aspect (potential squirrel drey); and • A desiccation fissure on a limb, located approximately 3 m high on the southern aspect. <p>These PRFs provide moderate suitability for roosting bats.</p>

At the time this report version being issued, T16 has been felled and removed from the site. This was done after all bat surveys has taken place and a likely absence of bats was assumed. No bats were discovered during the removal of this tree. T40 is still present on site and has features suitable for roosting bats. Therefore as a precautionary measure it is recommended that this tree is sectionally felled under supervision of a bat licenced ecologist.
