**Land off Scamps Hill,
Lindfield**

Designers Response Report

Report Reference 1723/4/A

Road Safety Audit: Stage 1

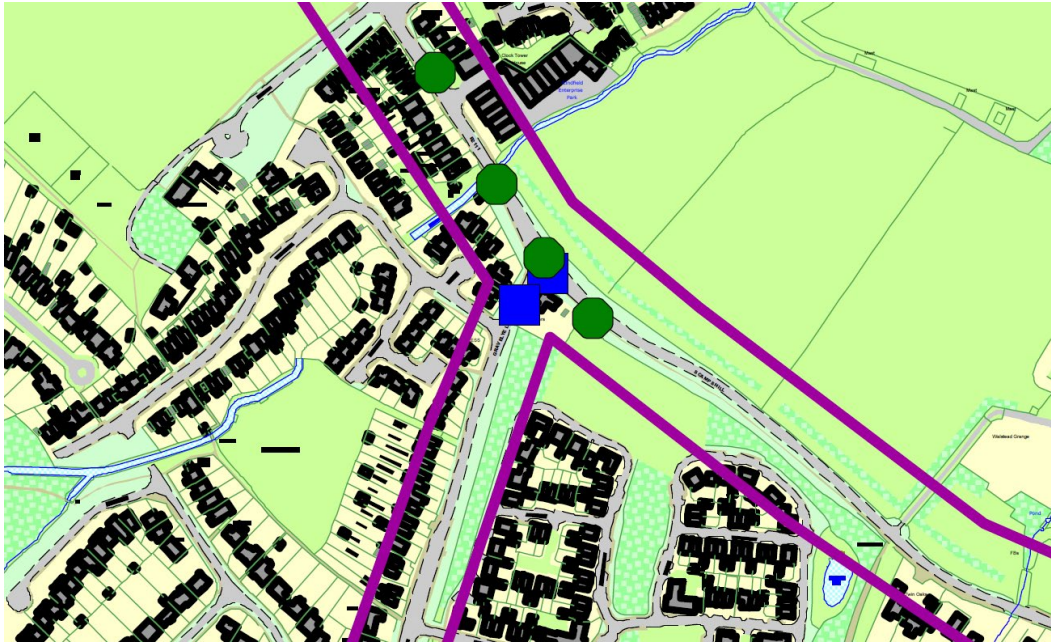
A total of six collisions have been recorded close to the proposed works. All of these collisions were to the west of the proposed access road. Four collisions; two serious and two slight in collision severity occurred at the junction with Gravelye Road.

An extract of the collision plot is shown below.

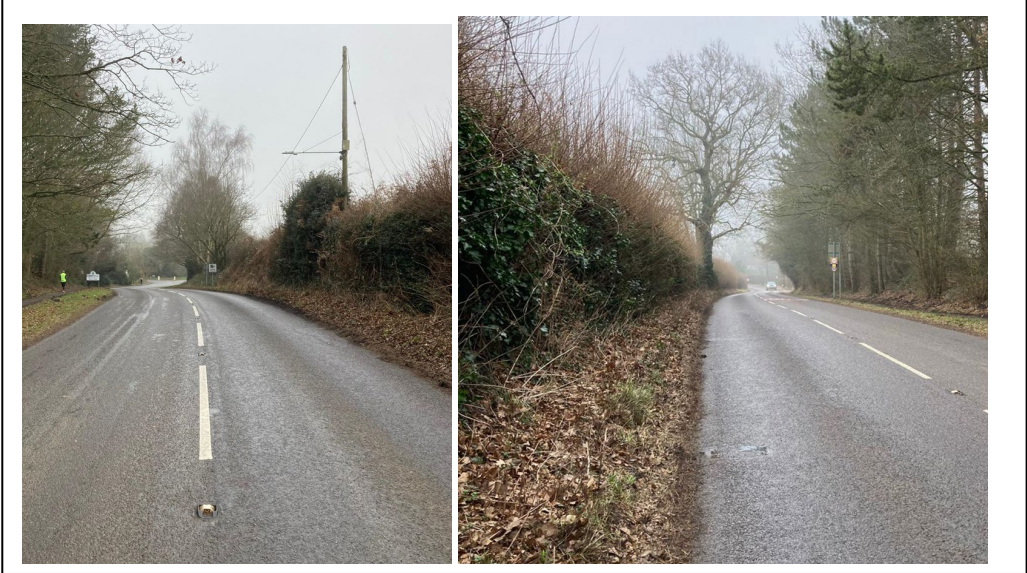
PROBLEM		1-1
Location:	Site access and uncontrolled crossing Scamps Hill.	
Summary:	Obstructed visibility will increase the risk of failure to give way and pedestrian/vehicle collisions.	
<p>Examination of the drawing provided does not clearly show any site clearance. The verge is heavily overgrown (photos).</p> <div style="display: flex; justify-content: space-around;">

</div> <p>Based on the drawings the existing vegetation will obstruct visibility and as such will increase the risk of failure to give way and pedestrian/vehicle collisions.</p>		
RECOMMENDATION		
Ensure that all vegetation is removed that can obstruct visibility.

2.1.4.1 Ensure that all vegetation is removed that can obstruct visibility.

2.1.5.1 It is accepted that some hedgerow will need to be removed/relocated near to the Site access to enable the provision of protected visibility splays. However, Drg No 1723/08 demonstrates that the majority of the sightlines are contained to within the grass verge (splay to the right) or the Scamps Hill carriageway (splay to the left) and are unaffected by vegetation.

RSA Problem	RSA Recommendation	Design Organisation Response	Overseeing Organisation Response	Agreed RSA Action
<p>1. Site access and uncontrolled crossing Scamps Hill.</p> <p>Obstructed visibility will increase the risk of failure to give way and pedestrian/vehicle collisions.</p> <p>Examination of the drawing provided does not clearly show any site clearance. The verge is heavily overgrown (photos). Based on the drawings the existing vegetation will obstruct visibility and as such will increase the risk of failure to give way and pedestrian/vehicle collisions.</p>	<p>Ensure that all vegetation is removed that can obstruct visibility.</p>	<p>It is accepted that some hedgerow will need to be removed/relocated near to the Site access to enable the provision of protected visibility splays. However, Drg No 1723/08 demonstrates that the majority of the sightlines are contained to within the grass verge (splay to the right) or the Scamps Hill carriageway (splay to the left) and are unaffected by vegetation.</p>	<p>The land required for the visibility splays at the site access and nearby uncontrolled crossing point is within the existing public highway and/or land forming part of the development. The extent of any vegetation clearance can be determined through the detailed design/s278 agreement.</p>	<p>No further action required at this stage.</p> <p>The exact details of vegetation clearance are to be agreed as part of the detailed design.</p>

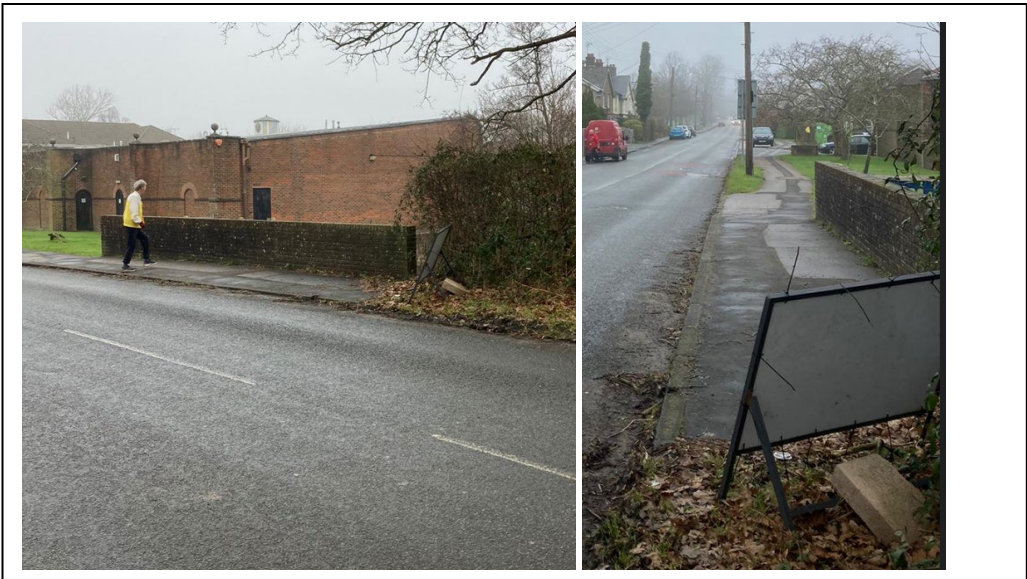
PROBLEM		1-2
Location:	Pedestrian/cycle access and connection to current footway Scamps Hill.	
Summary:	A lack of safe cycle facilities will increase the risk of cycle/pedestrian collisions and cyclist injuries.	
<p>It is proposed to create a 3.0m shared use route through the site and connect up to an existing footway to the west of the site access near Gravelye Lane. There does not appear to be any means by which cyclists are directed to rejoin the carriageway. The Audit Team were also concerned that this would result in cyclists travelling westbound on the footway and onto the bridge over the Scrase Stream. The bridge parapet did not seem high enough to safely allow a cyclist to use the footway and ride over the</p>

<p>bridge (photos). With the footway being narrow it would seem likely that there could either be a collision between a cyclist and a pedestrian or even due to the narrow width a cyclist could topple over the parapet.</p> <p>A lack of safe cycle facilities will increase the risk of cycle/pedestrian collisions and cyclist injuries.</p>

2.2.5.1 It is not the intention to encourage cyclists to use the existing footway on the north side of the B2111 and, particularly, the section of footway on the bridge. The scheme will include suitable cycle transition treatment with associated dropped kerbs, tactile paving and signage. An indicative arrangement is shown on **Drg No 1723/08/A** (refer Appendix C). The arrangement can be further considered at Detailed Design stage.

RECOMMENDATION		
<p>Either ensure that cyclists can safely rejoin the carriageway or increase the height of the parapet to 1400mm.</p>

<p>2. Pedestrian/cycle access and connection to current footway Scamps Hill.</p> <p>A lack of safe cycle facilities will increase the risk of cycle/pedestrian collisions and cyclist injuries.</p> <p>It is proposed to create a 3.0m shared use route through the site and connect up to an existing footway to the west of the site access near Gravelye Lane. There does not appear to be any means by which cyclists are directed to rejoin the carriageway. The Audit Team were also concerned that this would result in cyclists travelling westbound on the footway and onto the bridge over the Scrase Stream. The bridge parapet did not seem high enough to safely allow a cyclist to use the footway and ride over the bridge (photos). With the footway being narrow it would seem</p>	<p>Either ensure that cyclists can safely rejoin the carriageway or increase the height of the parapet to 1400mm.</p>	<p>It is not the intention to encourage cyclists to use the existing footway on the north side of the B2111 and, particularly, the section of footway on the bridge. The scheme will include suitable cycle transition treatment with associated dropped kerbs, tactile paving and signage. An indicative arrangement is shown on Drg No 1723/08/A. The arrangement can be further considered at Detailed Design stage.</p>	<p>Cyclists are to be directed back onto the carriageway were the cycle way ends rather than a shared use route continuing off-carriageway. The indicative arrangement is considered appropriate. The exact details can be considered through the detailed design/s278 agreement.</p>	<p>No further action required at this stage.</p> <p>The exact details are to be agreed through the detailed design.</p>

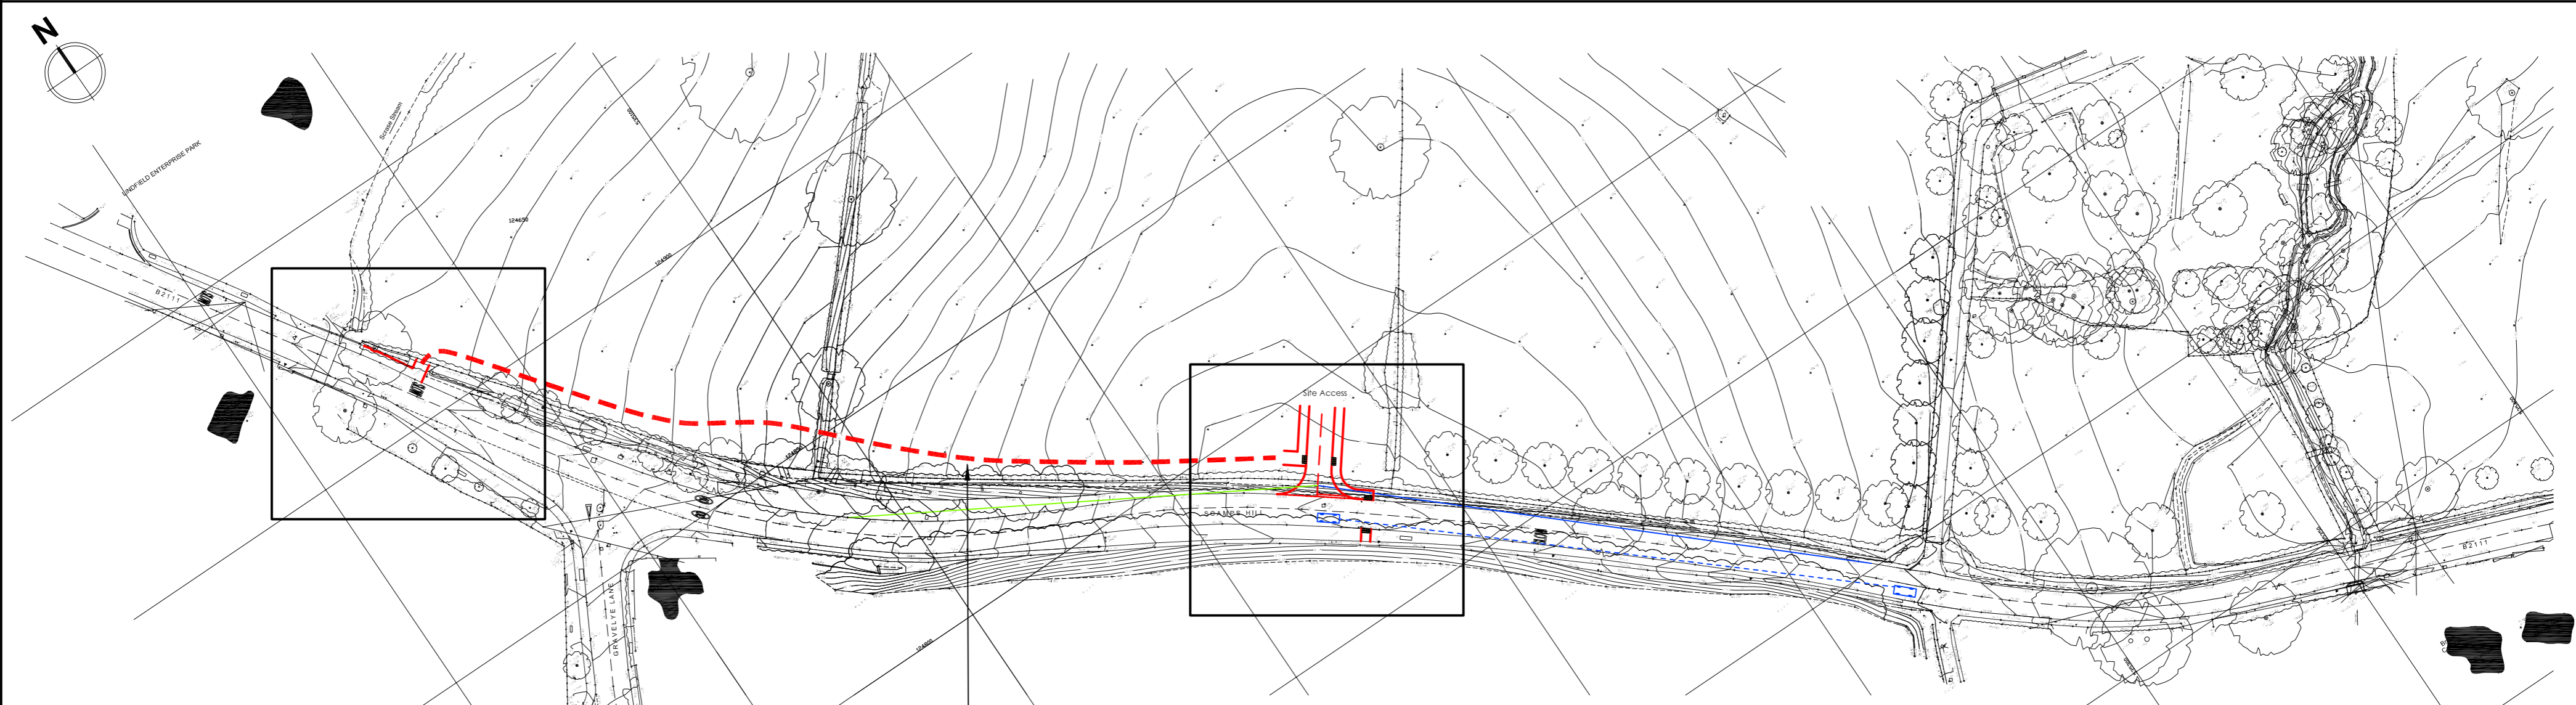
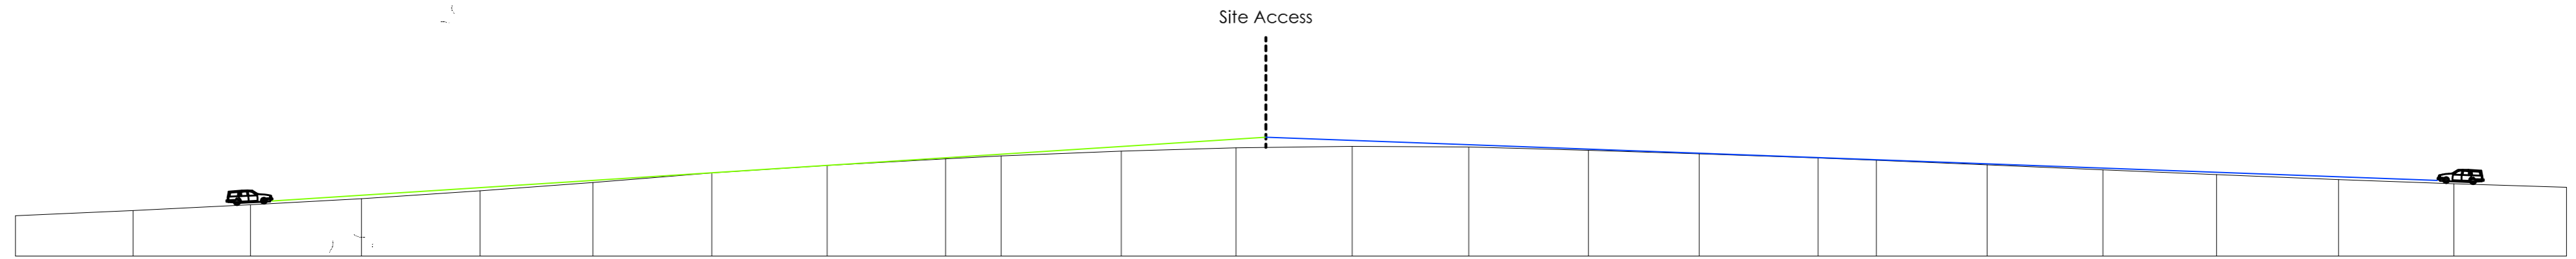
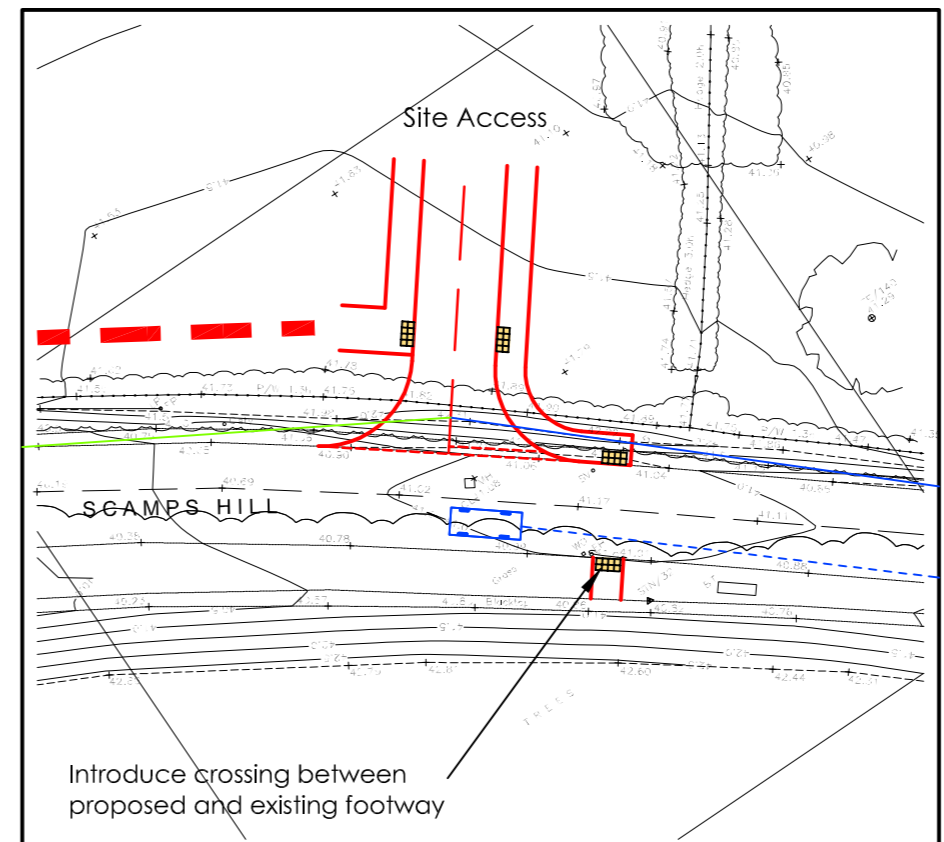
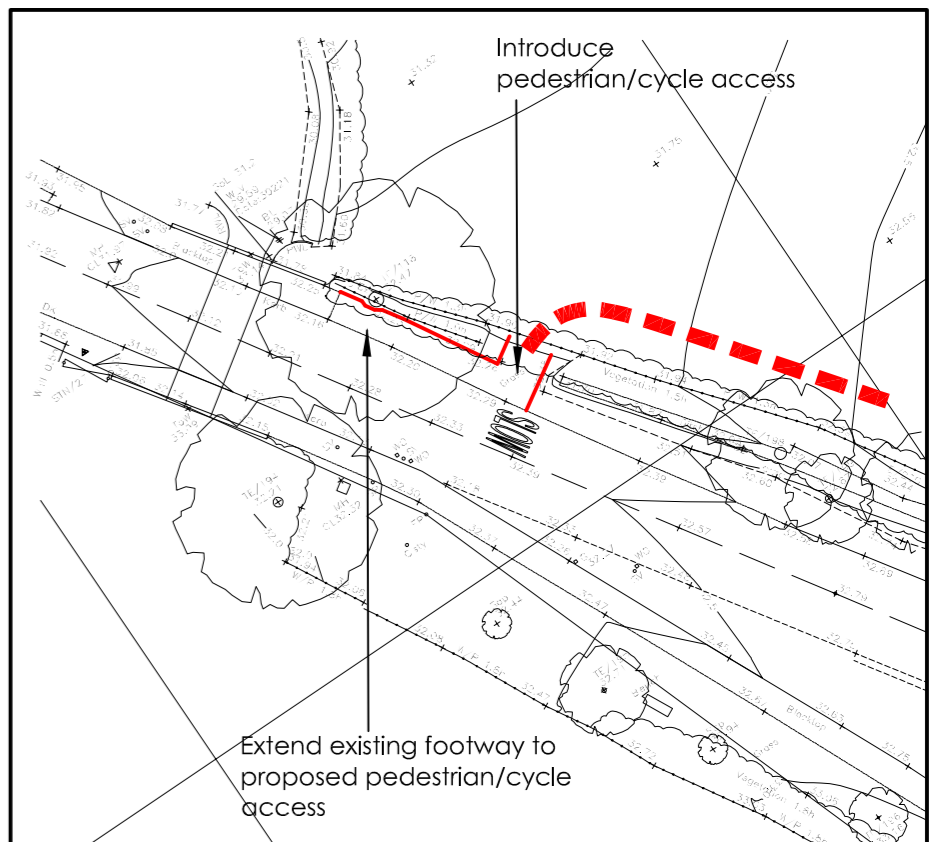
B Drg No 1723/08

1.2.2 The scheme shown on Drg No 1723/08 comprises:

- (i) Introduce new Site Access, forming a 'T' junction with Scamps Hill;
- (ii) Junction to operate under priority control;
- (iii) Site Access to measure 5.5m wide with 2.0m wide footways;
- (iv) 6.0m corner radii between the Site access and Scamps Hill;
- (v) Introduce dropped kerbs and tactile paving on Scamps Hill to the east of the Site access;
- (vi) Introduce 3.0m wide shared footway/cycleway within the Site between the proposed Site access and a point near the western boundary of the Site;
- (vii) Provide 2.4m x 120m visibility splay to the left, for vehicles emerging from the Site Access;
- (viii) Provide 2.4m x 101m visibility splay to the right, for vehicles emerging from the Site Access.

Driver's Eye Height: 1.05m
Object Height: 0.26m

Indicative route of 3.0m wide footway/cycleway

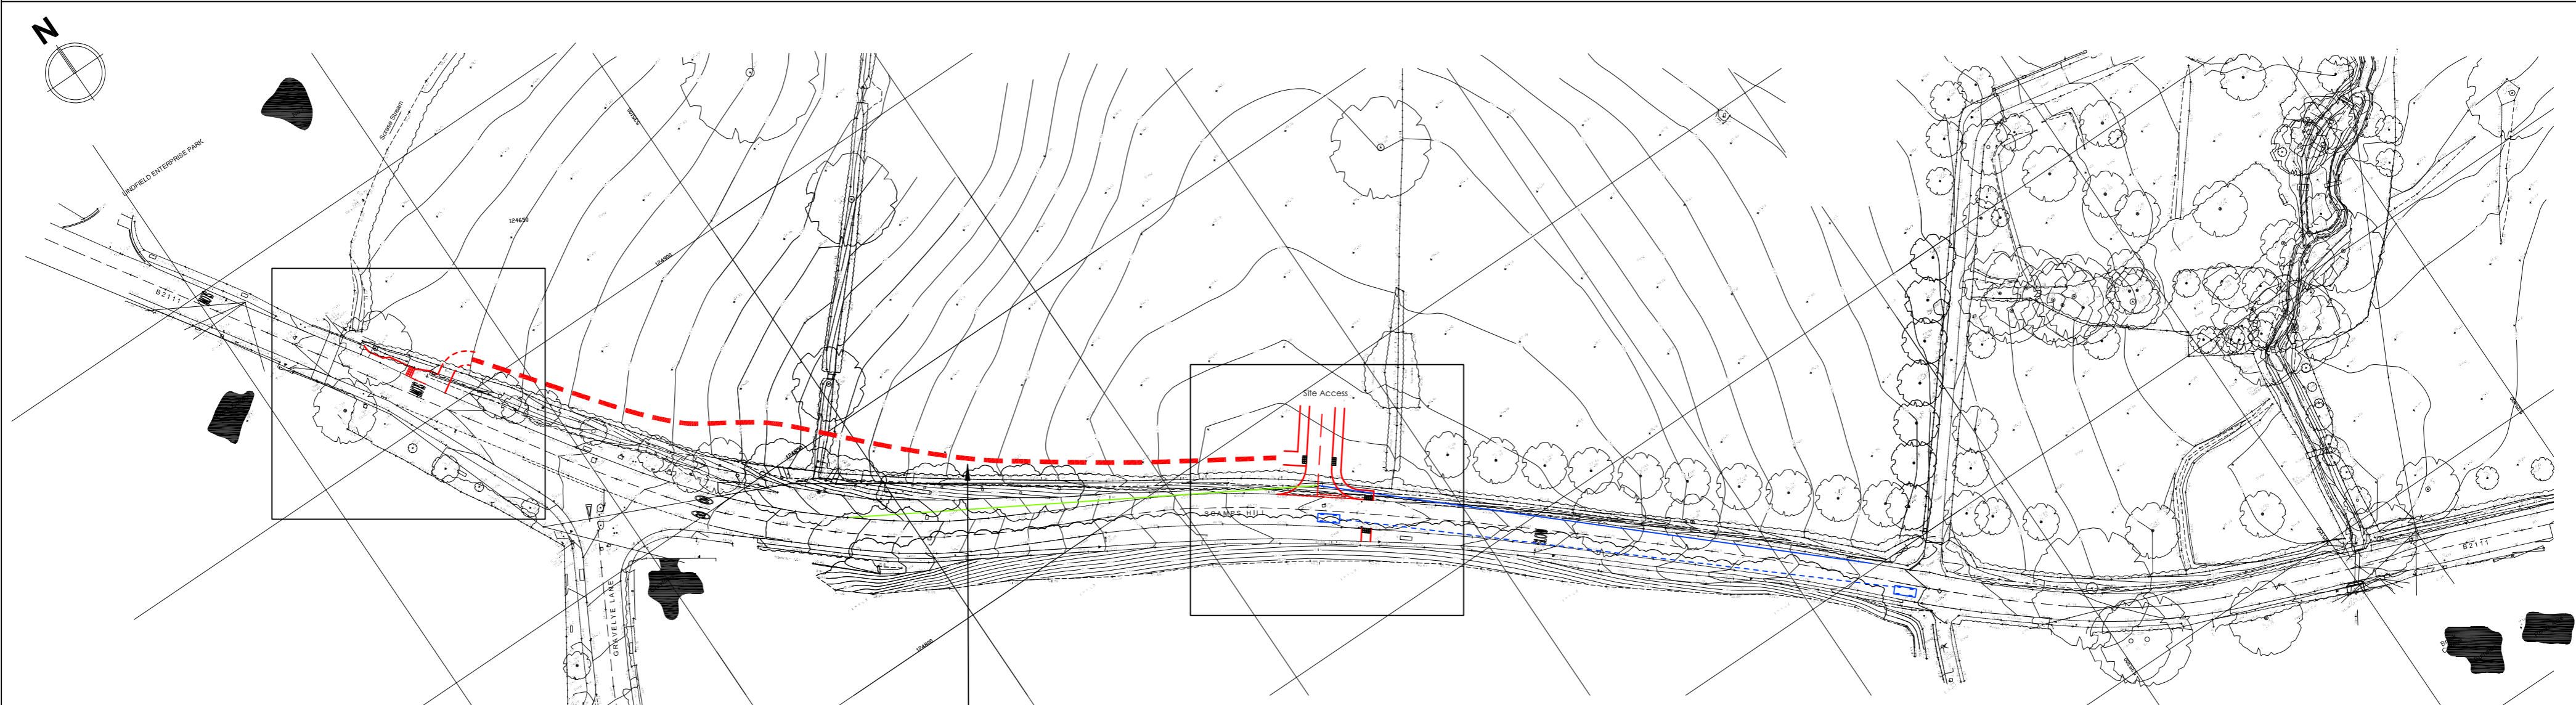
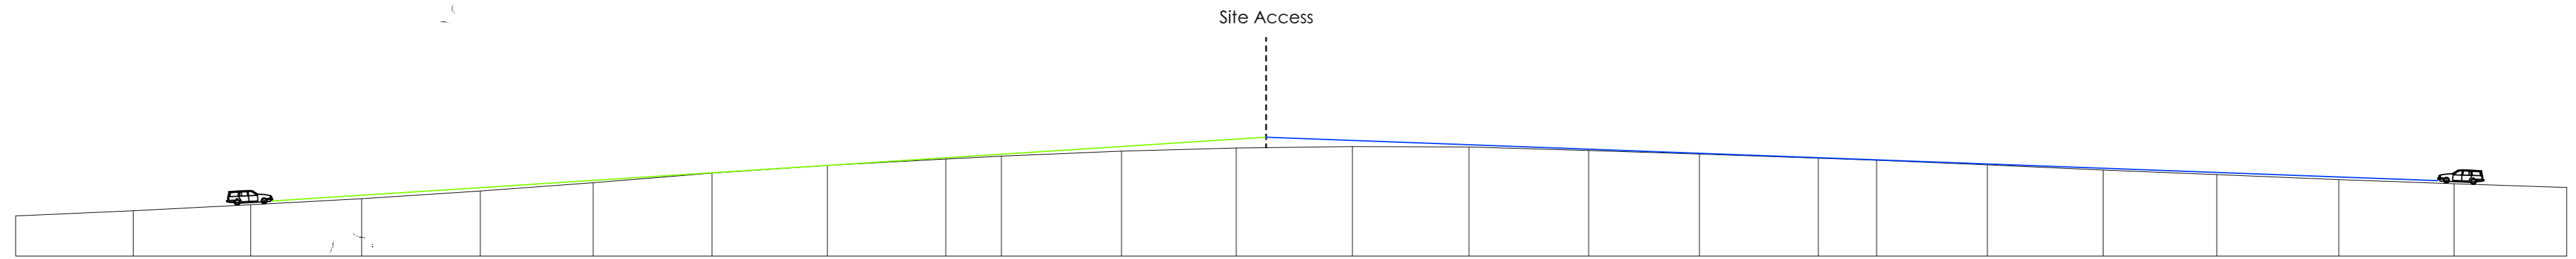
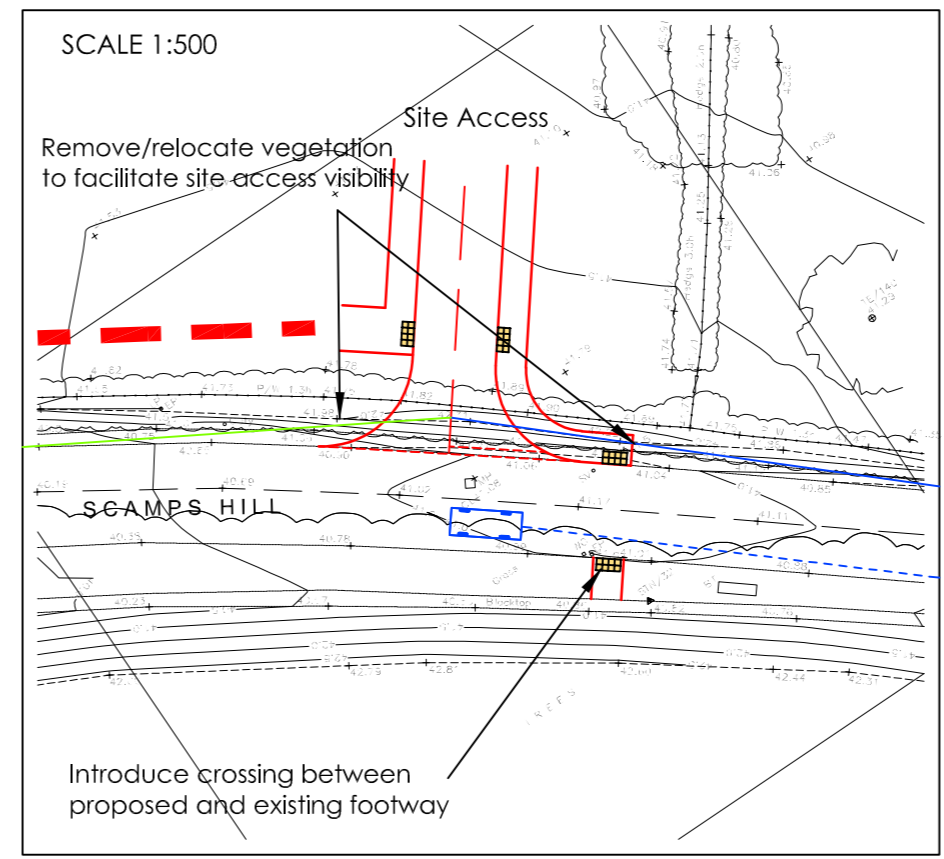
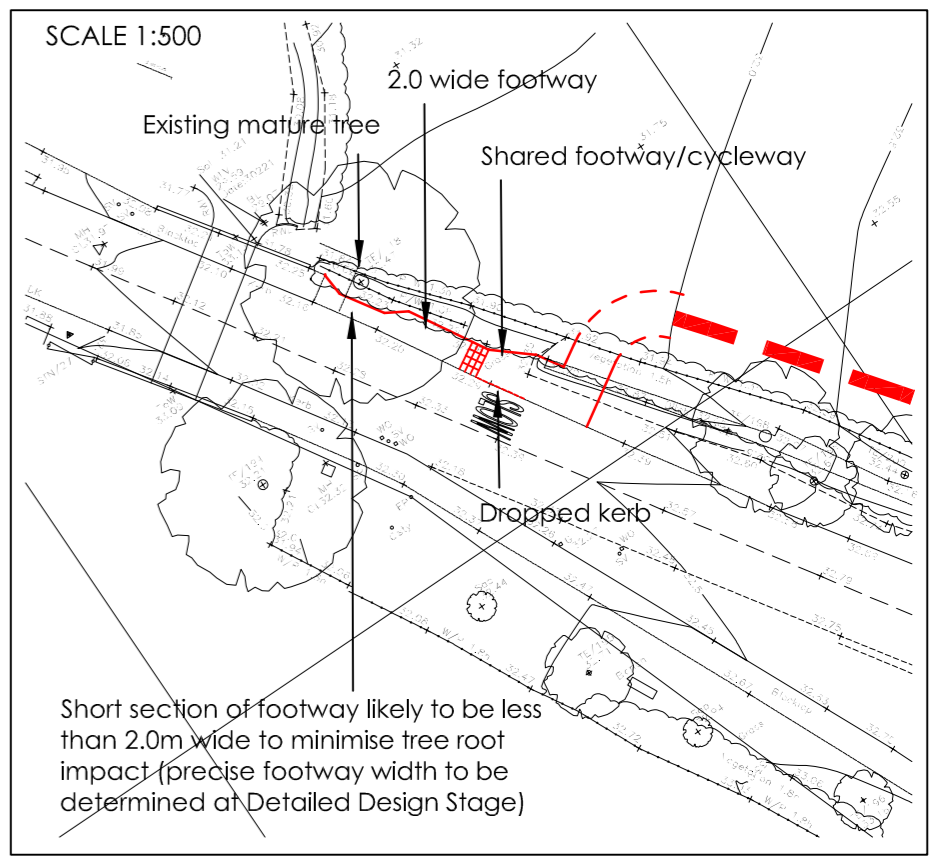
C Drg No 1723/08/A

- 3.2 The RSA identified only two problems and provided recommendations to address the issues.
- 3.3 AHA has carefully considered each problem and the recommendations of the Stage 1 Safety Audit Report. Drg No 1723/08/A has been prepared in response to comments about the treatment for cyclists at the western end of the proposed shared footway/cycleway. It is considered that the problems identified in the RSA are capable of being overcome at Detailed Design Stage.
