Inert Recycling Operation, associated Landscape Strategy (earthworks and native planting), Bolney
Park Farm, London Road, Bolney RH17 5QF

Appendix 1 LVIA 2020 Viewpoints 1 to 6

hla 394 R02 rev A

For PJB Construction Ltd

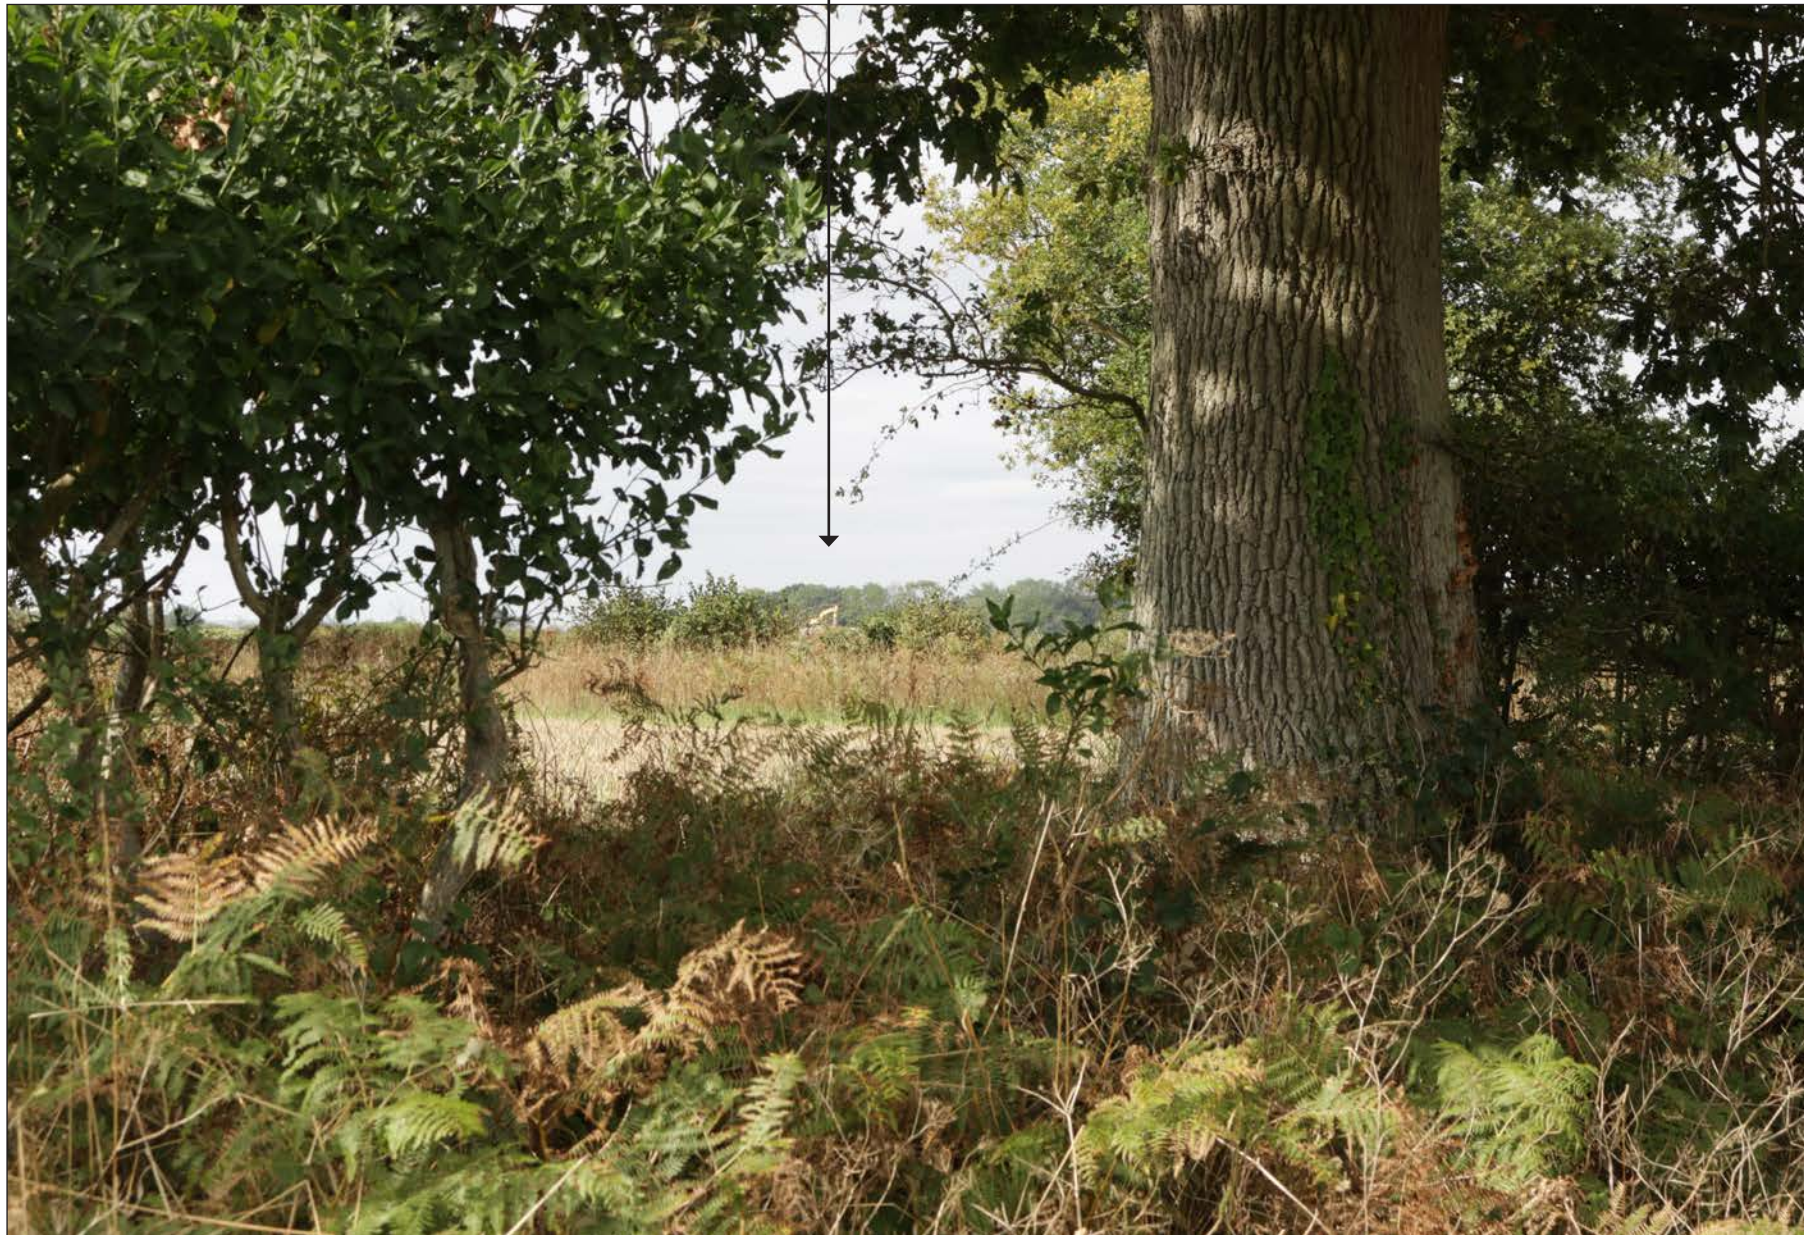
3.1 Viewpoint 1

Digger on Site
just discernible when
boom arm is in the
up position

3.1.1 *Location:* From PRoW 16CR (Footpath) 1km north east of the Site.
GPS ref: Lat 51.011063, Long -0.179872.

3.1.3 *Existing Views Description:* This is a long distance, partial and obscure rural view that looks south west towards the Site. The yellow digger can be seen through a rare gap in the hedge and tree planting although the main Site workings are predominantly screened. This is not representative of the typical views from this section of footpath and the Site is screened from view except at Viewpoints 1 and 2.

3.1.7 *During Operation Magnitude of Impact:* **Negligible Adverse.** (Construction machinery only, is barely discernible from this rare viewpoint. The Site workings have no influence on this section of footpath nor from this rare view as seen between tree and hedgerow planting).

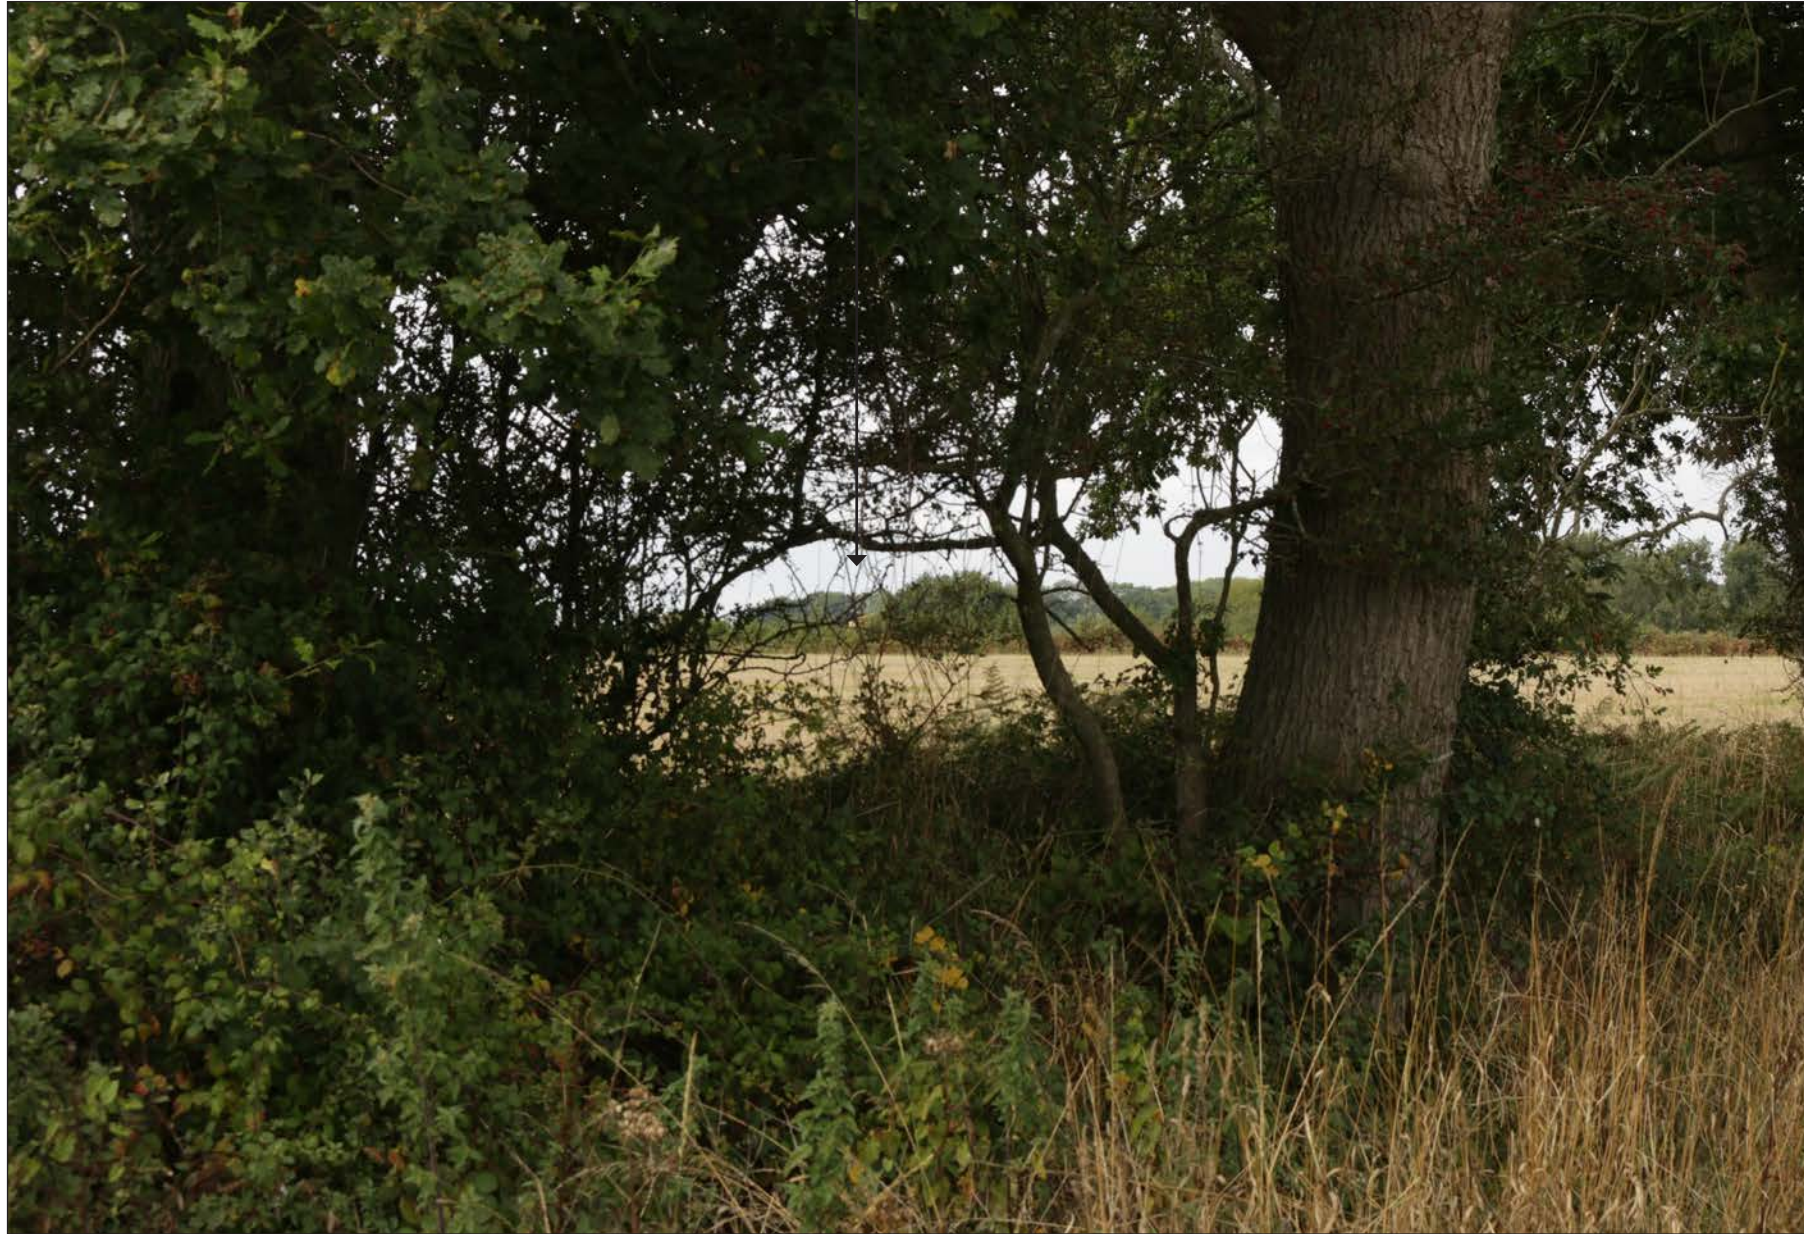
3.2 Viewpoint 2

Digger on Site
just discernible

3.2.1 *Location:* From PRoW 16CR (Footpath) 900m north west of the Site. GPS ref: Lat 51.11063, Long -0.181377.

3.2.3 *Existing Views Description:* This is a medium distance, partial and obscure rural view that looks south west towards the Site. The yellow digger can be seen through a rare gap in the hedge and tree planting although the main Site workings are predominantly screened. This is not representative of the typical views from this section of footpath and the Site is screened from view except at Viewpoints 1 and 2.

3.2.7 *During Operation Magnitude of Impact:* **Negligible Adverse.** (Construction machinery only, is barely discernible from this rare viewpoint. The Site workings have no influence on this section of footpath nor from this rare view as seen between tree and hedgerow planting).

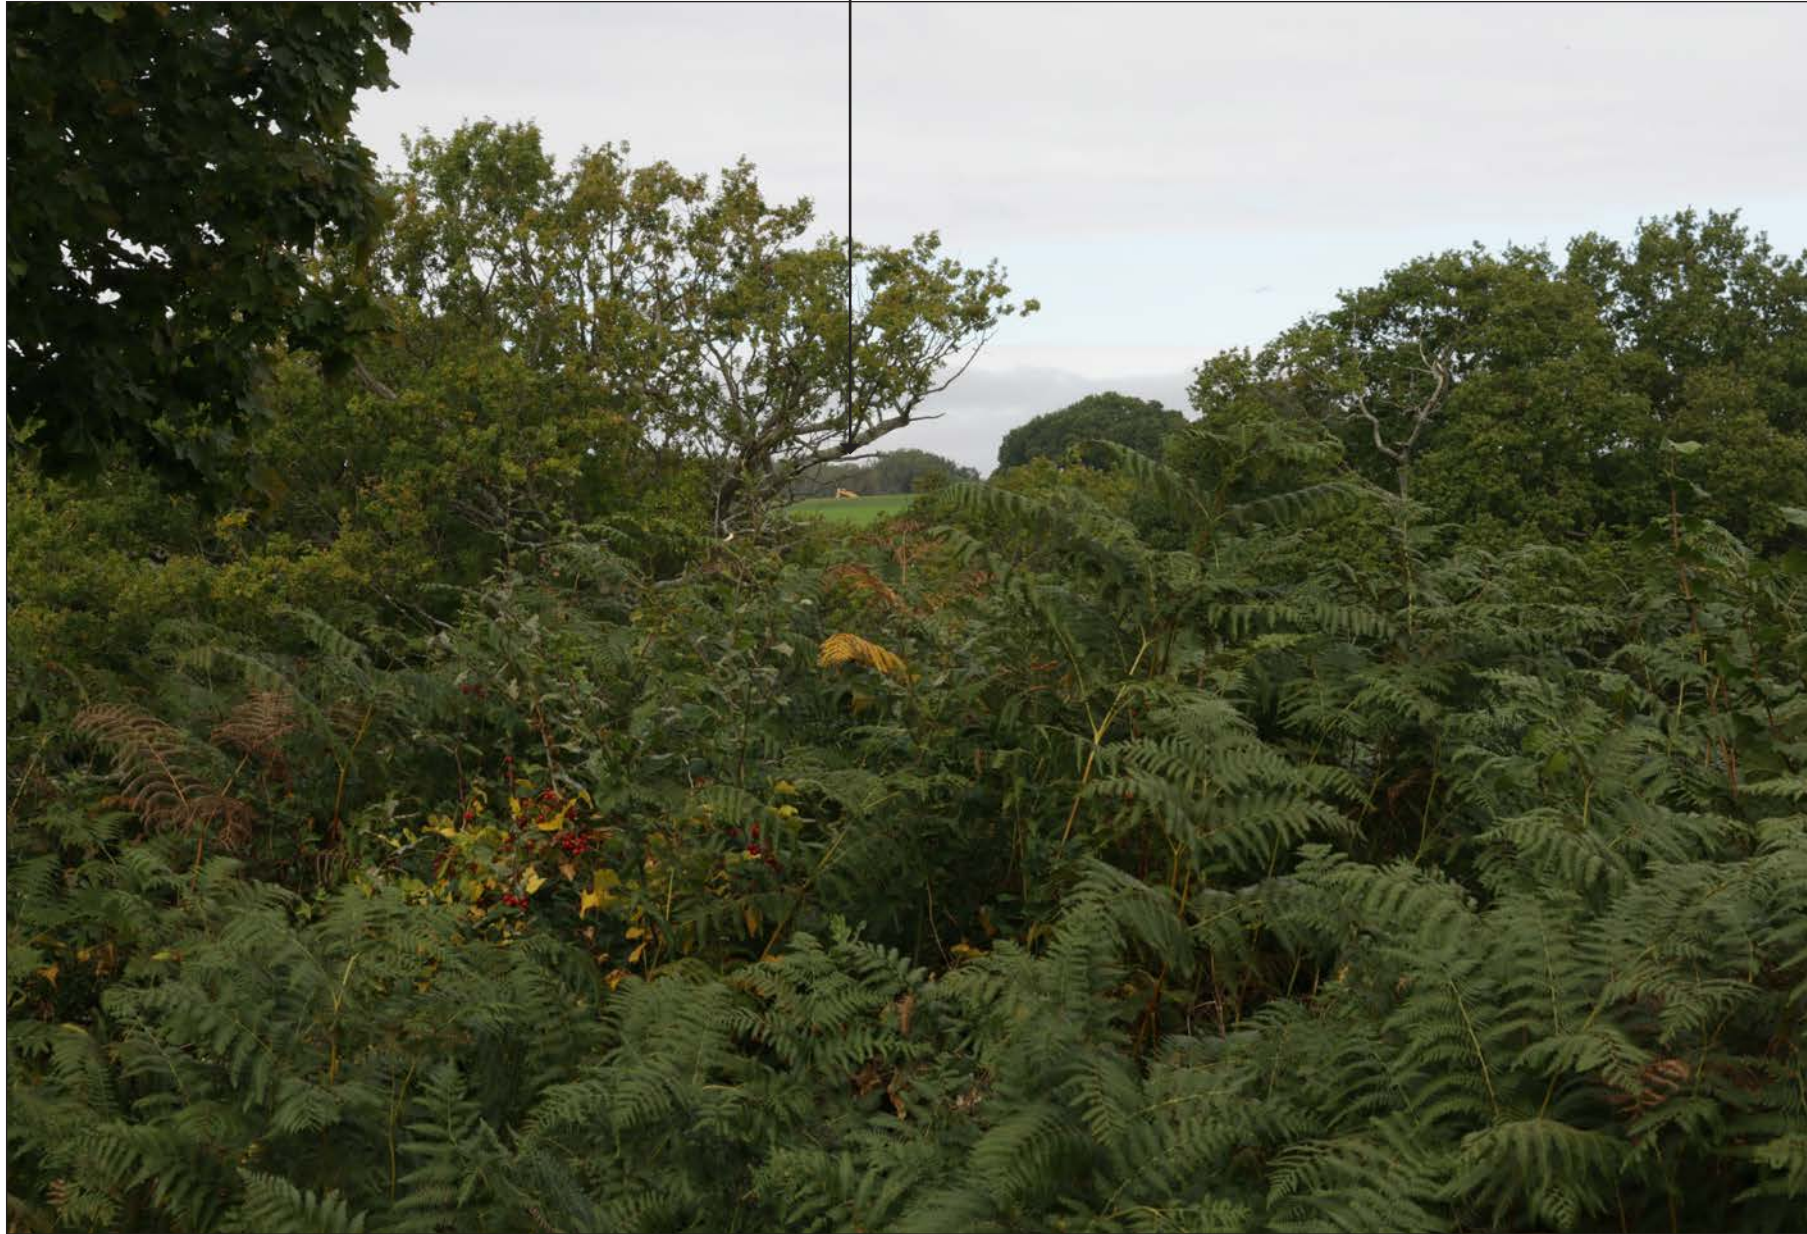
3.3 Viewpoint 3

Digger on Site
just discernible when
boom arm is in the
up position

3.3.1 *Location:* From Broxmead Lane 990m south east of the Site.
GPS ref: Lat 50.001803, Long -0.182722.

3.3.3 *Existing Views Description:* This is a medium distance, partial and obscure rural view that looks south west towards the Site. The yellow digger can be seen through a solitary gap in the hedge and tree planting although the main Site workings are screened. This is not representative of the typical views from Broxmead Lane and the Site is screened from view except at this specific Viewpoint.

3.3.7 *During Operation Magnitude of Impact:* **Negligible Adverse.** (Construction machinery only, is barely discernible from this rare viewpoint. The Site workings have no influence on this section of footpath nor from this rare view as seen between tree and hedgerow planting).

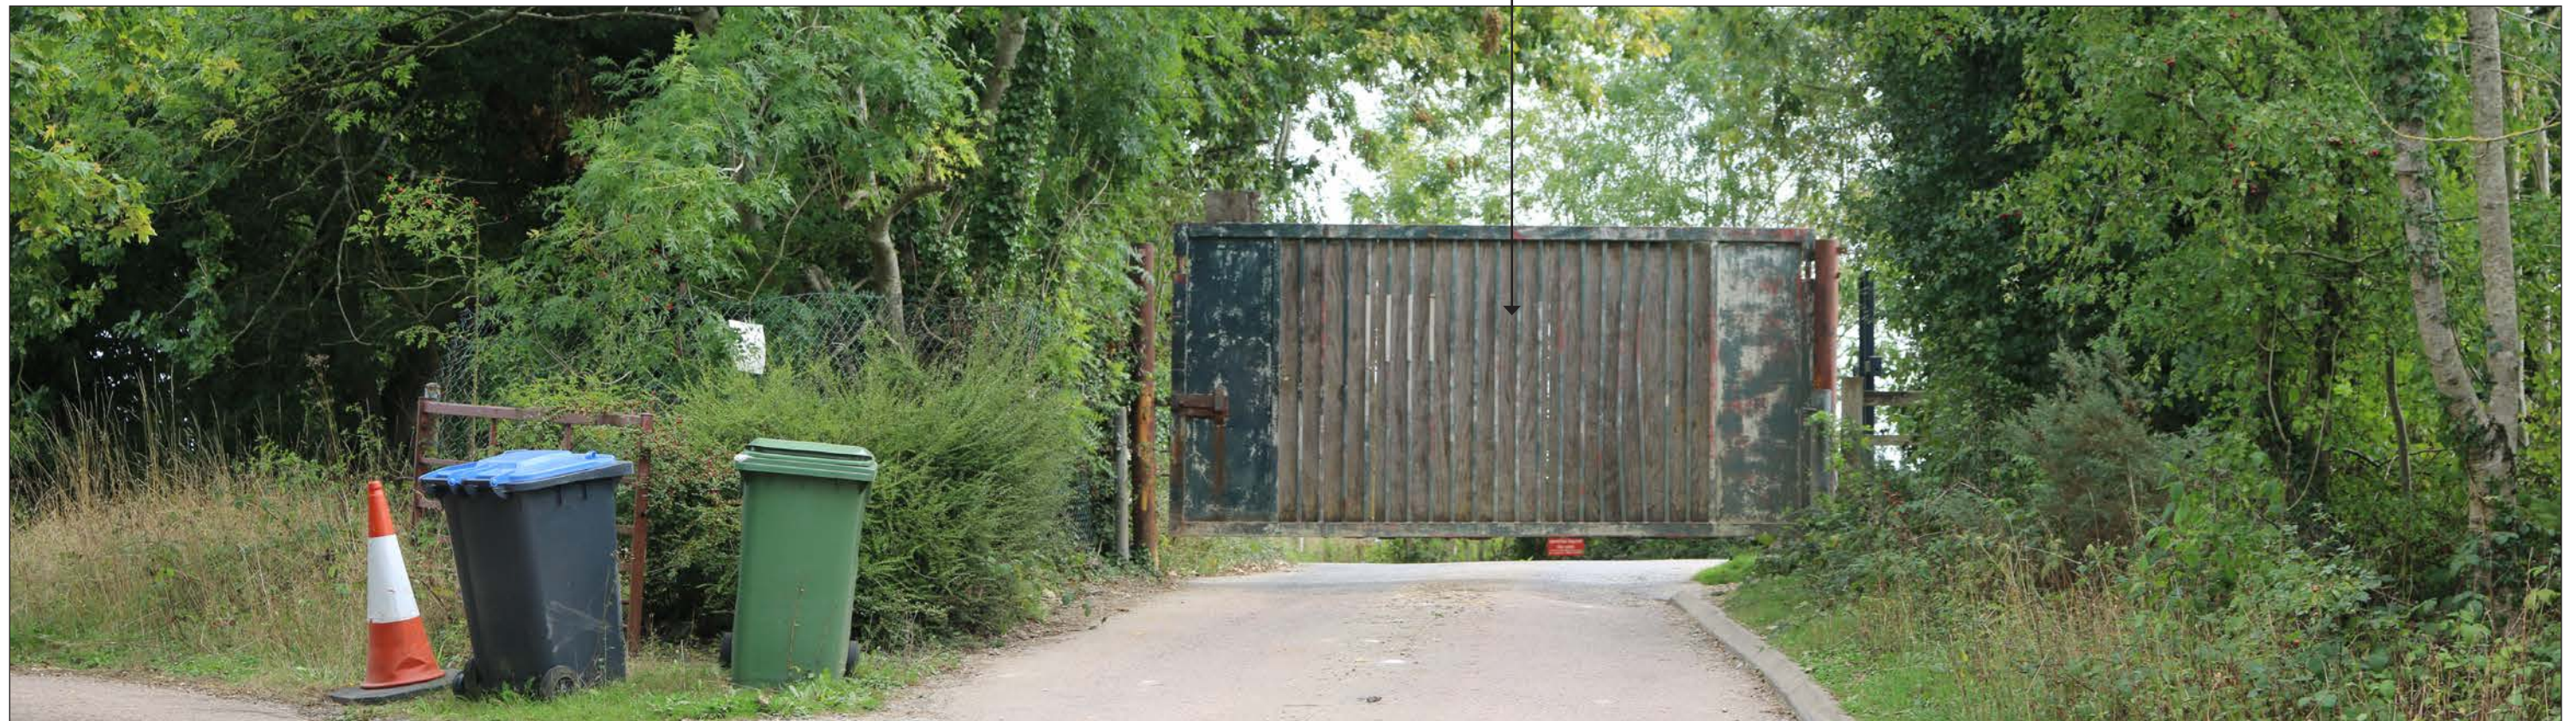
3.4 Viewpoint 4

- 3.4 Viewpoint 4, see Figure 1
- 3.4.1 *Location:* From A23 access looking east towards Site located 180m east. GPS ref: Lat 51.006768, Long -0.196991.

- 3.4.2 *Photographic Height:* 98m AOD (plus 1.5m photographers view).
- 3.4.3 *Existing Views Description:* This is a near distance screened view that looks east towards the Site which cannot be seen. The intervening gate and tree planting screen the views in. There are 25-30 lorry and car movements per day at random times between 8am and 5pm.

- 3.4.6 *Visual Sensitivity of Receptors* **Low**.
- 3.4.7 *During Operation Magnitude of Impact:* **Negligible Adverse**. (Lorries are occasionally seen accessing the Site although views would be from fast moving traffic on the A23 and therefore would be almost entirely indiscernible and this would be incrementally different to the agricultural vehicles that used the Site prior to the Recycling Operation).

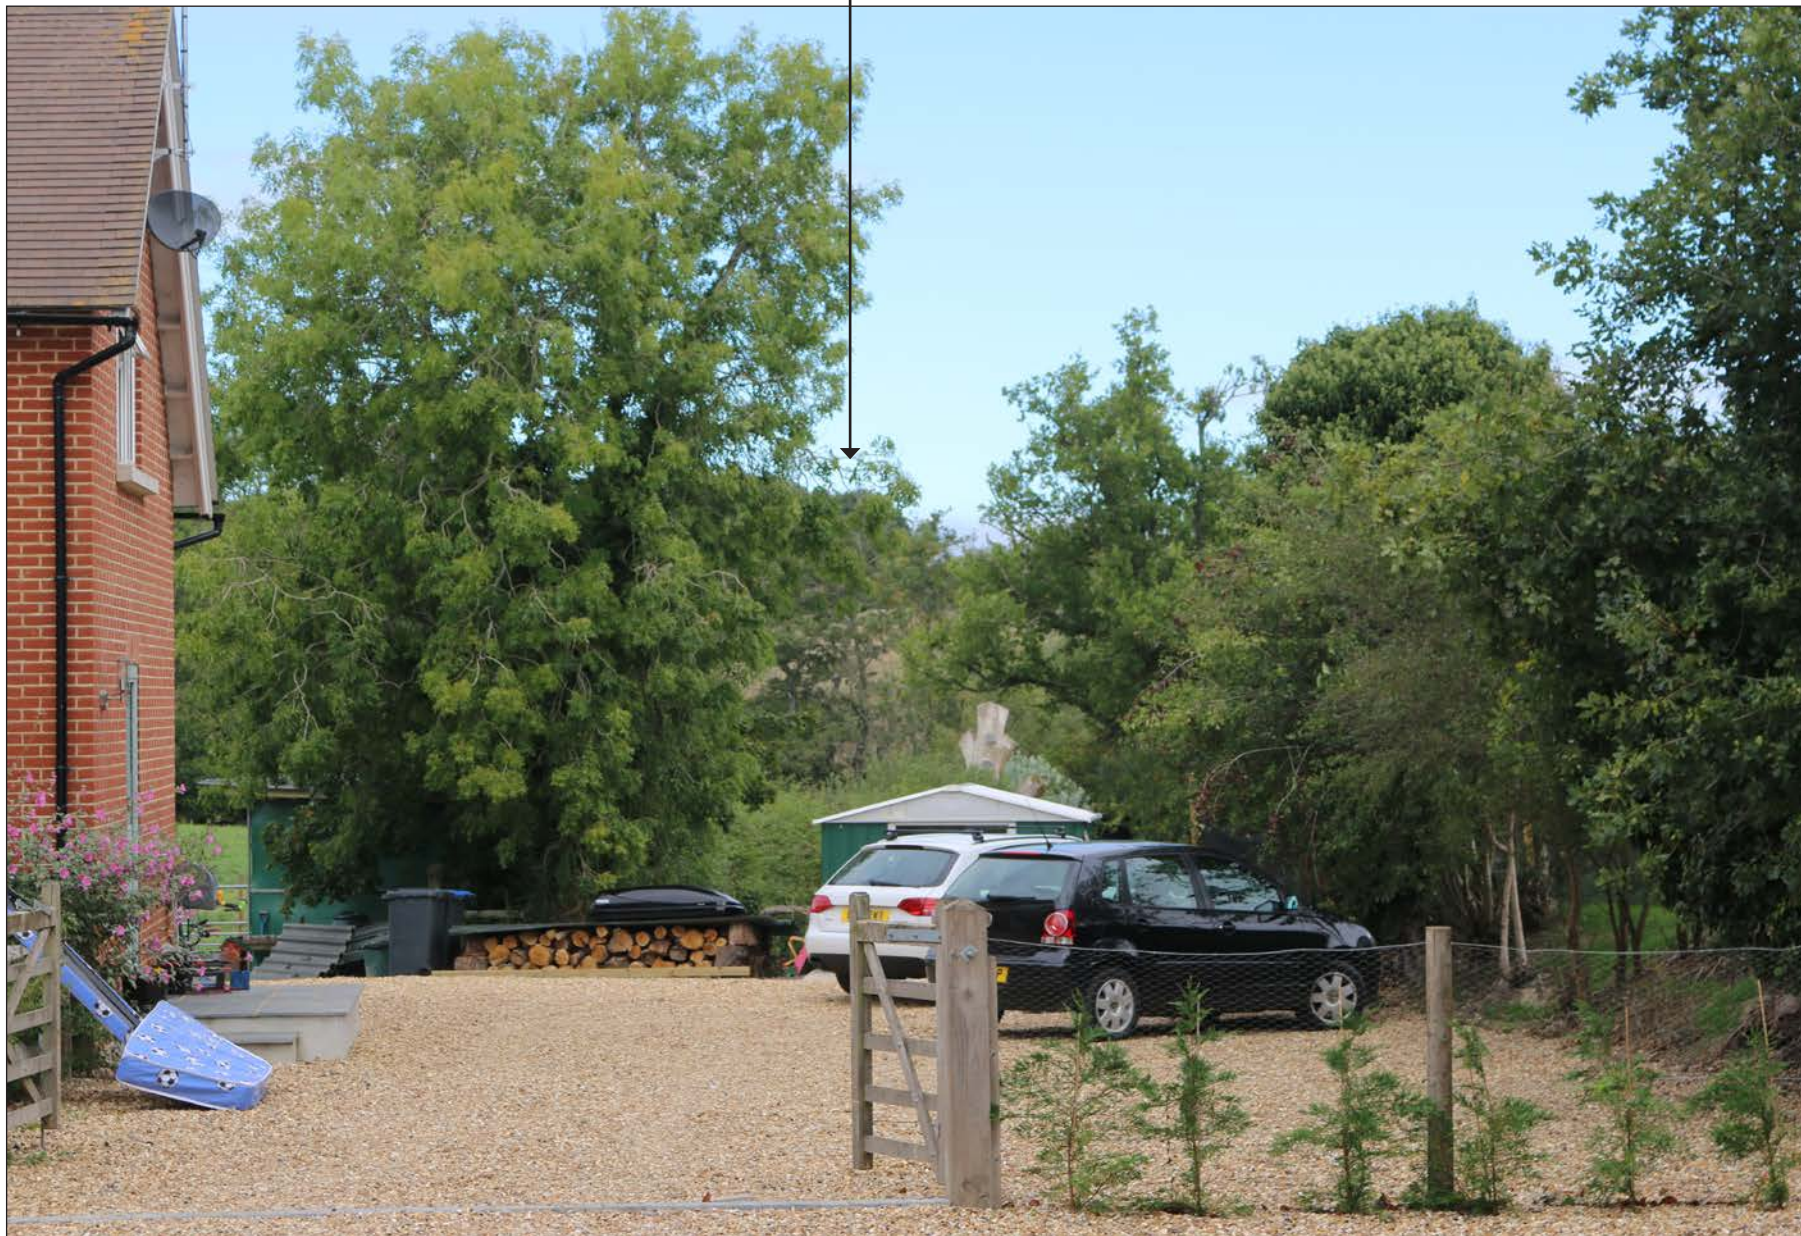
3.5 Viewpoint 5

Site almost entirely
indiscernible beyond
planting

3.5.1. *Location:* From Park Farm Cottages housing estate 550m south of the Site. GPS ref: Lat 51.001980, Long -0.194436.

3.5.3 *Existing Views Description:* This is a medium distance, rural residential view that looks north in the direction of the Site which is predominantly screened by the existing planting located on the north side of the estate.

3.5.7 *During Operation Magnitude of Impact: Negligible Adverse.* (The Site workings have no influence on views from this location although it may be more open in winter when there are no leaves on the trees).

3.5.9 *Mitigation or planting strategy:* Not required but native planting could be implemented at the southern end of the Site to restrict any winter intervisibility that may be seen.

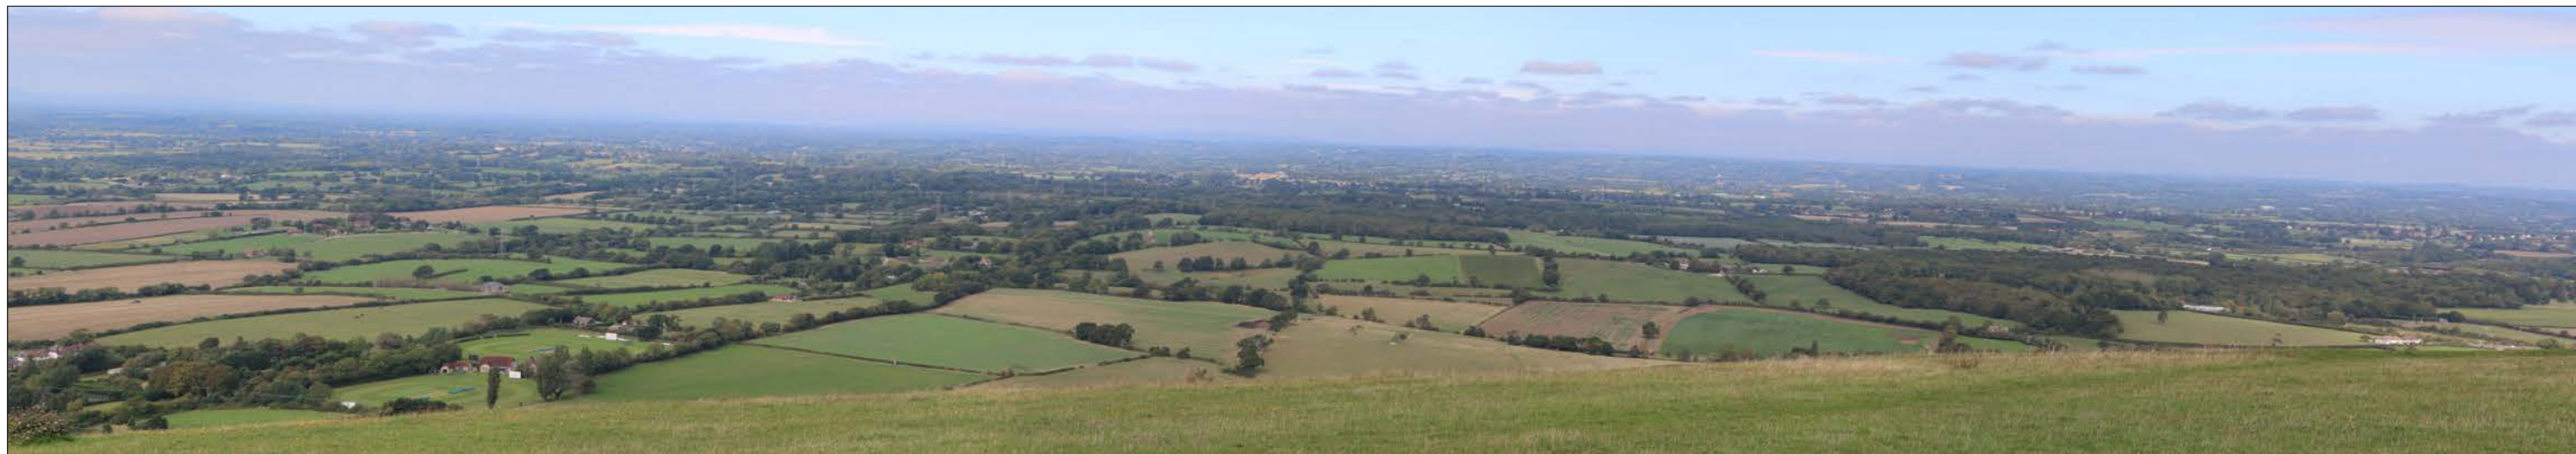
3.6 Viewpoint 6

- 3.6 Viewpoint 6, see Figure 1
- 3.6.1 *Location:* From the car park at Devils Dyke approximately 12km south of the Site.
GPS ref: Lat 50.885833, Long -0.212159.

- 3.6.2 *Photographic Height:* 215m AOD (plus 1.5m photographers view).
- 3.6.3 *Existing Views Description:* This is a high quality long distance view across the Low Weald from an elevated location on the top of the South escarpment at Devils Dyke. The Site is indiscernible from this range.
