**Road Safety Audit Stage 1 & 2**

**Proposed Section 278 Works**

**Roundabout for Development Site Access**

**Imberhorne Lane**

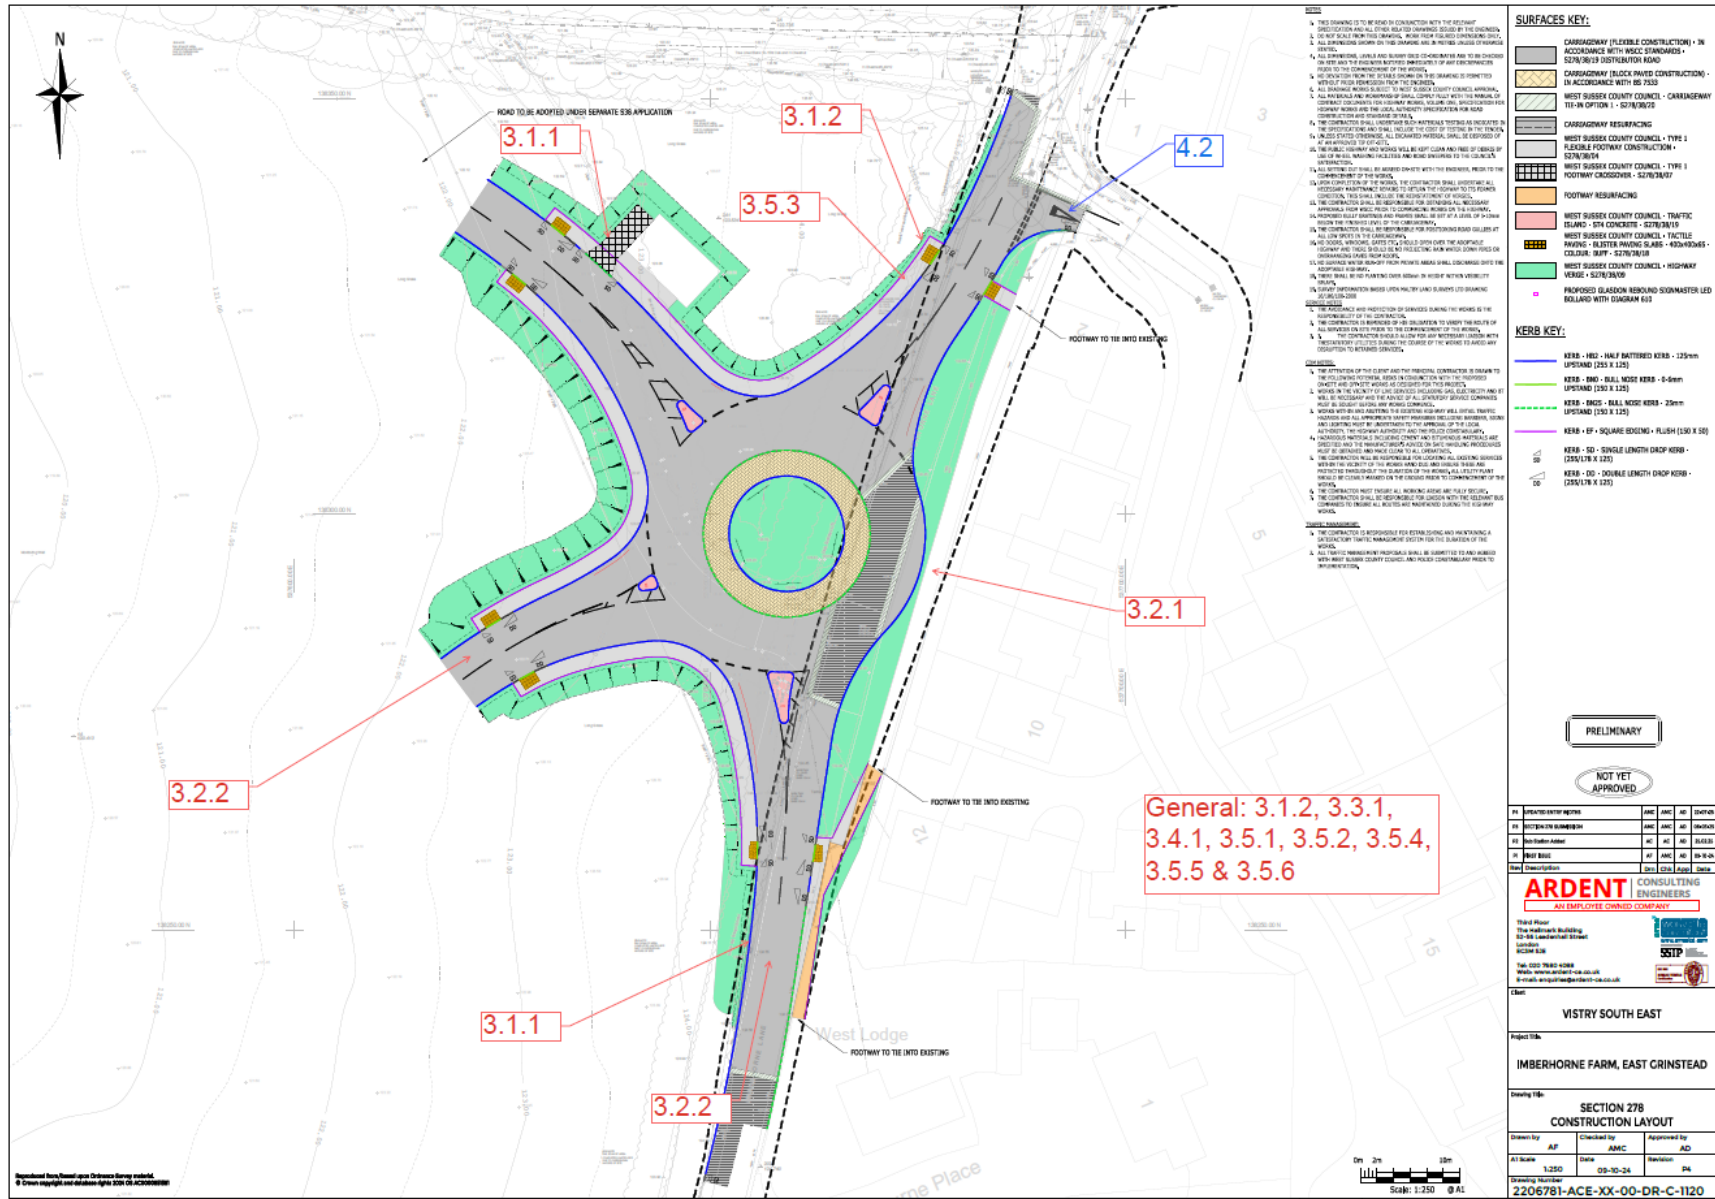
## **APPENDIX B**

Plan attached showing the locations of the problems identified as part of this audit (location numbers refer to paragraph numbers in the report).
