## **Damp and Timber Survey Report**

### **Marshall's Manor**

High Street  
Cuckfield  
Haywards Heath  
West Sussex  
RH17 5EL

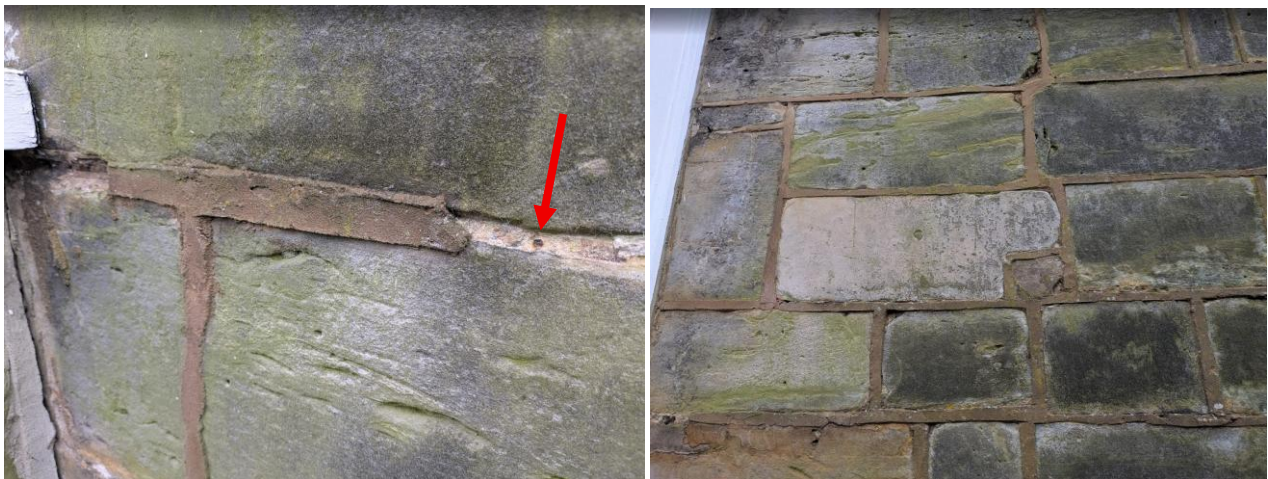
The Ardingly sandstone used on the main elevation is naturally porous. It contains tiny voids and capillaries that allow it to absorb water during rainfall and then release it again as conditions dry. This cycle of wetting and drying is normal and helps the stone remain durable over time.

That balance changes when cement pointing is introduced. Cement is harder and far less breathable than traditional lime mortar. Instead of helping the wall dry through the joints, it slows evaporation and forces more of the drying process to occur through the stone's face. As a result, the masonry remains wet for longer after rainfall. Water is not escaping as efficiently as it was designed to, and the stone stays saturated for extended periods.

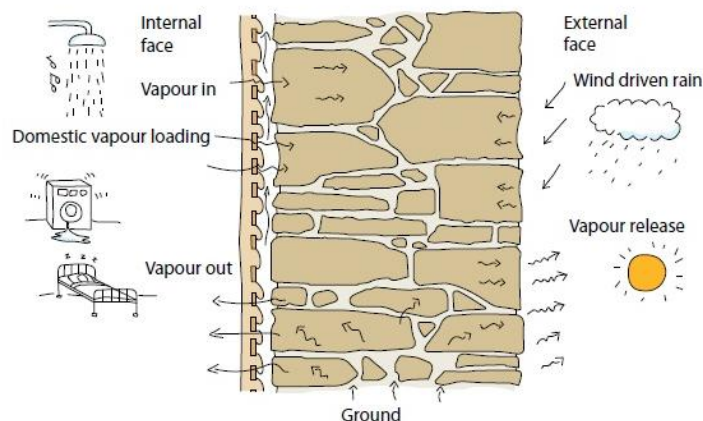
The main building is constructed in sandstone, a heavy material with significant thermal mass. Traditionally, these walls relied on a balance of heat, airflow and breathability. They would slowly absorb warmth, release it gradually, and allow water to evaporate through lime mortar and vapour-open finishes. That balance kept the internal environment stable.

When we alter that fabric by introducing cement pointing, dense plasters and restricted ventilation, we change how the building behaves. The walls stay colder, drying slows down, and the internal climate becomes more humid. The physics upon which the house once relied are disrupted, see below.

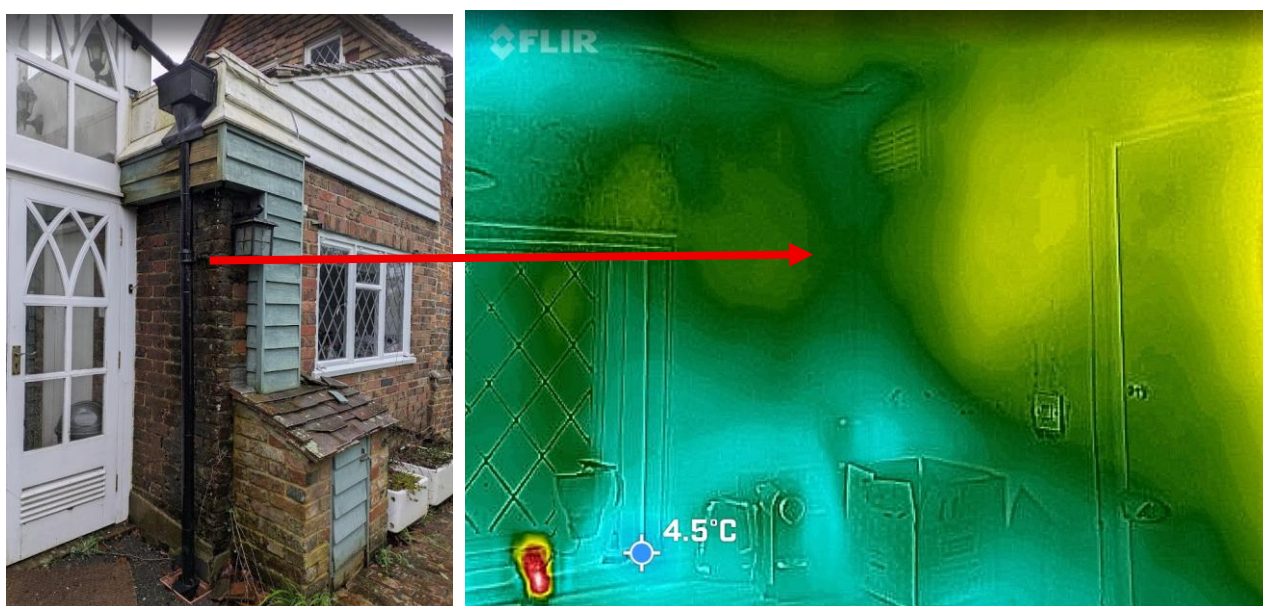
The damp symptoms in the master bedroom is being caused by a failure in the rainwater hopper above. During rainfall, water is discharging onto the wall rather than fully entering the downpipe, leading to repeated masonry saturation below. This is a localised rainwater issue, not a general damp condition.

Internally, the wall is currently finished with gypsum board. The gypsum forms a relatively sealed surface, limiting drying from the inside. As a result, water becomes trapped within the wall and small cavity and migrates towards the internal surface, leading to blistering and paint failure. The completely wet surfaces are indicated in pink and blue.

The affected area is on the first floor and directly aligned with the defective hopper. There is no evidence of moisture travelling from anywhere else nearby.

Moisture readings confirm that the issue is confined to the hopper alignment zone.

The first step is to repair the hopper and ensure rainwater is properly directed into the drainage system. Cement pointing in the affected area should then be replaced with compatible lime mortar to restore outward drying.

Damaged internal plaster should be removed locally, and the wall allowed to dry naturally over time. Reinstatement should use breathable materials to prevent recurrence.

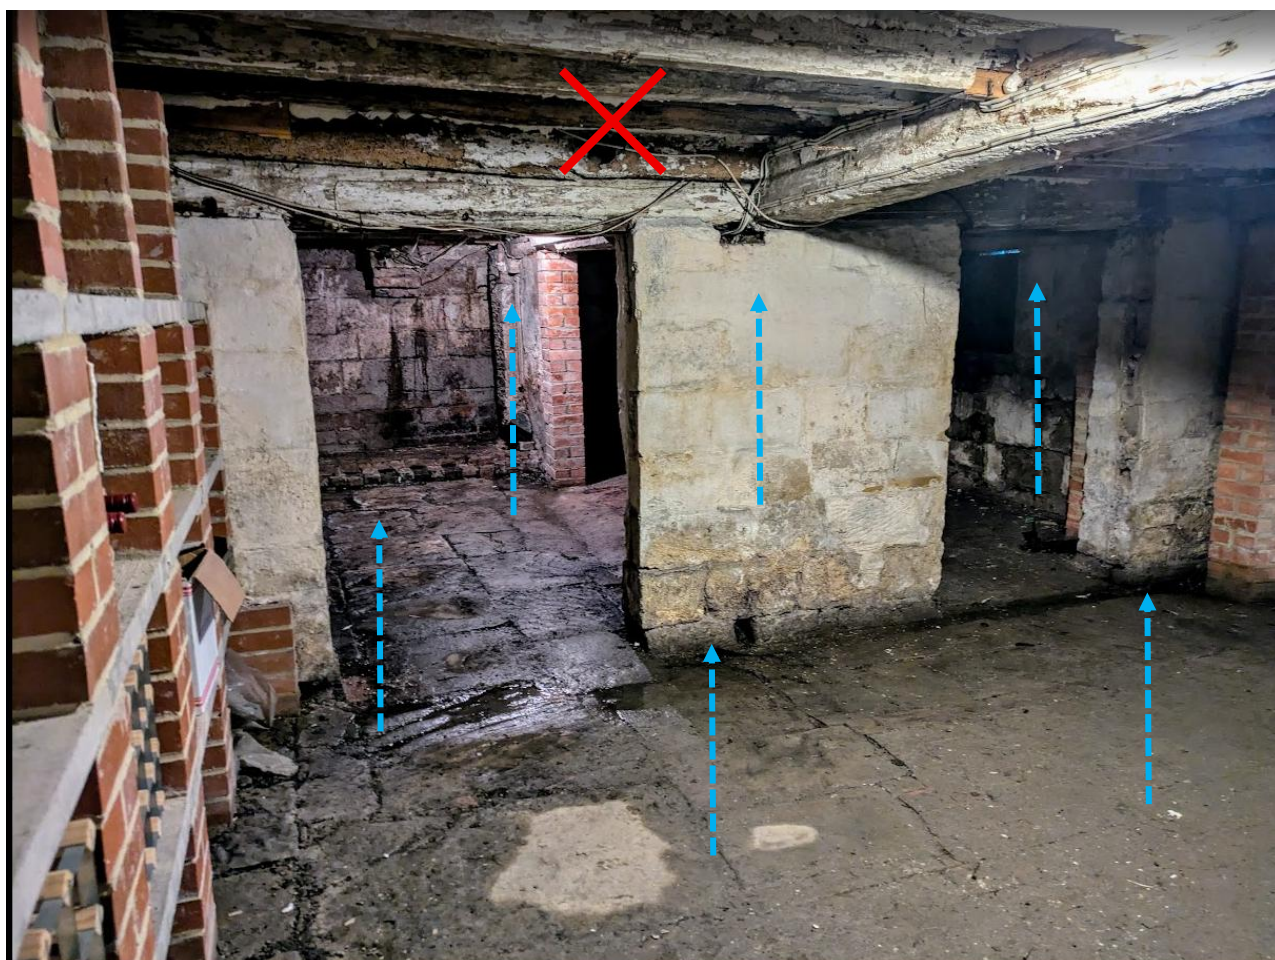
As internal vapour load increases, the dew point temperature rises. When the dew point rises, surfaces that were previously above the condensation threshold may fall below it.

This means that the basement condition influences condensation risk in upper floors, even if those rooms have no direct water ingress.

The priority is to remove the standing water and restore drainage. Once liquid water is removed, mechanical ventilation must be introduced to keep the basement humidity below 65%. Until that source of airborne humidity is controlled, the upper floors will continue to feel its effects.

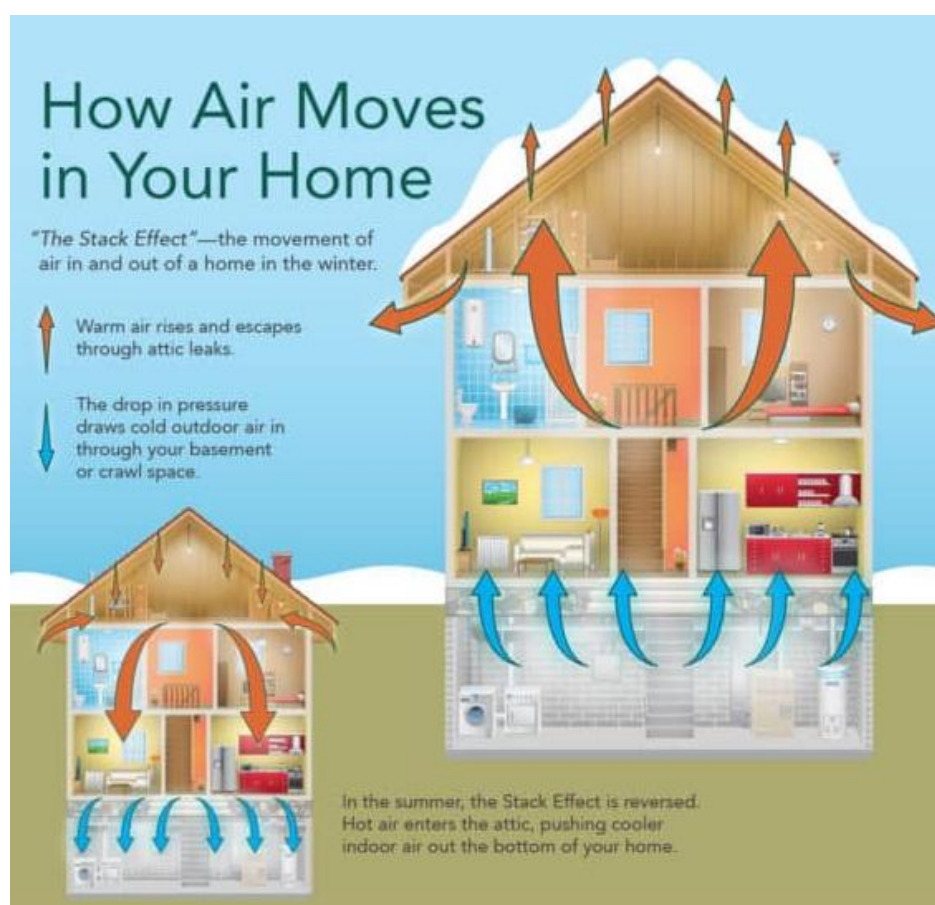
Air moves vertically within buildings through the stack effect. As warmer air rises in the upper floors, replacement air is drawn upward from below. In the current condition, humid basement air is being drawn into the ground floor and beyond.

This means that the principal building timbers above are not merely influenced by external winter humidity. They are being influenced by a damp substructure environment feeding upward.

While no structural decay was confirmed in accessible upper timbers at the time of inspection, continued operation of the basement as a vapour reservoir increases the risk that embedded joist ends, floor timbers adjacent to the stairwell, and lower-level structural elements will experience elevated equilibrium moisture content over time.

Where timber ends are embedded in masonry that is itself damp and slow to dry due to cement pointing and reduced breathability, the microclimate at that junction can remain persistently damp even if room air improves intermittently.
