JUSTIFICATION

RE-FACING OF MAIN CHIMNEY BREAST

107 HIGH STREET, LINDFIELD, HAYWARDS HEATH, RH16 2HR

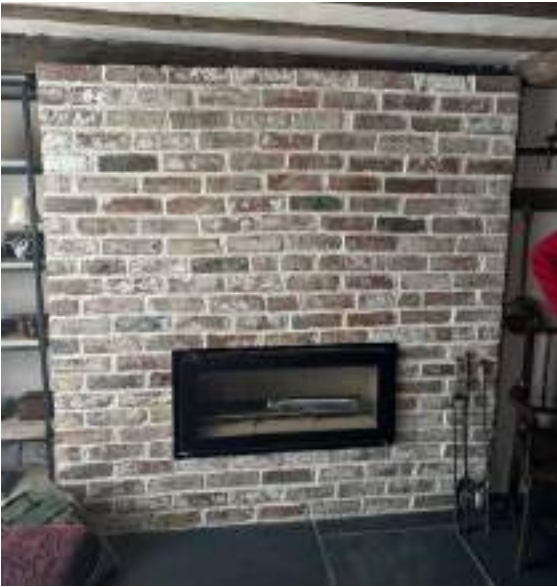
Ground floor living room re-faced chimney breast

The condition of the ground floor main chimney breast has been significantly improved. The chimney breast has been re-faced in reclaimed brick using hydraulic lime mortar, with a new hearth being incorporated. This is considered an improvement to the listed house and a heritage benefit as outlined in the supporting HCUK heritage statement.

2. Existing blockwork removed from behind the existing hearth
3. Reclaimed brickwork cleaned where required across full extent of chimney prior to any repair works.

4. Any serious erosion from spalled brickwork removed, then cleaned out and infilled with new brickwork and mortar mix with colour, texture and pointing to match existing.

5. Chipped or cement coated bricks removed, cleaned out and infilled with new brickwork and mortar mix with colour, texture and pointing to match existing.

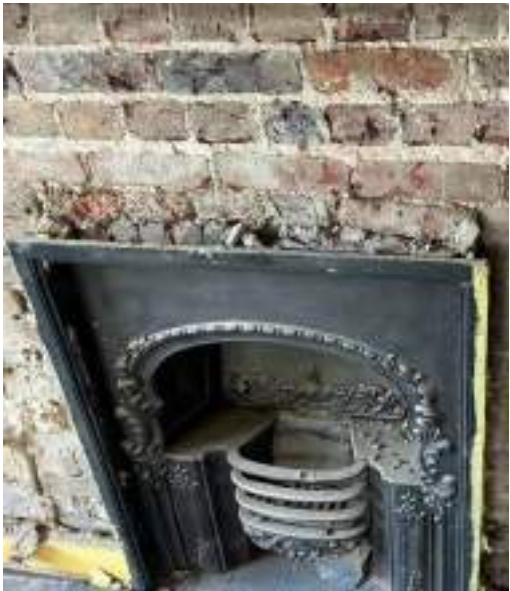
Original firebox blocked up

First floor bedroom fireplace and chimney breast before works

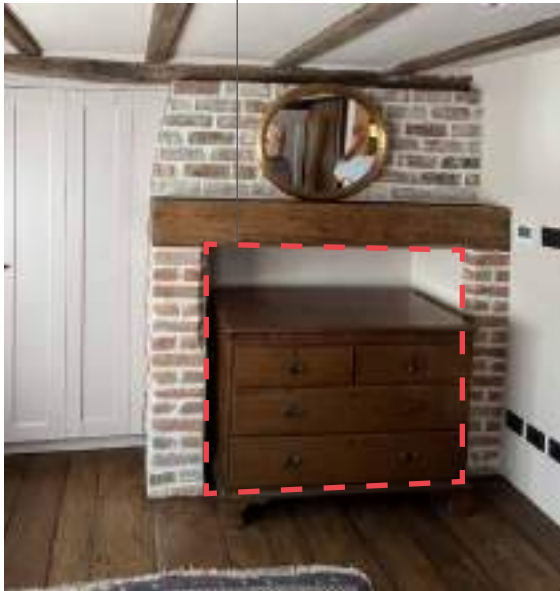
Original firebox retained

First floor bedroom re-faced chimney breast

On the first floor, the fire place was modified to resemble the historic one by reinstating the hearth opening. The condition of the chimney breast has been significantly improved. The chimney breast brickwork has been cleaned and re-pointed. A new horizontal timber mantle was introduced for aesthetic reasons.

1. Existing fireplace insert removed
2. Brickwork infill around inserted fireplace removed to reinstate the historic firebox
3. Reclaimed brickwork cleaned where required across full extent of chimney prior to any repair works.
4. Any serious erosion from spalled brickwork removed, then cleaned out and infilled with new brickwork and mortar mix with colour, texture and pointing to match existing.
5. Chipped or cement coated bricks removed, cleaned out and infilled with new brickwork and mortar mix with colour, texture and pointing to match existing.
6. Any open mortar joints, if not found to be a consequence of structural defects, cleaned out and infilled with new mortar mix with colour, texture and pointing to match existing.
7. New timber mantle by Nick Cane of Cruck Frame Carpentry installed above the opening. Timber treated to match the floorboards.

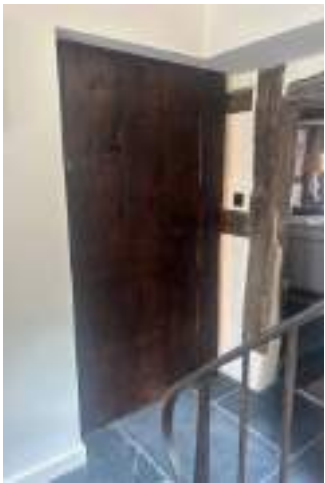
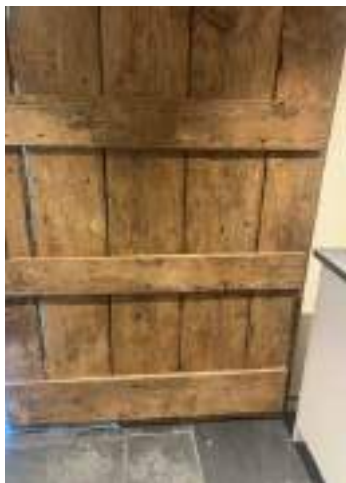
Photographs of the sliding door

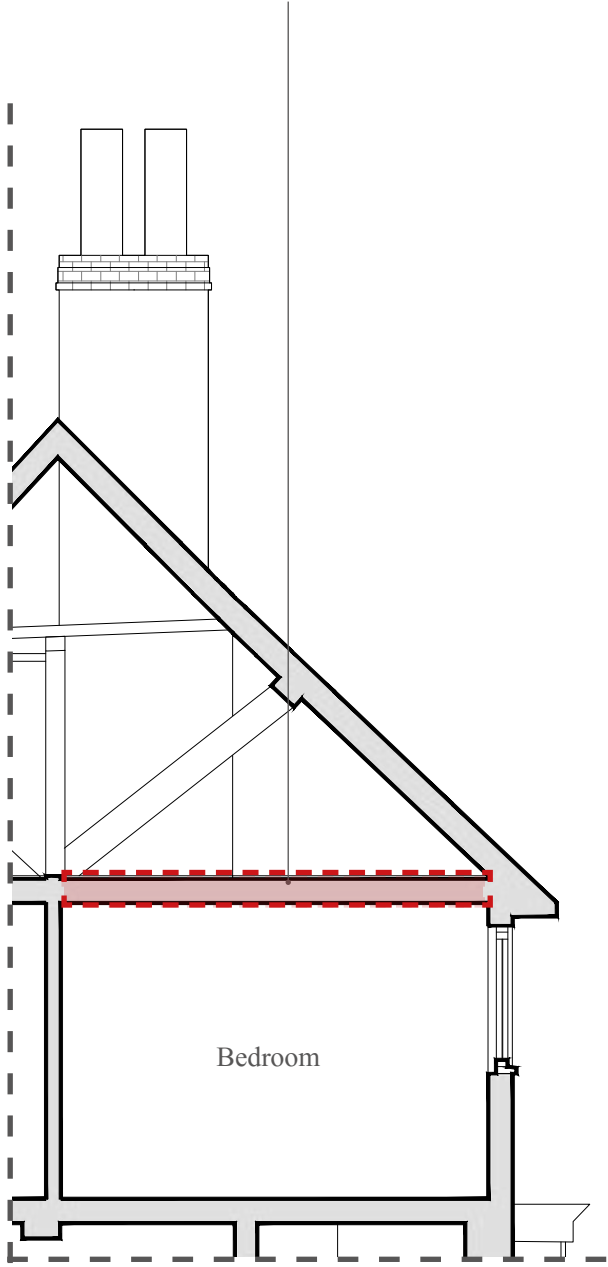
Extract of Existing Section AA

Area of ceiling demolition above bedroom. Rotten, wood worm infested timber boards to non-original floor build-up removed. New vaulted ceiling introduced.

Existing non-original ceiling removed. Limited information on build-up

- Gypsum plasterboard ceiling to bedroom side
- Modern timber joists
- 80mm insulation
- Loose laid oak floorboards to attic side, rotten and wood worm infested

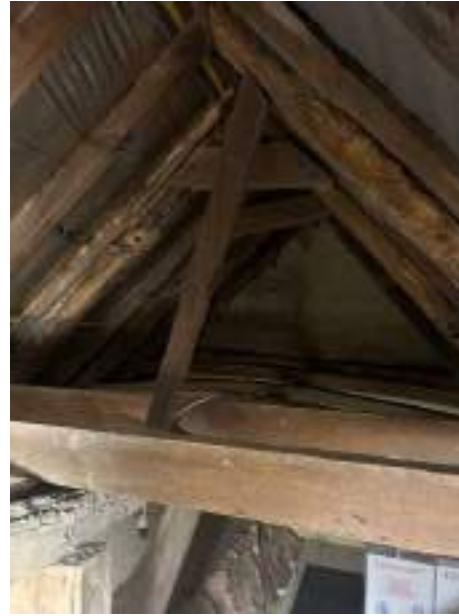
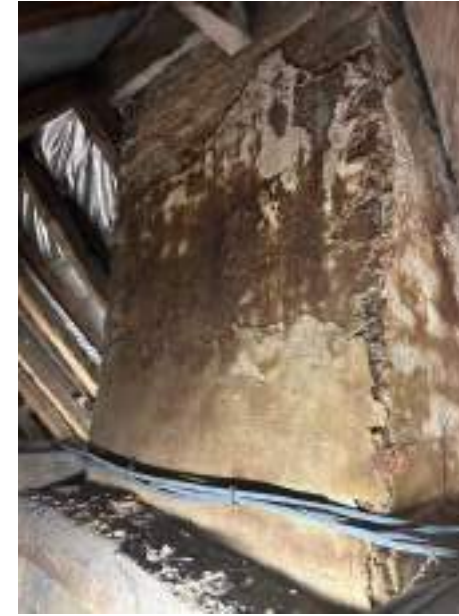
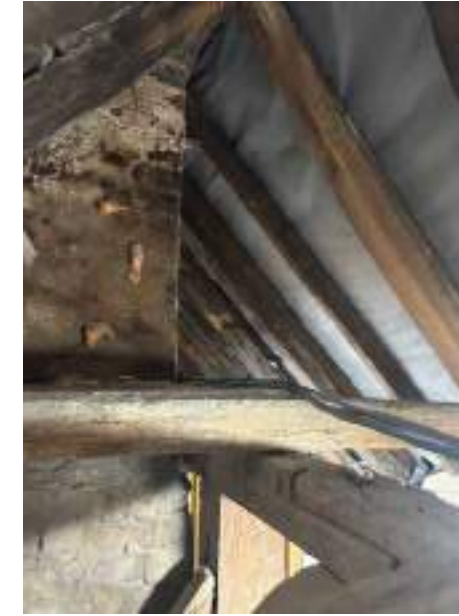
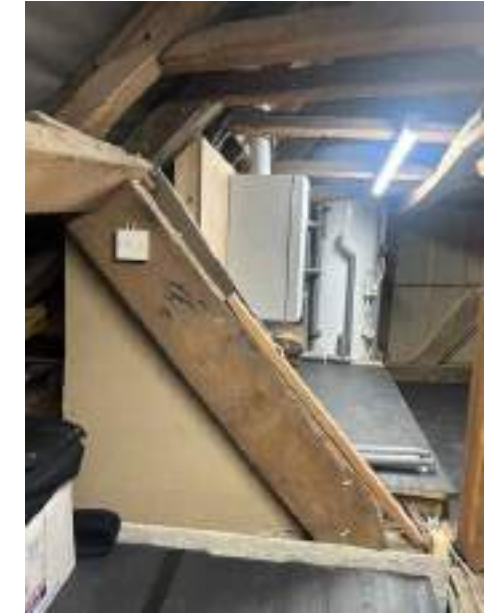
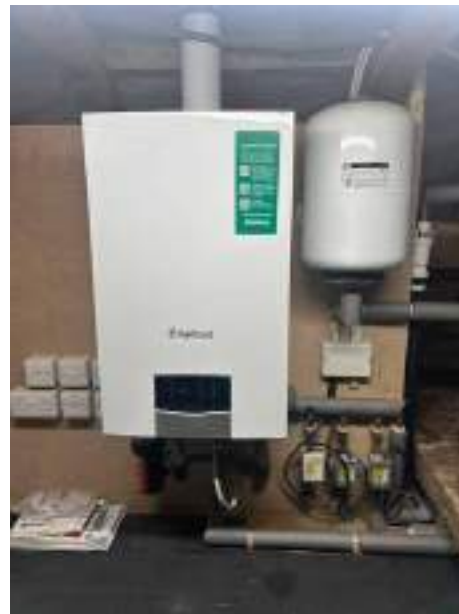
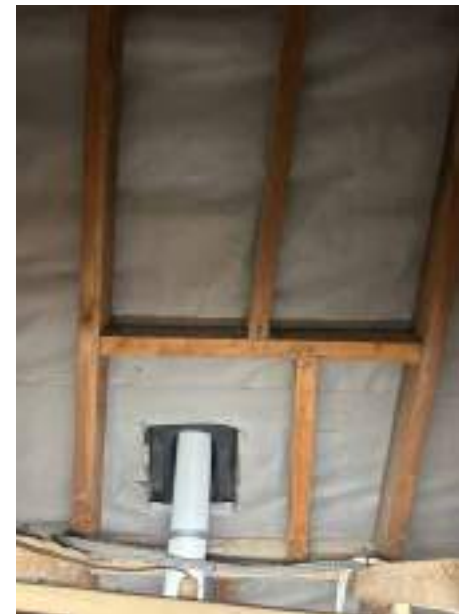
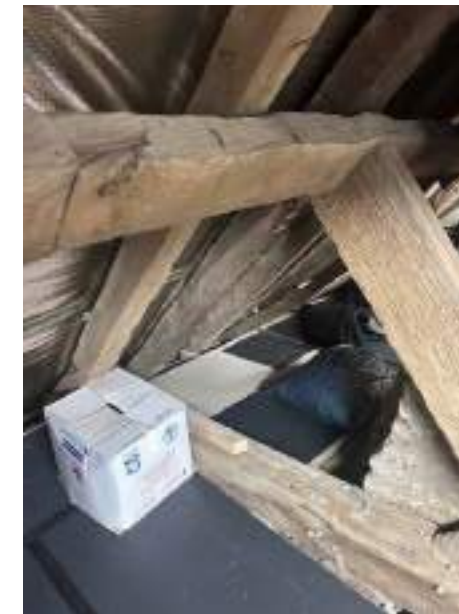
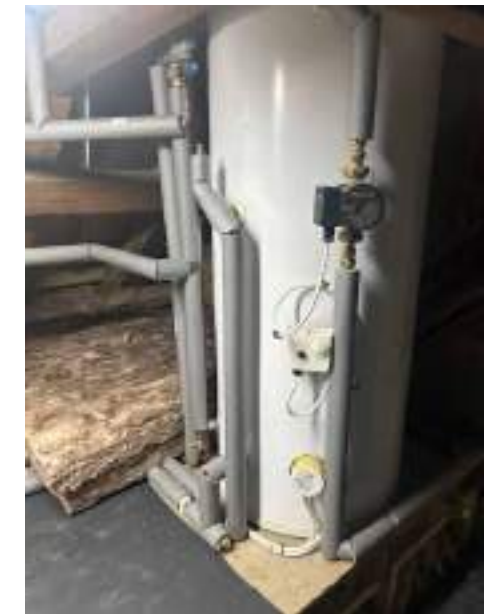
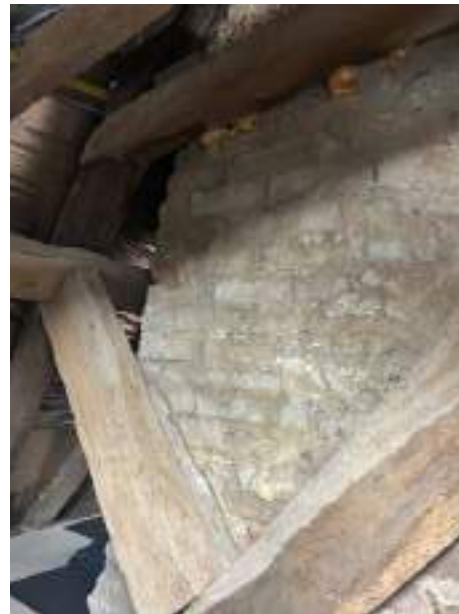
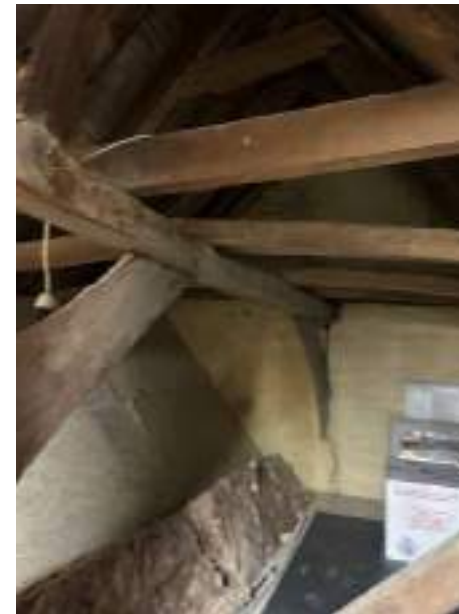
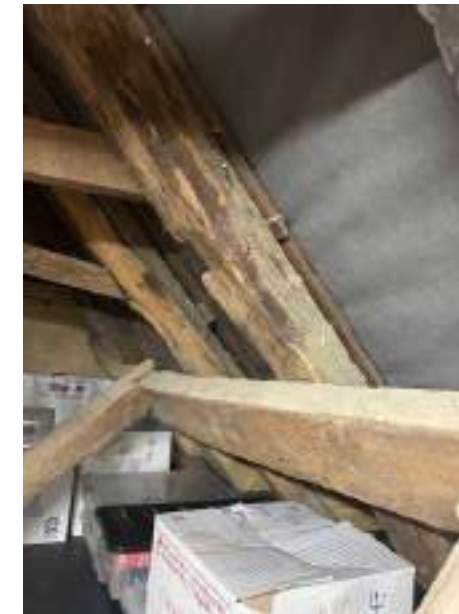
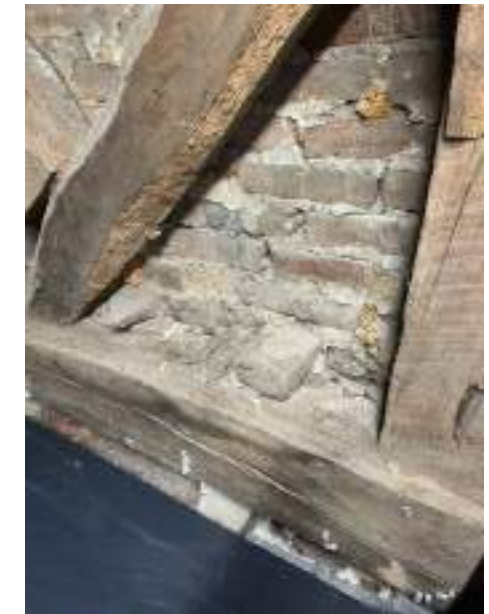
The adjacent photographs are of the current condition of the attic.

Timber frame was unaltered.

All roof structures of historical and national significance have been preserved, with loose floorboards carefully reused and modern materials removed, ensuring that the heritage value of the attic construction is maintained.

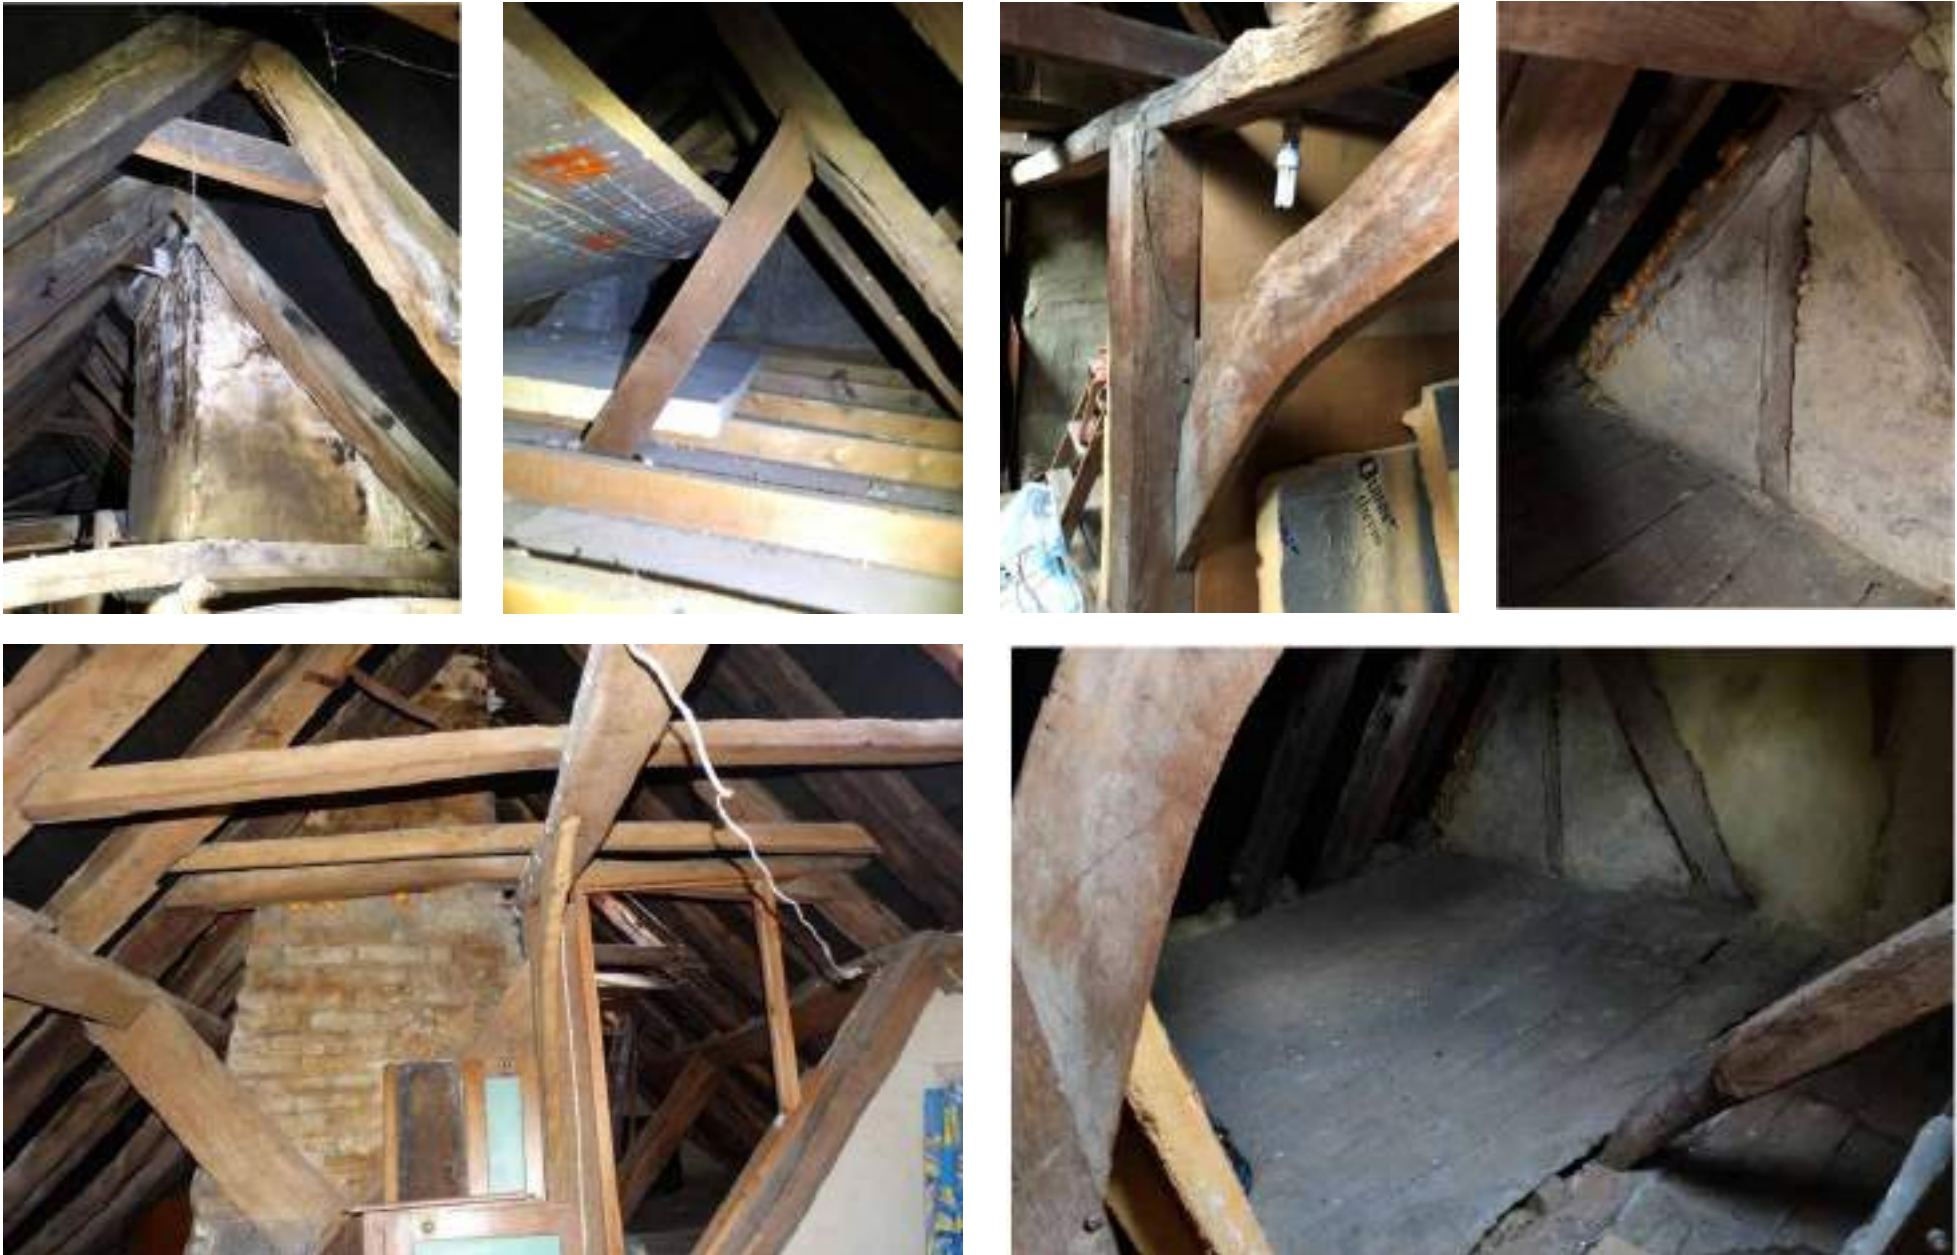
For comparison, the adjacent photographs are of the attic before any works were undertaken by the current owner.

It is noted that the timber frame was unaltered and untreated.

All roof structures of historical and national significance have been preserved, with loose floorboards carefully reused and modern materials removed, ensuring that the heritage value of the attic construction is maintained.

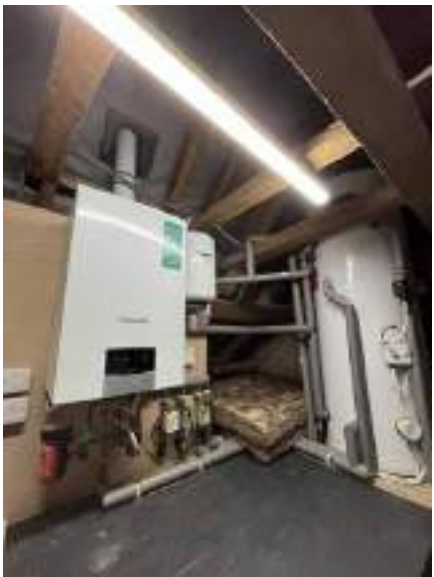
Recent photograph capturing the new water tank and boiler installed in attic

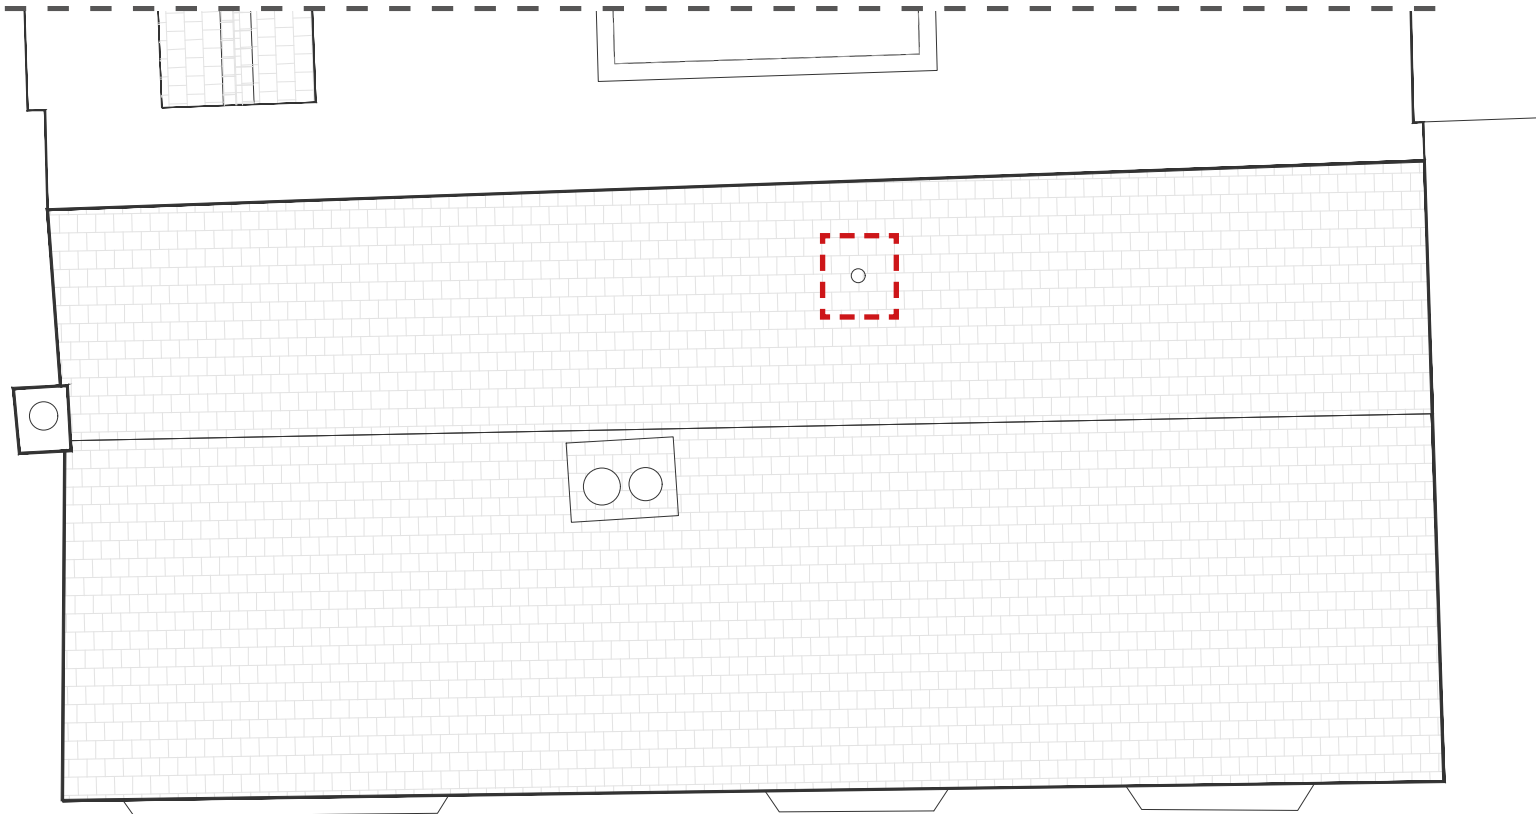
Proposed roof plan

As can be seen from the drawings below, the position of the boiler flue on the rear sloping roof pitch is such that it is not visible from the principal elevation.

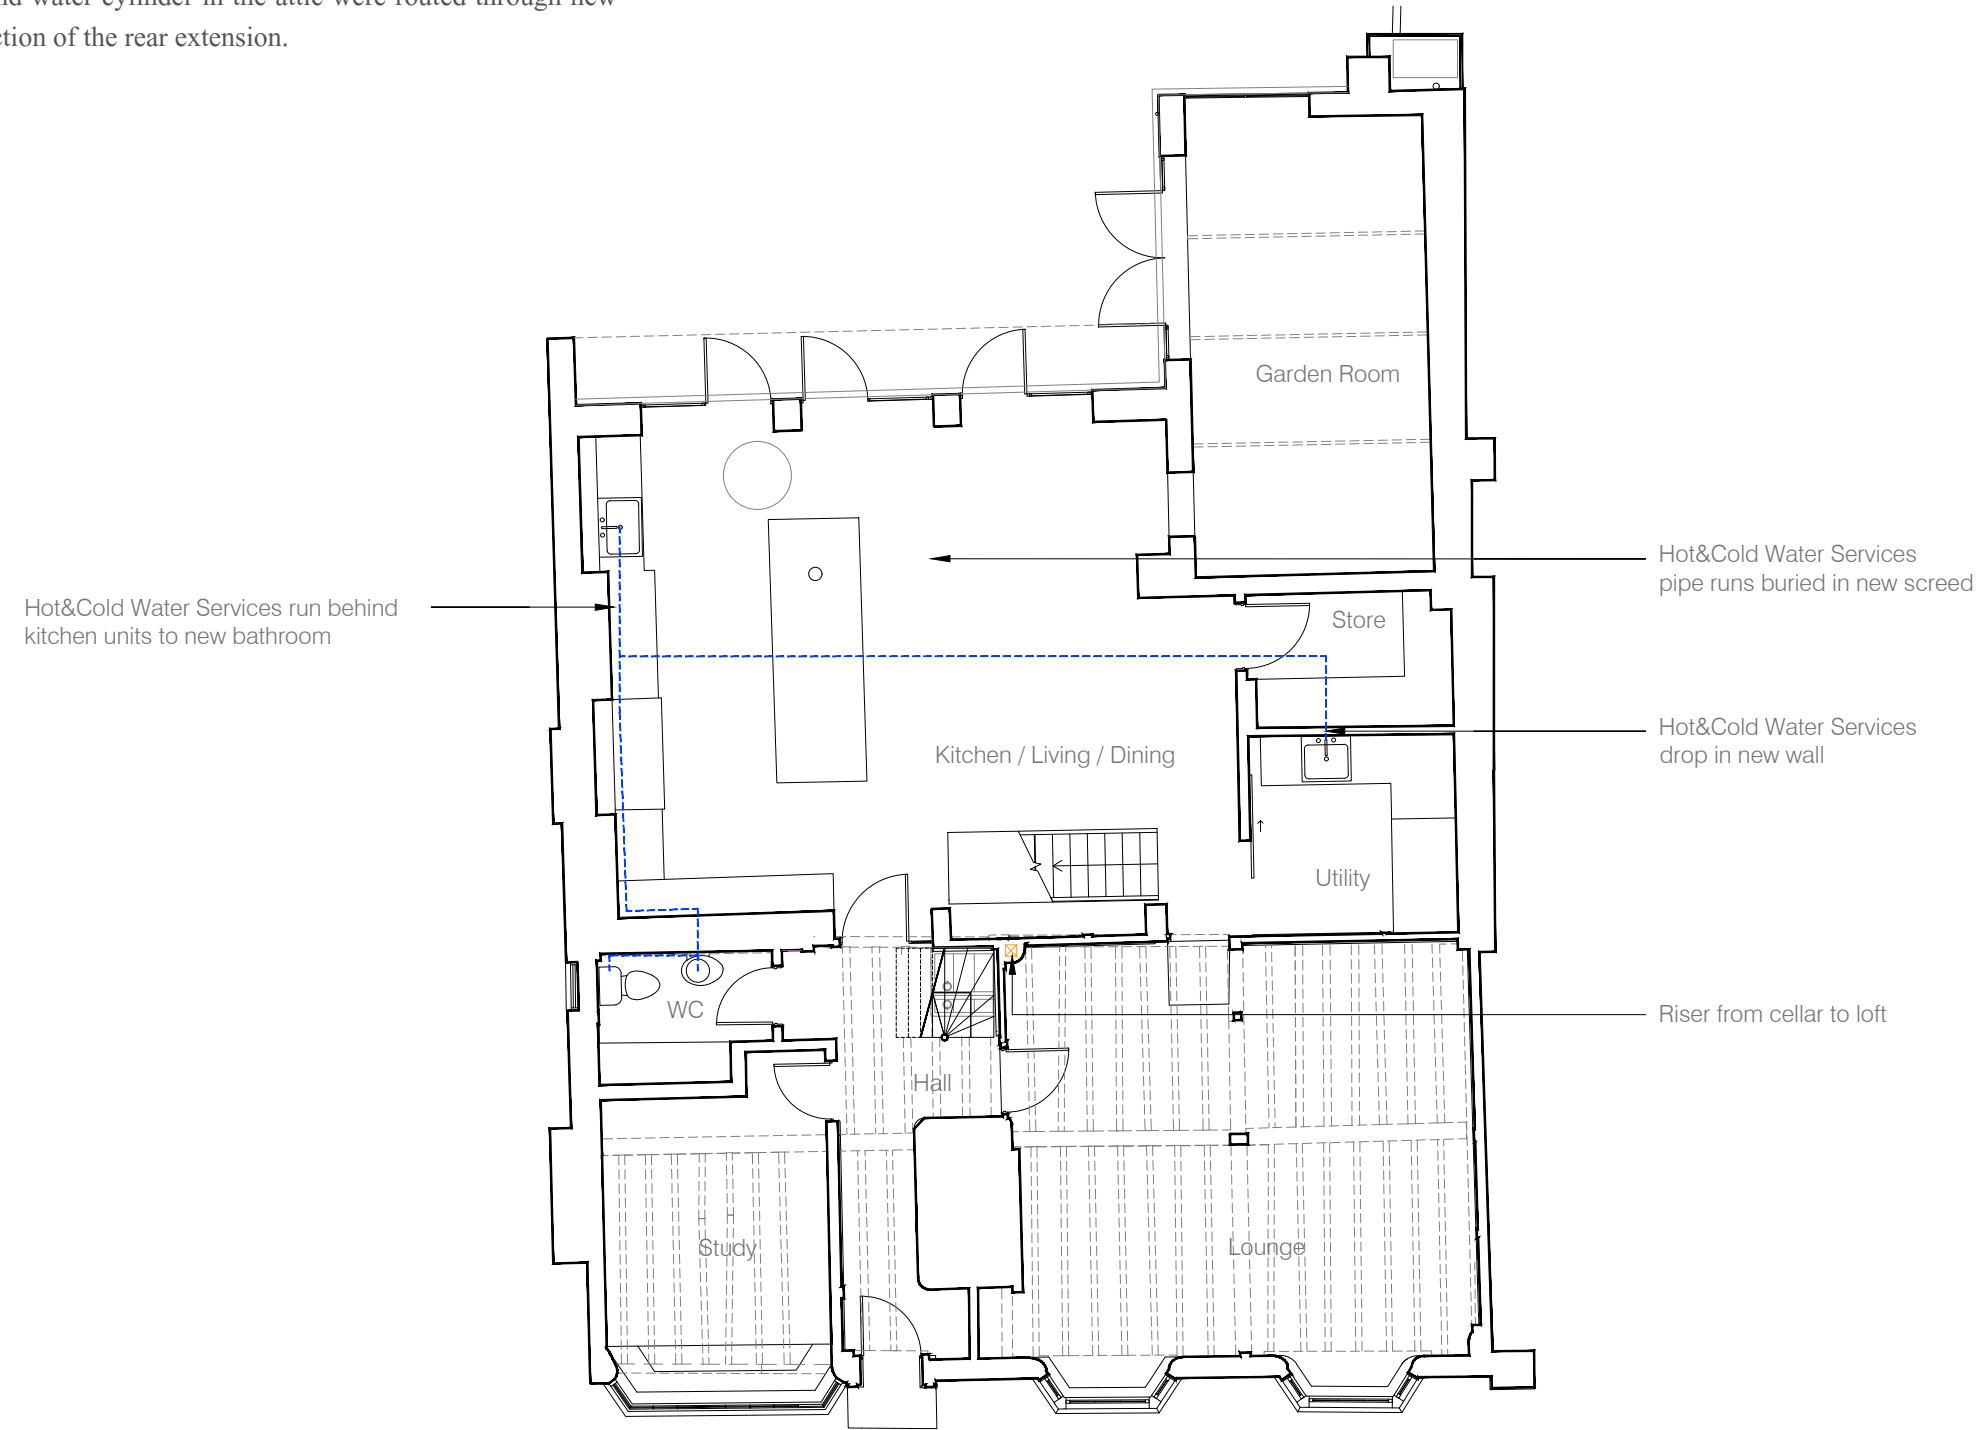
As-built ground floor plan

The adjacent diagram illustrates new water pipe runs serving the building.

Where possible existing house service routes were used, minimising impact on the existing building. Pipe runs to new boiler and water cylinder in the attic were routed through new construction of the rear extension.

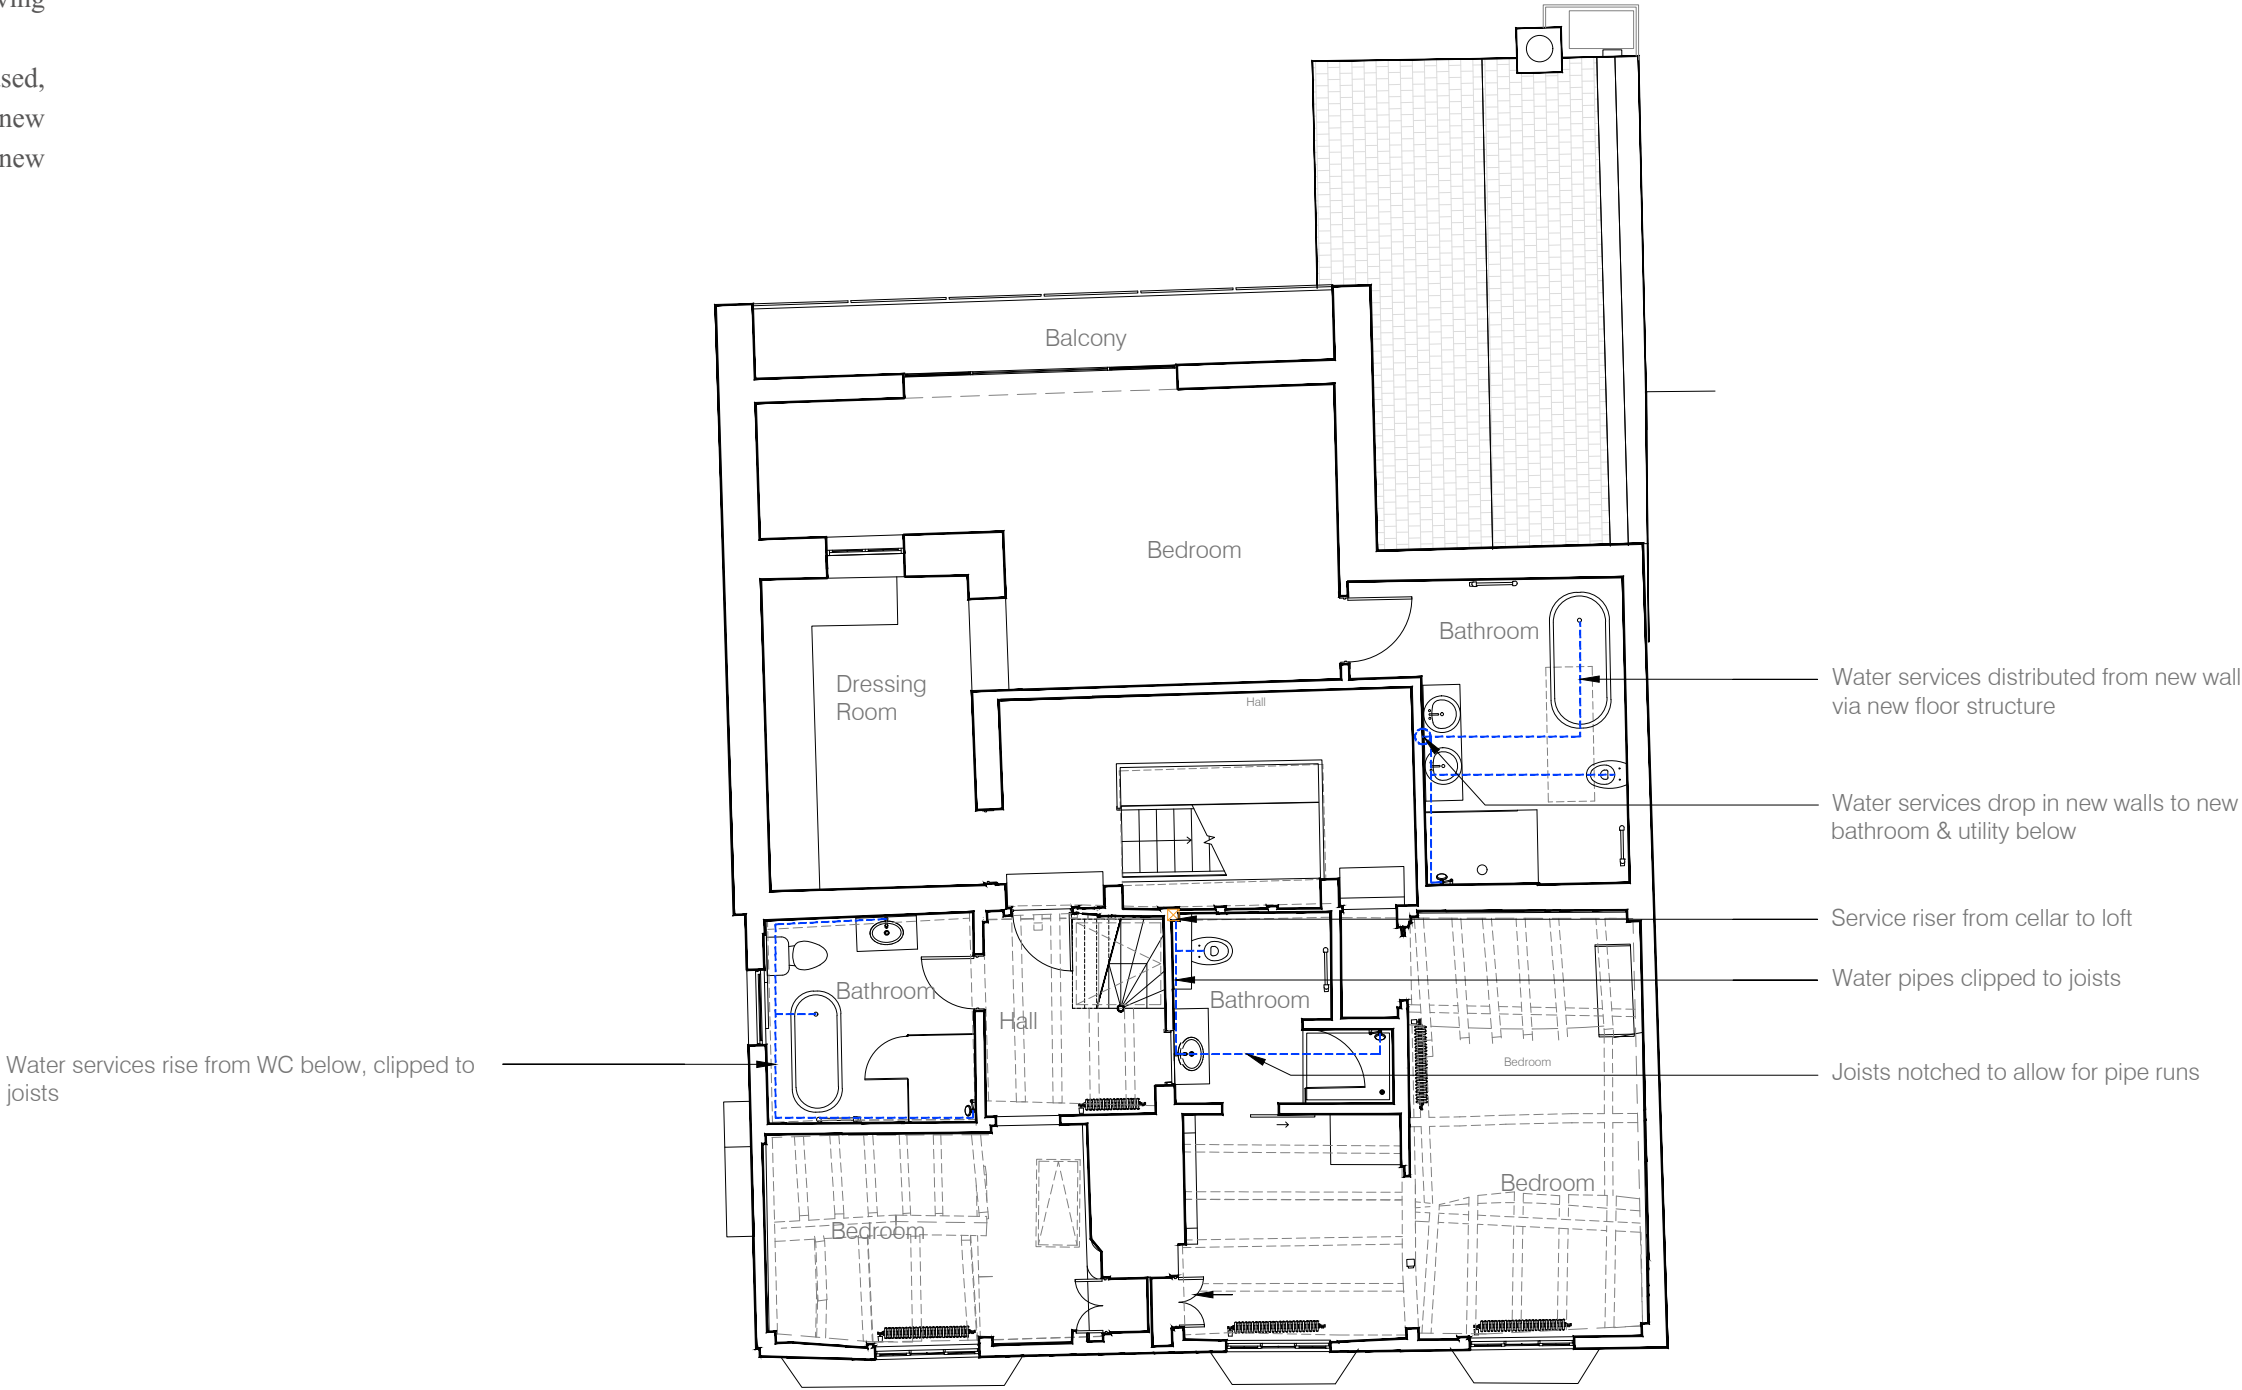
As-built first floor plan

The adjacent diagram illustrates new water pipe runs serving the building.

Where possible existing house service routes were used, minimising impact on the existing building. Pipe runs to new boiler and water cylinder in the attic were routed through new construction of the rear extension.

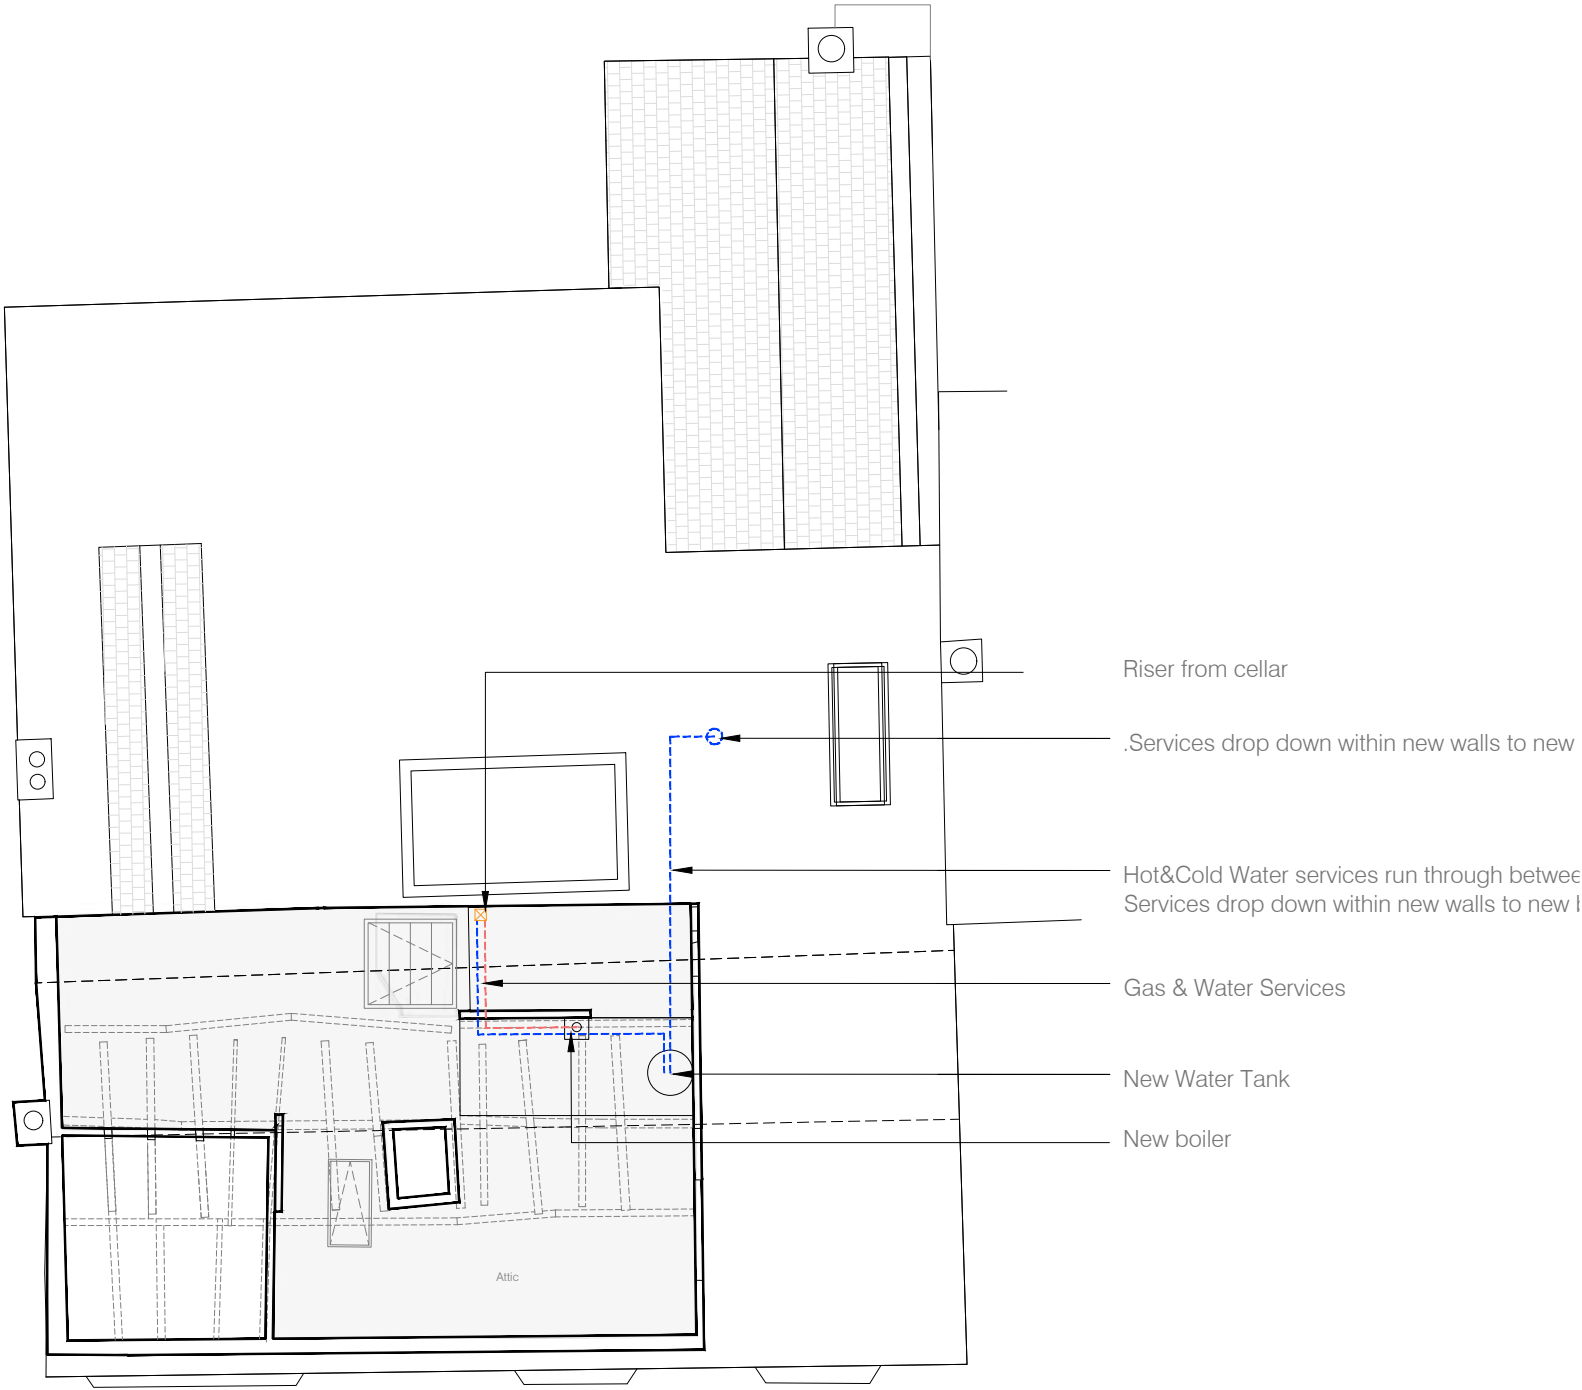
As-built attic floor plan

The adjacent diagram illustrates new water pipe runs serving the building.

Where possible existing house service routes were used, minimising impact on the existing building. Pipe runs to new boiler and water cylinder in the attic were routed through new construction of the rear extension.

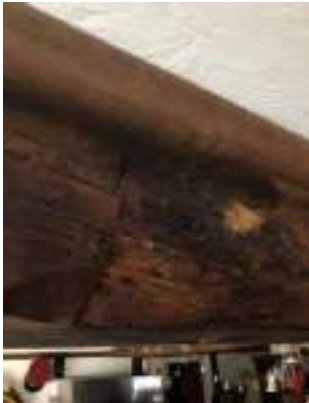
Timber frame was carefully cleaned and left untreated. There could have been some damage done by the previous owners as the Heritage Statement by Desbruslais confirms that the frame was cleaned on a regular basis. Additionally, many of the oak joists and bressummers have been oiled, as illustrated on the adjacent photograph.

Photographs of oiled oak joist prior to restoration

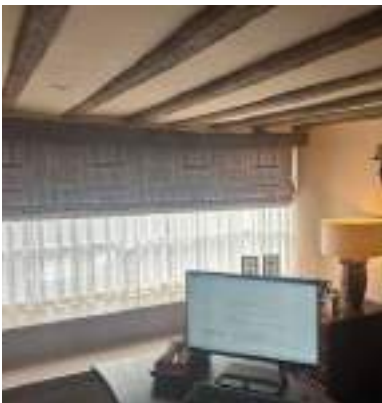
Photographs of ground floor study - previously not visible timber frame on ceiling exposed

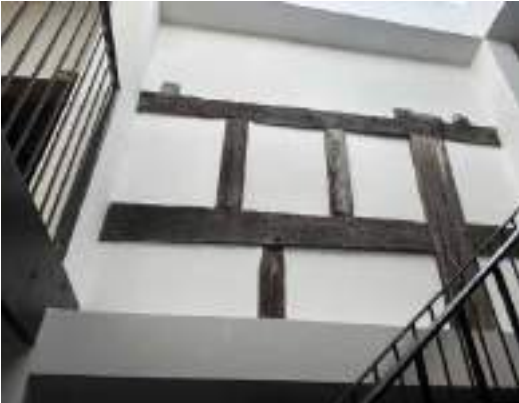
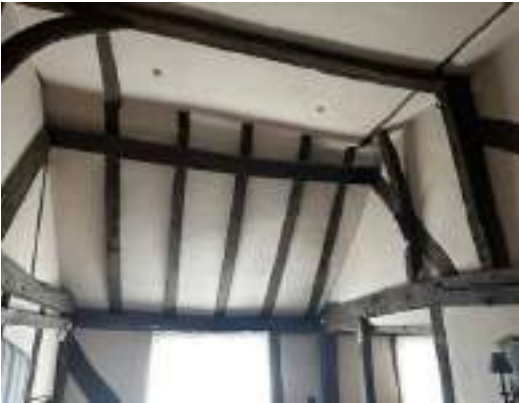
Photographs of restored historic oak frame

- 1. Comprehensive survey of the historic timber elements to assess the condition of the oak. Timbers checked for decay, insect damage, splits, warping, or structural weakness.
- 2. Timber renovated using historically appropriate techniques - gentle clean using soft bristle brush. Timber left are without any coatings. The timber’s patina, age marks, and tool finishes retained.

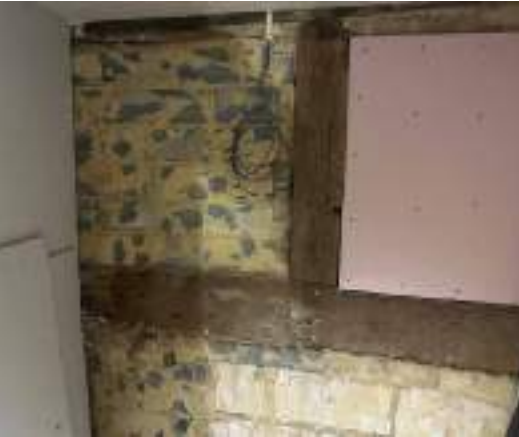
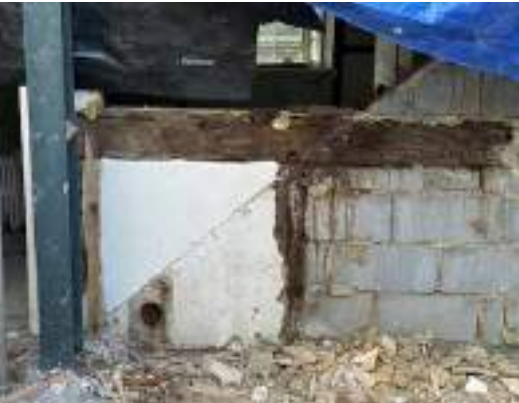
Photographs of historic oak frame prior to restoration
