**Tree Survey and Arboricultural Impact Assessment  
In Accordance with BS 5837:2012**

| <b>Project No<br/>11353</b> | <b>Field Adjacent to Rocky Lane S5 11e, Roundway, Haywards Heath,<br/>RH16 4TW</b> | | |
| Client: | | Circet UK Wireless | |
| Date of Report: | 12/02/2025 | Revision: | A |

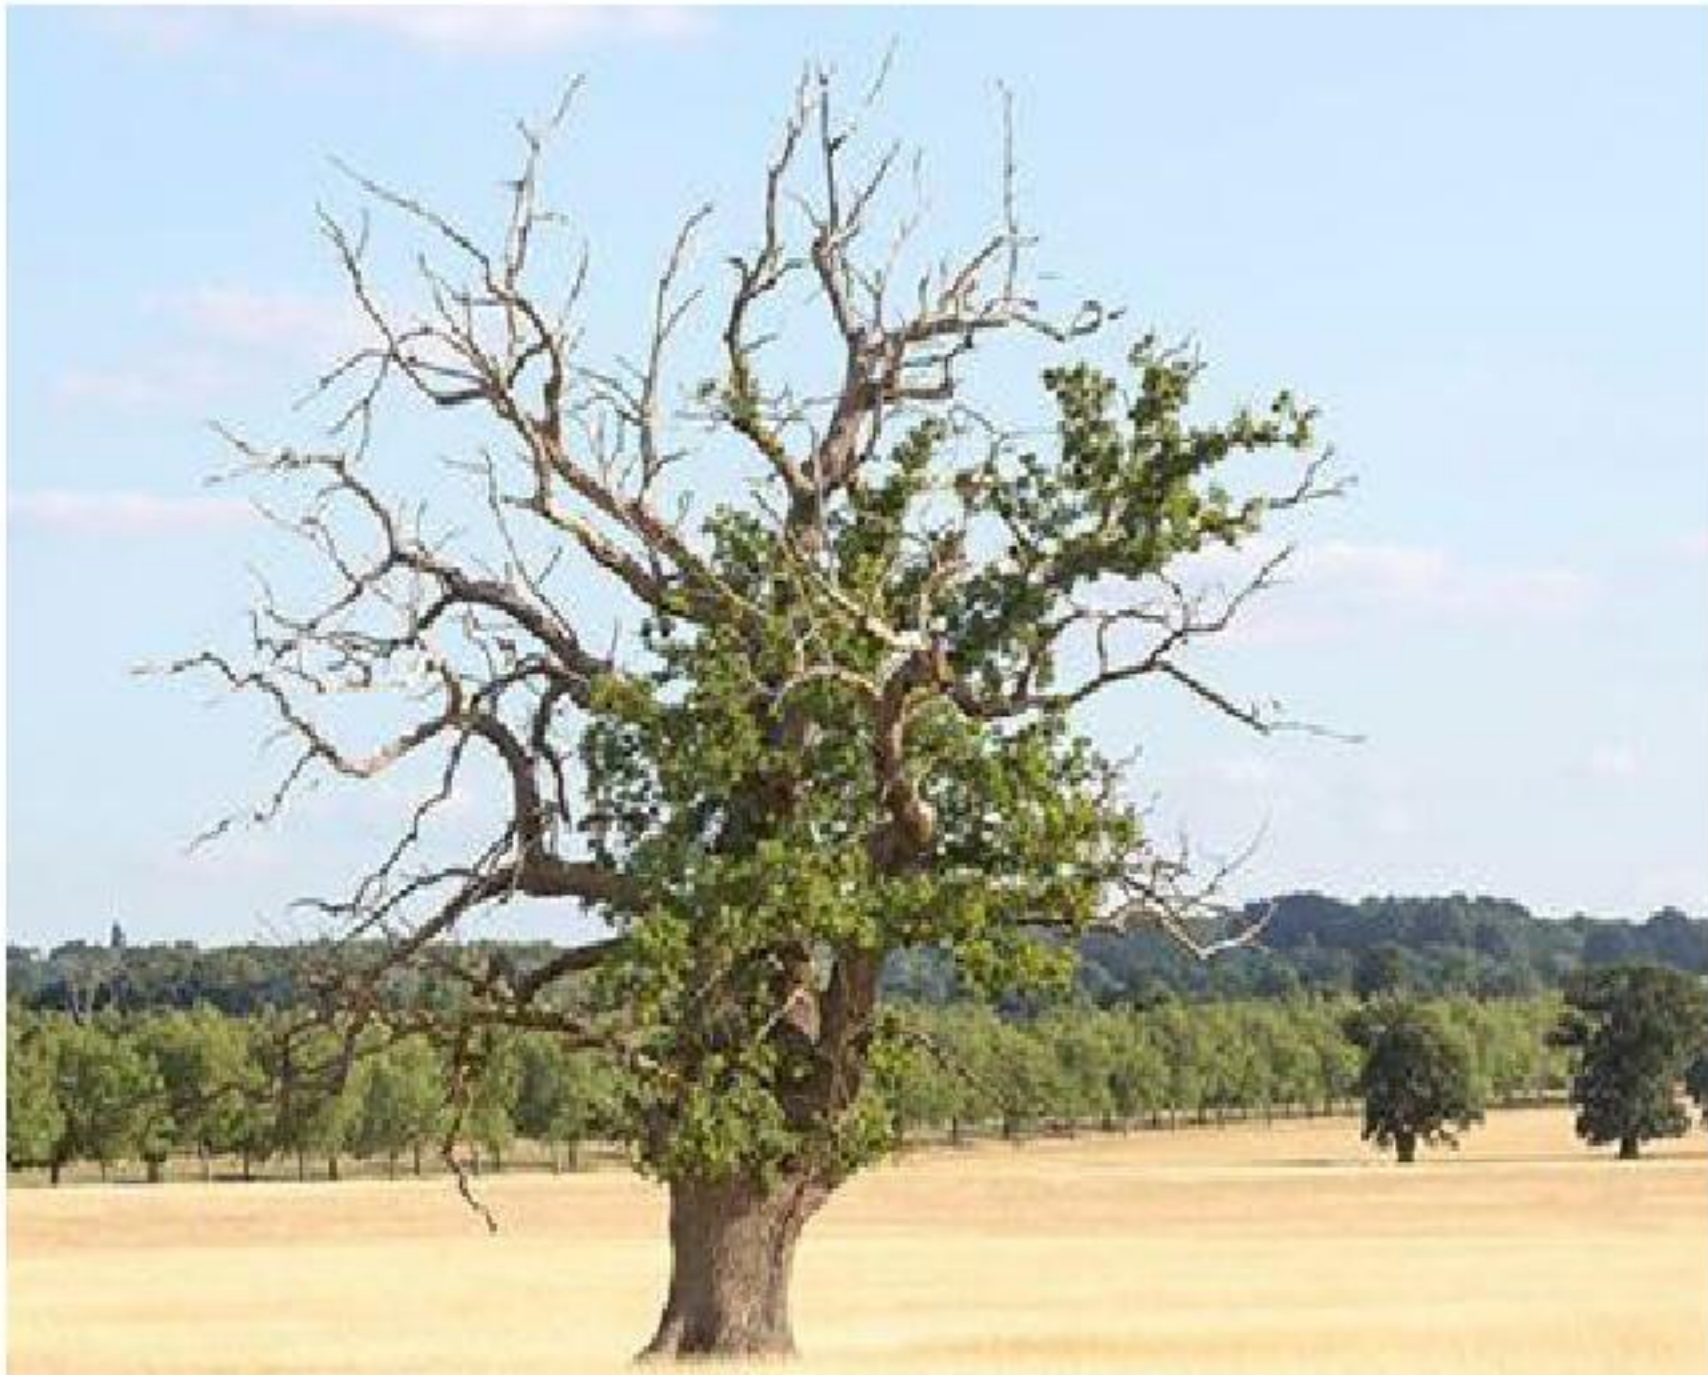
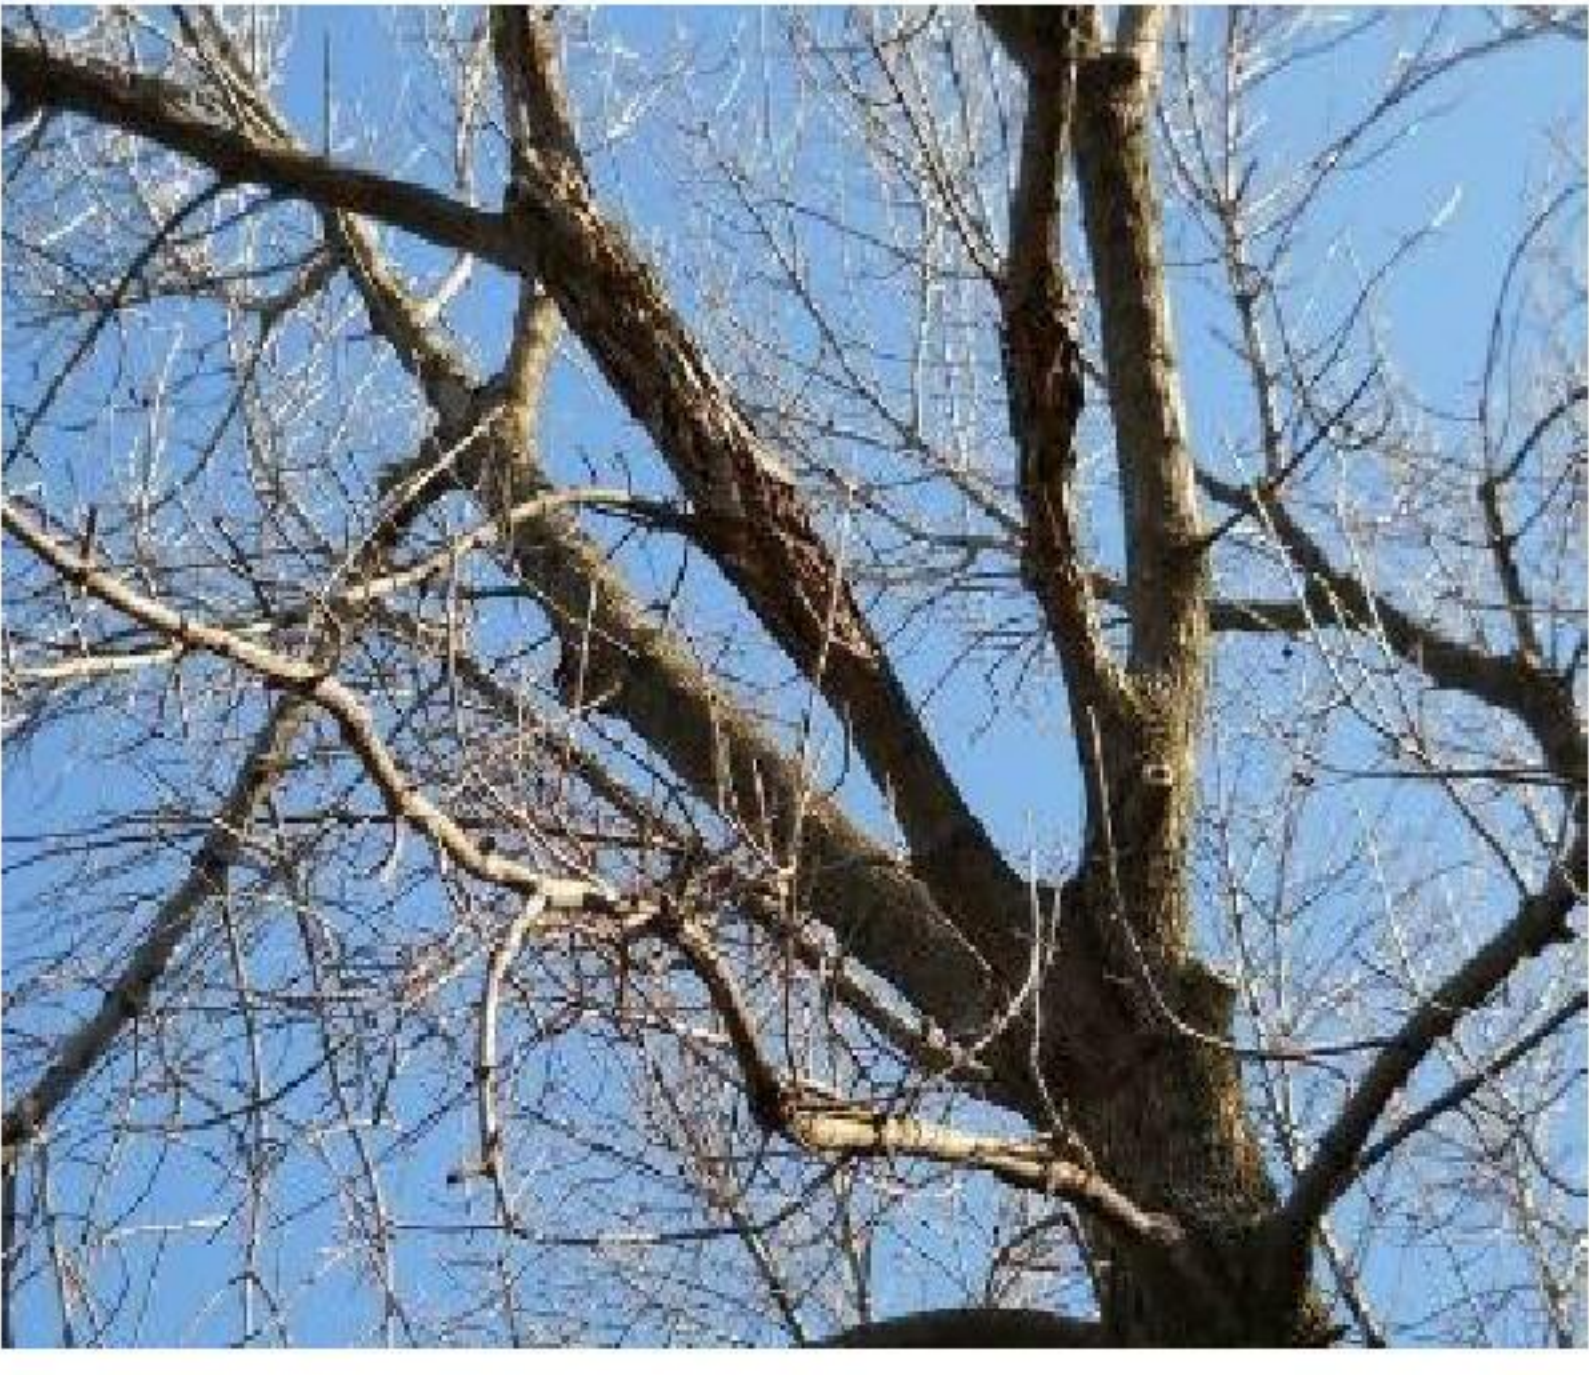
| Name: Deadwood | |
|---|---|
| Symptoms/damage type and cause: | This relates to dead branches in the crown of the tree. In the most cases this is caused by the natural ageing process of the tree or shading due to its close proximity to neighbouring trees. However, in some situations, it may be related to fungal, bacterial or viral infection. |
| Consequence: | Depending upon the location and mass of dead wood removal of the affected tissue may be necessary to prevent harm to persons or property as the wood will become unstable as it decays and in some circumstances is likely to fall from the tree with little or no warning. |

| Name: Deadwood | |
|---|---|
| Control: | Detailed monitoring should be undertaken on those trees showing signs of excessive deadwood production to identify the underlying cause. |

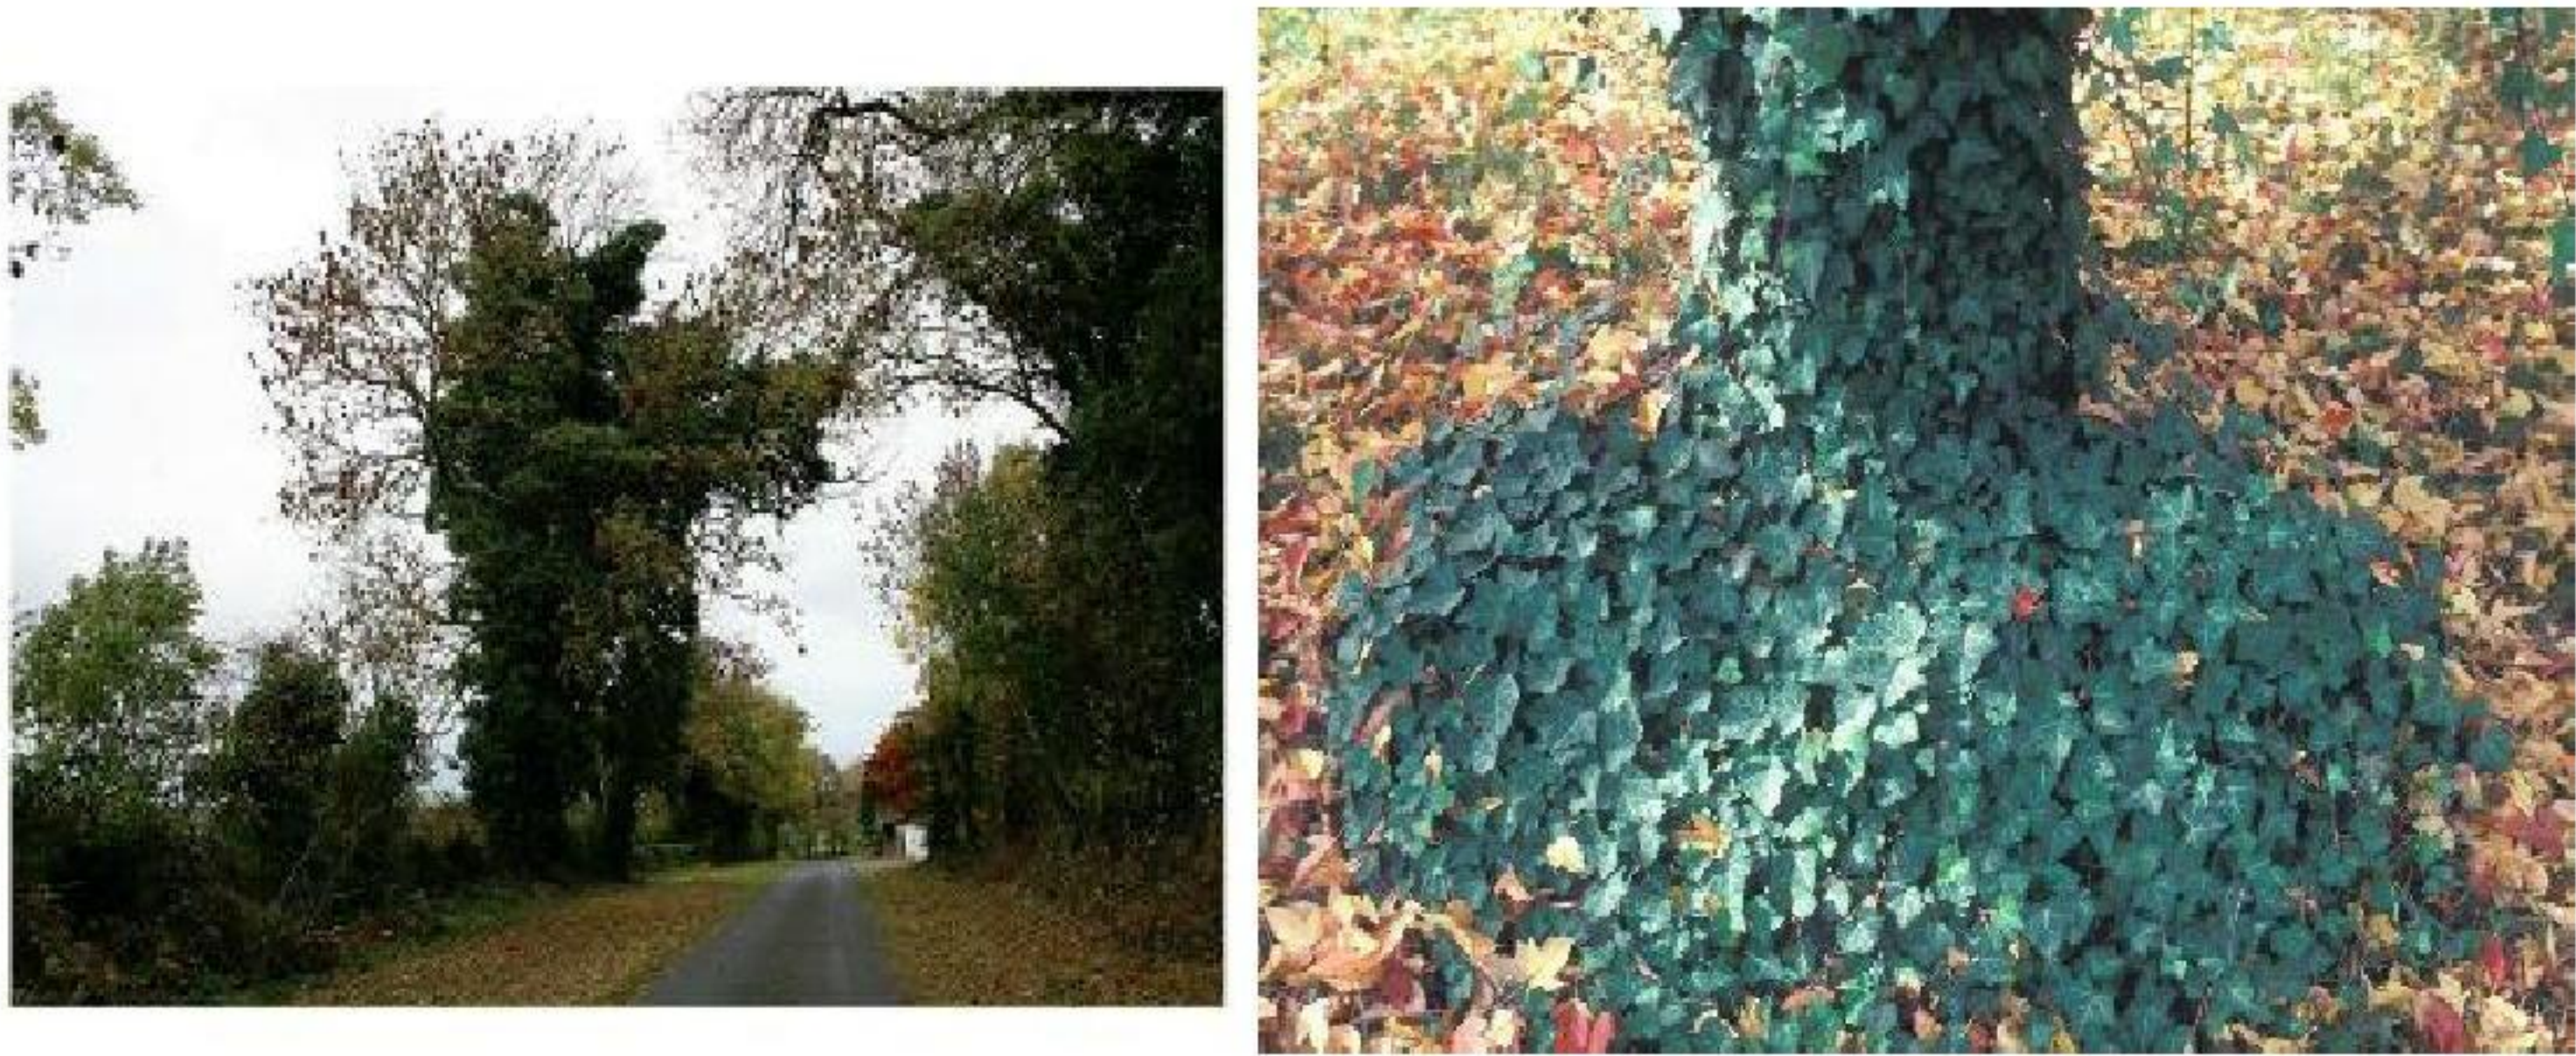
| <b>Symptoms/damage type and cause:</b> | Ivy may grow to varying degrees on all areas of a tree from the base to the upper crown. It is possible that in doing so it will out-compete the host tree for available light thereby suppressing the host. |

| <b>Control:</b> | Ivy should only be removed if absolutely necessary because it provides abundant cover to wildlife and then by severing twice close to the ground and removing a length of stem thereby causing the gradual dying away of the aerial parts of the plant providing extended benefit to wildlife whilst relieving the pressure on the tree. |
