### Crack and Level Monitoring

Date of Issue: 31/10/2024

Address: 22 Wheatsheaf Close, Burgess Hill, West Sussex, RH15 8UT

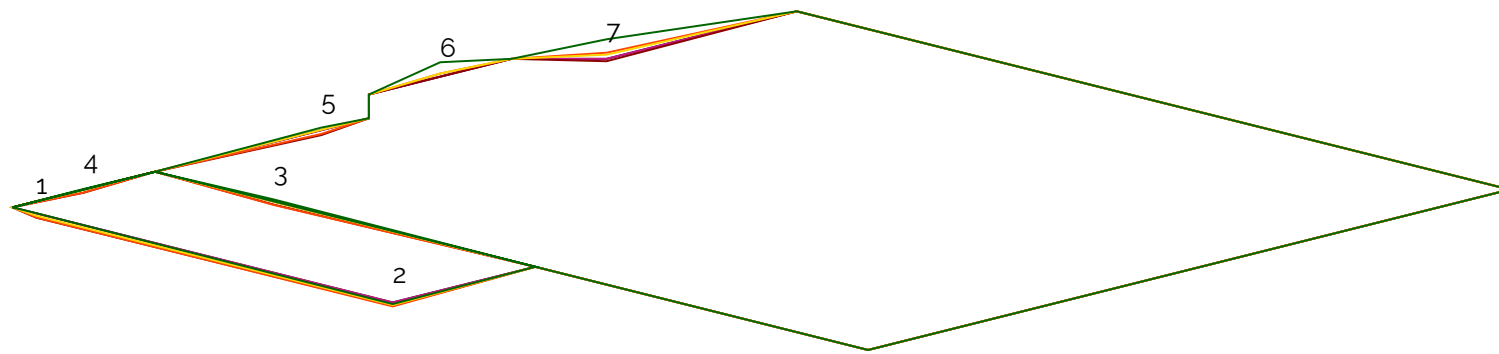
Relative Movement (Relative Survey, for illustration purposes only)

| Visit | Surveyors Note |
|---|---|
| Visit 5 | points 6 and 7 on the conservatory have been double checked |

| | Visit 1 | Visit 2 | Visit 3 | Visit 4 | Visit 5 | Visit 6 | Visit 7 | Visit 8 |
|---|---|---|---|---|---|---|---|---|
| 6 | 0 | 0 | +1.6 | +1.6 | +7.3 | | | |
| 7 | 0 | -1.2 | +3.1 | +2.1 | +9.9 | | | |

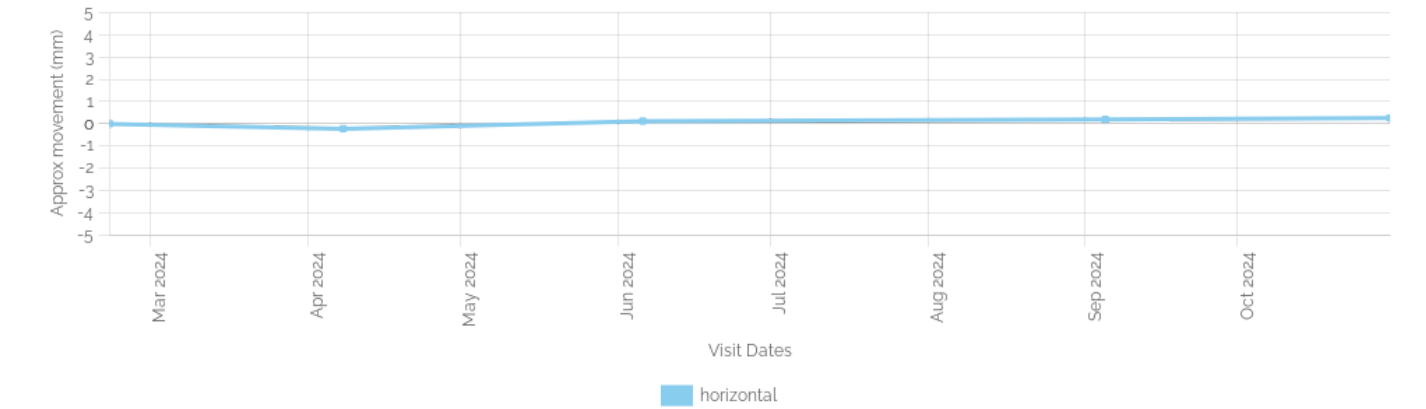
INT - Rear elevation in rear lounge - Crack Readings Differences (Displayed in Millimetres)

INT - Rear elevation in rear lounge

| | Visit 1 | Visit 2 | Visit 3 | Visit 4 | Visit 5 | Visit 6 | Visit 7 | Visit 8 |
|---|---|---|---|---|---|---|---|---|
| H | 0.22 | 0 | 0.34 | 0.42 | 0.48 | | | |

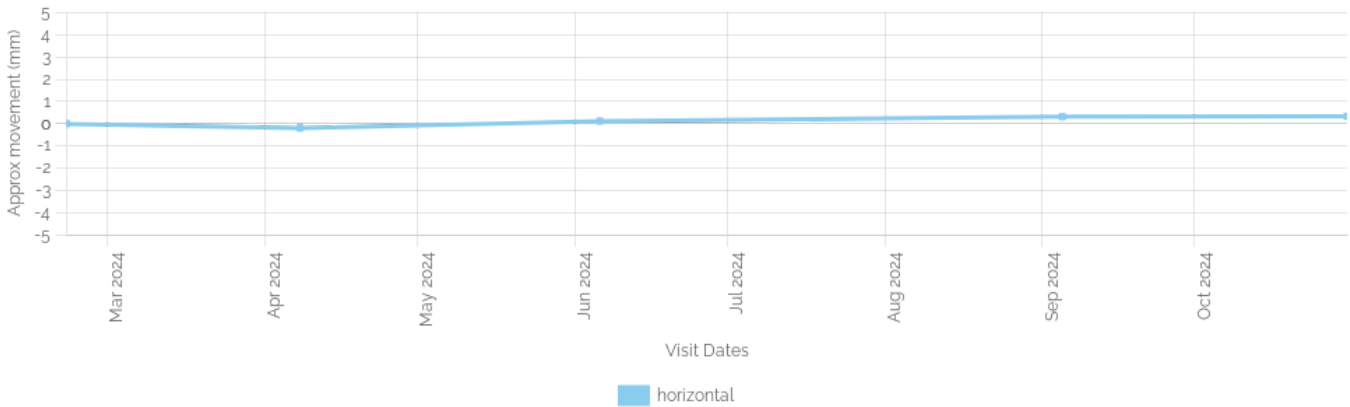
INT - Rear elevation in rear bedroom - Crack Readings Differences (Displayed in Millimetres)

INT - Rear elevation in rear bedroom

| | Visit 1 | Visit 2 | Visit 3 | Visit 4 | Visit 5 | Visit 6 | Visit 7 | Visit 8 |
|---|---|---|---|---|---|---|---|---|
| H | 0.19 | 0 | 0.31 | 0.51 | 0.53 | | | |

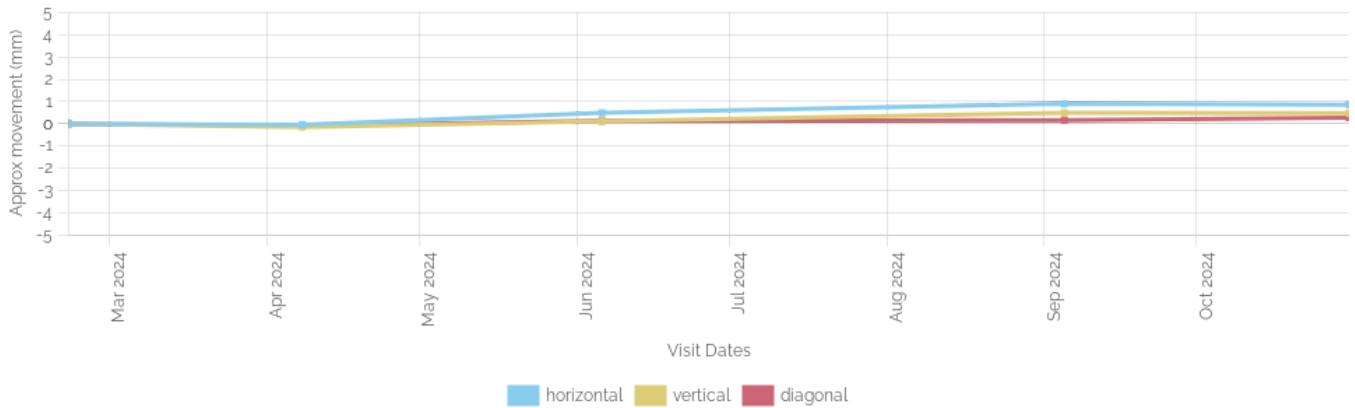
EXT - Rear elevation above patio door into house - Crack Readings Differences (Displayed in Millimetres)

EXT - Rear elevation above patio door into house

| | Visit 1 | Visit 2 | Visit 3 | Visit 4 | Visit 5 | Visit 6 | Visit 7 | Visit 8 |
|---|---|---|---|---|---|---|---|---|
| H | 0.03 | 0 | 0.52 | 0.93 | 0.89 | | | |
| V | 0.14 | 0 | 0.26 | 0.63 | 0.62 | | | |
| D | 0.07 | 0 | 0.2 | 0.24 | 0.35 | | | |
