Re DM/25/2661|Outline planning application (with all matters reserved except for access) comprising a residential development of up to 210 dwellings (Use Class C3); with associated access; landscaping; amenity space; drainage and associated works. Land At Coombe Farm London Road Sayers Common West Sussex

I writing to request that you contact WSCC LLFA to advise of some serious surface water flooding that took place at the above site on 27th January 2026. I believe it is important for them to know of the extent of this flooding in order for them to be able to make an informed consultation response on the above development.

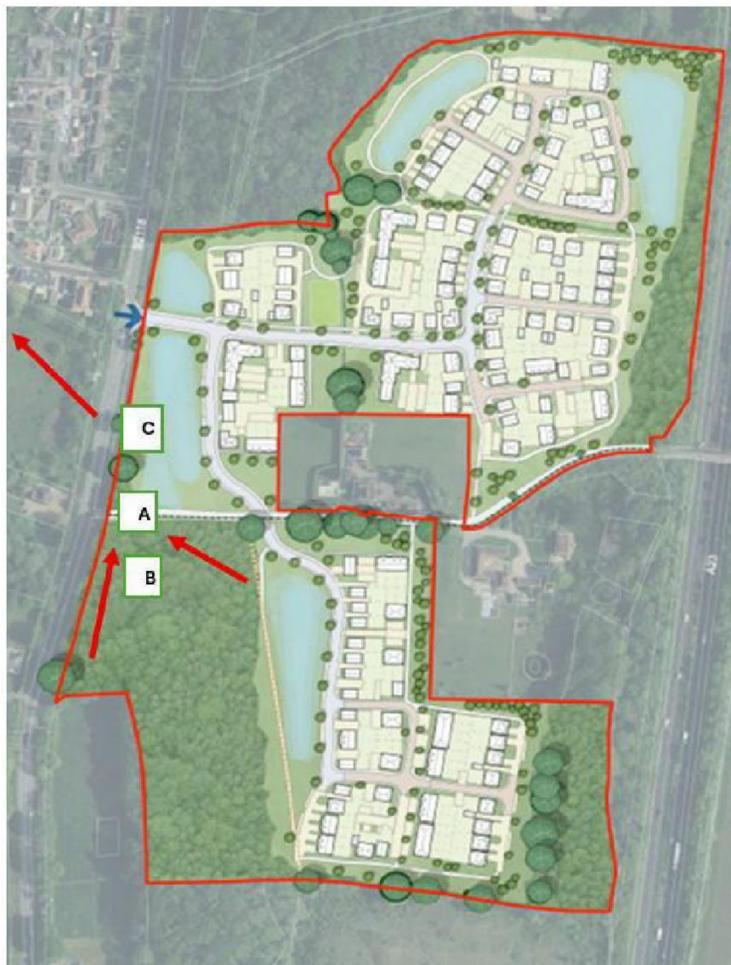
Heavy rain caused surface water flooding to the western side of the site, its lowest lying part. This floodwater came not only from the higher parts of the site itself in the east and southeast but also from offsite, down from Coombe Hill to its south.

Copy of the site map with the red arrows showing the waterflow directions and the letters showing the locations of the photographs below, all taken 27/01/2026 at around 11:30am.
