# **BS5837:2012 Tree Survey & Arboricultural Impact Assessment Report.**

## **Standen House and Garden – Extension to Visitor Reception Building.**

**Revision 2.**

**January 2026.**

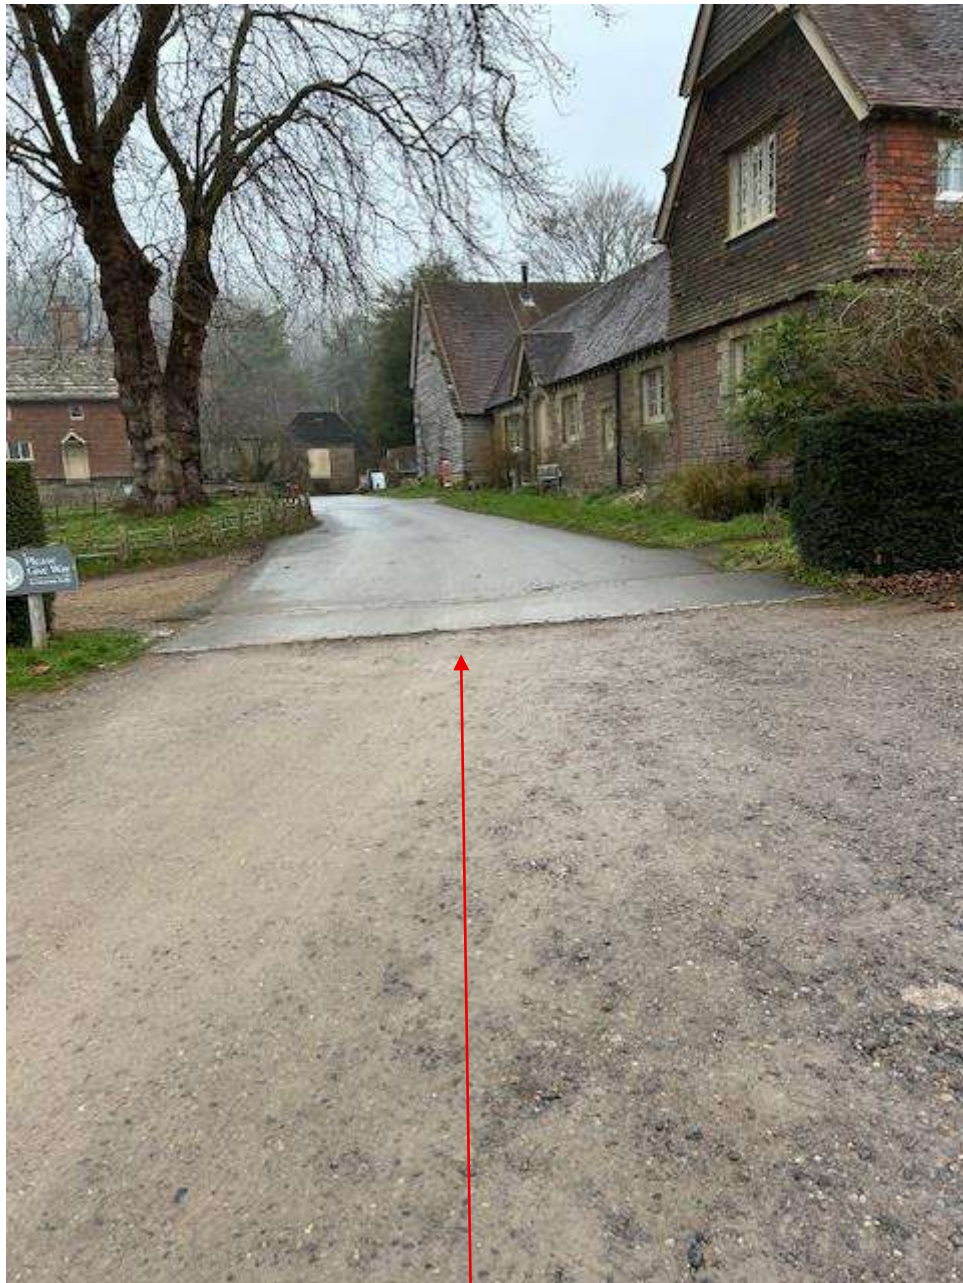
Photograph 1 – Visitor Reception Building.

Northern side of building to be extended, resulting in the removal of the group of hydrangea shrubs.

4.2.1 A group of hydrangea shrubs, located to the north of the visitor reception building, will need to be removed to enable the proposed extension to this building (Photograph 1, Appendix E). These shrubs could be transplanted to another suitable area of the property grounds.

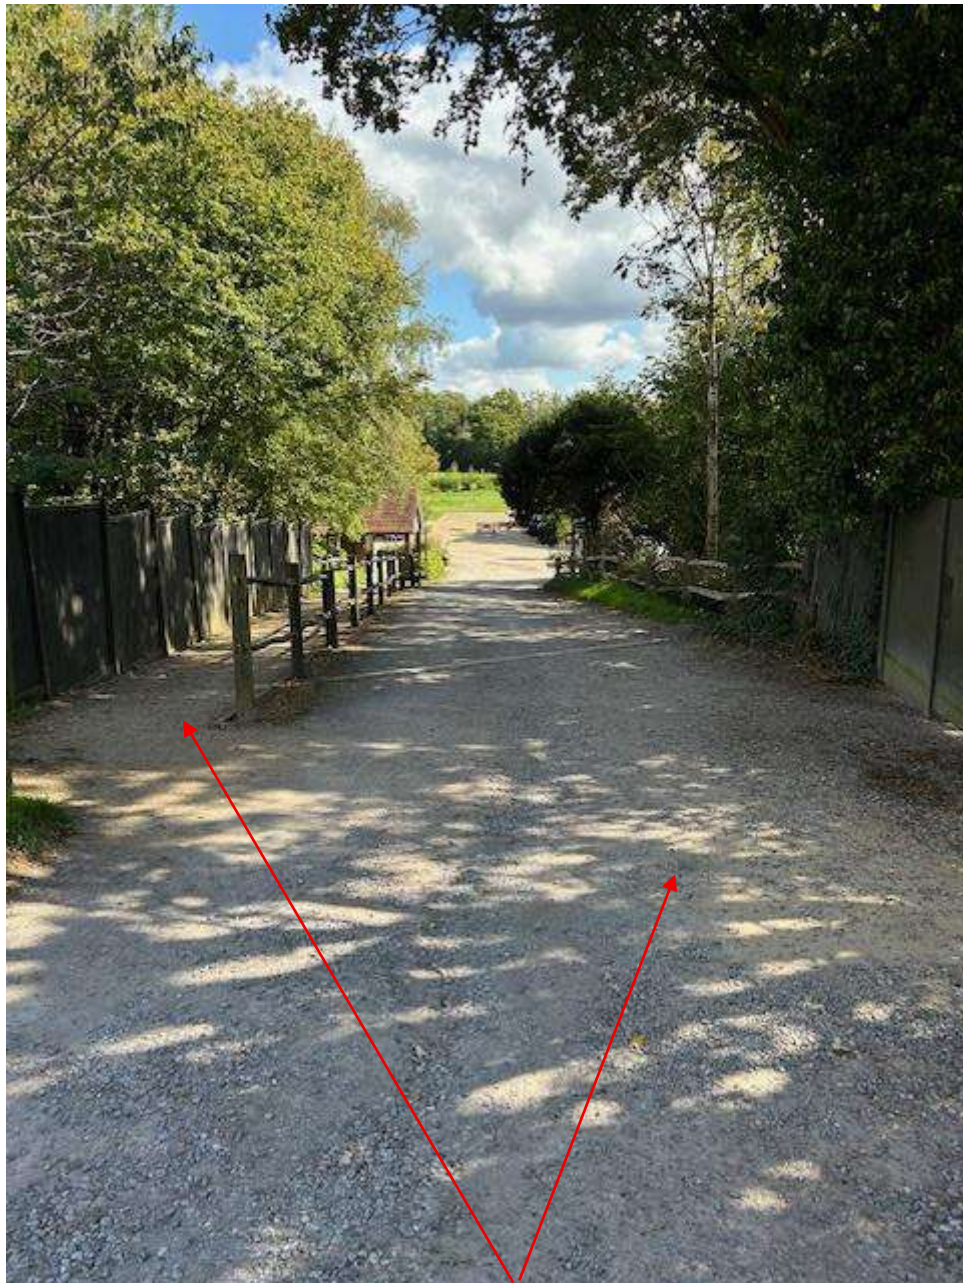
Photograph 2 – Section of main access drive where surfacing changes from tarmacadam to crushed stone adjacent to the Barn Cafe.

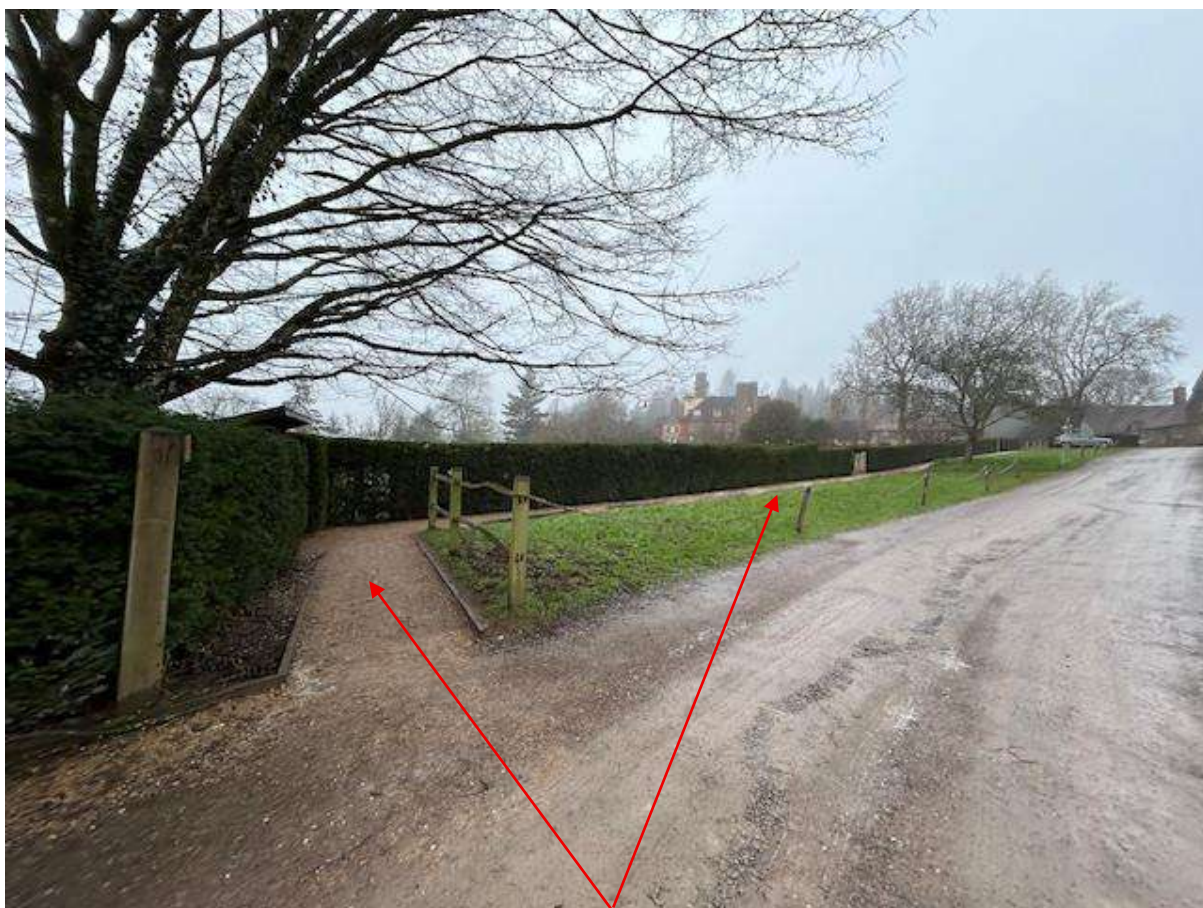
Photograph 3 – Pedestrian access path which runs from the visitor reception building, along the northern side of the access drive, crossing over to the southern side.

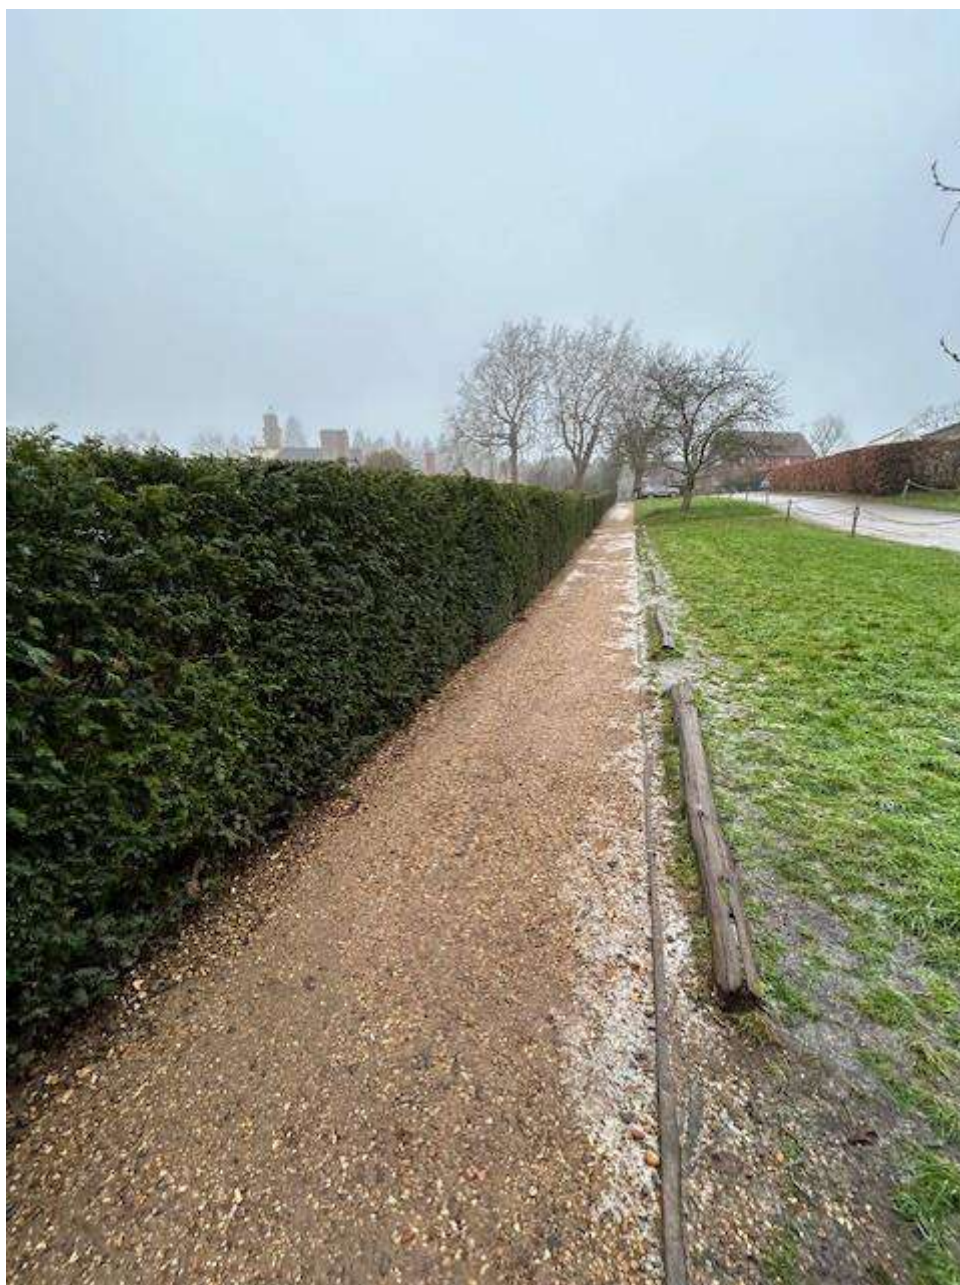
Photograph 4 – Section of pedestrian access path on southern side of road crossing, extending alongside allotment gardens towards the main house.

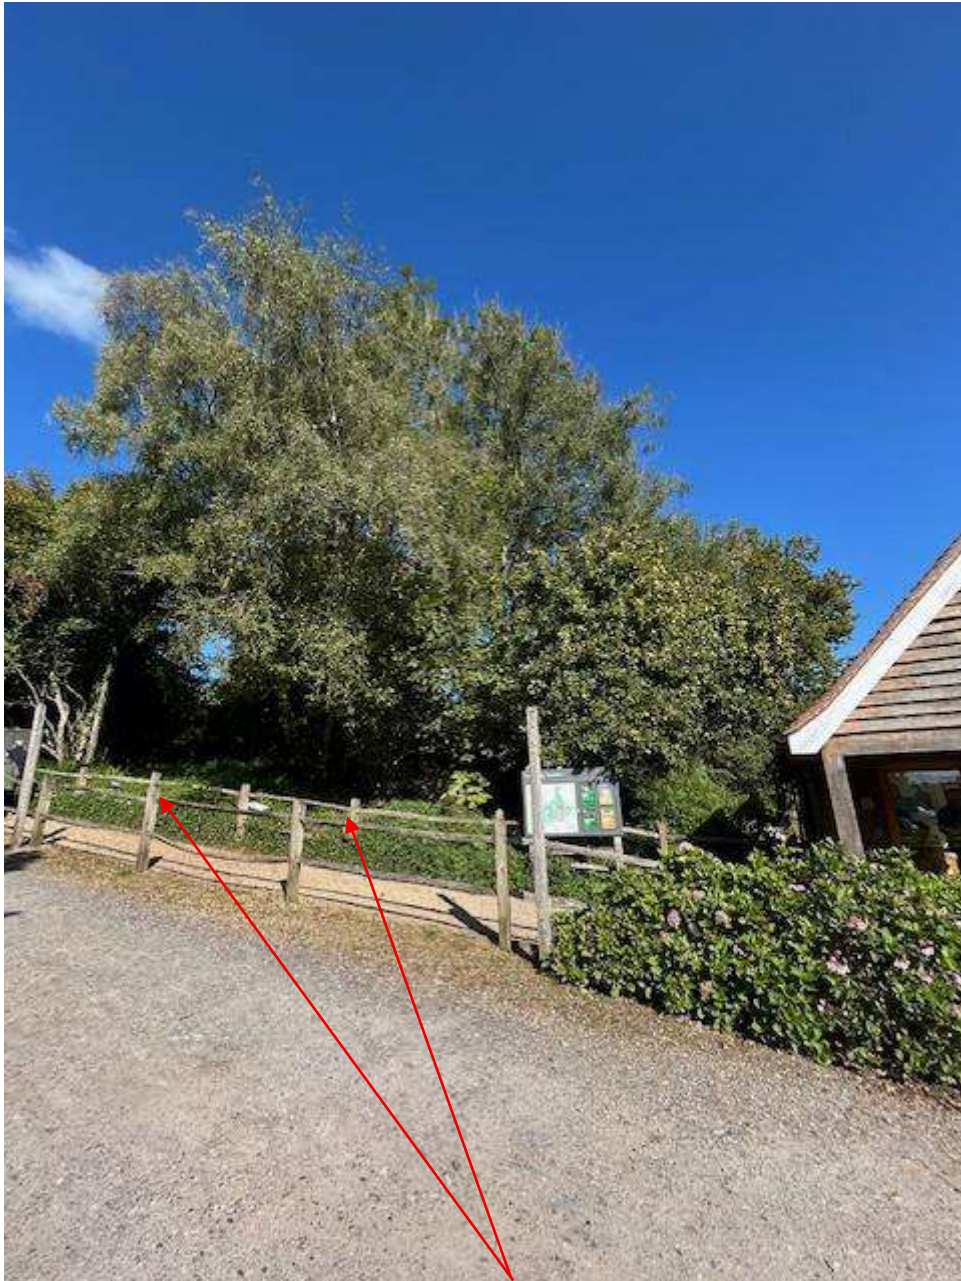
Photograph 5 - Section of pedestrian access path on southern side of access alongside allotment gardens (separated by formal maintained yew hedge) towards the main house.

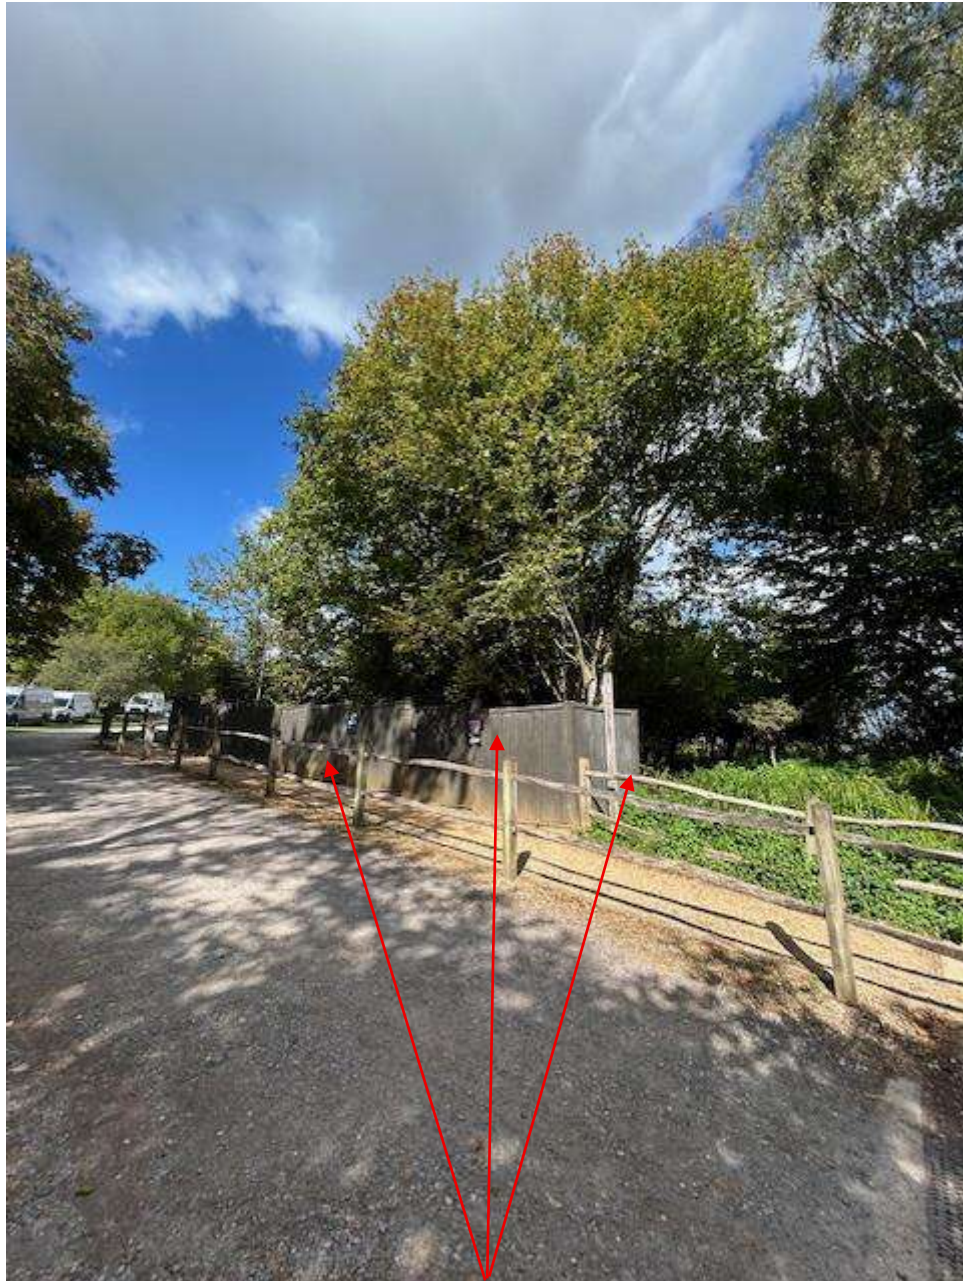
Photograph 6 – Section of wooden post and rail fencing on either side of access drive.

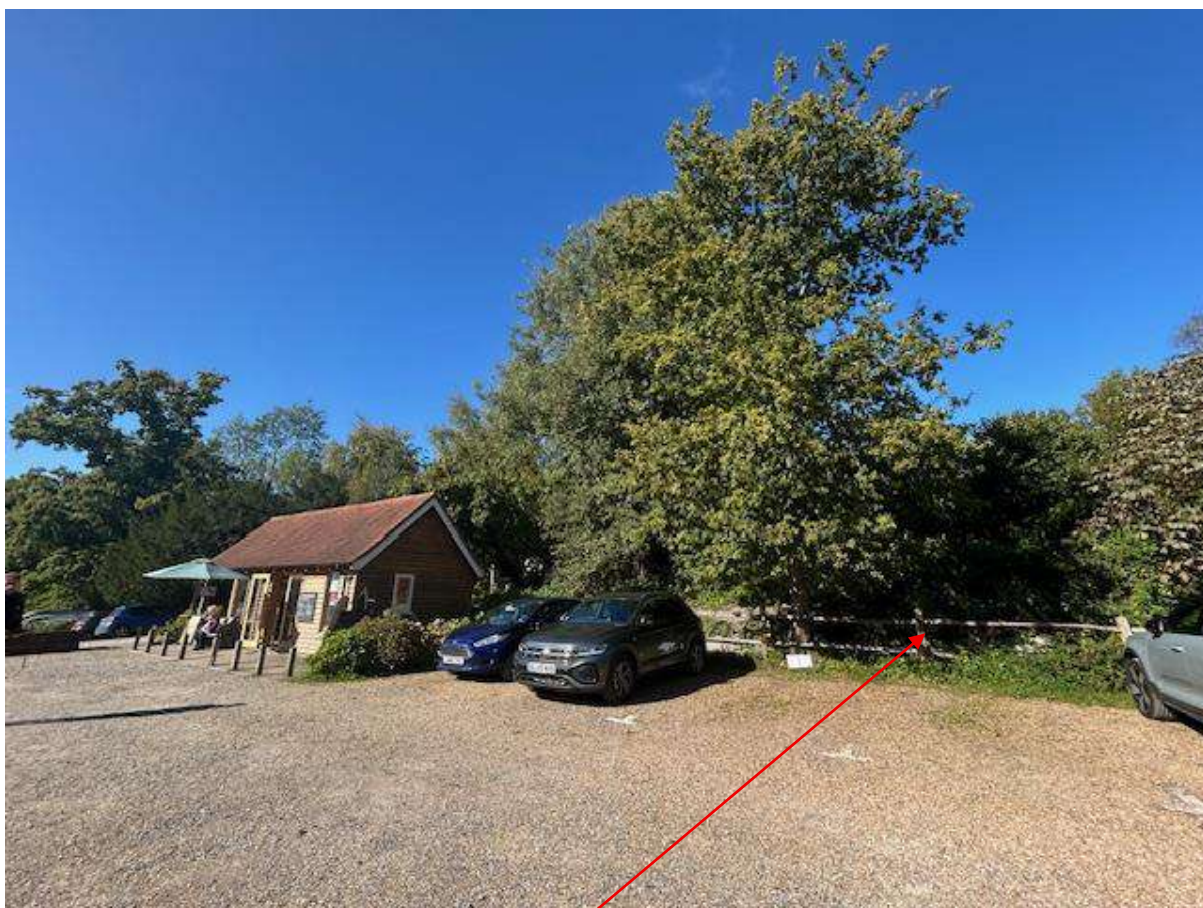
Photograph 7 – Section of wooden post and rail fencing and close board fencing on northern side of path and wooden post and rail fencing on southern side of path.

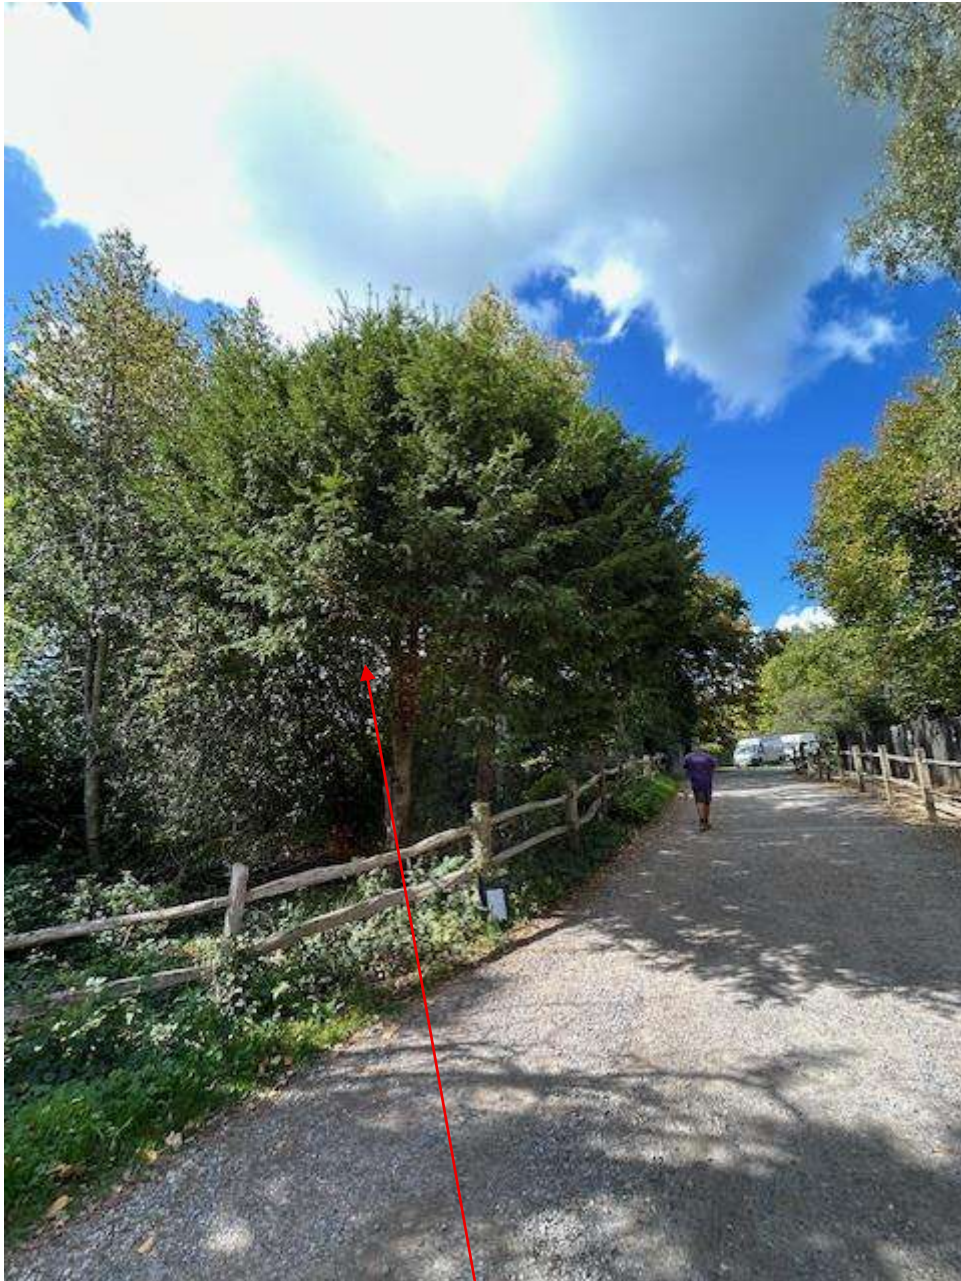
Photograph 8 – Wooden post and rail fencing running along the rear of the visitor reception building.

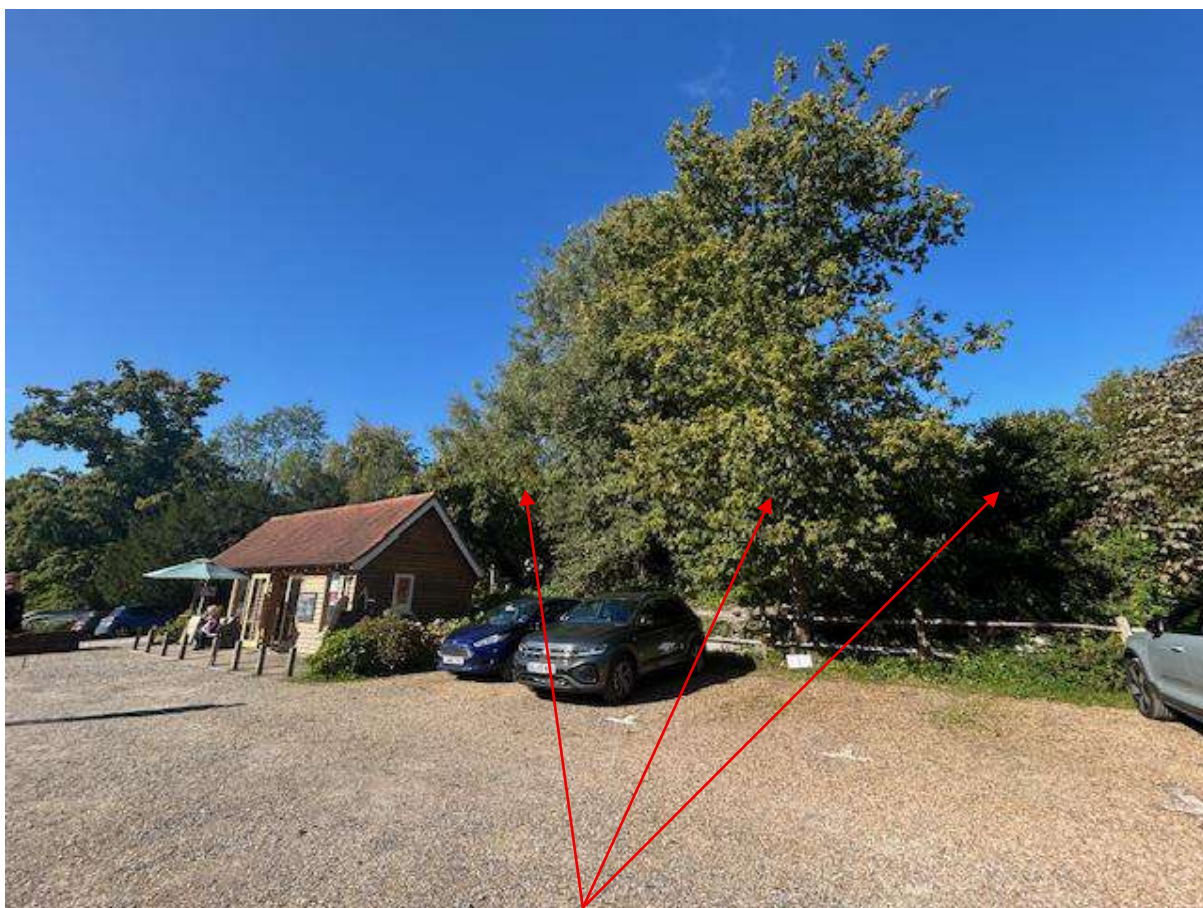
Photograph 9 – Shaw of trees on southern side of access drive with post and rail fencing.

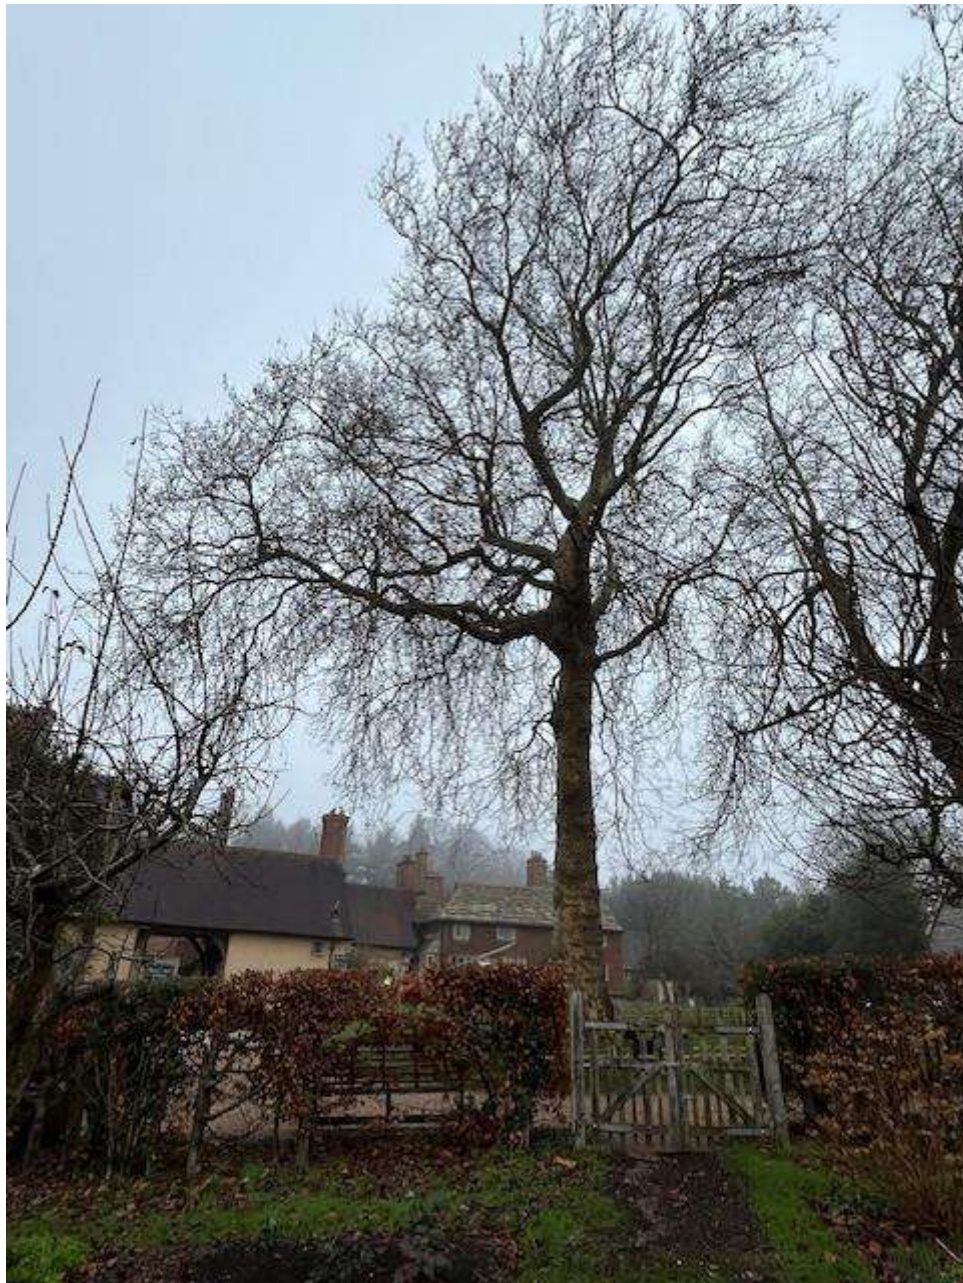
| Tree and Tag No<br>Species | Hght<br>(m) | Stems | | Crown | | Age | RP<br>A (m²)<br>R (m) | Phys<br>Condition | Structural<br>Condition | Preliminary Recommendations | | Cat<br>ERC |
|---|---|---|---|---|---|---|---|---|---|---|---|---|
| London Plane<br><i>Platanus x hispanica</i> | 22 | 1 | 980 | N | 4 | 4 | M | A: 434.5<br>R: 11.76 | Good | C: Good<br>S: Good<br>B: Good | Remove :: Suspended or broken branches<br><br>Mature tree in good condition.<br>1 no. broken, suspended branch in north-eastern side of<br>crown at a height of approximately 10m. | A.1.2<br><br>>40 yrs |

Photograph 14 – London plane (T10)
