## IMBERHORNE LOWER SCHOOL, EAST GRINSTEAD

### FOUL SEWAGE & SURFACE WATER DRAINAGE ASSESSMENT

JULY 2026

Ref: 14392/03/HOP/RPT/02

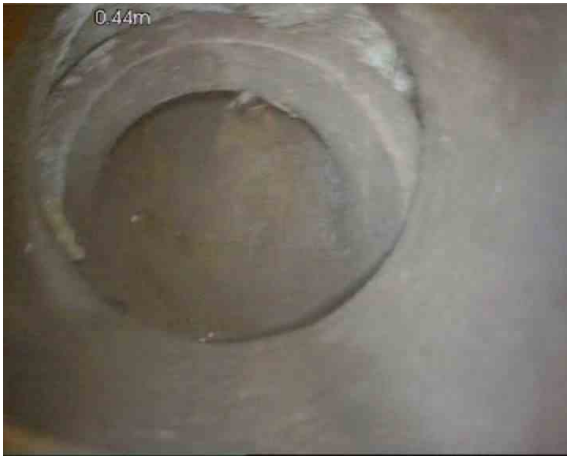
| Item No. | Inspection Direction | PLR | Client's Job Ref | Contractor's Job Ref |
|---|---|---|---|---|
| 18 | Upstream | GULLYX | | N3004 |

1, 00:00:15, 0.44 m  
Joint displaced, large

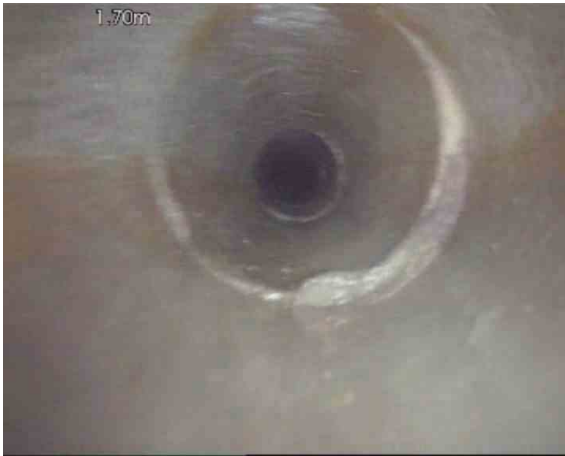
| Item No. | Inspection Direction | PLR | Client's Job Ref | Contractor's Job Ref |
|---|---|---|---|---|
| 21 | Downstream | MH09 (X)X | | N3004 |

1, 00:00:19, 1.70 m  
Joint displaced, medium
