# LBM ECOLOGY

Preliminary Roost Assessment

Copthorne

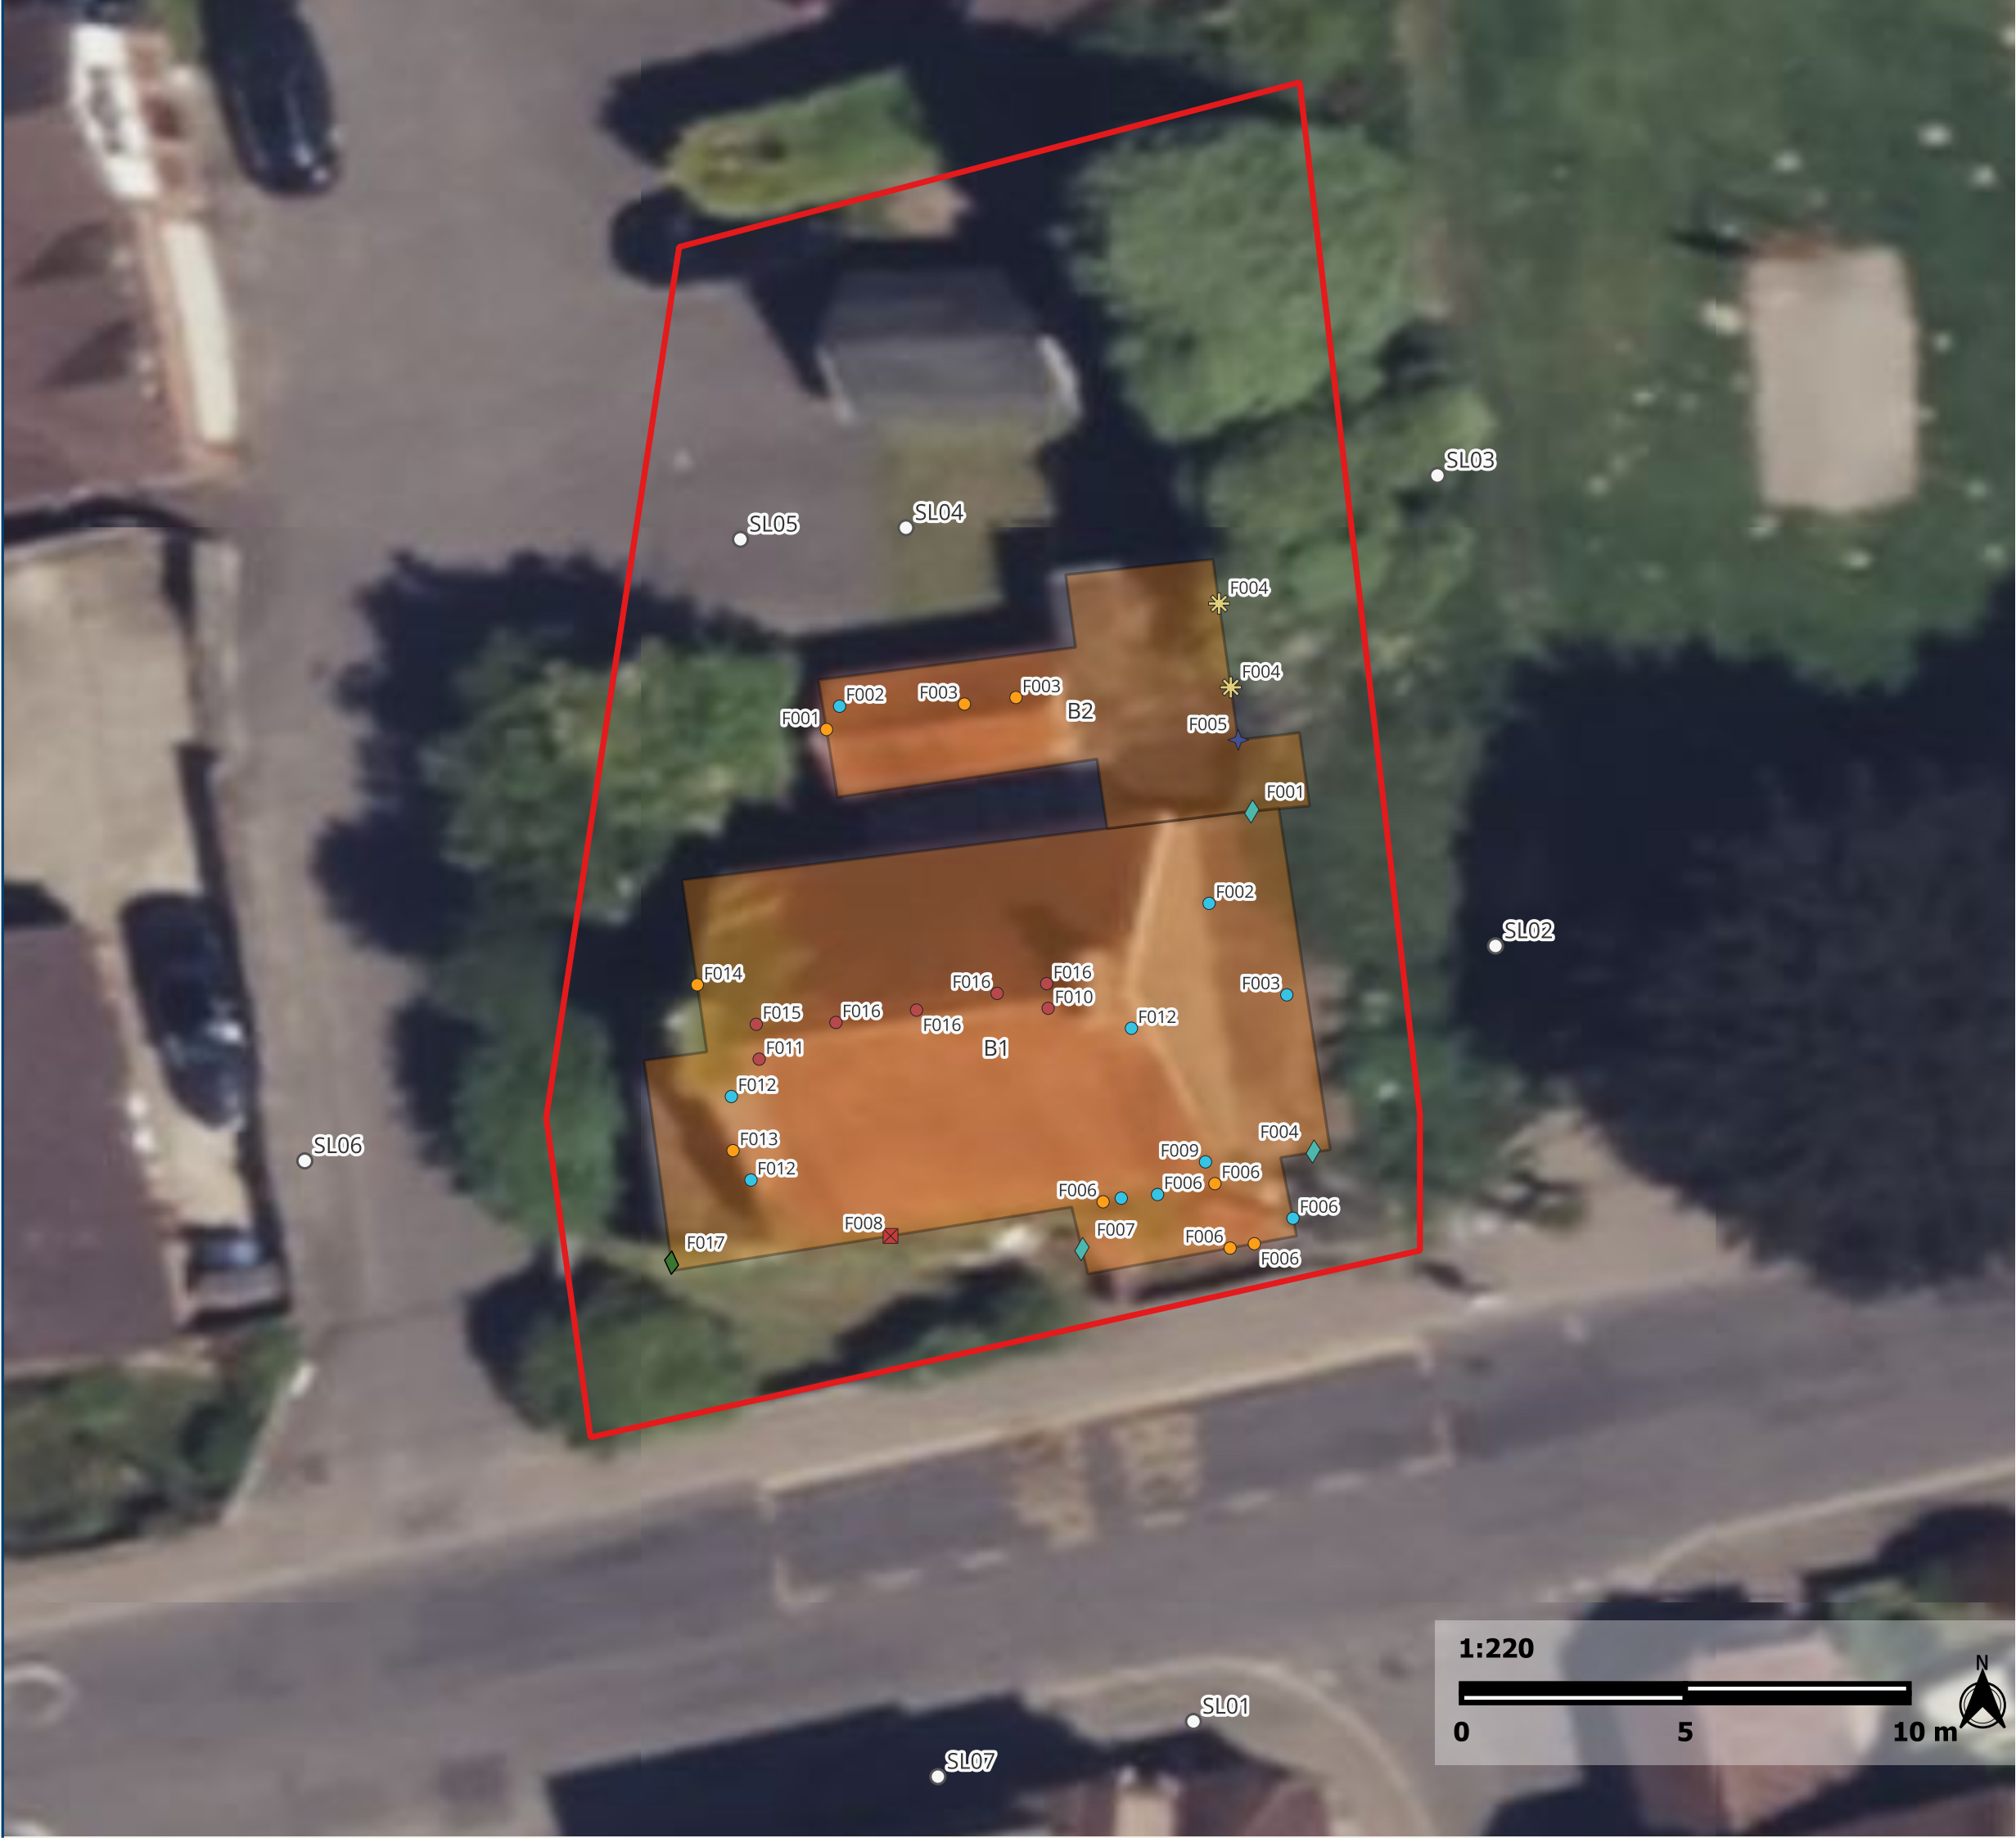
Title: Figure 1 PRA Survey Results

- PRFs
- Hole in brickwork
  - Lifted tile
  - Missing mortar
  - Lifted ridge tile
  - Missing tile
  - Missing mortar under tile
  - Gap between fascia board and wall
  - Missing wooden cladding

- Roosting Suitability
- Moderate
