MS05636

Barn to south east of  
Pickhams House,  
Cuckfield Road,  
Hurstpierpoint BN6 9LL

| JOB TITLE<br>Barn at Pickhams House, Hurstpierpoint. | | DATE<br>May 2021 |

Barn to south east of Pickhams House, Cuckfield Road, Hurstpierpoint BN6 9LL.

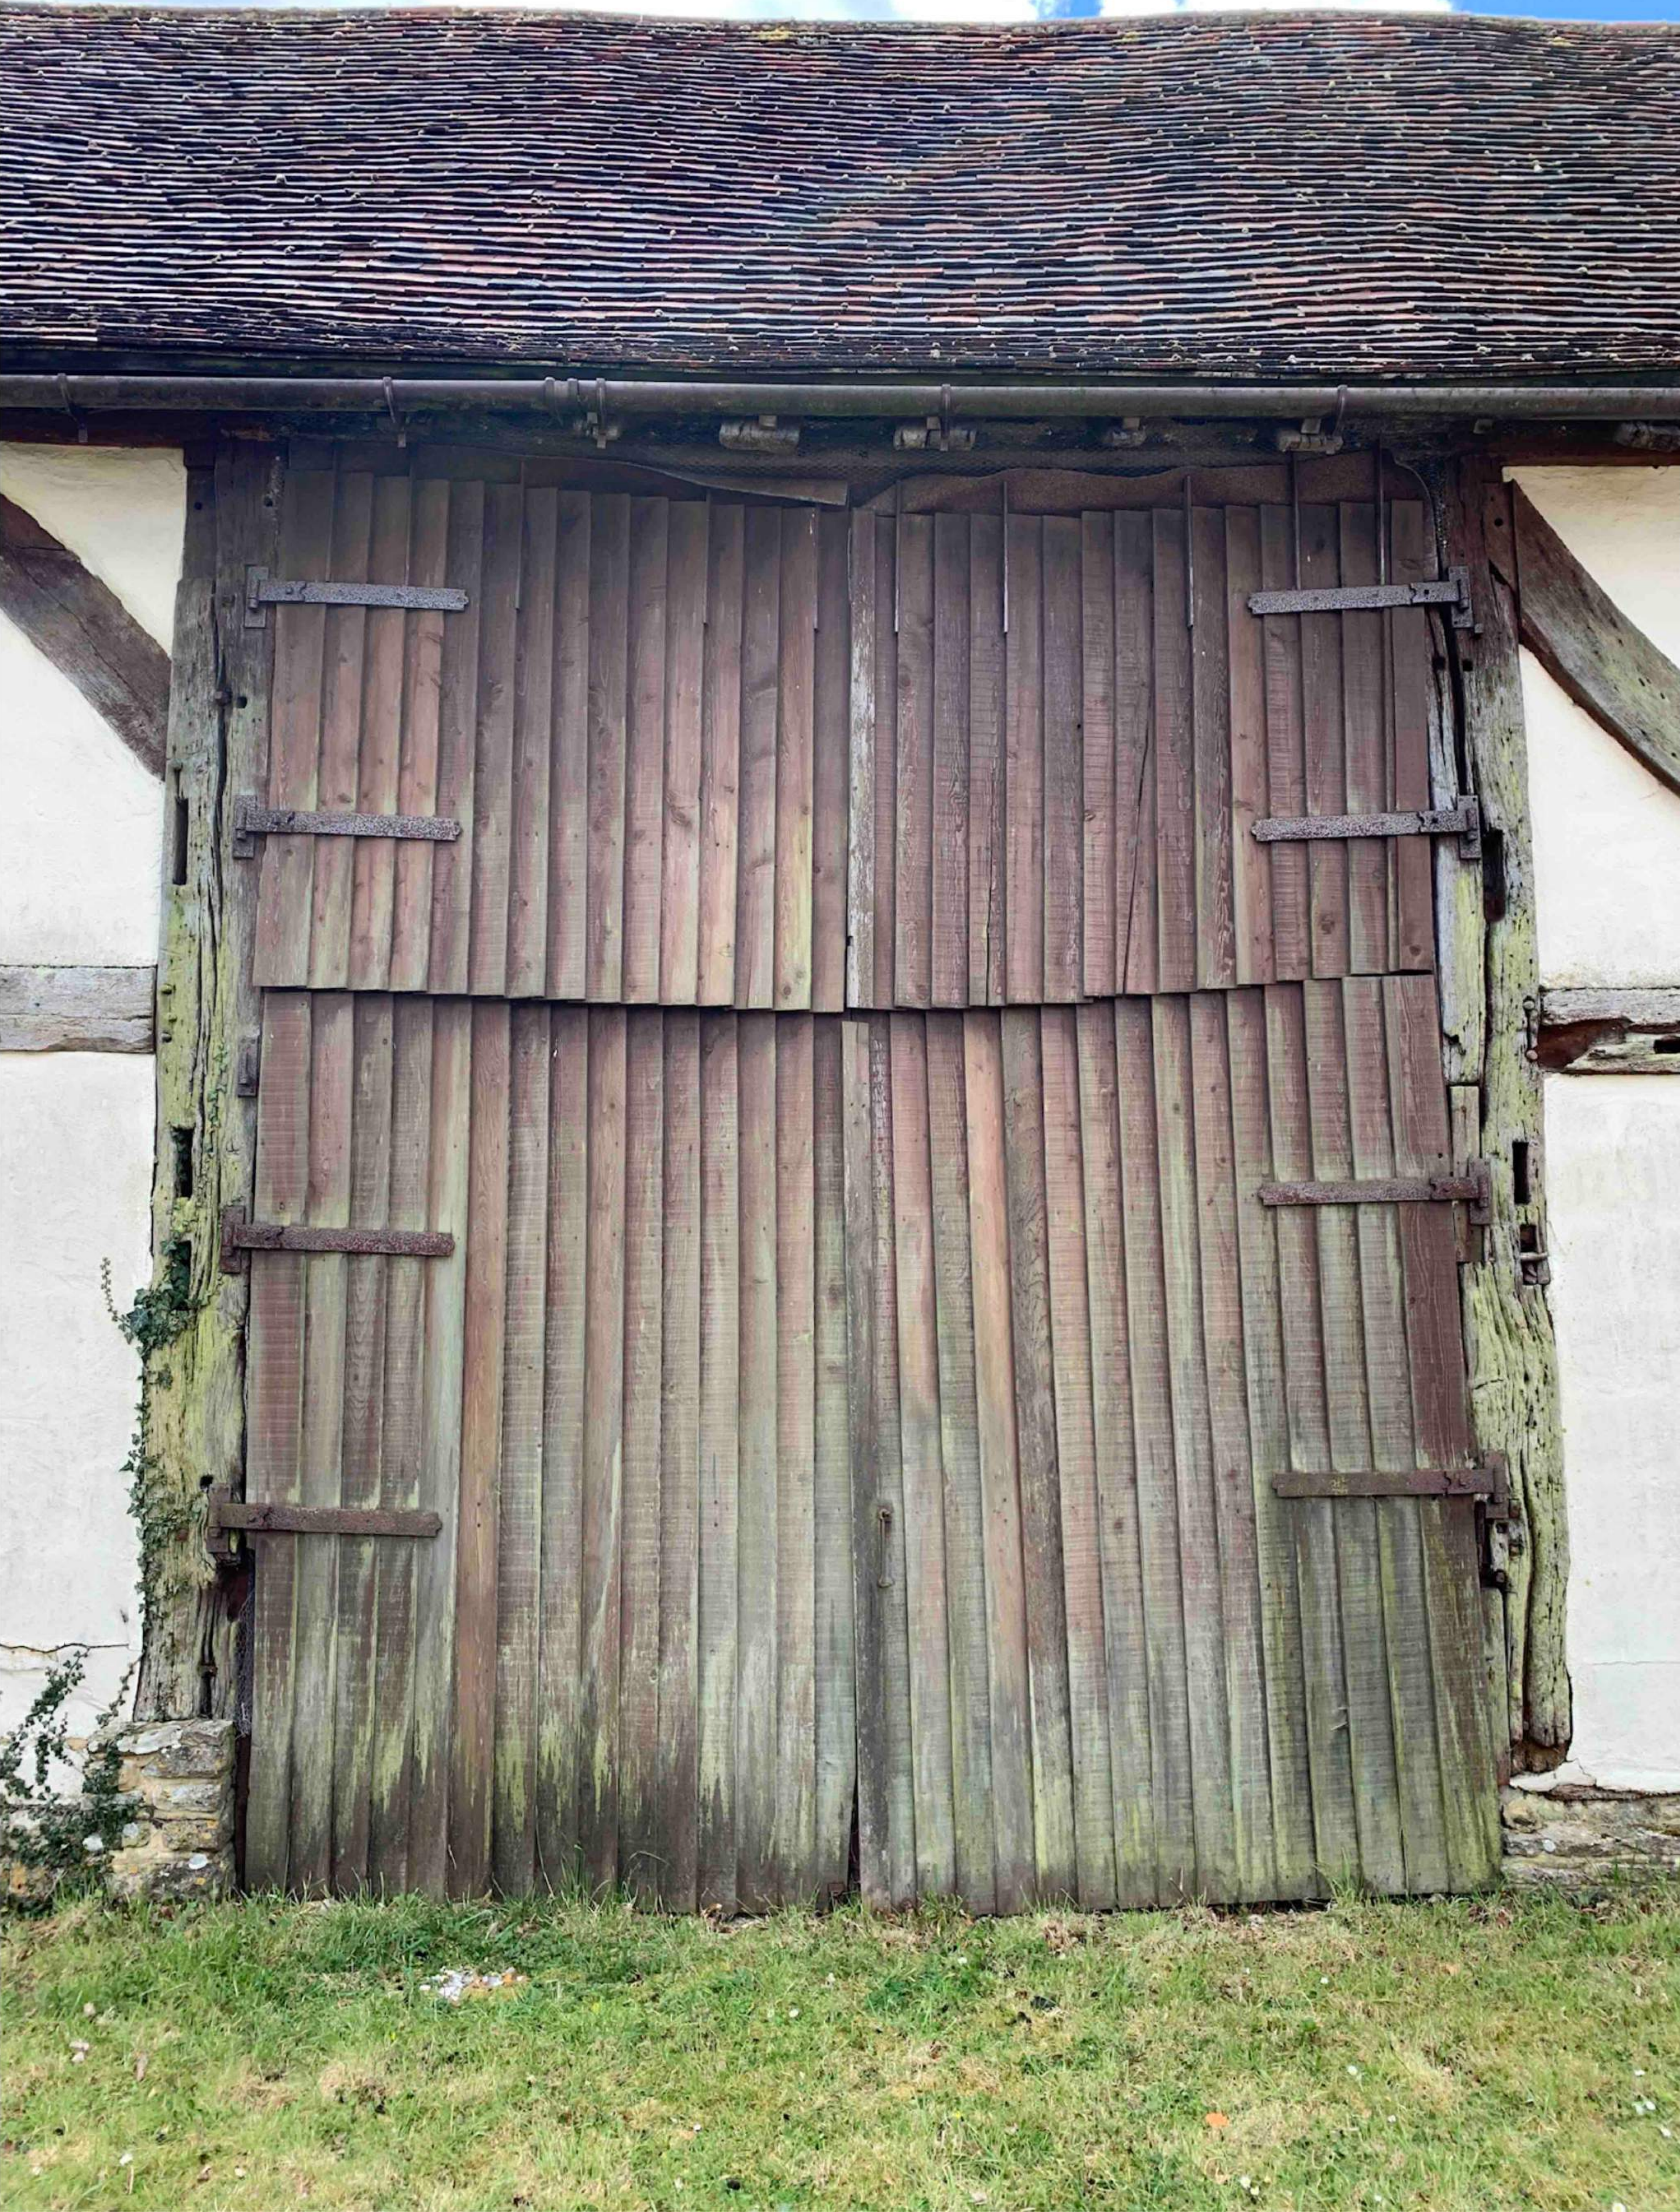
125mm  
DECAY

1.5mm  
CRACK

MINOR  
SURFACE/  
EDGE  
DECAY

20mm  
EDGE  
DECAY

140mm  
DECAY

25mm  
END/EDGE  
DECAY TO  
POST

PATCH TO  
FRONT HALF  
OF SOLE PLATE

HALF-LAPPED  
SCARF

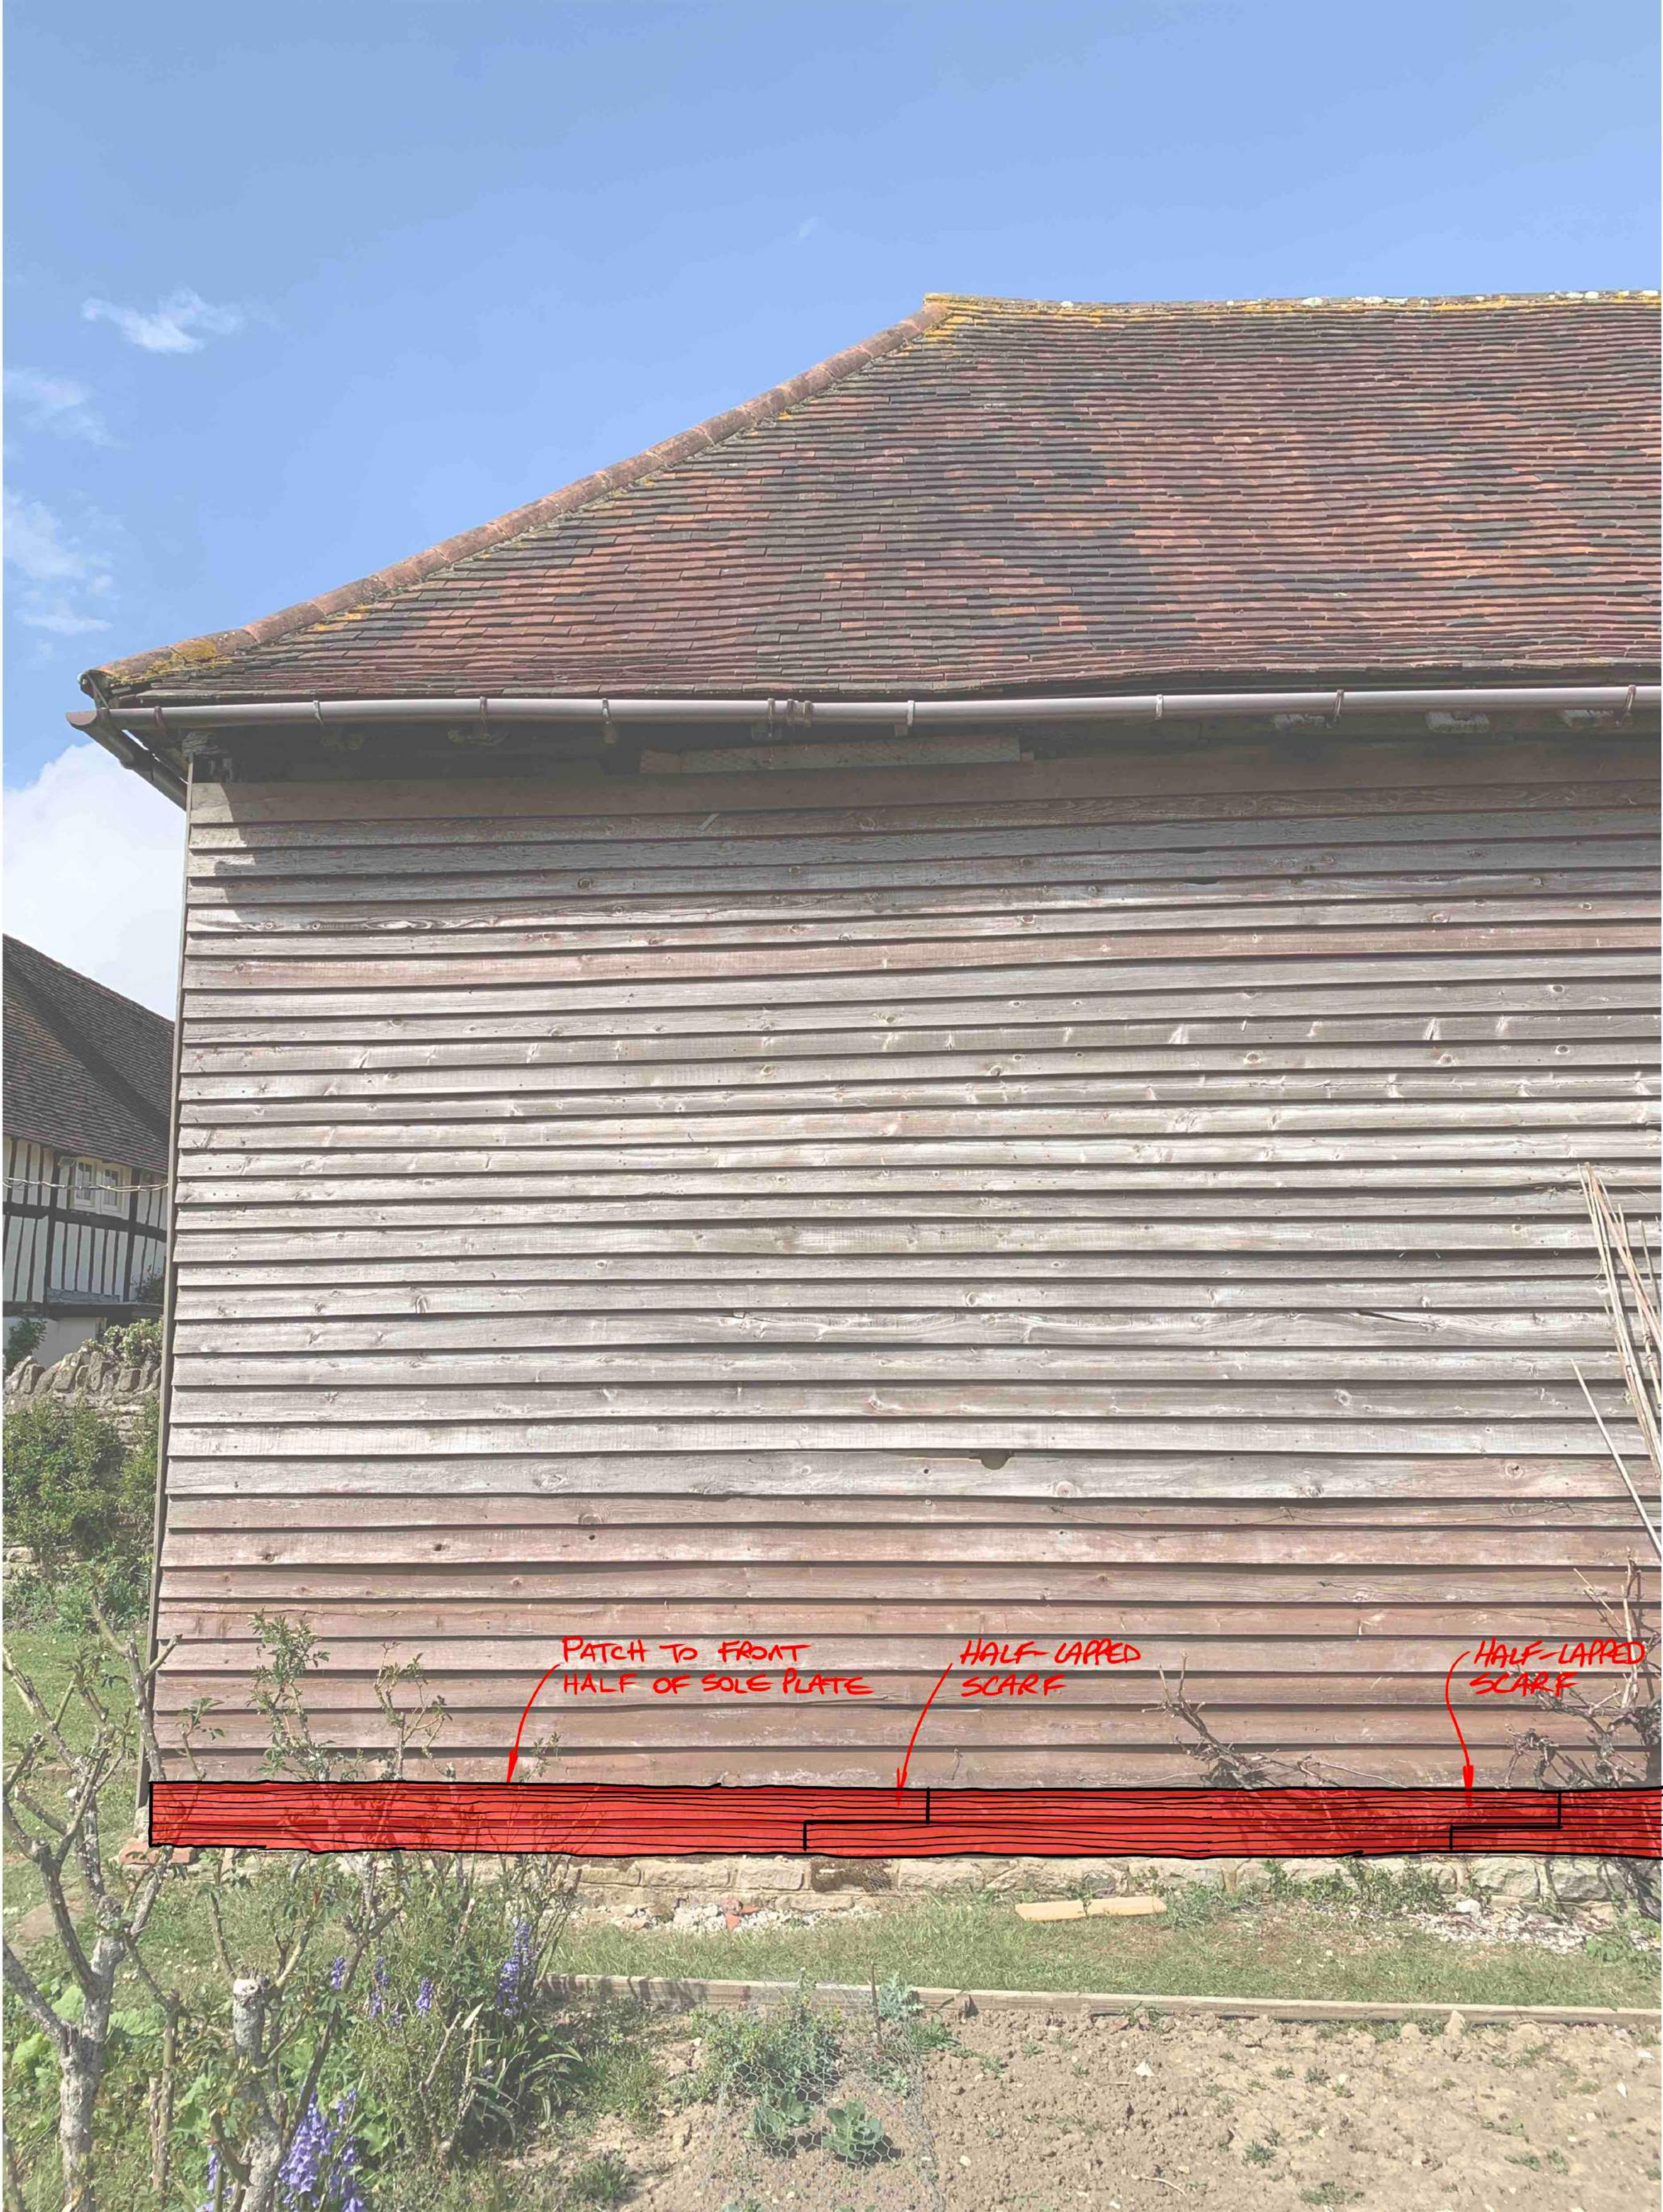
95mm DEEP  
SPLIT WITH  
END DECAY

END OF  
STUD  
LOOSE

SOLE PLATE  
FULLY DECAYED

155mm DEEP DECAY  
TO TOP OF SOLE PLATE  
170mm DEEP DECAY  
TO BOTTOM OF PLATE

110mm DEEP  
DECAY

REPLACE  
AND RAISE  
SOLE PLATE  
WITH NEW  
BRICKWORK  
MASSORY &  
FOUNDATION  
BELOW

PATCH TO FRONT  
HALF OF SOLE PLATE

HALF-LAPPED  
SCARF

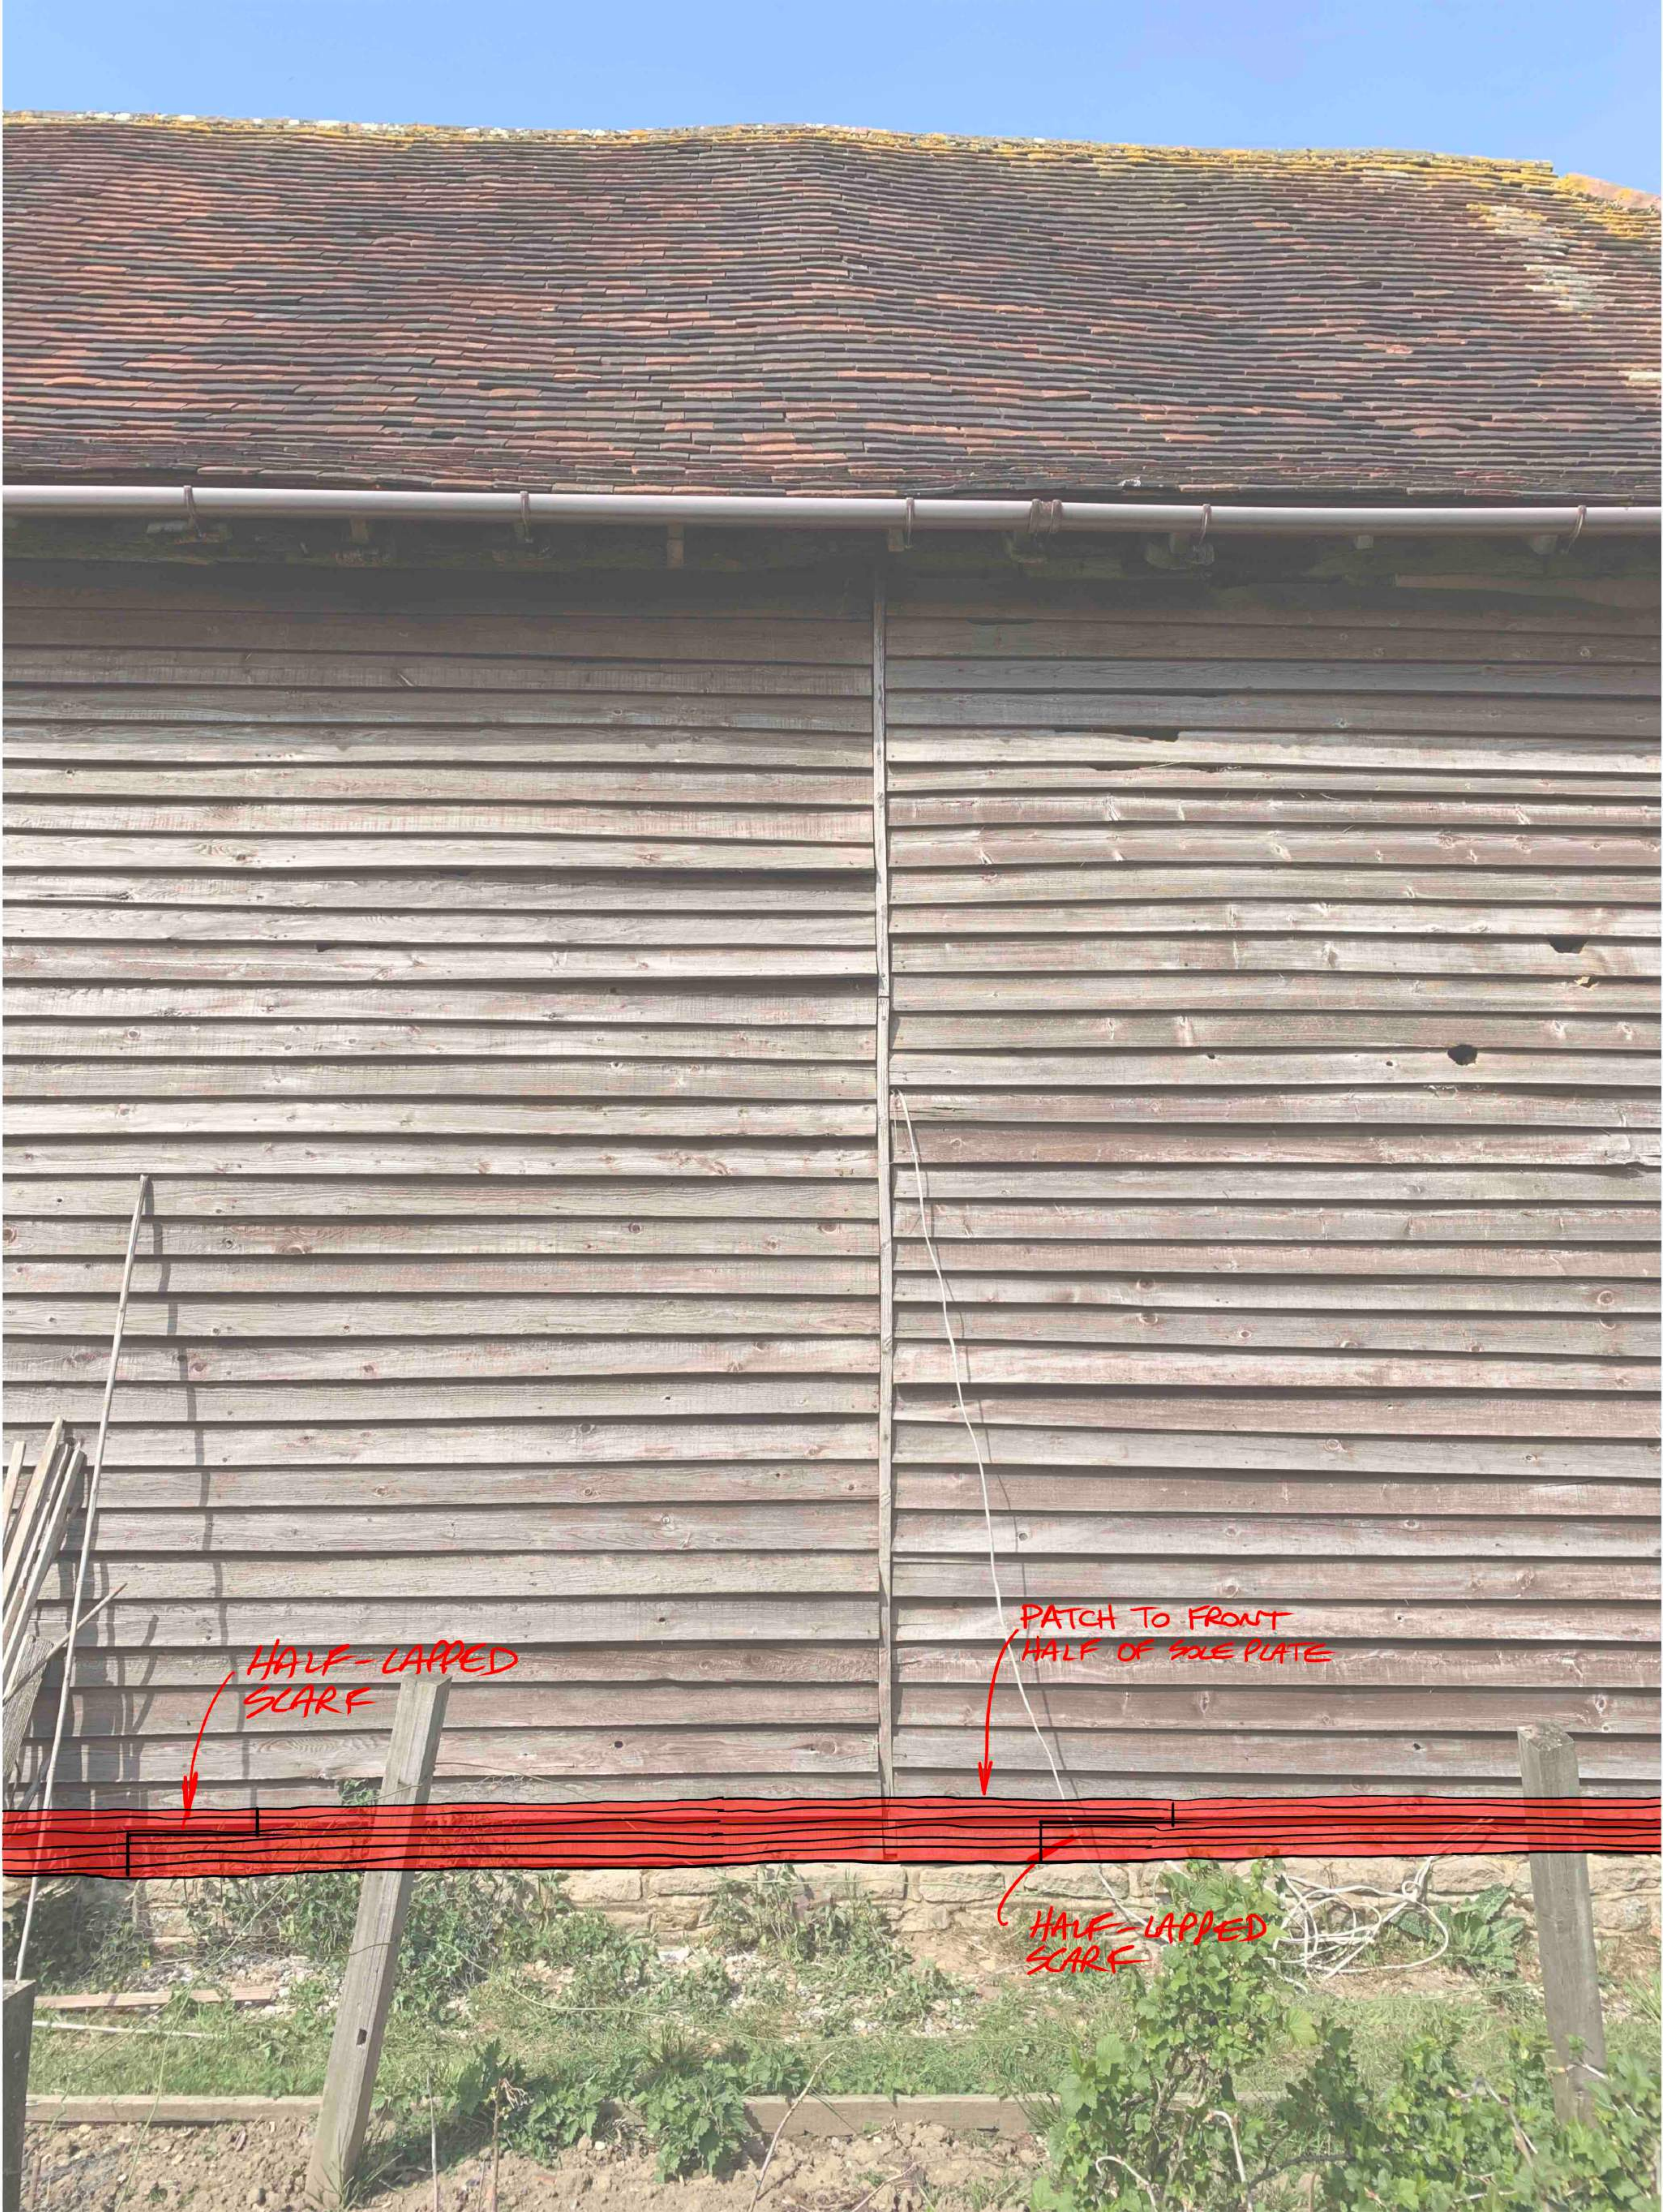
DECAY TO TOP OF POST

PATCH TO FRONT  
HALF OF SOLE PLATE

HALF LAPPED  
SCARF

HALF-LAPPED  
SCARF

FILLER REPAIR

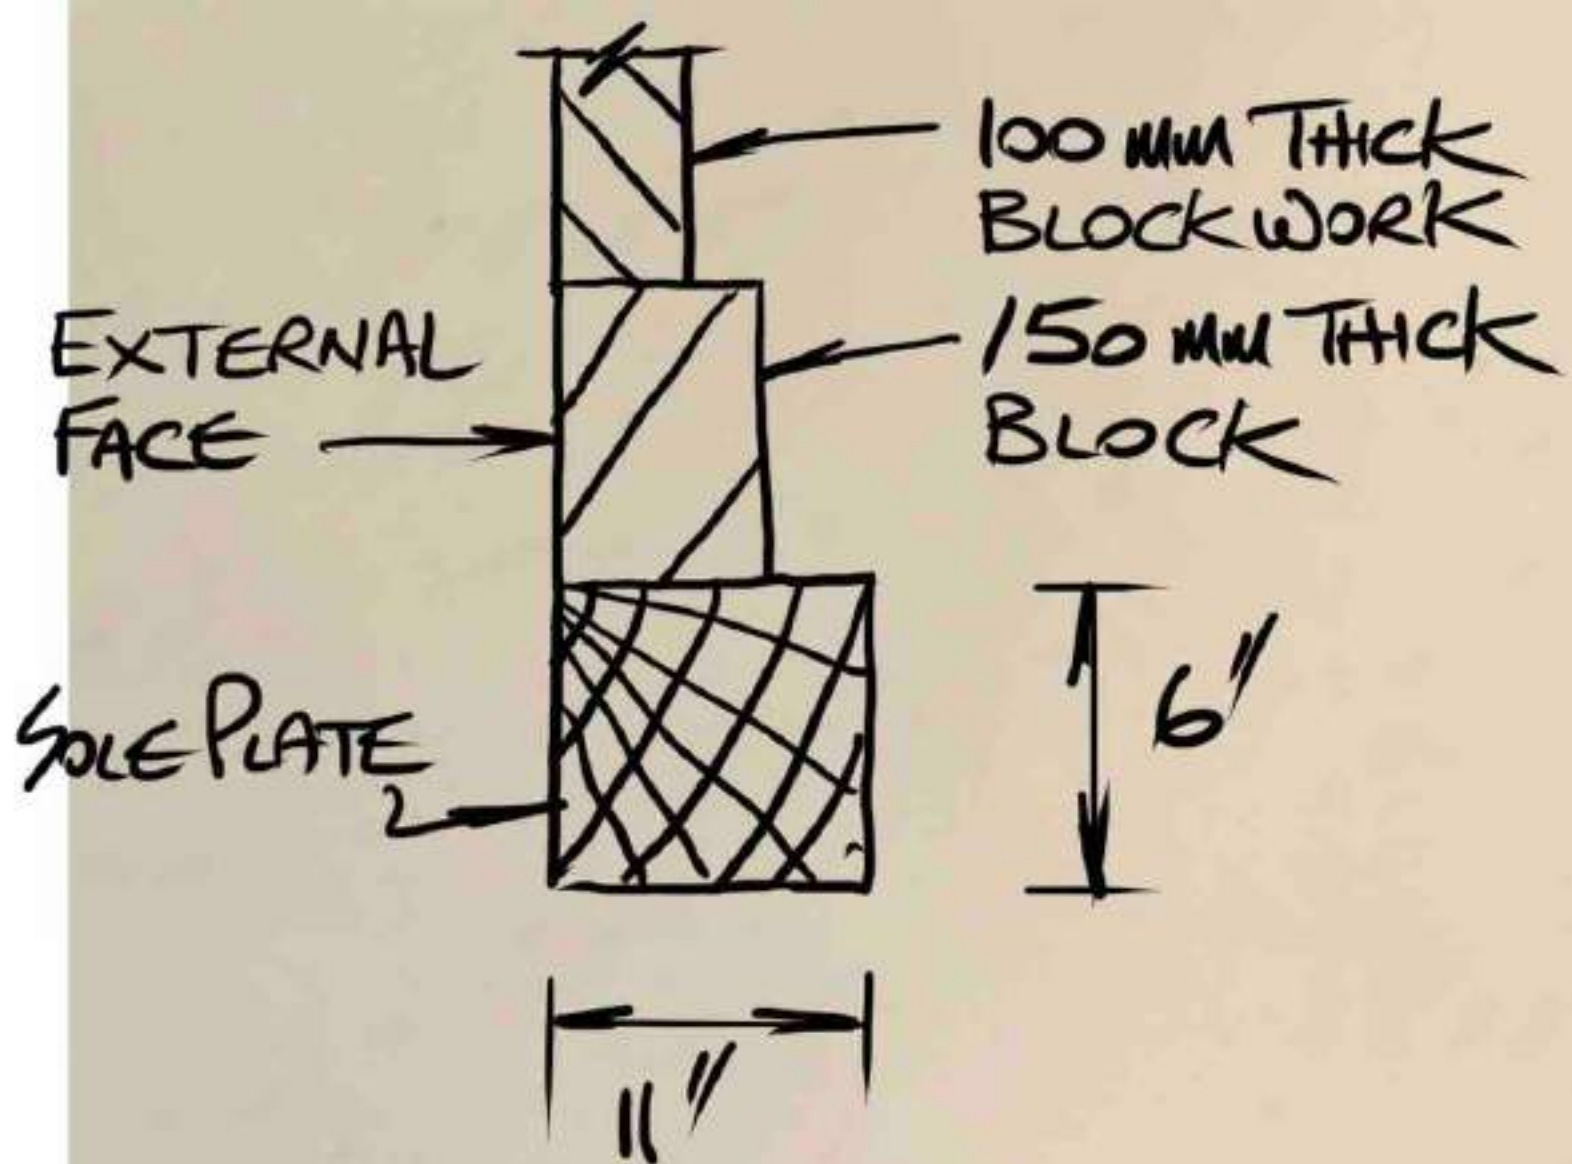
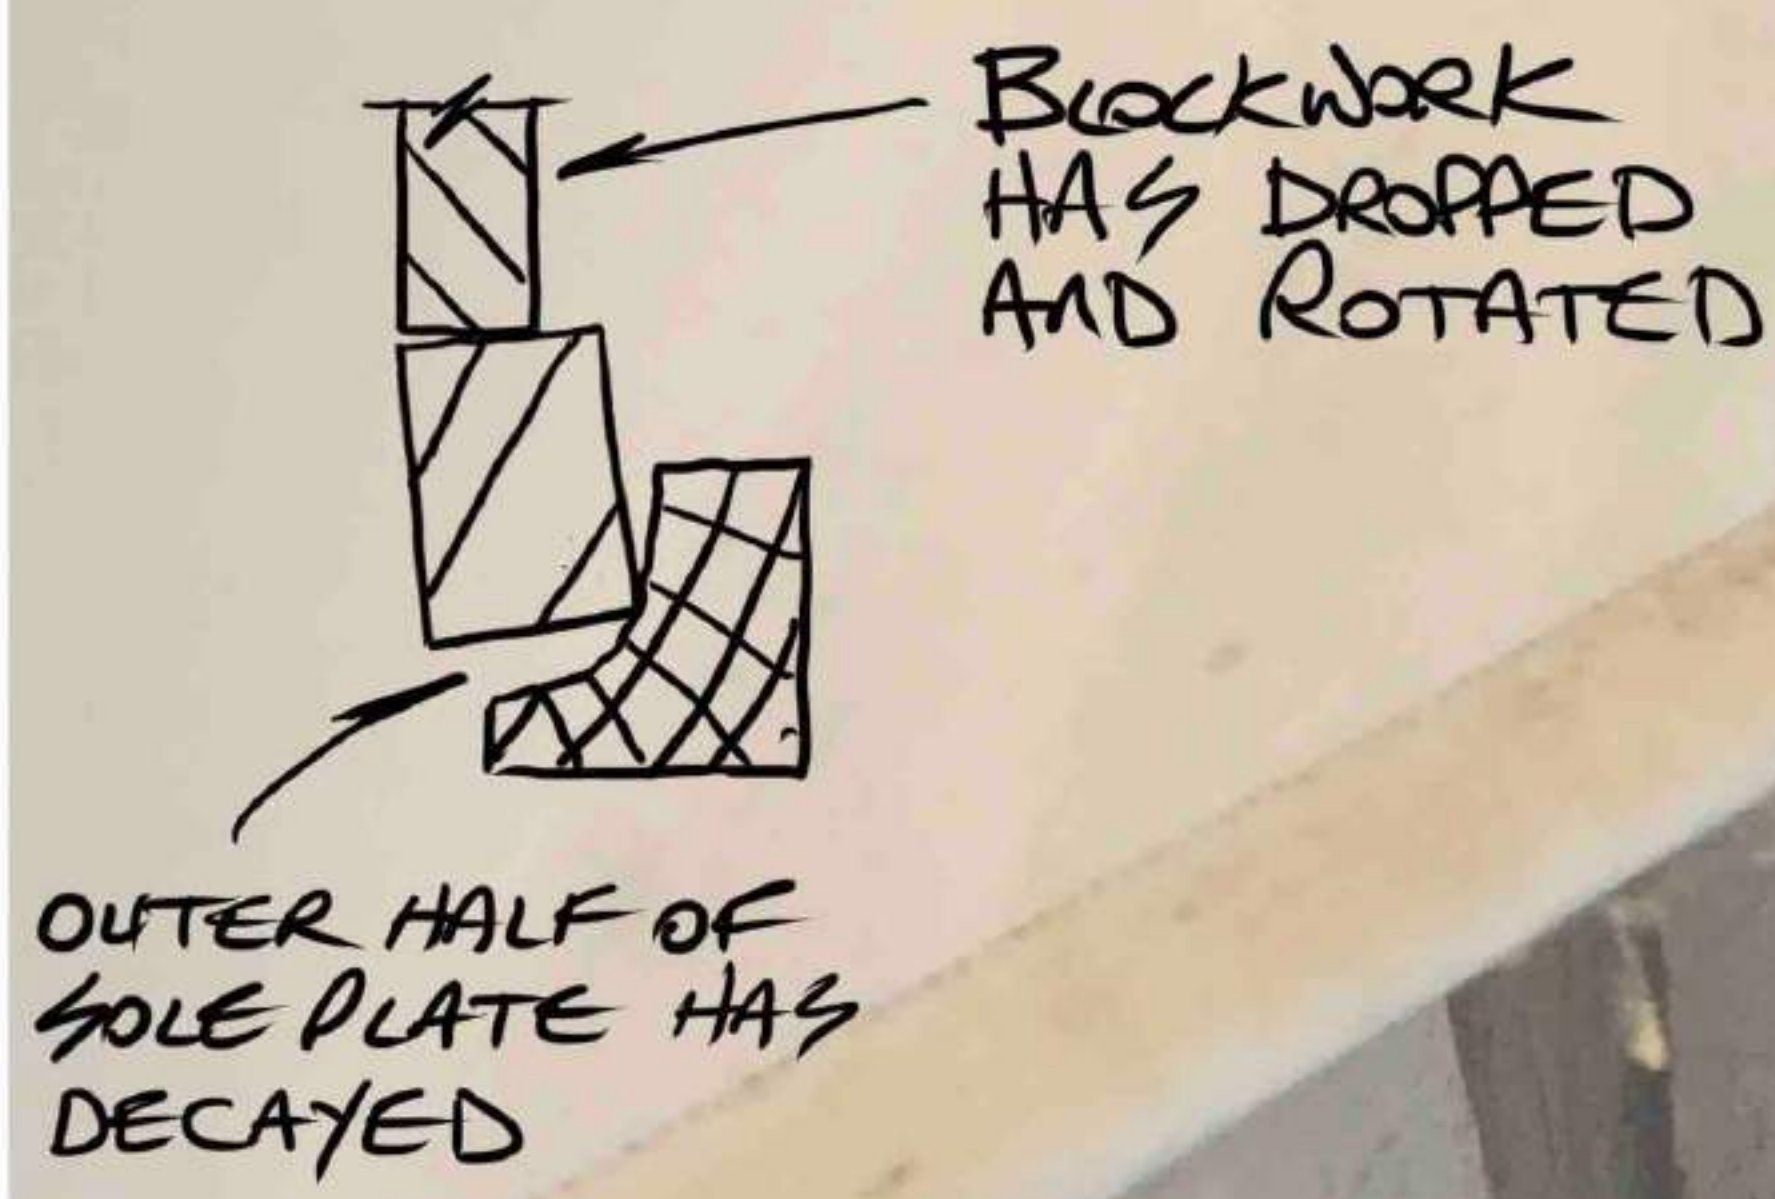
220mm DECAY TO SOLE PLATE SOFFIT

180mm DECAY TO SOLE PLATE

50mm DEEP DECAY

130mm DEEP DECAY

LOSS OF OUTSIDE  
HALF OF SOLE PLATE  
GENERALLY

DECAY TO  
END OF POST  
AT OUTSIDE  
FACE

PATCH TO FRONT OF SOLE PLATE

REPLACE  
AND RAISE  
SOLE PLATE  
WITH NEW  
BRICKWORK  
AND FOUNDATION  
BELOW
