**Project****Project Name:** Eastlands Farmhouse - SW**Project Description:** CCTV Survey, trace & plot**Project Status:** Complete**Project Date:** 05/10/2025**Inspection Standard:** MSCC5 Sewers & Drainage GB (SRM5 Scoring)

# **EYES ON DRAINAGE**

## **CCTV-Trace-Plot-Map-Repair**

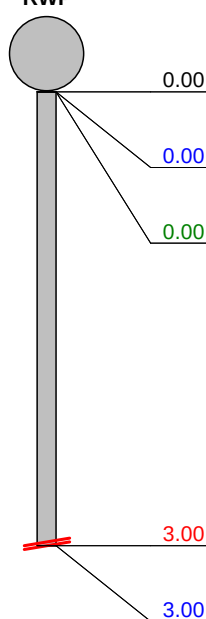
| No. | m+ | Code | Observation |
|---|---|---|---|
| 3 | 0.00 | RM | Roots, mass, 100% cross-sectional area loss, Continuous |
| 4 | 3.00 | XP | Collapsed drain or sewer, 100% cross-sectional area loss |
| 5 | 3.00 | SA | Survey abandoned, Unable to continue, assumed to discharge to pond |

<table><tr><td>0.00</td><td>MH</td><td>Start node, manhole, reference: RWP: Exposed to confirm route.</td><td>1, 2</td><td></td><td></td><td></td></tr></table>

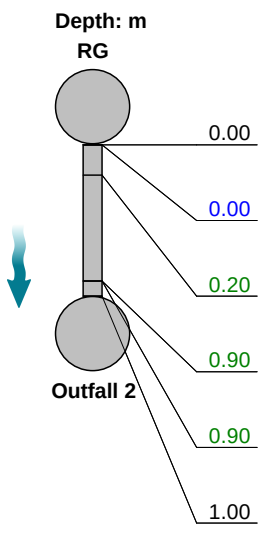
| No. | m+ | Code | Observation |
|---|---|---|---|
| 3 | 0.20 | RFJ | Roots, fine at joint |

| Scale: | 1:50 | Position [m] | Code | Observation | MPEG | Photo | Grade |
|---|---|---|---|---|---|---|---|
| | | 0.00 | GY | Start node, gully, reference: RG | | 1, 2 | |
| | | 0.00 | WL | Water level, 0% of the vertical dimension | 00:00:00 | 3 | |
