### Resistograph Test of T01 Quercus Rubra (Red Oak).

Mr Daniel Ford  
Tower House Close  
Cuckfield  
Haywards Heath  
East Sussex  
RH17 5EQ

Wednesday 04<sup>th</sup> December 2024

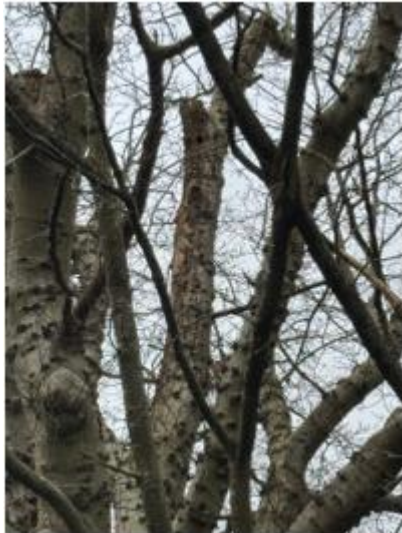
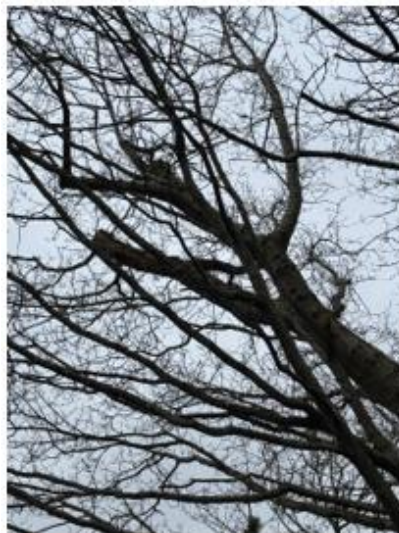
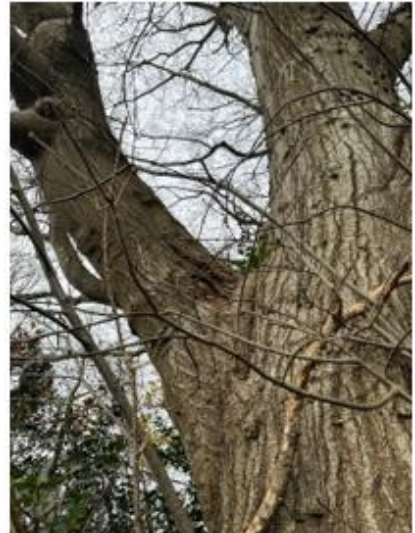
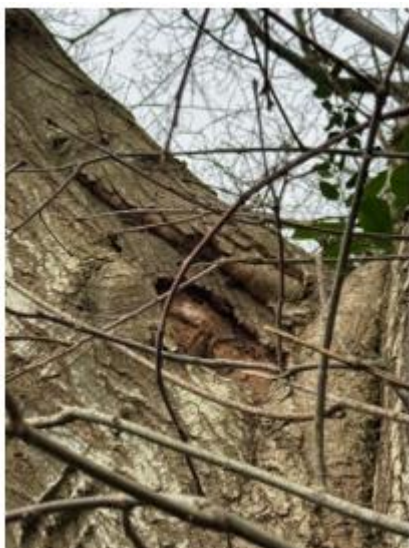
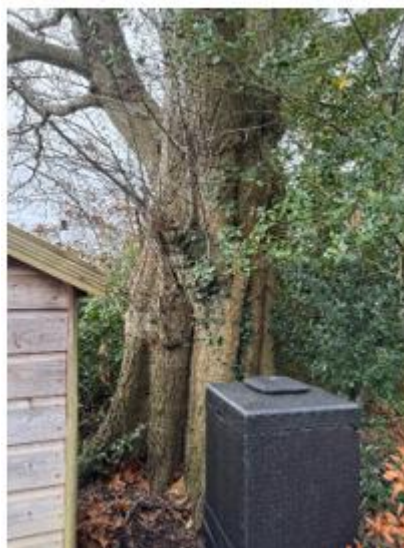
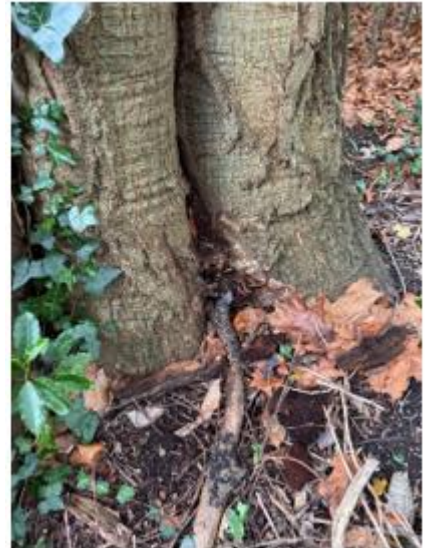
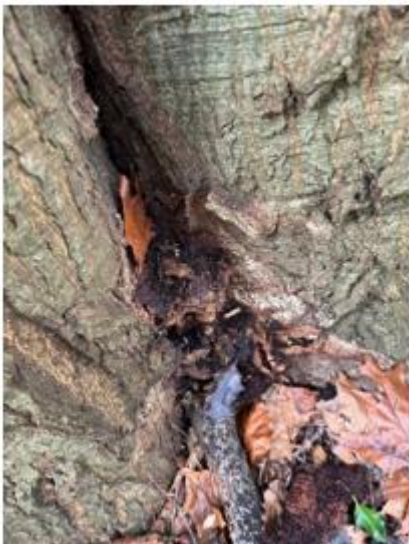
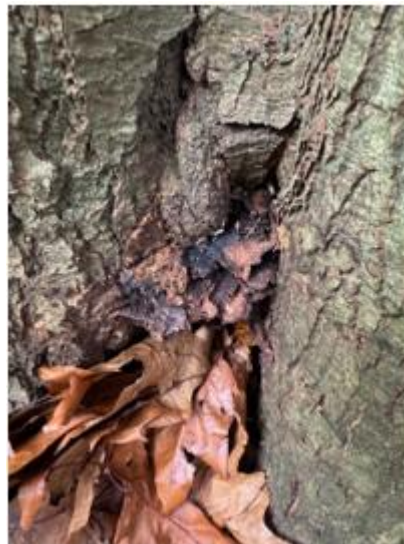
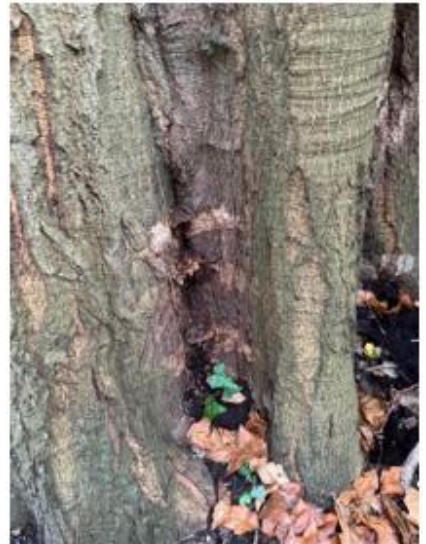
Photos taken from site visit 2024:

- 2.3 Tree species: Quercus Rubra (Red Oak)
- 2.4 Height: 16.6 metres  
Stem size: 1910cm at 0.5m from ground level.
- 2.5 The Red Oak is located adjacent to the North boundary within the treeline boundary between the garage block/ driveway and the neighbouring gardens. Noted on the north, east, south and west sides of the main stem can be found multiple sections of Fruiting bodies identified as Ganoderma Australe. Following this inspection was highlighted sections of deadwood in the crown in range of 25mm and greater and multiple sections of dieback from the old, decayed pruning points as well as a deceased central upright stem.

- 4.2 There is significant decay in the main stem of the tree as can be seen in Appendix 1 the Resistograph carried out in the main stem, high levels of decay at the old pruning points and decay at the bifurcated stem union.

- 4.4 Following interpretation of the data from the test drillings I would recommend. Carefully felling to near ground level as the levels of decay are beyond that of a safe level to retain with remedial safety works i.e. reduction, pollard, monolith etc. The target area for this tree is considered high.
