## East Boundary Wall at Sackville College

# Structural Engineering Report

Sackville College

*Document reference:* 0180/REPORT 01

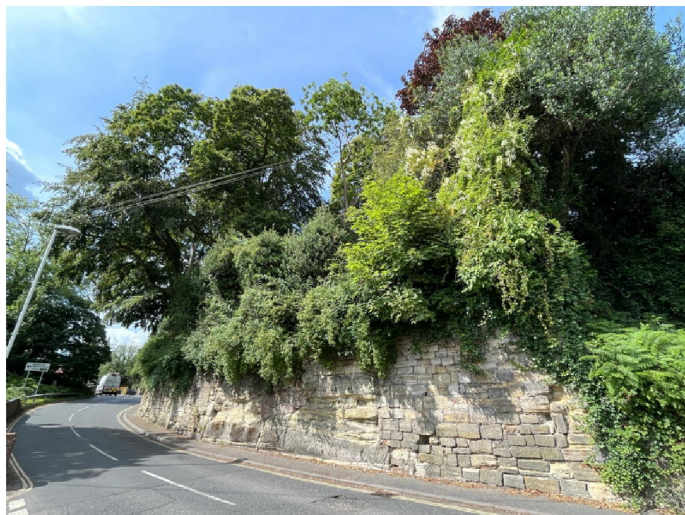
*Image 2.1:*

*Boundary wall from College Lane*

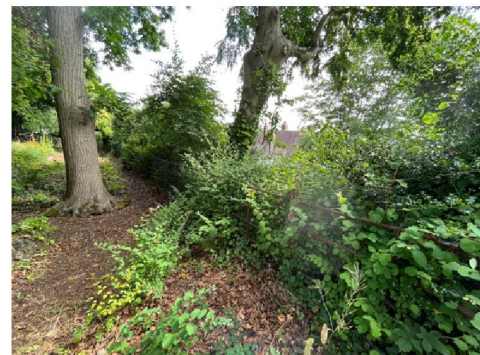
**Image 3.2.1a (right)**

3.2.1 The ground along the top of the wall forms an informal garden below the canopy of the trees. Shrubs predominate along the top edge of the wall outside the line of a metal fence.

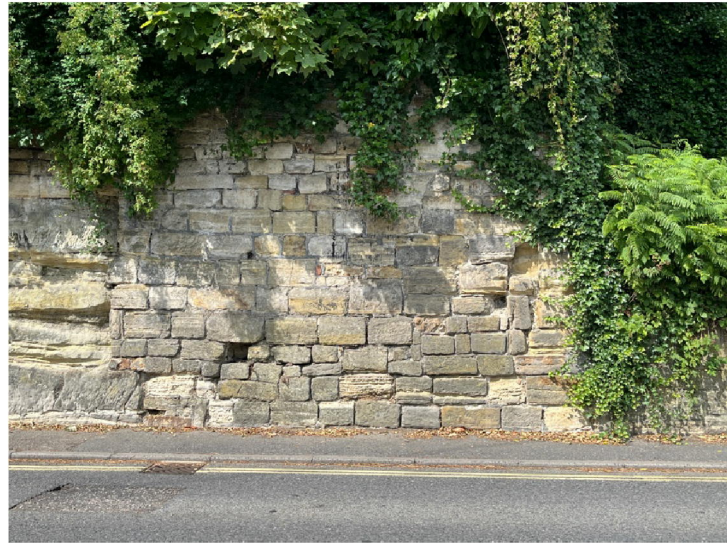
*Image 3.3.1*

Height upto c.4.0m.

Wall faced with  
coursed stonework.

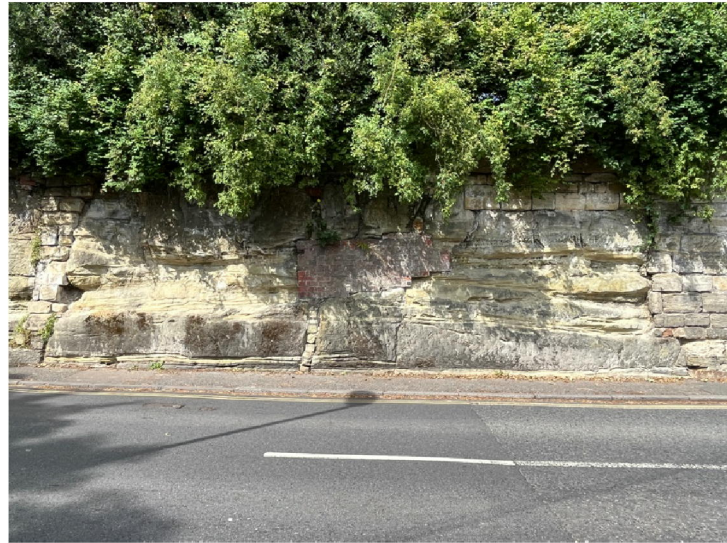
*Image 3.4.1*

Height c.3.2-3.5m.

Wall faced with bedrock and coursed stonework at high level, with localised sections of brickwork.

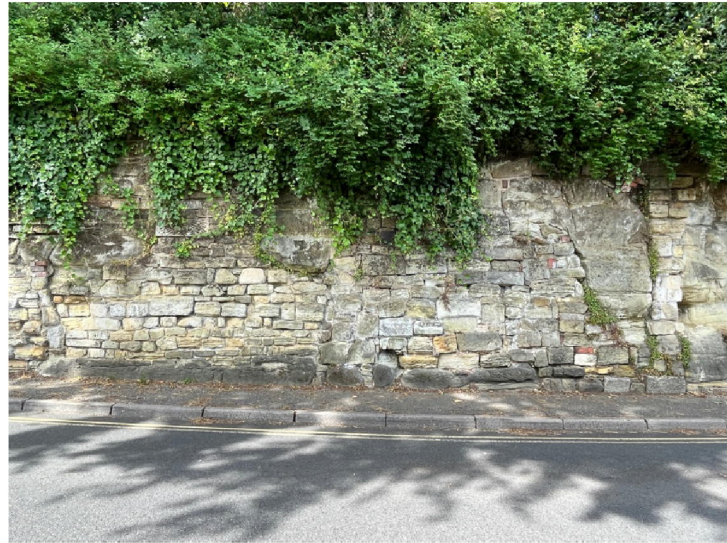
*Image 3.5.1*

Wall faced with bedrock and coursed stonework, with localised sections of brickwork.

A small holly tree is located above the middle part of this wall section.

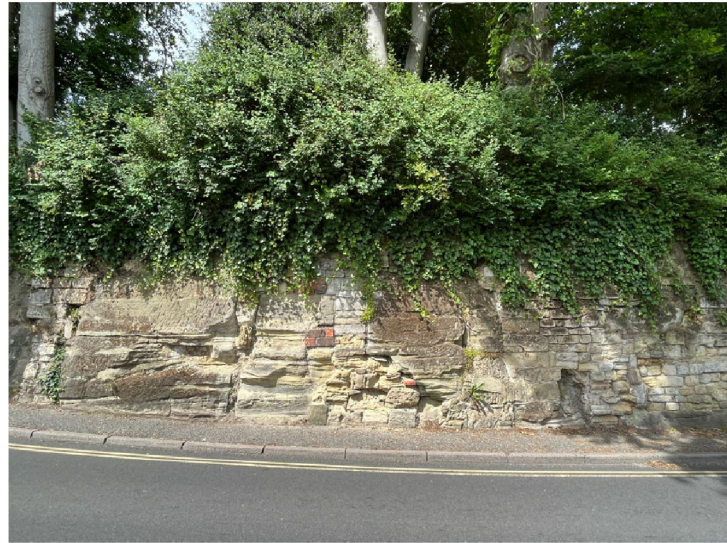
*Image 3.6.1*

Wall faced with bedrock and coursed stonework, with localised sections of brickwork.

A mature beech (?) tree sits above the righthand side of the wall.

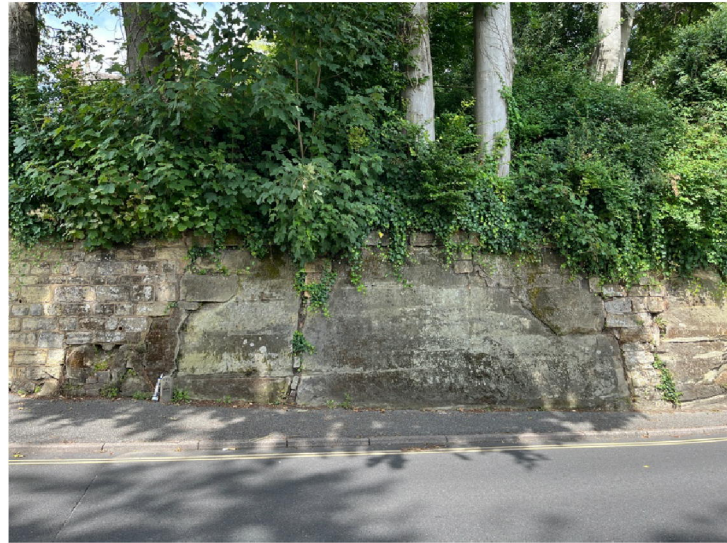
*Image 3.7.1*

Wall faced with bedrock and coursed stonework. Drainage pipes visible on lefthand side.

Three mature beech (?) trees sit above the wall section: two on the righthand side, and one on the lefthand side.

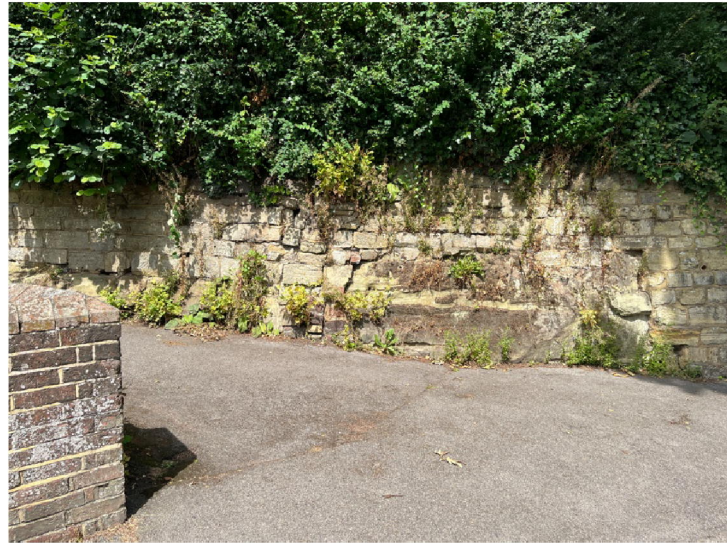
*Image 3.8.1*

Wall faced with  
bedrock and coursed  
stonework.

A mature beech (?)  
tree sits above the  
righthand side of the  
wall.
