Supporting Statement for Applications  
[refs. DM/25/2654 and 2655]  
**Wykehurst House, nr Bolney RH17 5QQ**

**Rev B 14.04.2026**

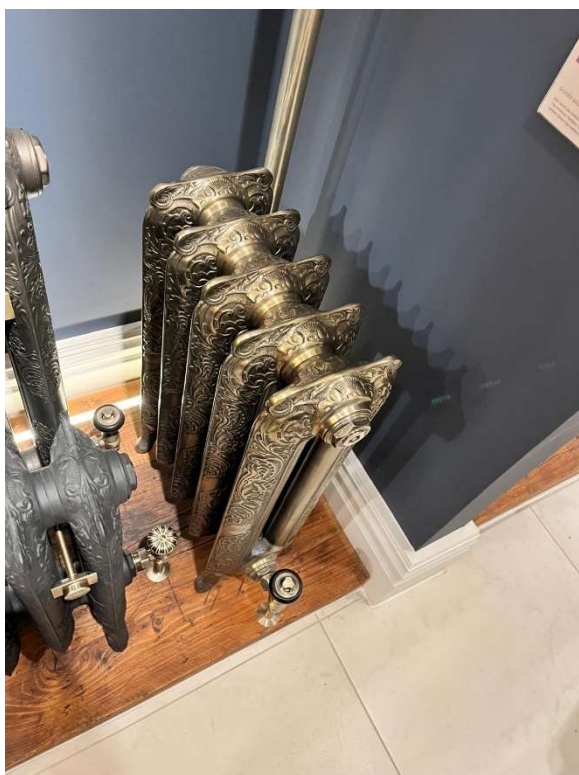
Proposed floor standing cast iron radiator

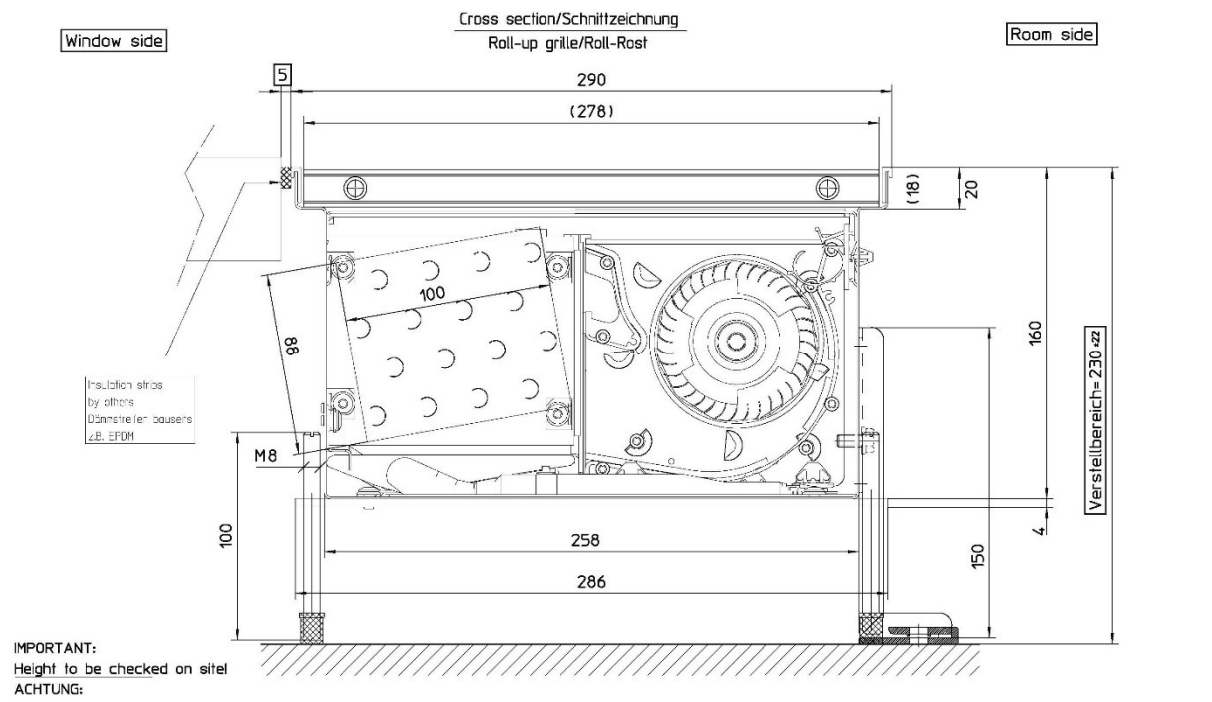
We attach below a detail of the proposed product, for consideration. The proposed method of installation involves the trimming and bridging of existing floor joists to accommodate the new trench heater box width. The grille itself is rolled into a floor rebated 'tray' so that only the grille is visible inside a fine outline (the tray lip).

The adjacent photograph shows exploration of the existing dining room floor void, revealing modern timber supports below and a void of sufficient depth to hold the proposed trench heater product. Only the grille being visible, flush to the floor.

The floor joists below will be 'trimmed' locally to provide space for the heater, requiring one joist to be cut-out, with the ends re-supported by perpendicular double timbers, spanning between the remaining joists.
