# AN ARCHAEOLOGICAL INTERPRETIVE STUDY FOR THE OLD COACH HOUSE, 8 CUCKFIELD ROAD, HURSTPIERPOINT, WEST SUSSEX, BN6 9RU.

Report number: ASL 351-25

## SUMMARY

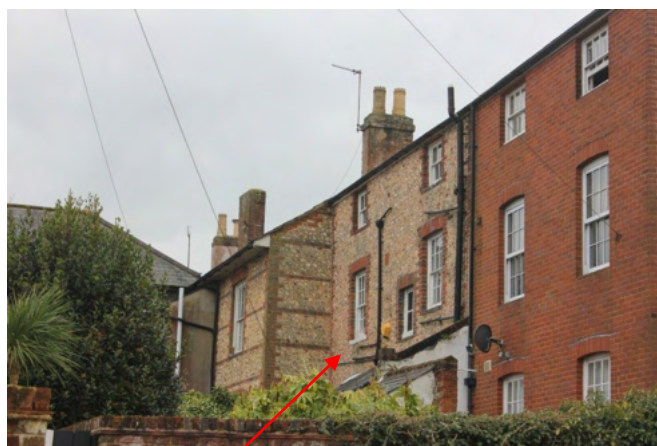
- 3.2 The front facade is stuccoed, a form of lime render applied directly to what is almost certainly a coursed flint wall, which can be seen to the rear without stucco applied (Plate 4). There is a cellar below the front room only. The roof was re-covered in the mid-20<sup>th</sup> century when major restorations took place. It is likely that all the windows date to this period as well, although some of the original glass has been re-used.

**Plate 4. The rear, east facing elevation of the Coach House in flint with brick dressings.**

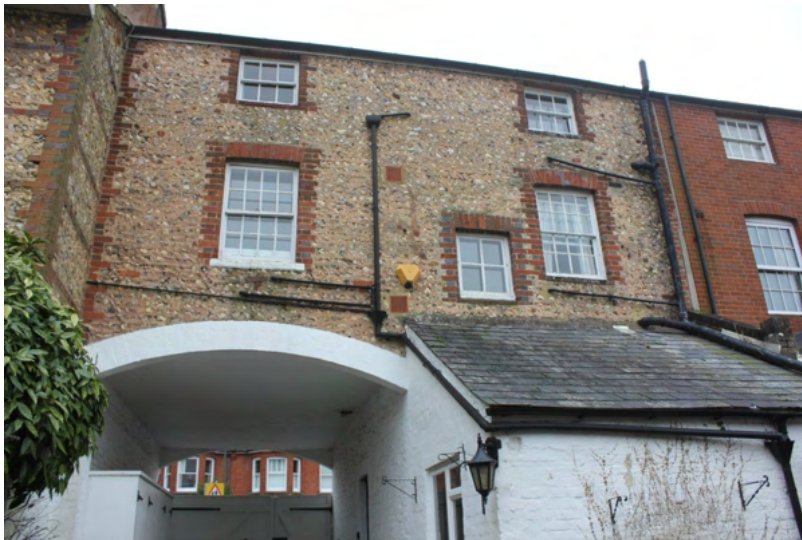
As discussed above, the front elevation is stuccoed throughout, scored to resemble stonework and the rear elevation (Plate 7) is constructed from coursed flint, with occasional bricks. However, there are not enough bricks within the masonry to consider this as Bungaroosh, which is usually a mixture of brick, flint, stone and often chalk. The windows and quoin dressings on the wall edges are oxidized, red bricks with segmental arched lintels above the windows. There are plastic downpipes and hoppers with some cast iron soil pipes.

**Plate 7. The rear elevation.**

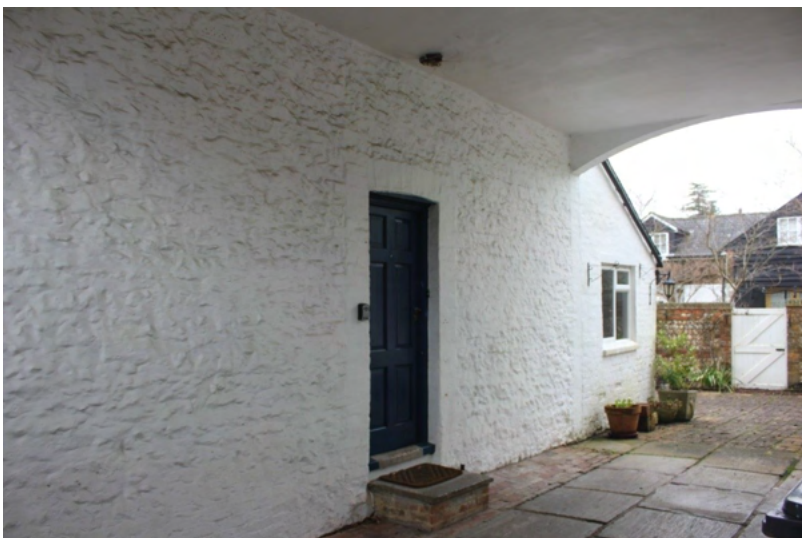
The principal side of the coach entrance which faces the road consists of a wide archway constructed from a gauged bricks (all rendered) which leads through the building to the rear yard. The walls to either side are painted, coursed flint with four rows of brick string coursing to the south which is not replicated on the north side (Plate 8).

**Plate 8. The south facing elevation within the Carriageway.**

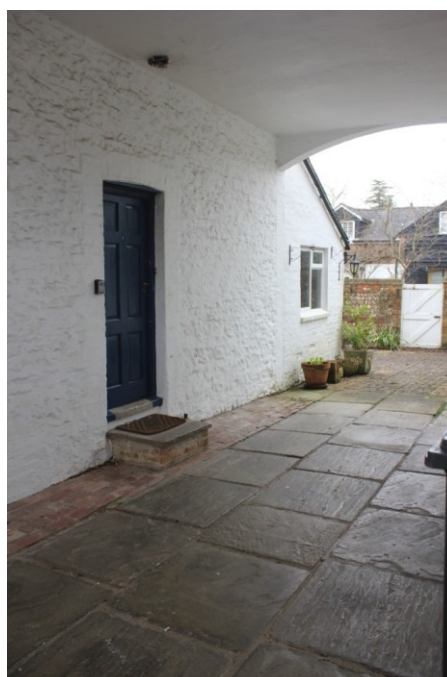
**Plate 10. Flagstones without obviously signs of wear.**

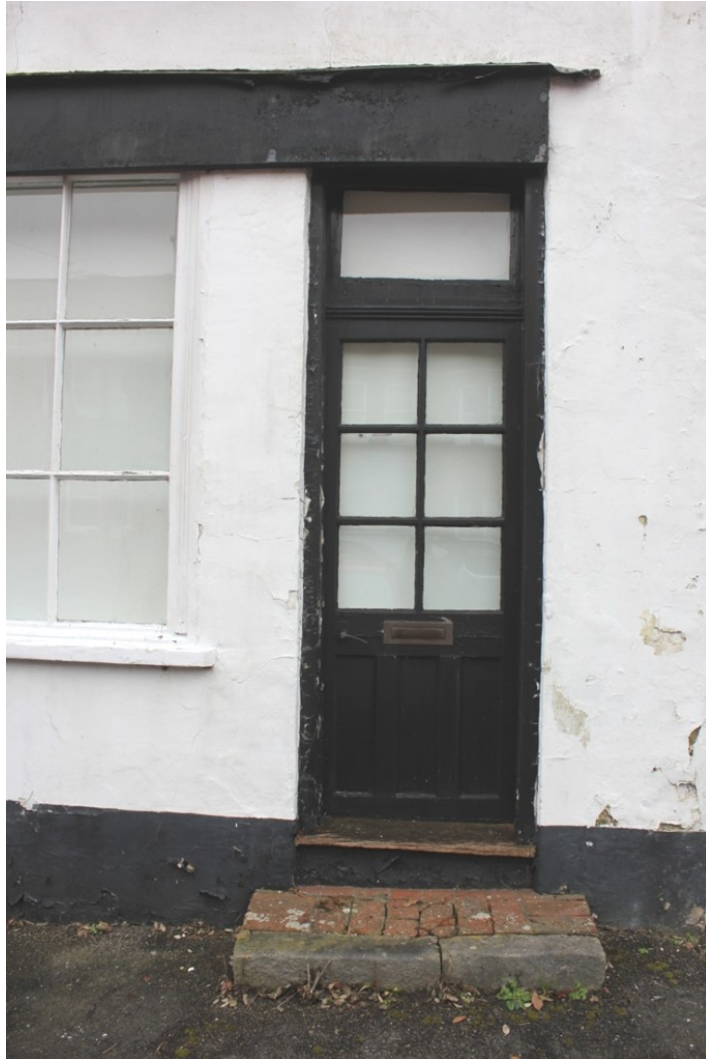
There is a large, 9 light fixed window with thin lambs tongue glazing bars on the horizontal rails with thicker plain mullions in the front elevation. There are two original glass lights but the rest are modern replacements. This window is likely to be a replacement and is not original. There have been a series of repairs patched into the jambs of the window. Above the window and door is a modern painted fillet with a lead apron over (Plate 11).

**Plate 11. The front, east facing window and doorway.**

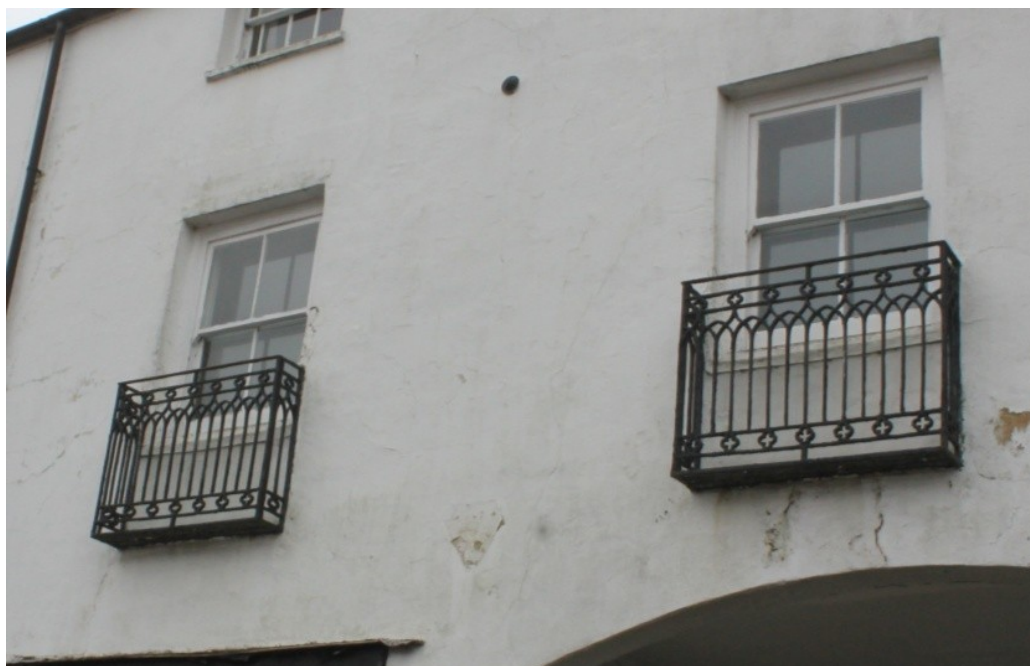
**Plate 12. Original hand forged Juliette balconies.**

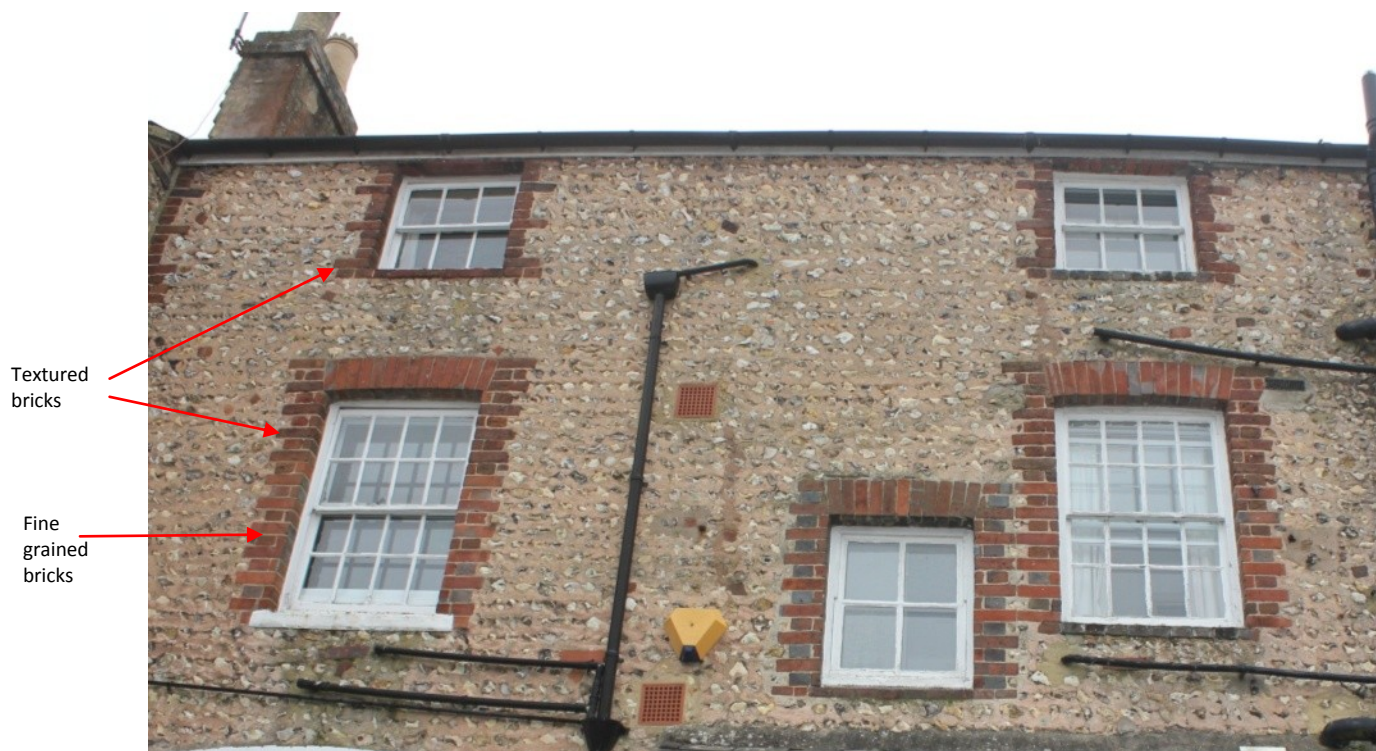
**Plate 14. Brick dressings with two brick types present.**

The brickwork dressings are odd in that there are two types of brick present with some finer grained, well fired bricks, some with burnt headers but with rougher textured bricks above. This is replicated in the wall quoins (See Plates 14 and 15). The brick dressings here are all textured rather than fine grained.

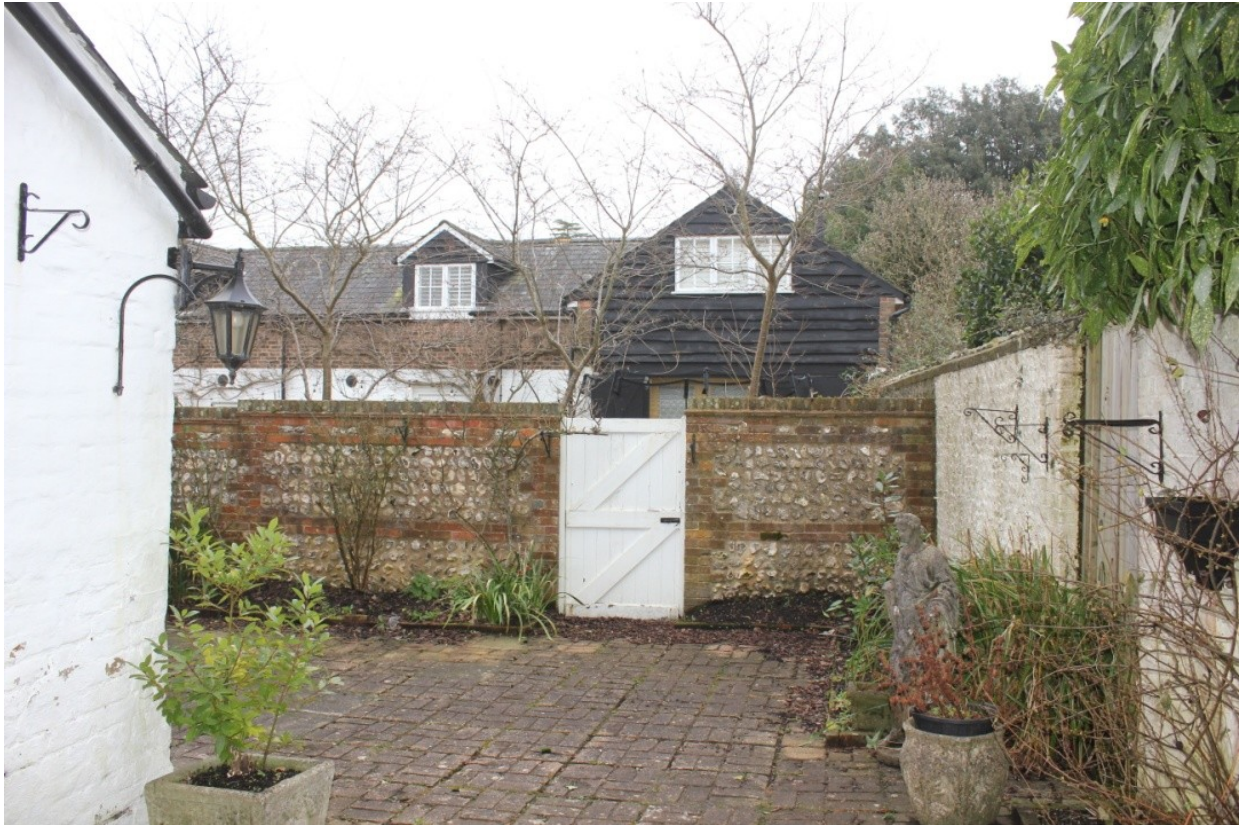
The yard has been sub-divided providing a small garden covered mostly by modern cement paving slabs which are designed to replicate bricks. The converted stables are now within separate ownership and new walls have been built which divide the original stable yard (Plate 16).

**Plate 16. The rear yard, looking east towards the Stables.**

The boundary walls are flint with brick dressing which are modern but the dividing wall to the south is painted flint which is probably original. There is a modern doorway with brick dressings here leading into the rear garden of No.6, Lamb House. There is also another modern doorway leading into the garden of the stables to the rear of the Coach House.

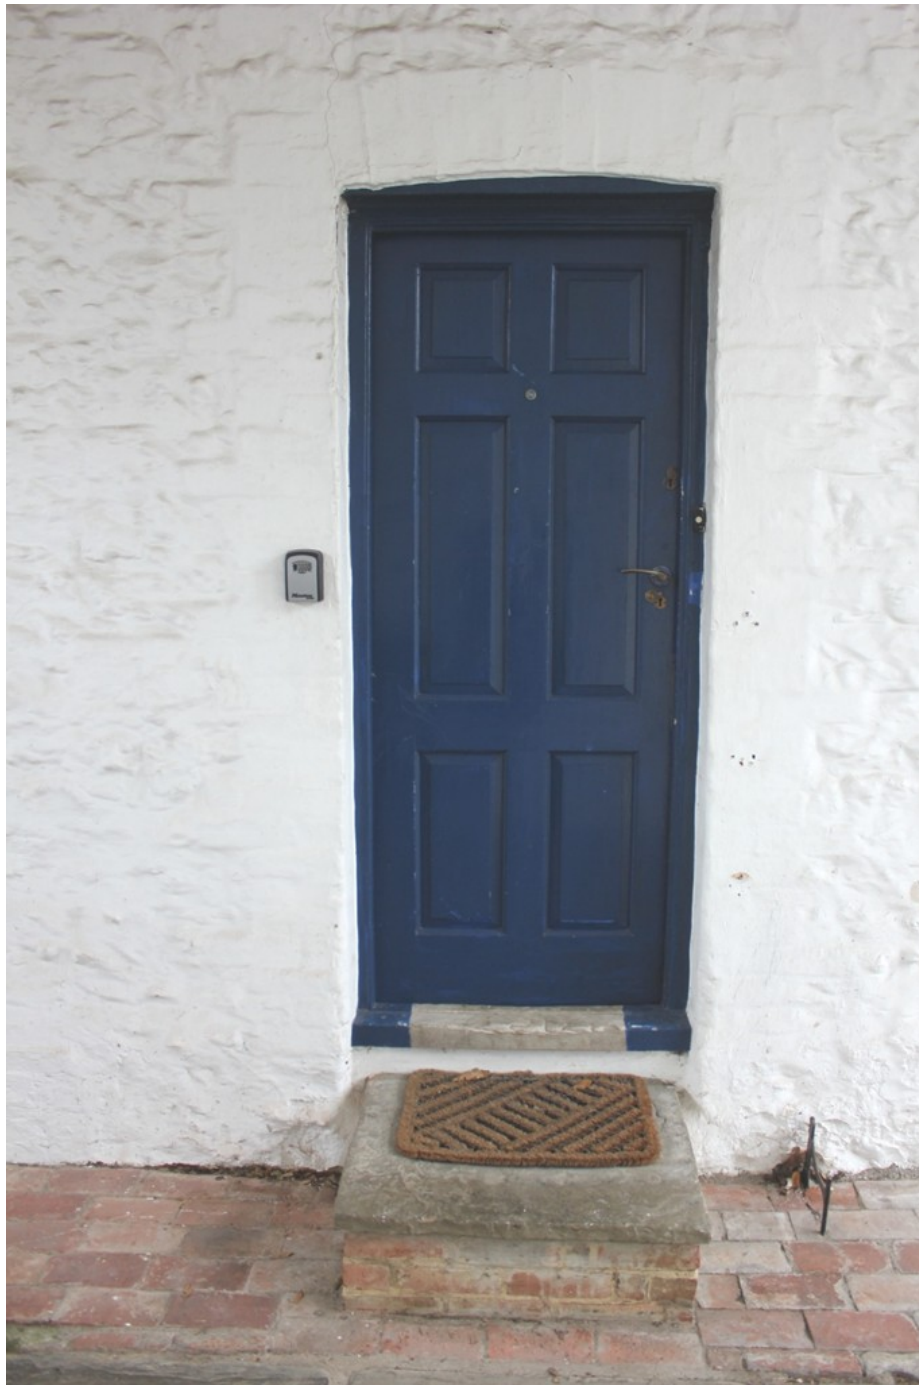
The existing step leading to the side doorway within the Carriageway is a modern construction of newer bricks topped by a flagstone but with original brick dressings to the sides of the aperture. The threshold is oak and is worn. The door frame may well be original with a slight bead and a segmental arched brick lintel above but the door is a modern, six panelled replacement. The door handle is possibly early 20<sup>th</sup> century and there is an original boot scraper on the east side of the door (Plate 17).

**Plate 17. The side entrance.**

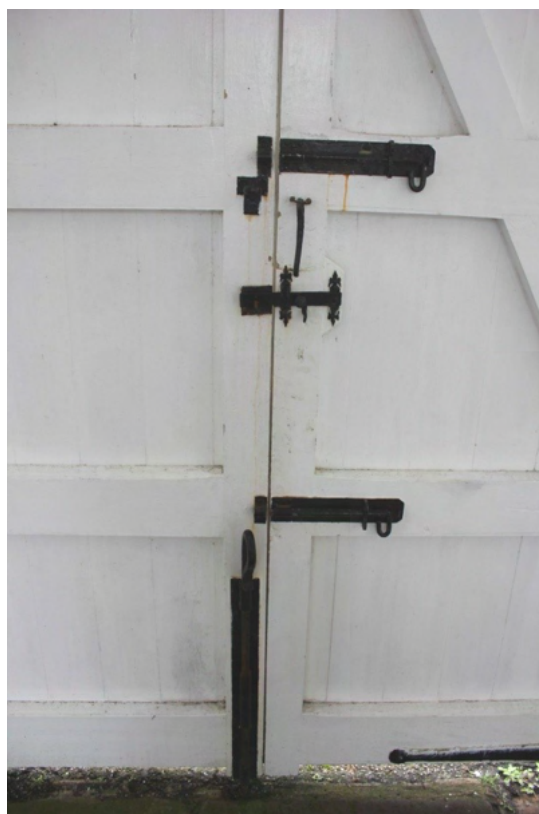
The timber carriageway doors have a wider door for the coaches and a narrow one for pedestrians; they are 20<sup>th</sup> century in date but using the original pintles, strap hinges and sliding vertical bolt (Plate 18). The decorative latch is likely to be a later addition which has fleur de Lys embellishments (Plate 19).

**Plate 18. The rear of the Carriageway doors.**

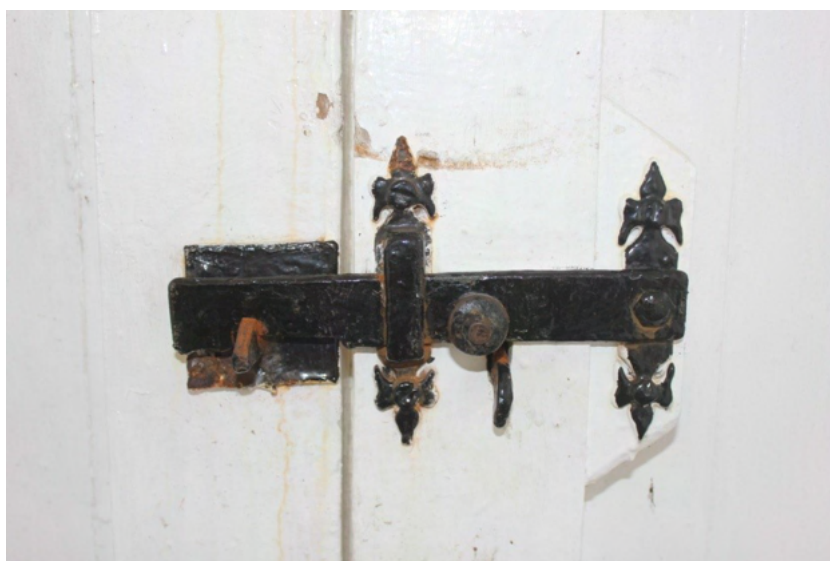
**Plate 19. Replacement door latch.**

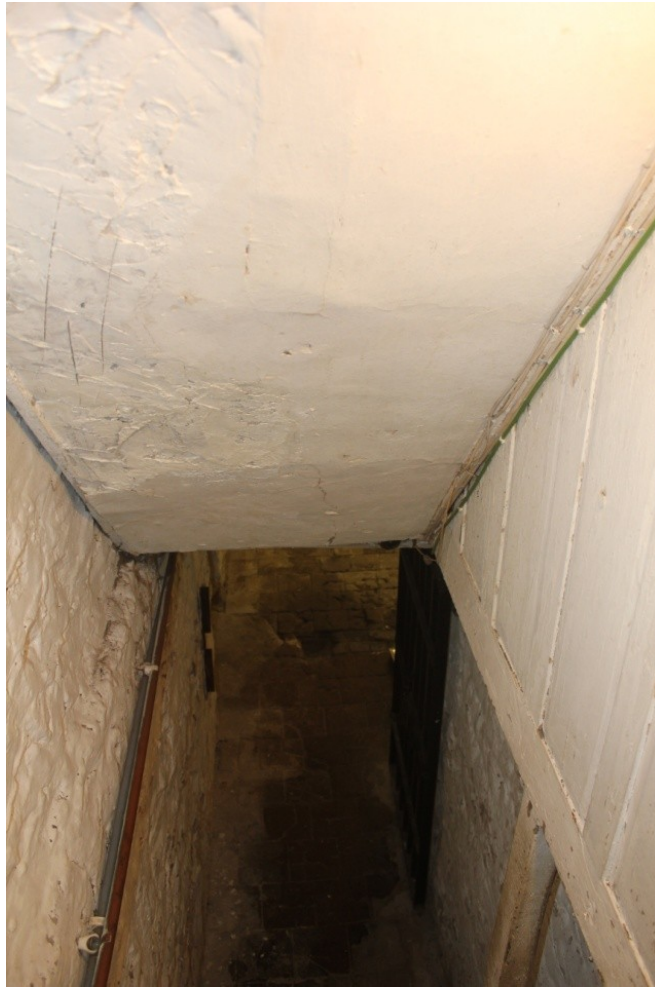
- 5.4 There is an original coal/barrel chute (plate 23) which was accessed from the south wall within the Carriageway although the aperture has since been blocked.
- 5.5 There is a small patch of original joists which remain *in-situ* over part of the stairs which are lime washed, although the floorboards above the joists forming the base of the stairs leading to the first floor have been replaced. The underside of the stairs in the floor above are covered with original lath and plaster (Plate 24).

**Plate 24. Underside of the stairs leading to the first floor.**

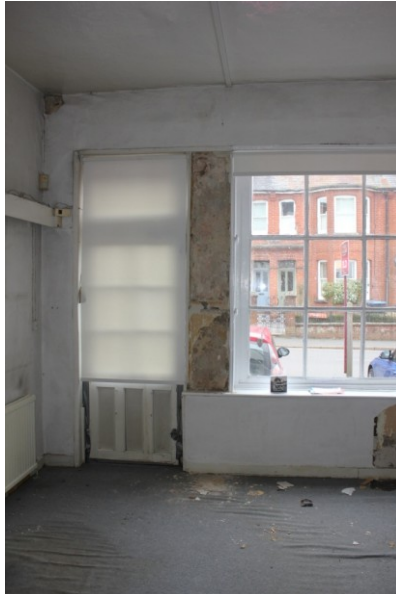
This principal room is entered from the principal elevation on the western side of the road via a small front yard area which is covered with tarmac, providing two parking spaces. The door and step have previously been described but internally the replacement architrave continues across the top of the door and the window (Plate 25). The window cill has a bull-nosed timber cill and the whole window is a replacement although two original glass panes survive, re-used.

**Plate 25. The replacement door and window to the front.**

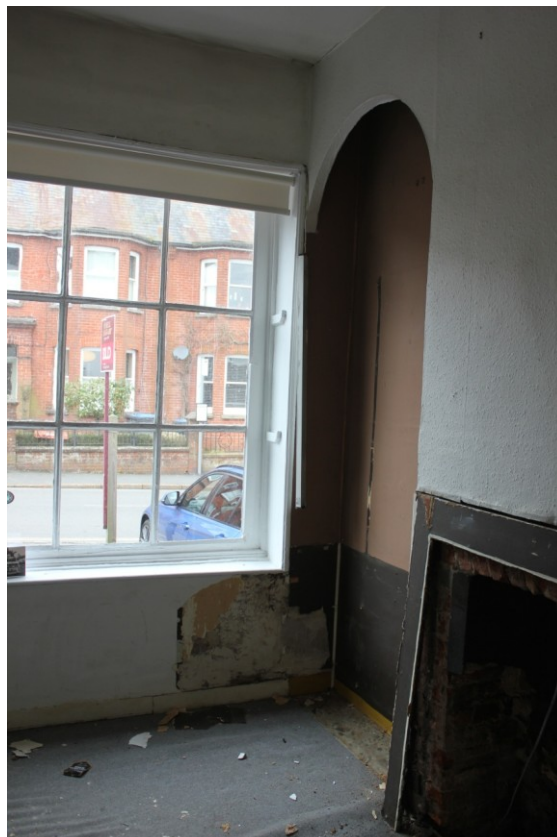
**Plate 28. Modern arches built into the alcoves.**

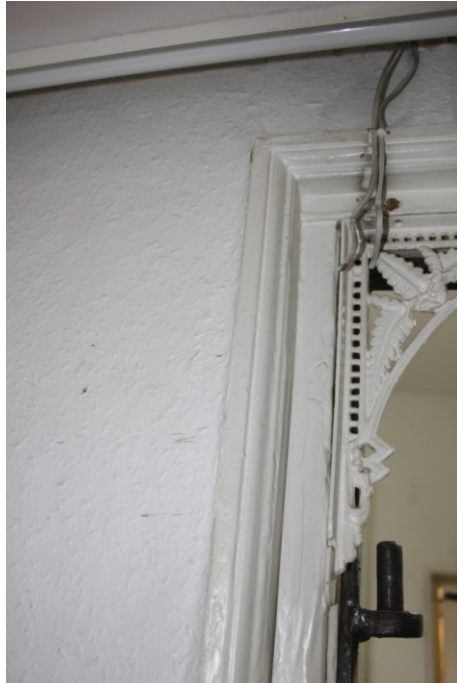
The doorway leading to Room G2 to the east no longer has a door and there is a modern steel frame which once had a metal barred door inserted but the architrave is original (Plate 29). The metal bars were attached to the surfaces in the 1990s when the building was used as an antique shop so these can be safely removed without impacting the historic fabric.

**Plate 29. Original architrave in the doorway between Room G1 and G2.**

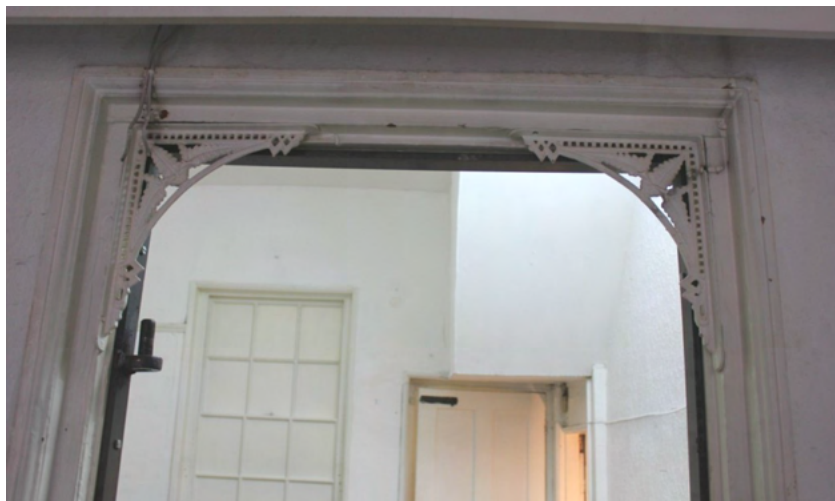
The doorway in the western room leading into Room F1 is original although there are two decorative brackets in the top corners which are later insertions (Plate 30). There is a picture rail running around the room which is modern and machined and is not original although it runs behind the partitioned stairwell wall so pre-dates this feature. The ceiling is covered by modern plasterboard although the walls are mostly covered with original lime plaster applied to the solid masonry walls.

**Plate 30. Inserted metal brackets in the doorway.**

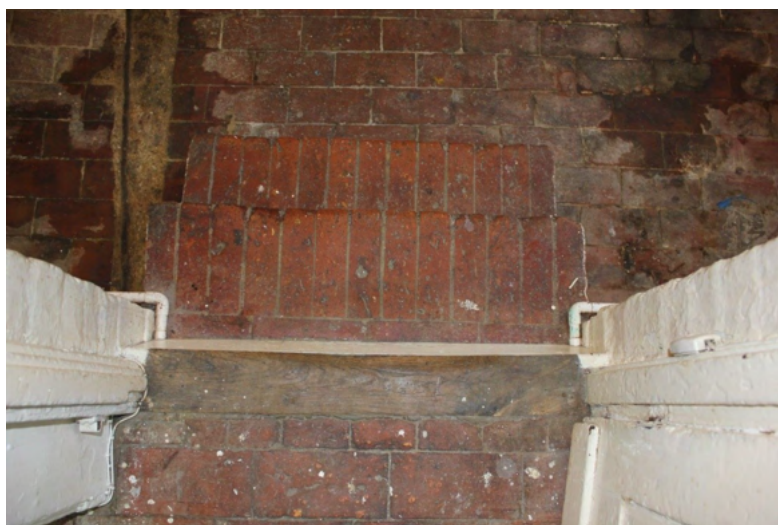
There is a doorway leading into the lean-to which is original and four panelled with doorknob and latch which are also likely to be contemporary with the door. This would have been the original door leading into the back yard, as are the two brick steps which give access to the lower ground floor level beyond (Plate 32). The timber threshold is very worn.

**Plate 32. Steps leading down into lean-to with different bricks to the flooring.**

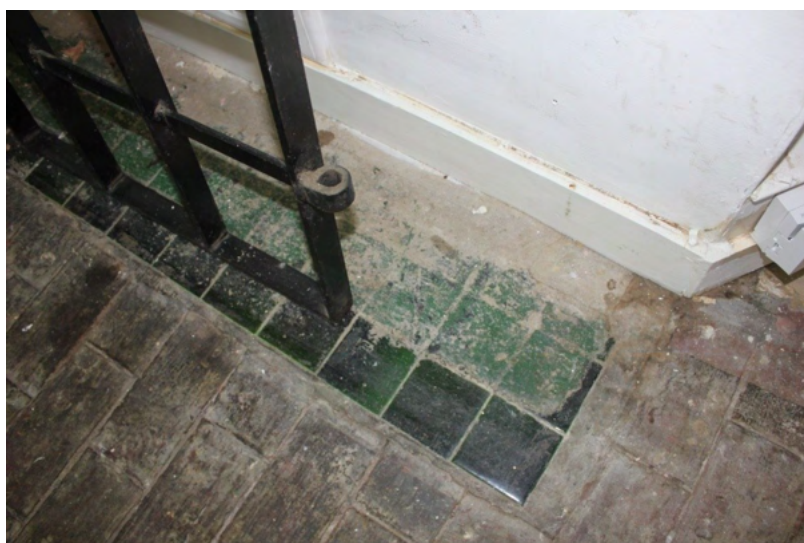
**Plate 34. Green glazed hearth tiles.**

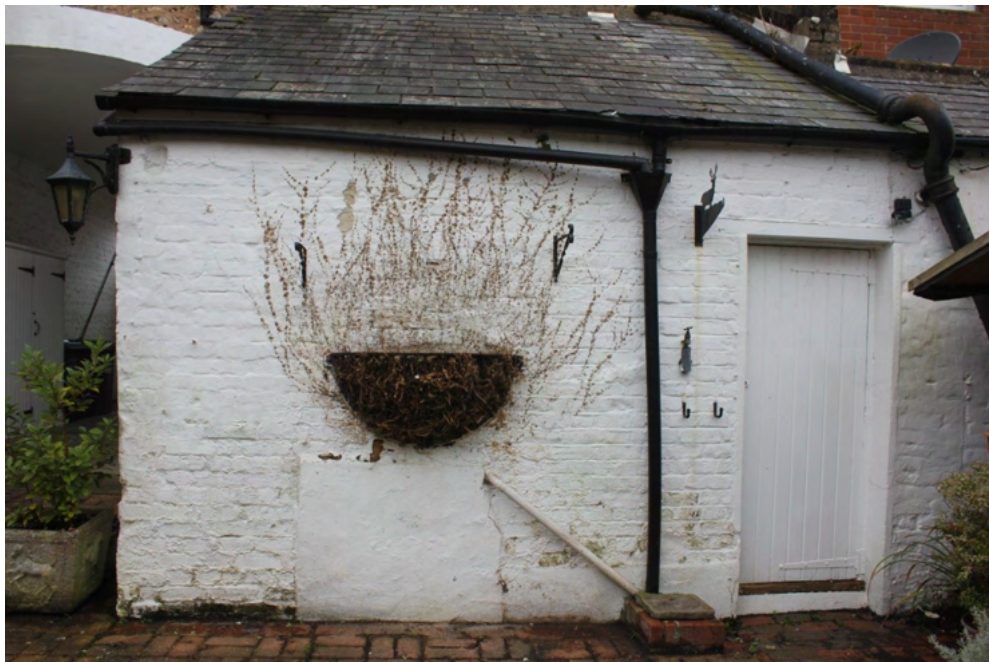
The lean-to (Plate 38) was built at a slightly later date than the building as borne out by the presence of the blocked window in what was the original rear wall of Room G2 next to what was originally the back door. Originally the lean-to did not have any windows but a modern mid-20<sup>th</sup> century casement has been inserted in the southern wall. The lean-to is brick built but is heavily painted so the bond type cannot be ascertained. The roof is covered with slate and the rear wall has a blocked aperture, an outside tap and an original hay rack fixed to the wall.

**Plate 38. The rear wall of the lean-to.**

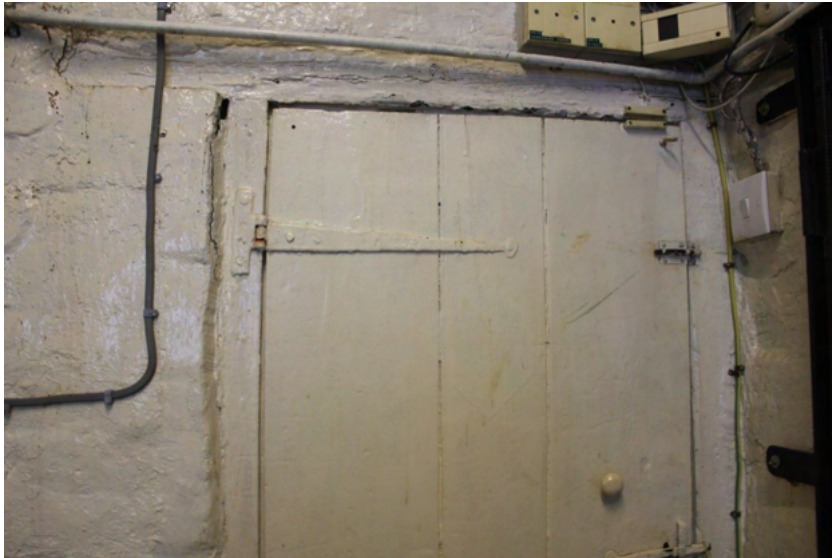
very narrow plank door with contemporary fittings including the strap hinges with small round terminals and latch (Plate 41). The planks are of uneven width and have a slight bead to the edges.

**Plate 41. Door leading into the toilet.**

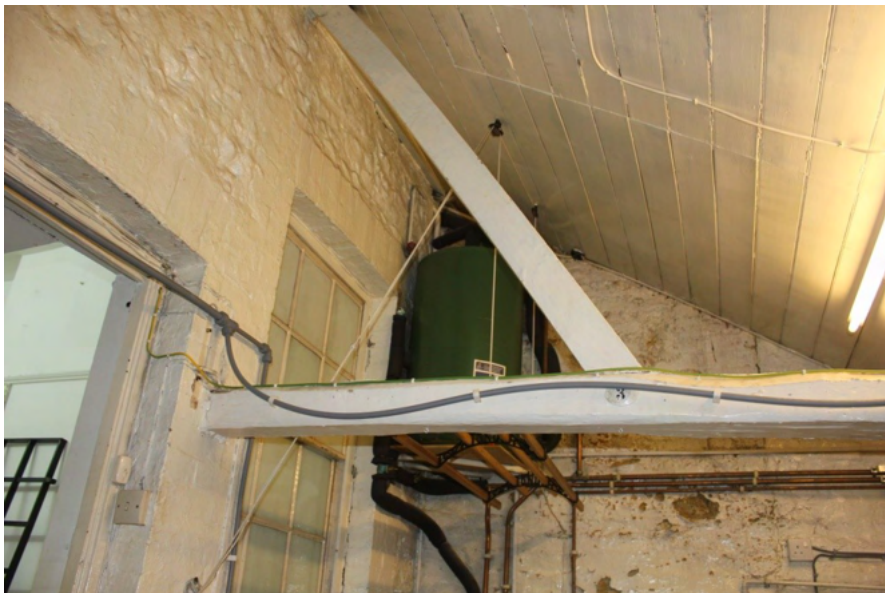
The underside of the roof is covered by tongue and grooved boards (with a small bead) so the rafters or other timbers are not exposed but there is one central roof tie which has been painted but has evidence for axe marks so is likely to be a hardwood (Plate 42). There is one raking strut attached to the tie which is also painted but is more uniform in profile and has circular saw marks so is likely to be softwood. It would be beneficial to remove the paint from these timbers.

**Plate 42. Roof tie and raking strut.**

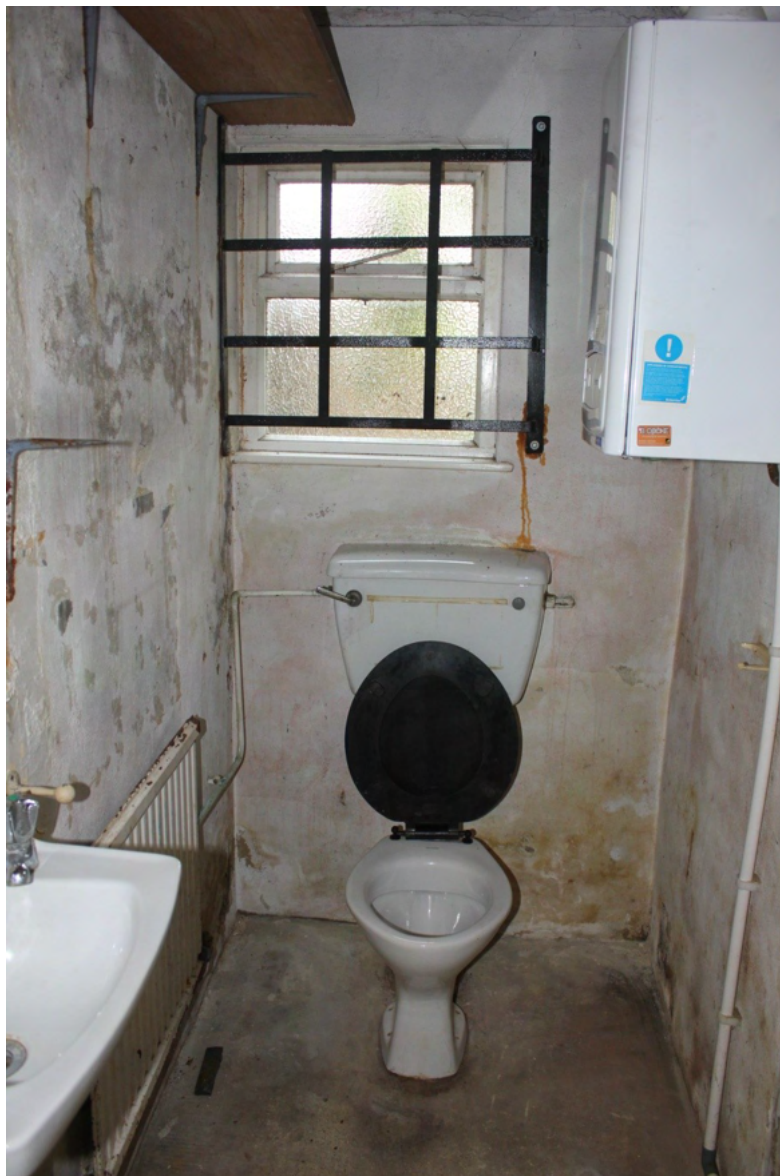
two modern windows inserted; one to the north is mid-20<sup>th</sup> century and has opaque glass (Plate 43) whereas the one to the east is a four light casement with thin lamb's tongue glazing bars and a monkey tail casement stay. This has some age to it but it unlikely to be original. It is possible there was there a door here although the wall outside is heavily painted and could not be fully accessed to inspect. The ceiling is covered with fibre-board and the walls are cementitious render. The toilet and sink are modern and the southern wall (formed from the external northern wall of the lean-to) appears to be lime rendered.

**Plate 43. 20<sup>th</sup> century sanitary ware and inserted window.**

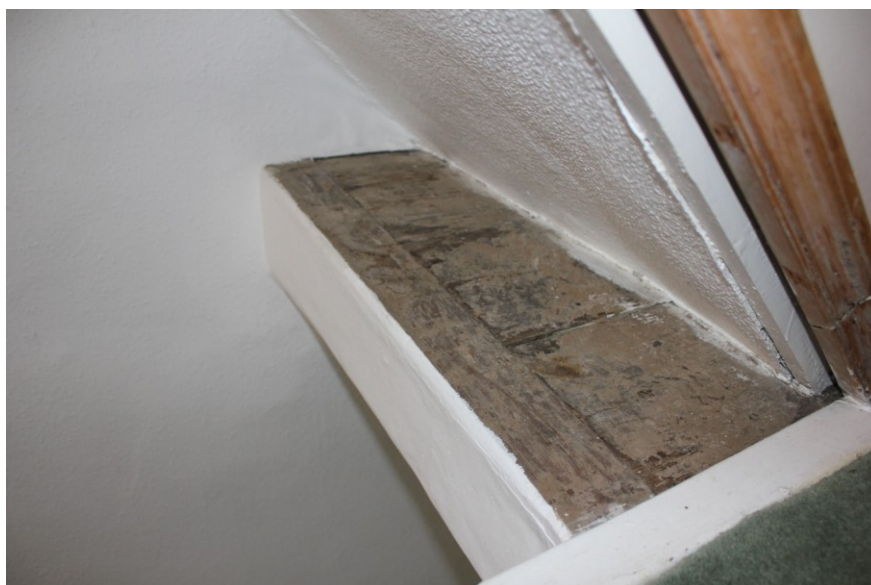
There is a small section of original first floor boarding exposed under the stairs which continue to the second floor (Plate 46). The rest of the floor throughout is covered by carpets, so this *may* be an indication that the floorboards on this level remain original and *in-situ*.

**Plate 46. Small section of original floorboards within the first floor landing.**

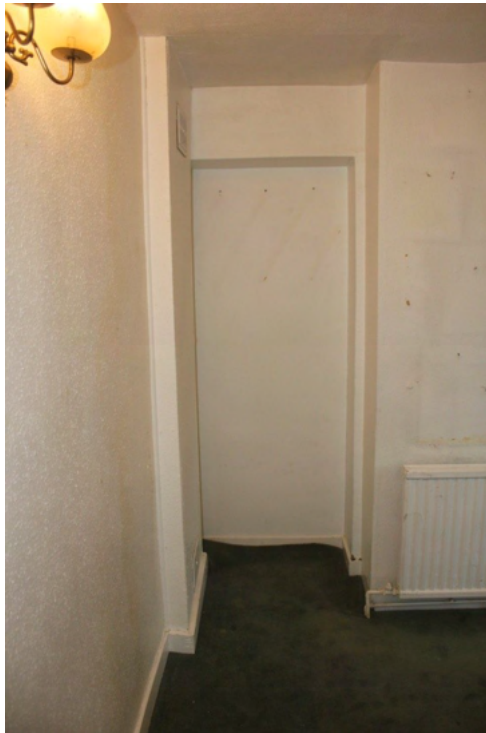
This includes the landing area which gives access to three rooms; Room F2 is a modern bathroom to the rear; Rooms F3 and F4 are currently one large, open room to the front of the building which was originally sub-divided and finally Room F5 is a modern kitchen to the south. Room F1 has few original features and has a modern cupboard built into the west wall with a projection in the stud wall to the north of this (Plate 47) which has two modern air vents within. It is a modern stud wall and it is not clear what this is.

**Plate 47. Blocked doorway in the north wall. Plate 48. Partition wall across the stack.**

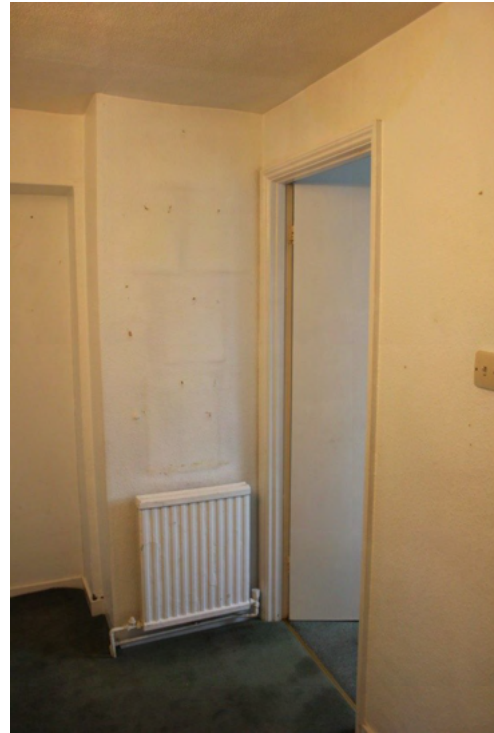
The now blocked chimney stack is present in the north wall (Plate 48) and the space has been re-configured to provide the modern bathroom and cupboard here, which has a small corridor between the two. There are two modern stud walls now sub-dividing the space, one of which cuts across the chimney. Originally there would have been a corridor to the west side and one bedroom where the bathroom now is. At the north end of the short corridor is another blocked access to the property adjacent to the Coach House. The landing ceiling is papered but is likely to be lath and plaster.

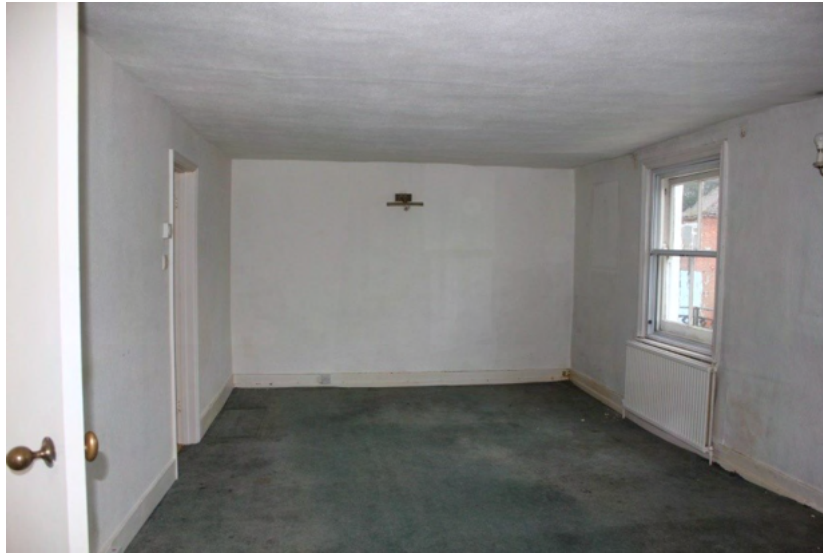
This room is entered through an original doorway off the west side of the landing and the door is a modern replacement, probably painted plain plywood, along with the frame and architrave which is also likely to be a later insertion. There is a significant rise in floor in the centre of the room where there must presumably be a transverse beam in the ceiling below. This also marks the location of the missing partition wall between what would have been the two principal bedrooms Rooms F3 and F4 which is one large room as previously discussed (Plate 49).

**Plate 49. Looking south from Room F3 into Room F4.**

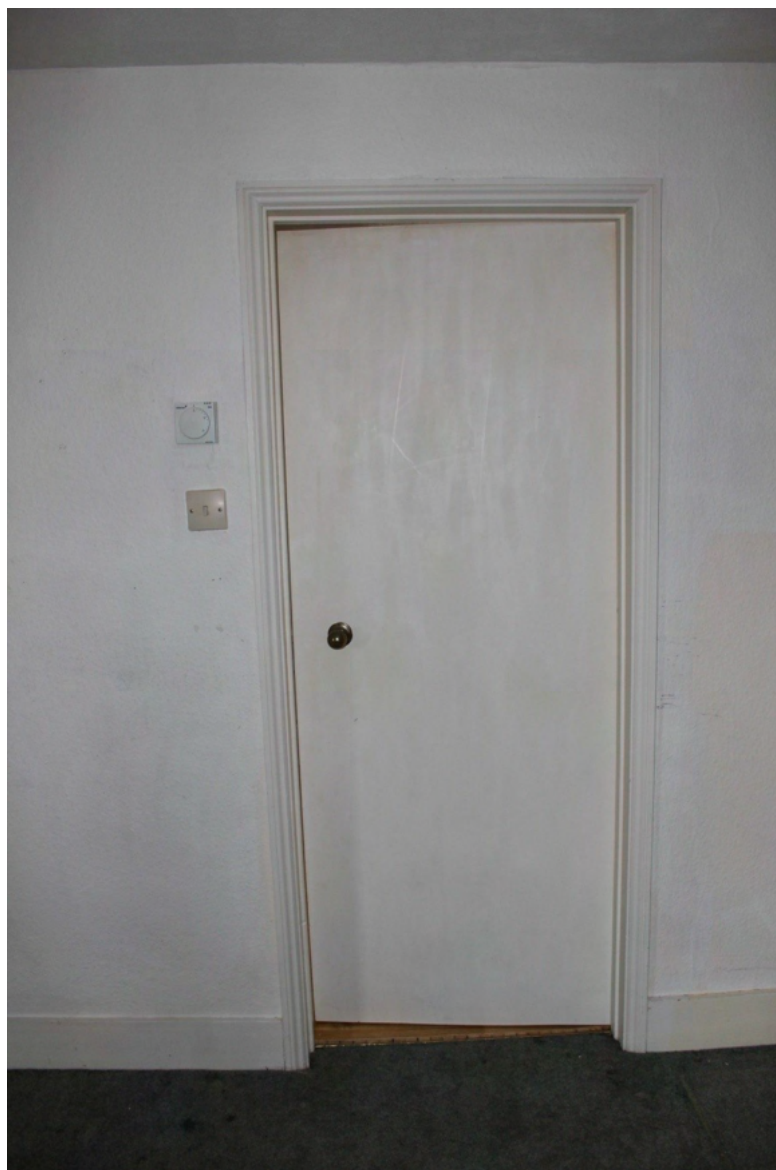
This room is accessed directly from the landing Room F1 through an original narrow, four panelled door with contemporary Suffolk latch and hinges, as well as through a matching original doorway in the west wall leading into Room F4. Both doors have original architrave (Plate 52).

**Plate 52. Original architrave but modern door in the doorway leading into Room F5.**

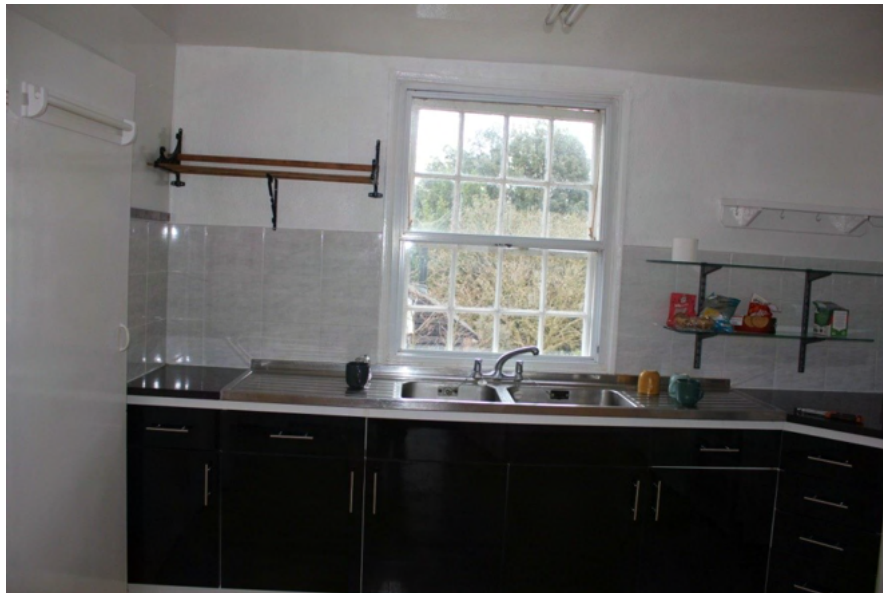
The ceiling is *probably* lath and plaster whilst the floor is covered with modern engineered oak. The room has been fitted out as a kitchen in the late 20<sup>th</sup> century (Plate 53) and the wall which flanks the south side of the stairwell is lined with lath and plaster on both sides, including the interior of the kitchen cupboards here (Plate 54).

Plate 53. Original six over six sliding sash window in the east wall of Room F5.

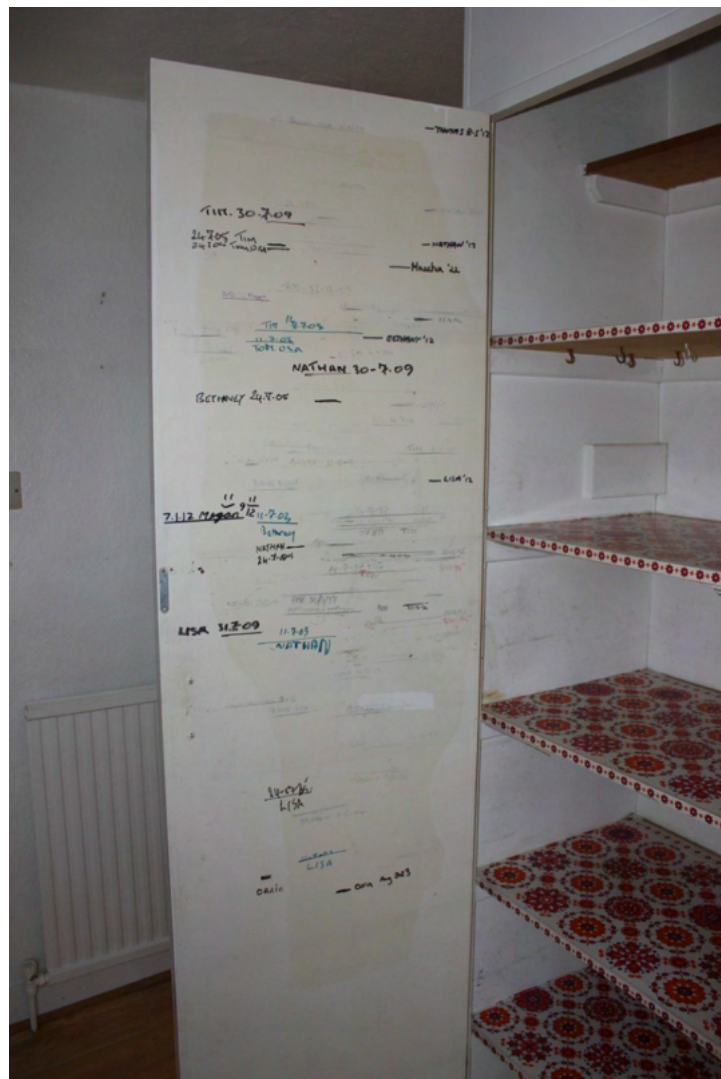
Plate 54. Cupboard in the north wall of Room F5 with lath and plaster to the rear.

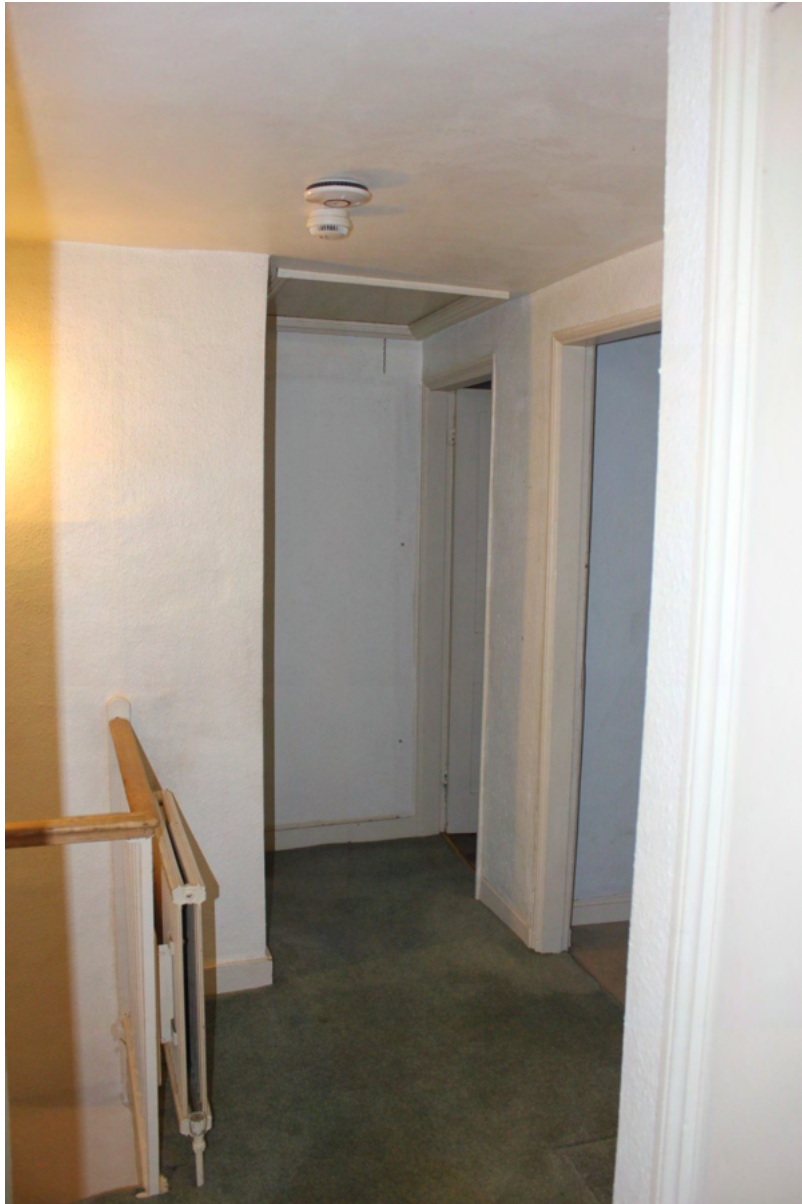
- 8.1 This floor is divided into smaller rooms once again, with a landing area (Plate 55) giving access to a modern bathroom to the rear in Room S2, and two front bedrooms in Rooms S3 and S4 and a rear bedroom in Room S5. The floor is carpeted throughout but is bowing and creaking so is *likely* to be original although this could not be verified on the day of the survey. Between Rooms S3 and S4 in the landing, the floor slopes away on both sides, probably due to movement in the floor over the top of a girding beam.

**Plate 55. The landing area Room S1 with bedrooms doors on the west side.**

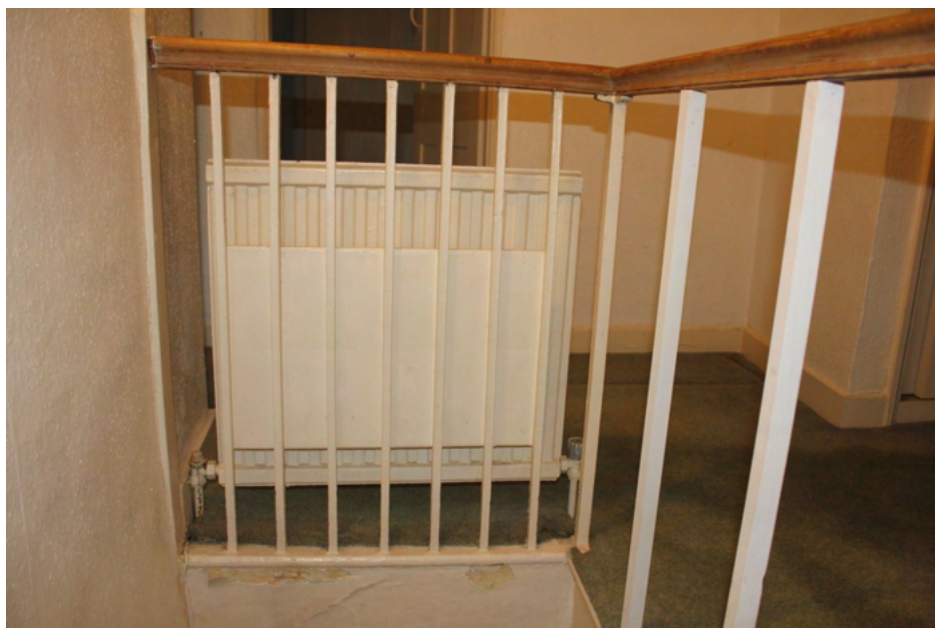
The stairs here have another half landing with three final steps leading to the second floor. There is a small section of original *in-situ* balusters within the landing with slender, square, plain balusters (Plate 56). These span two original vertical timbers

which are different to the existing newel posts, suggesting the other posts throughout are also replacements.

**Plate 56. Surviving *in-situ* balusters and slender newel post.**

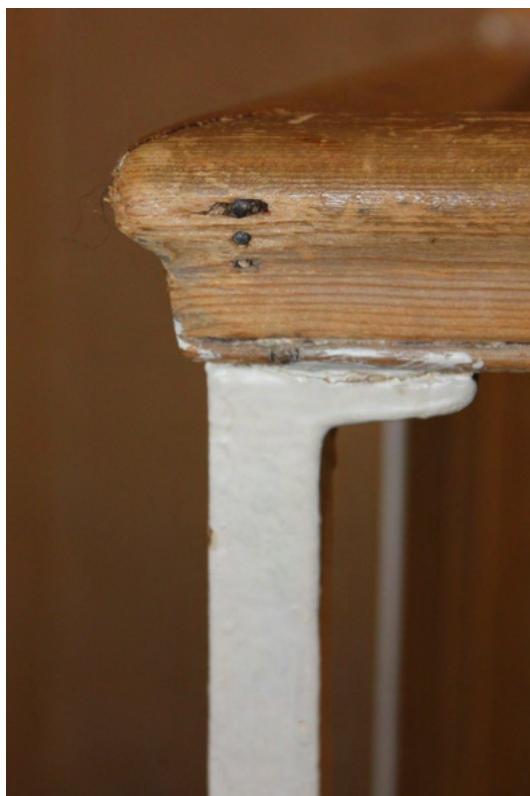
The newel post on this level is very slender and has an L-shaped bracket (Plate 57), top and bottom, providing support for the handrail although it is very slender. There also appears to be an original flat post attached to the wall (Plate 58) which has a rounded top which is in contrast to the later, pointed newel posts.

**Plate 57. Original newel post.**

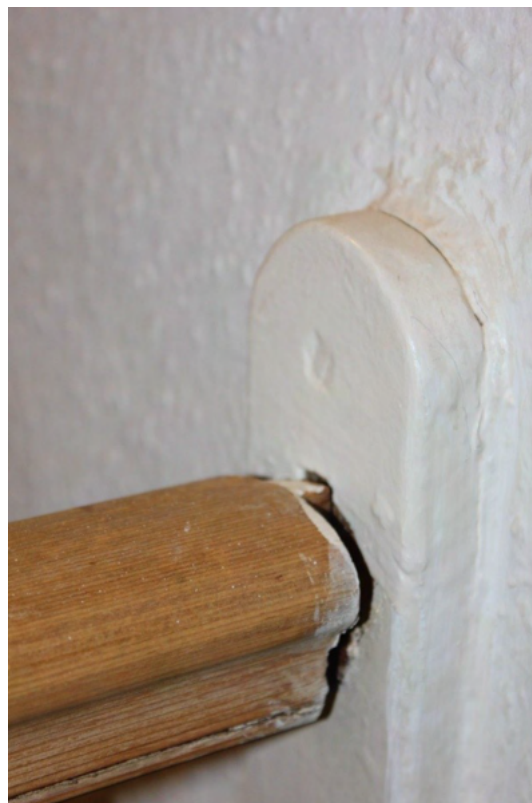
**Plate 58. Wall post with rounded top.**
