# AN ARCHAEOLOGICAL INTERPRETIVE STUDY FOR THE OLD COACH HOUSE, 8 CUCKFIELD ROAD, HURSTPIERPOINT, WEST SUSSEX, BN6 9RU.

Report number: ASL 351-25

## SUMMARY

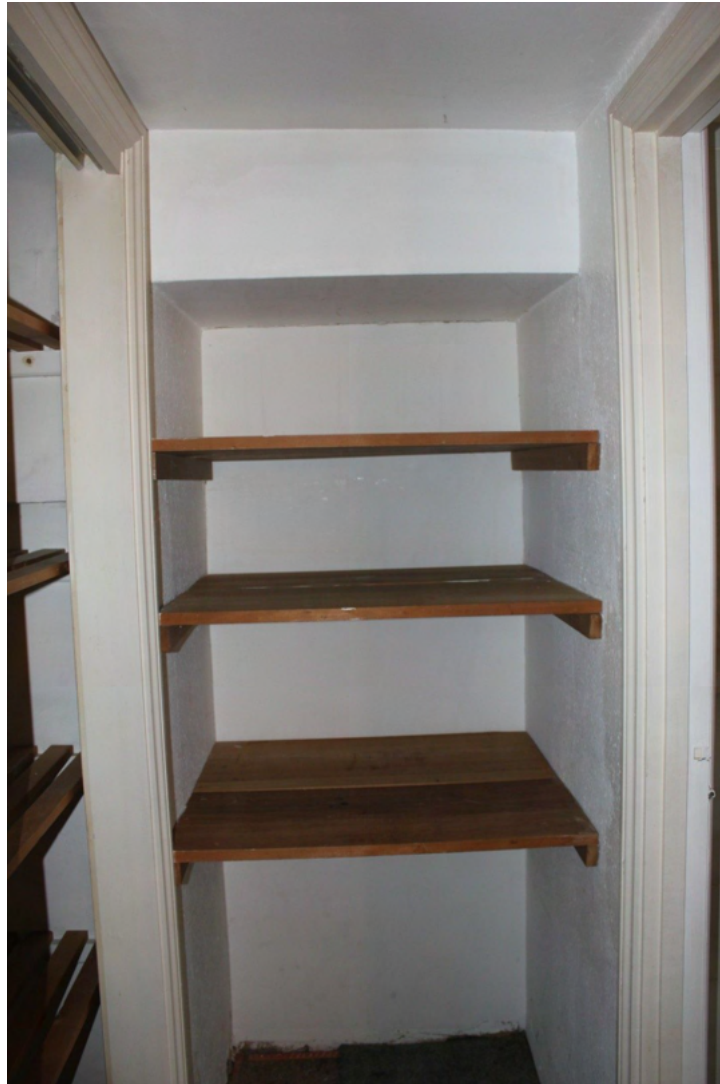
This floor is built partly into the roof space with skielings evident. There is no window lighting the half landing. The southern wall is covered with lath and plaster but the north wall is a modern stud wall where another modern bathroom has been created in borrowed space. There is another cupboard within the landing and a blocked doorway in the north wall (Plate 59) next to the chimney stack (which has no fire surround) which would have once again given access to the neighbouring property.

**Plate 59. Cupboard formed in the blocked doorway to the north.**

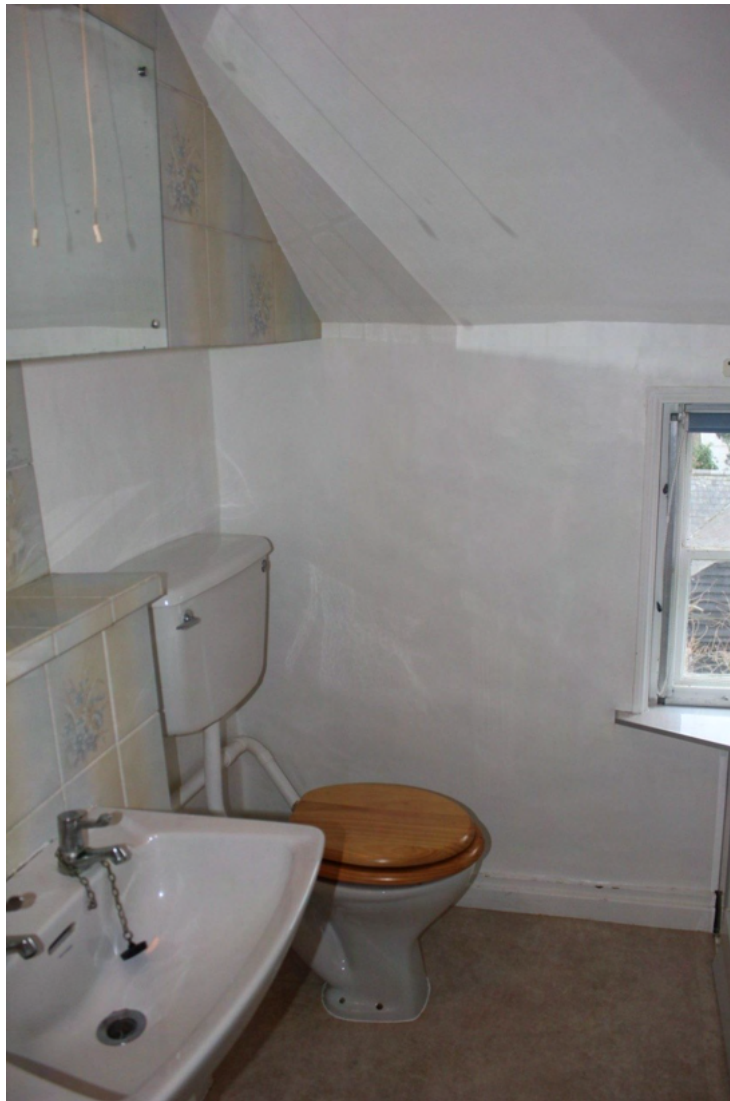
The modern bathroom here has a linoleum covered floor and tiled/wallpapered walls and the doorway is modern with a plywood painted door. The exposed eastern wall is covered with modern plasterboard as well as the skielings (Plate 60), but has a lath and plaster ceiling. There is modern square edged skirting. There is an original, three over three sliding sash window in the rear, east wall with two lights and sash cords still present (Plate 61).

**Plate 60. Room S2 with plasterboard wall and skilings.**

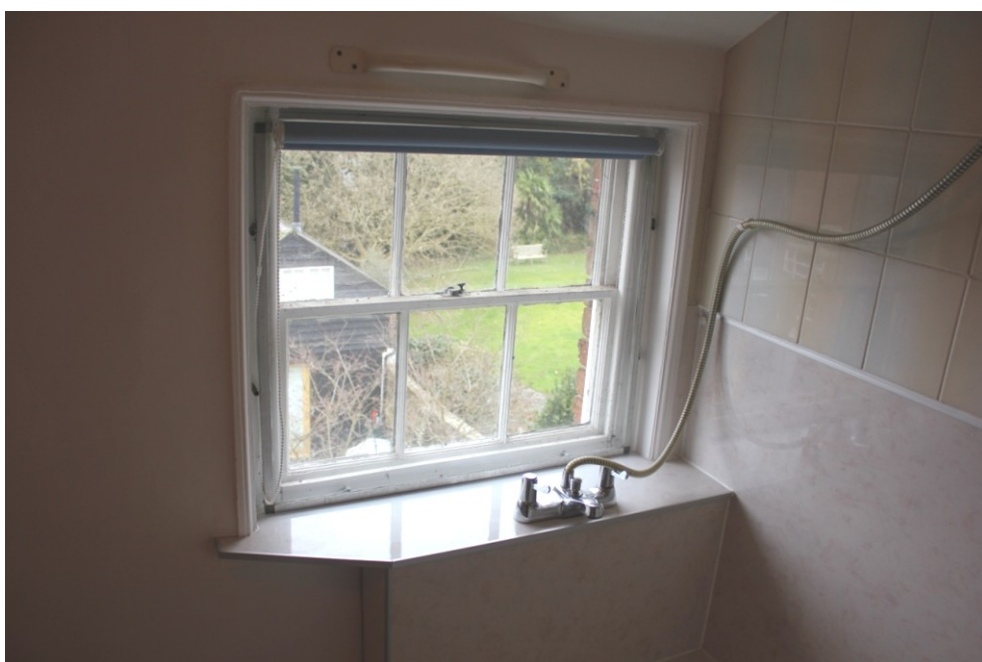
**Plate 61. Original sliding sash window in the east wall.**

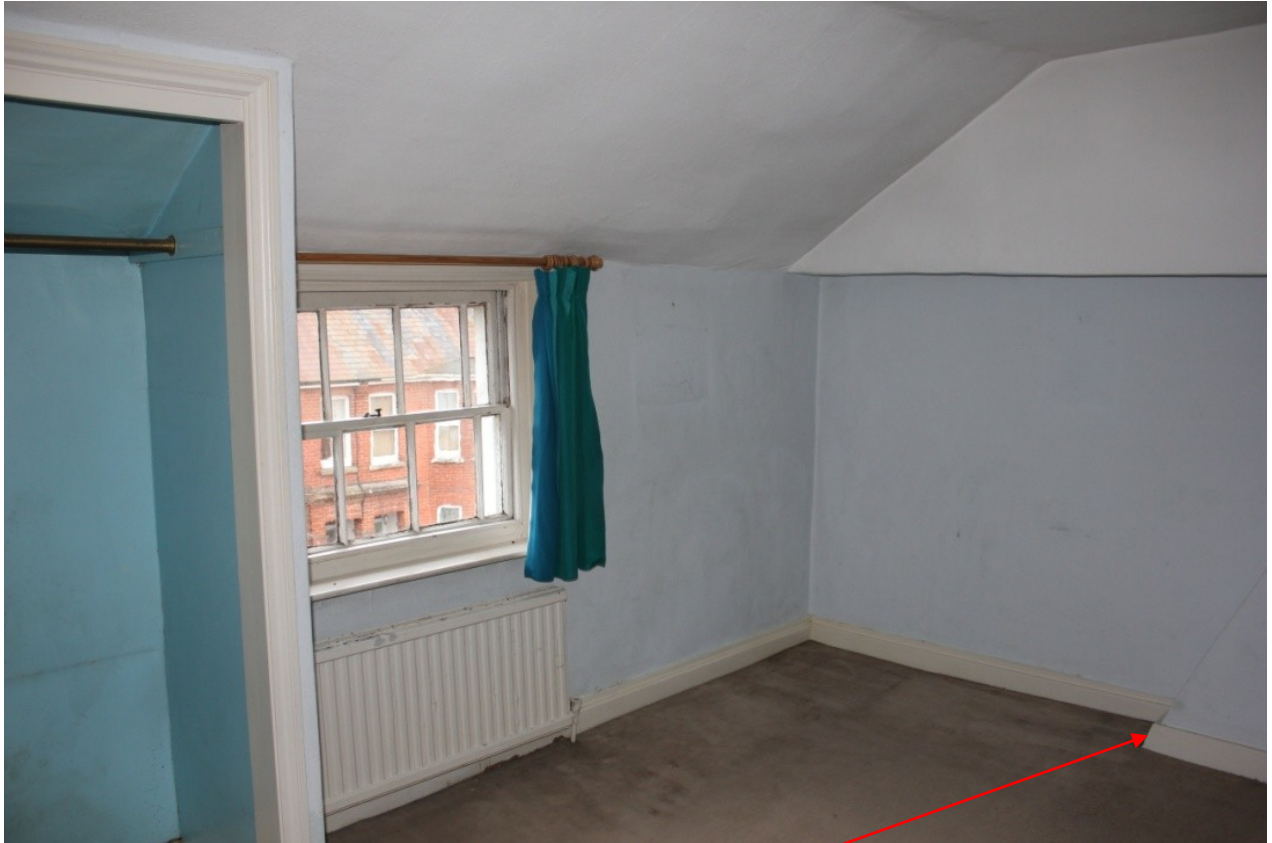
This room is accessed through an original doorway in the west wall of the landing Room S1. The ceiling is papered but appears to be lath and plaster across the width of the room including the skielings (Plate 62). There is a fitted cupboard in the west wall next to the window which is a three light, sliding sash with narrow fielded panels either side and there are just two original lights *in-situ*. Part of the north wall is boarded out and the projecting, angled stack is exposed.

**Plate 62. Room S3 with angled stack just evident.**

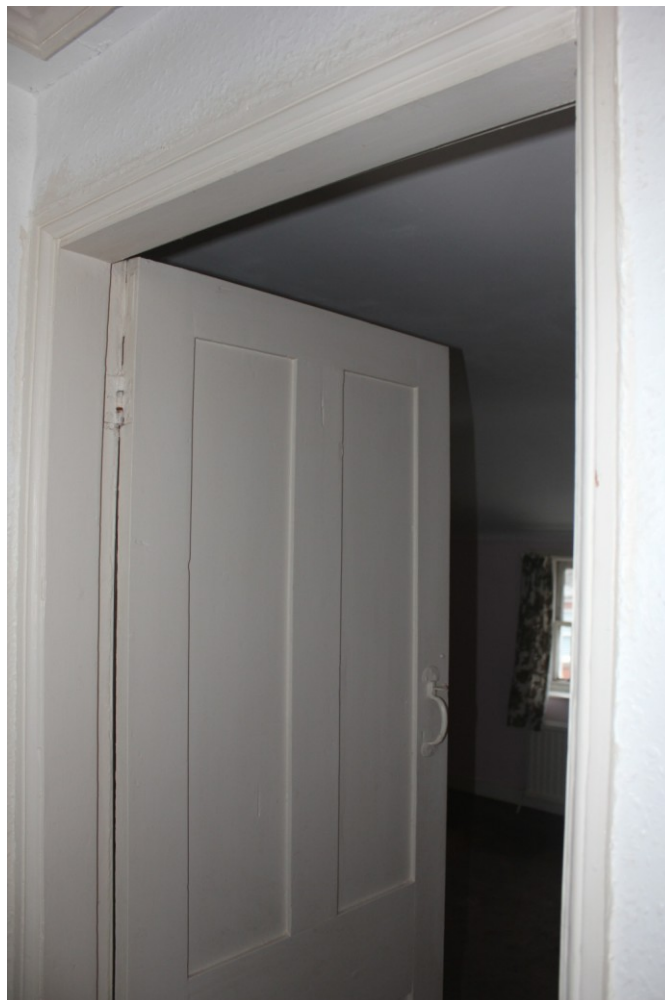
This room is accessed through an original doorway in the far south side of the west wall of the landing Room S1. The wall between this room and Room S5 to the east consists of two cupboards which have been built side by side with modern plywood or plasterboard forming the divisions. The doorway has an original four panelled door with a Suffolk latch and contemporary architrave (Plate 63).

**Plate 63. The door leading into Room S4.**

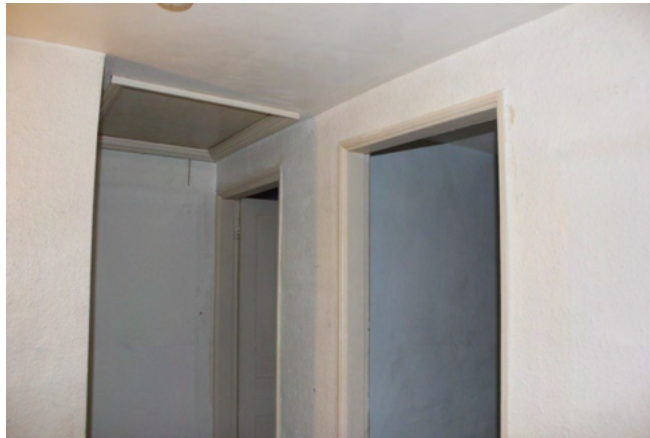
**Plate 65. Doorway arrangement in the landing with the two bedrooms doors on the right, loft hatch above and doorway into Room S5 on the left.**

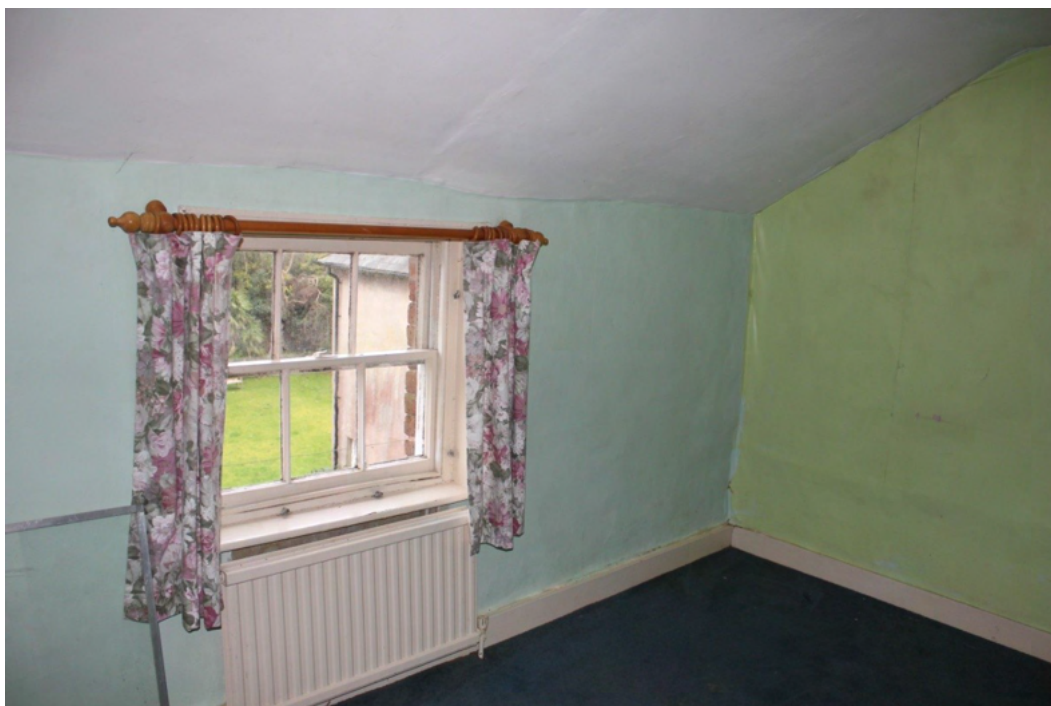
The north and east walls are all lath and plastered, including the south wall but the ceiling/skielings have possibly been re-plastered but this is not certain. There is a small patch of floorboards exposed in the cupboards which appear to be original. The window is a sliding three over three sash without horns as before (Plate 66) and the entrance door is four panelled with a round brass knob which is more likely to be later 19<sup>th</sup> century. The architrave to the rear is also different (Plates 67 and 68) and is more modern than the others which suggests there has been a re-arrangement of the doorway to this room.

**Plate 66. Window in the east wall of Room S5.**

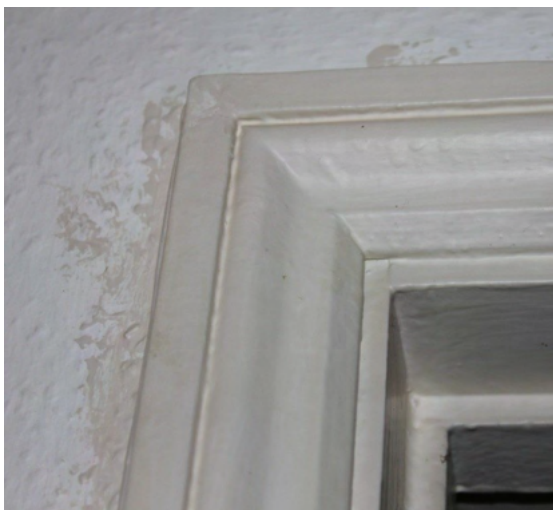
**Plate 67. Doorway to Room S5.**

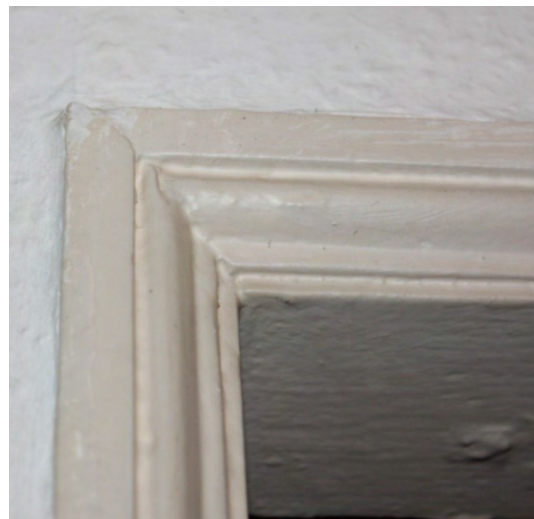
**Plate 68. Doorway to Room S3.**

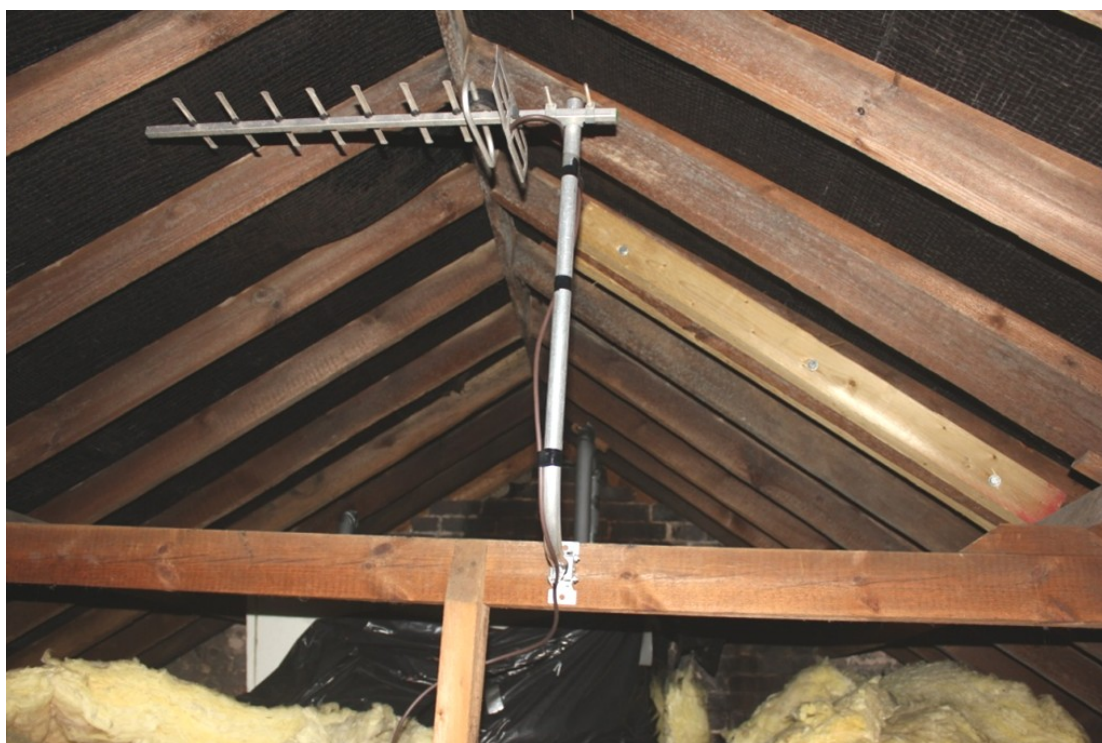
The roof is accessed via a loft hatch in the south side of the Landing Room S1. The roof has been re-built and is a mid-20<sup>th</sup> century construction consisting of common, paired rafters with intermediate collars of which there are only two across the whole roof structure (Plate 69).

**Plate 69. The roof structure, looking north.**

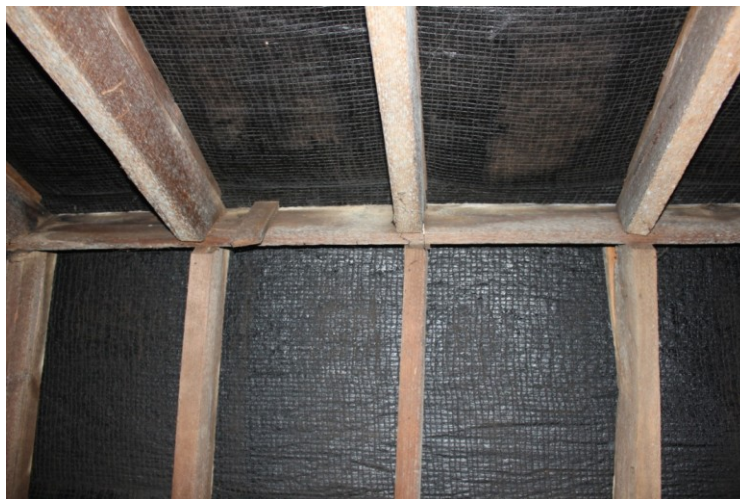
The purlins are set on edge with blocks between the rafters and purlins in the central section only. The timbers throughout are bandsawn and there is a slim ridge-board, with bitumen lining with furring pieces evident throughout (Plate 70).

**Plate 70. Machined timbers and bitumen lined roof.**

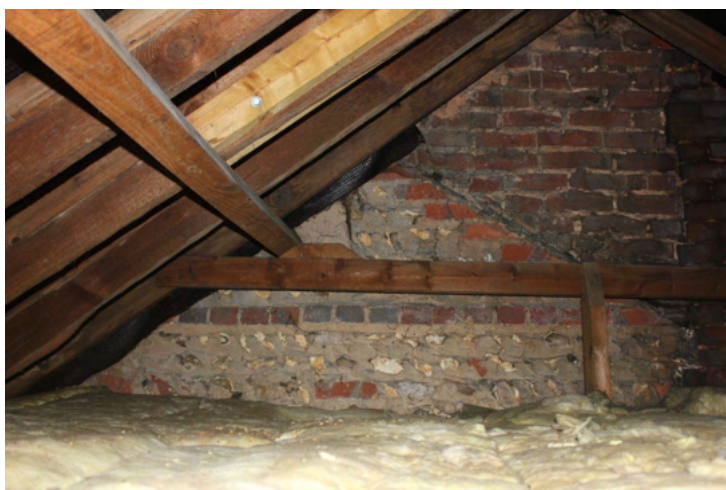
The south wall consists of the gable of No.6 to the south, which is flint with brick bands. There is the outline of a stack here which belongs to the adjacent property. There is patched brickwork between the stack and the roof of No.6 which is clearly seen in outline in this gable end (Plates 71 and 72).

**Plate 71. Gable of No. 6 with flint and brick masonry evident as well as the slate roof.**

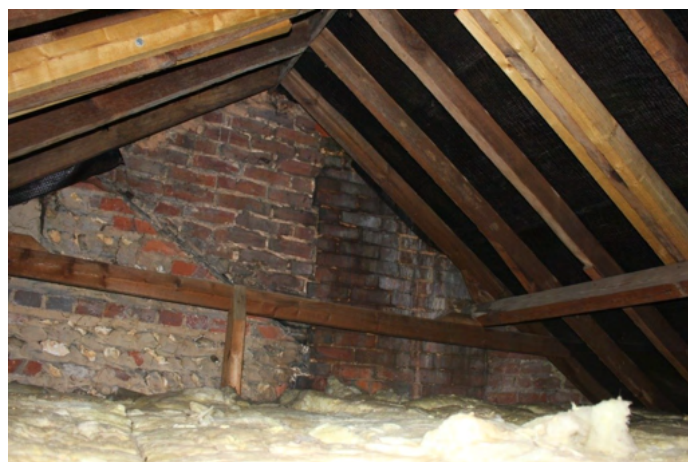
**Plate 72. Infill brickwork in the southern gable.**
