# Site Investigation Report

129282.1.USI

Auger were commissioned by Crawford & Co to undertake a site investigation and CCTV inspection of the underground drainage within the area of concern at the property.

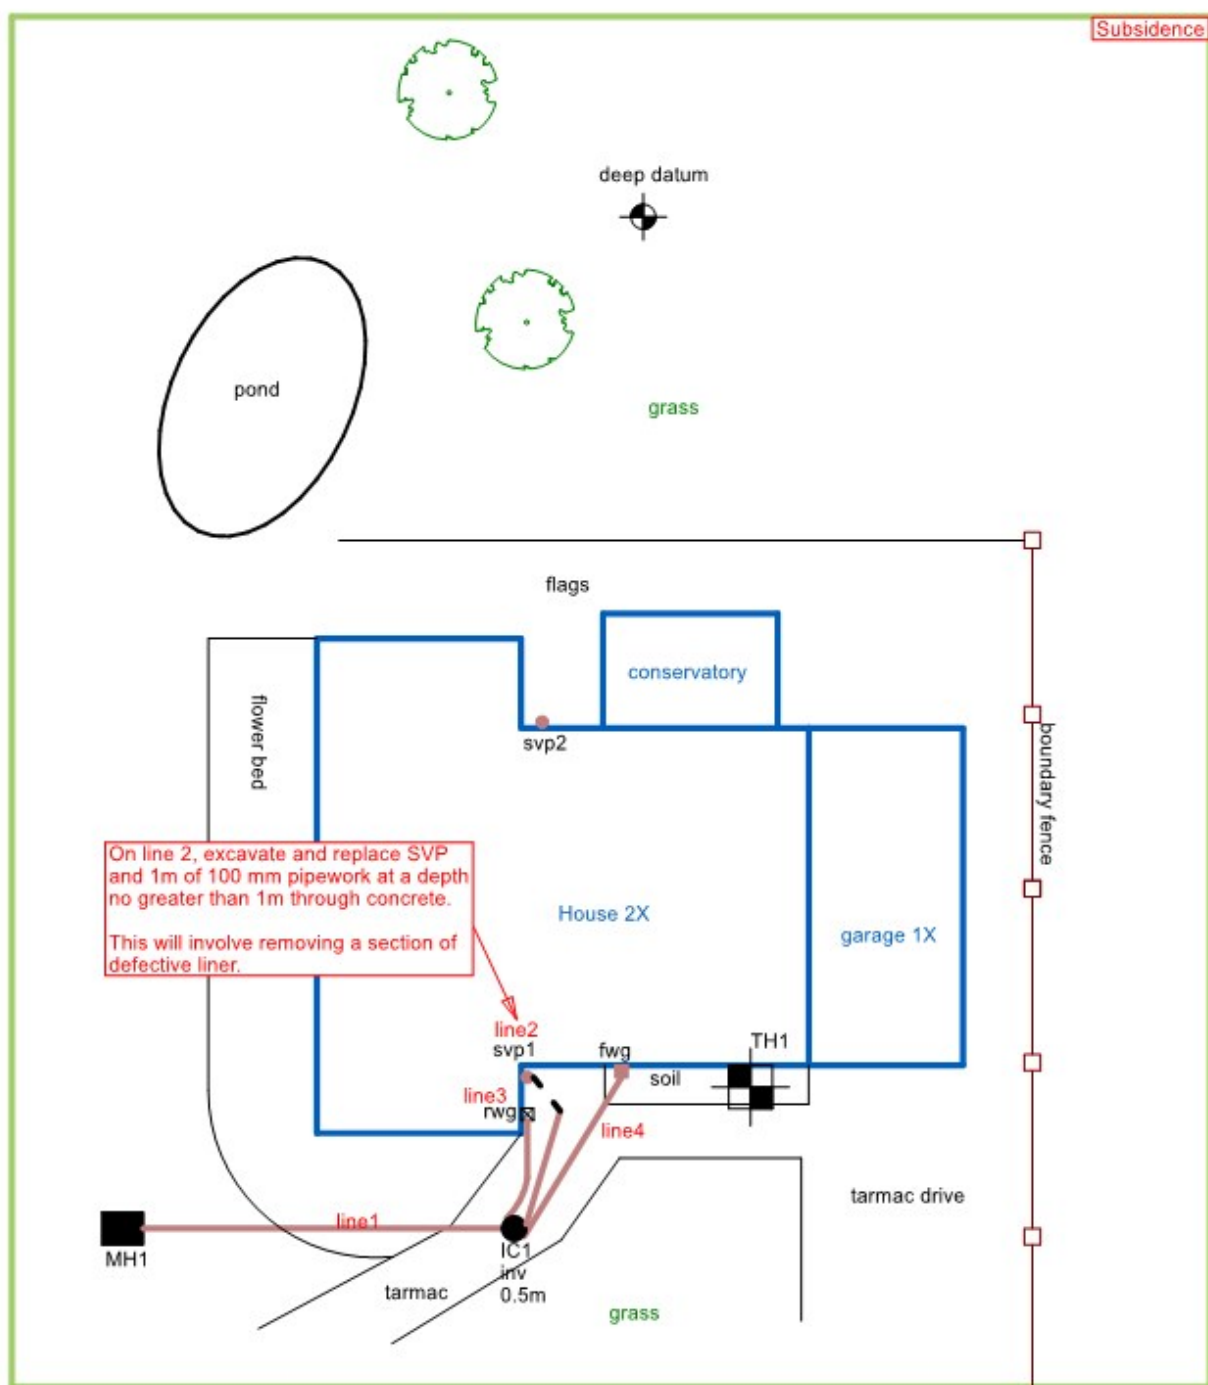
## FRONT OF PROPERTY

Our CCTV survey revealed that this drain has previously been lined. Furthermore the end of the liner on the restbend is not flush to the pipe. As a result this has caused a 'lip' on the drain which may cause blockages.

The above mentioned defects to the below ground drainage system have been caused by ground movement.

On line 2, excavate and replace SVP and 1m of 100 mm pipework at a depth no greater than 1m through concrete. This will involve removing a section of defective liner.

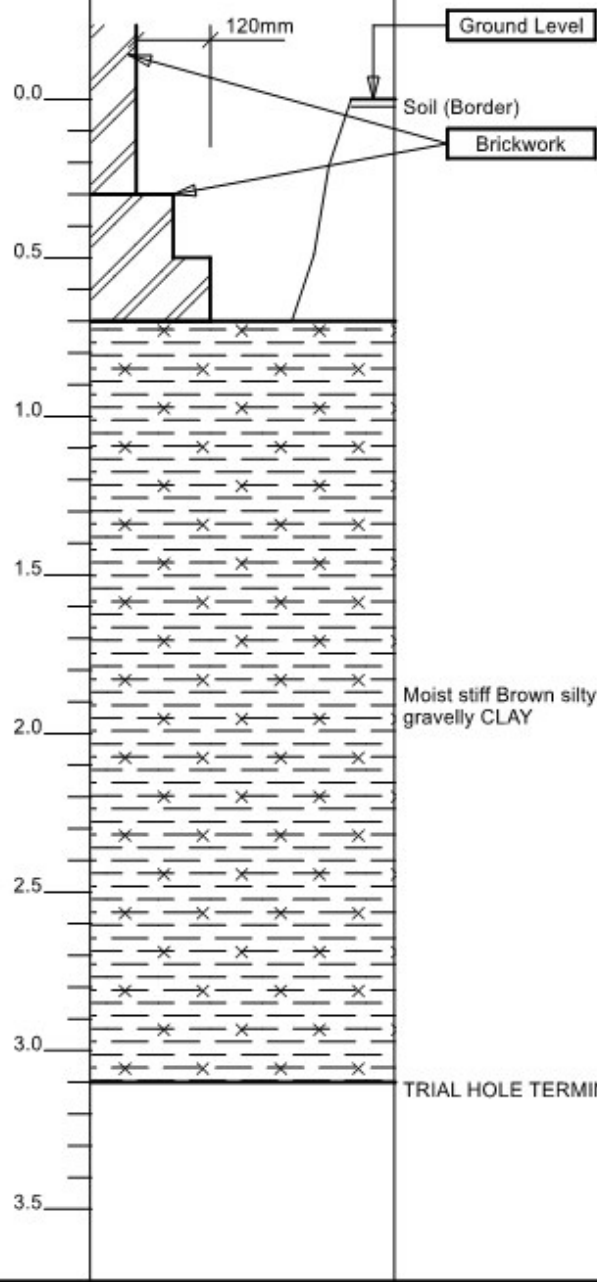
# Trial Hole Log No.1

Location: Front wall of the house

| Depth<br>(m) | Symbolic Log | Strata Description | Insitu Tests | | Soil<br>Sample | Root<br>Sample |
|---|---|---|---|--|---|---|
| 2.0 | | Moist stiff Brown silty fine to medium<br>gravelly CLAY | 94kpa | | Soil<br>@ 1.7m | |
| 3.0 | | TRIAL HOLE TERMINATED | 120kpa | | Soil<br>@ 2.7m | |

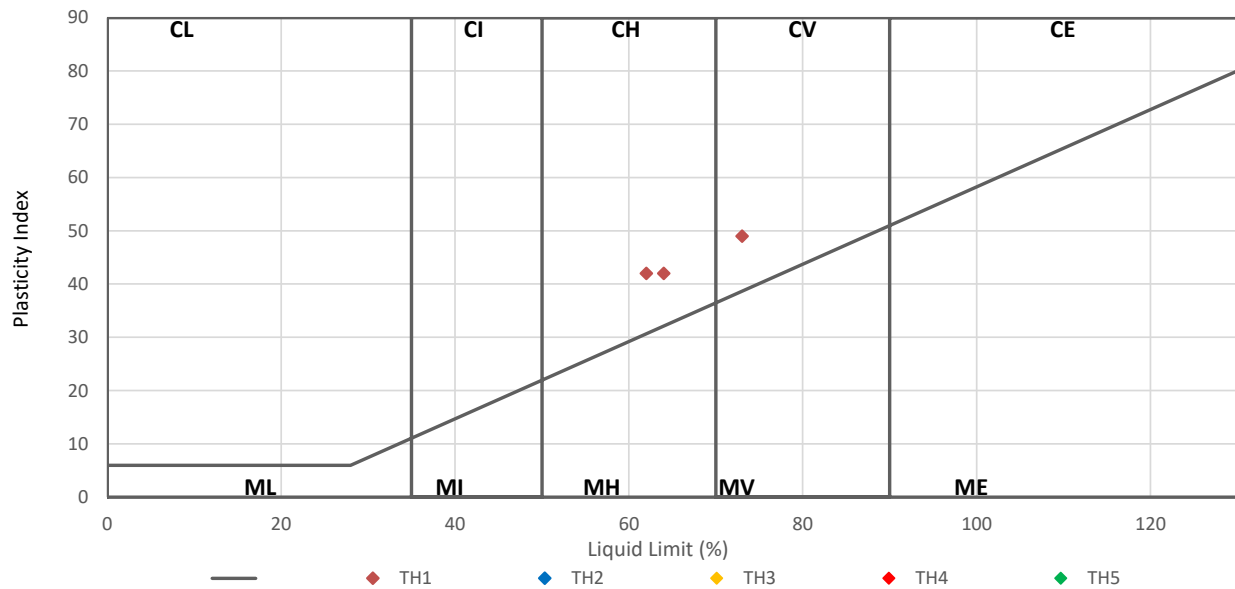
PLASTICITY CHART FOR CASAGRANDE CLASSIFICATION  
BS 5930:1999+A2:2010

Modified Plasticity Index (PI) <10 : Non Classified  
 Modified PI = 10 to <20 : Low volume change potential (LOW VCP)  
 Modified PI = 20 to <40 : Medium volume change potential (Med VCP)  
 Modified PI = 40 or greater : High volume change potential (HIGH VCP)
