## **7 Appendices**

**Project Name:** Prince Albert Pub RH10 3QX  
**Project Description:** General CCTV - Condition Check  
**Project Number:** JSD7518  
**Project Status:** Complete  
**Project Date:** 25/07/2024  
**Inspection Standard:** MSCC4 Sewers & Drainage GB (SRM4 Scoring)

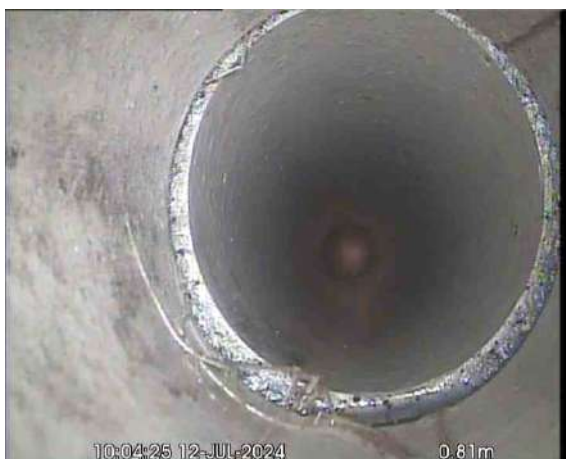
| Scale: | 1:50 | Position [m] | Code | Observation | MPEG | Photo | Grade |
|---|---|---|---|---|---|---|---|
| | 0.81 | CCJ | Crack, circumferential at joint from 6 o'clock to 9 o'clock | 00:01:01 | GULLYX_b10122b8-1f1f-4b61-53ee-44b1 | | 2 |

GULLYX\_b10122b8-1f1f-4b61-85ad-1d1dd839dd63\_20240725\_090208\_797.jpg, 00:01:01, 0.81 m  
Crack, circumferential at joint from 6 o'clock to 9 o'clock

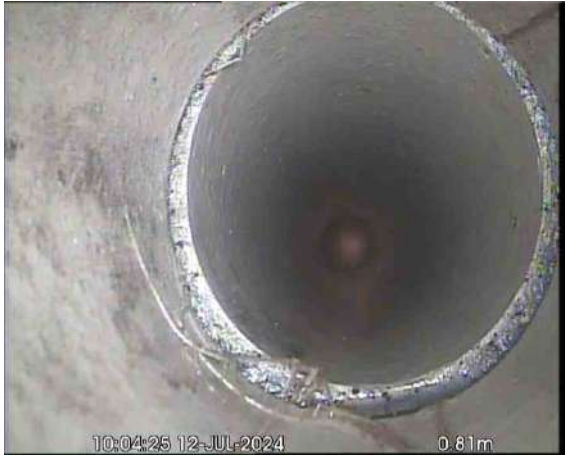
GULLYX\_be408751-b267-4dcb-87b2-47920da53df0\_20240725\_090226\_317.jpg, 00:01:01, 0.81 m  
Joint displaced, medium

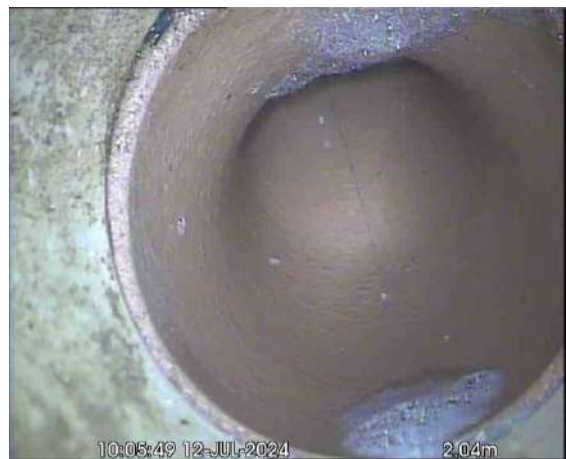
W\_CX\_96eda4f4-1bbb-49c3-bdf5-b6f3418d49e6\_20240725\_090429\_528.jpg, 00:00:47, 2.04 m  
 Line deviates up, REST BEND

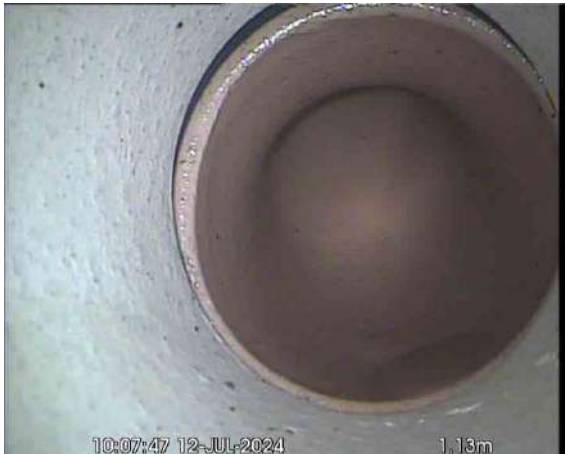
W\_CX\_1865770f-a7a0-438a-95c3-9da68d53db4d\_20240725\_090701\_492.jpg, 00:00:39, 1.13 m  
 Joint displaced, medium

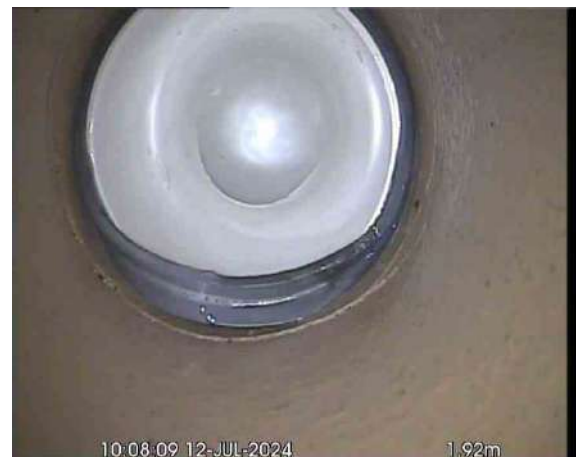
W\_CX\_dc0dc9d8-5d35-437e-89b2-f803bfeb8fe8\_20240725\_090809\_548.jpg, 00:01:01, 1.92 m  
 Sealing ring intruding, intruding but not hanging from 4 o'clock to 8 o'clock, (ON PAN CONNECTOR)

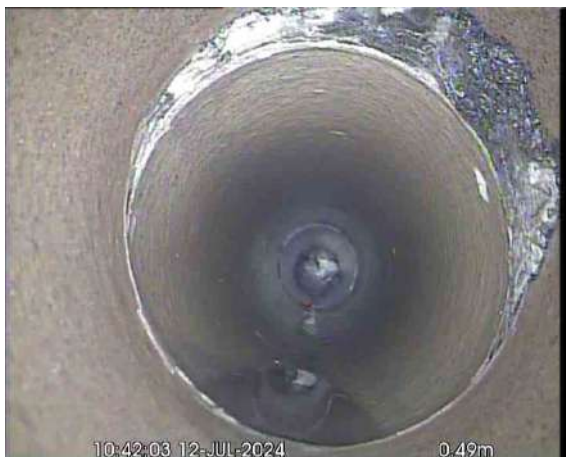
REDUNDANTX\_0df9520d-4cc8-45ca-b8b9-6ea8c8cc1138\_20  
240725\_091130\_965.jpg, 00:00:34, 0.49 m  
Joint displaced, large

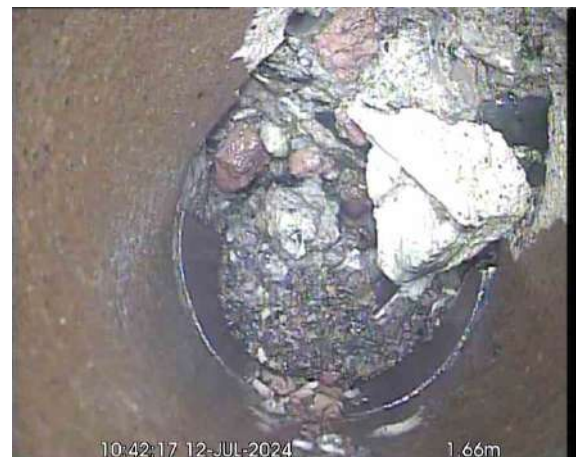
| Section | PLR | Grade | Description |
|---|---|---|---|
| 5 | REDUNDANTX | 4 | Broken pipe from 10 o'clock to 3 o'clock |

| Scale: | 1:50 | Position [m] | Code | Observation | MPEG | Photo | Grade |
|---|---|---|---|---|---|---|---|
| | | 1.66 | B | Broken pipe from 10 o'clock to 3 o'clock | 00:00:47 | REDUNDANTX_29814b43-2bf | 4 |

REDUNDANTX\_29814b43-2bf2-411c-83a3-7448b2e32080\_2  
0240725\_091151\_156.jpg, 00:00:47, 1.66 m  
Broken pipe from 10 o'clock to 3 o'clock

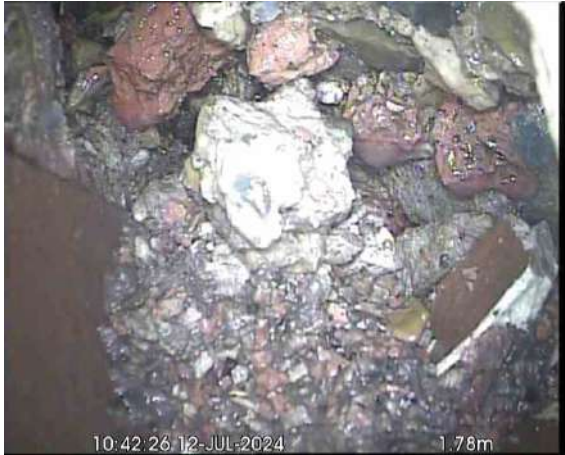
REDUNDANTX\_716789ca-25ee-4cc2-8135-a7bc7aff19d4\_20  
240725\_091212\_524.jpg, 00:00:56, 1.78 m  
Settled deposits, hard or compacted, 100% cross-sectional  
area loss

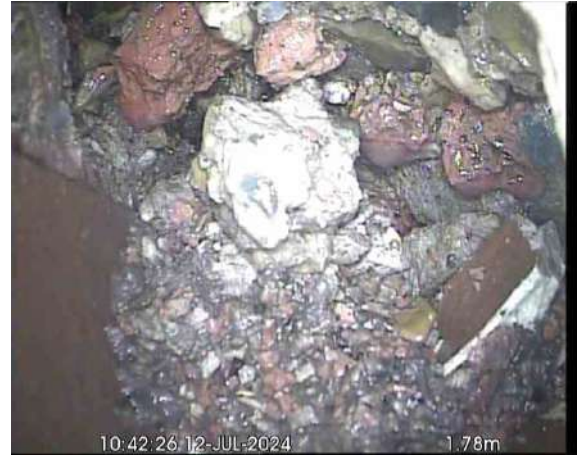
REDUNDANTX\_8ff2f762-c2e0-455c-bf22-40405fb29865\_202  
40725\_091223\_724.jpg, 00:00:56, 1.78 m  
Survey abandoned, S/A - REDUNDANT LINE

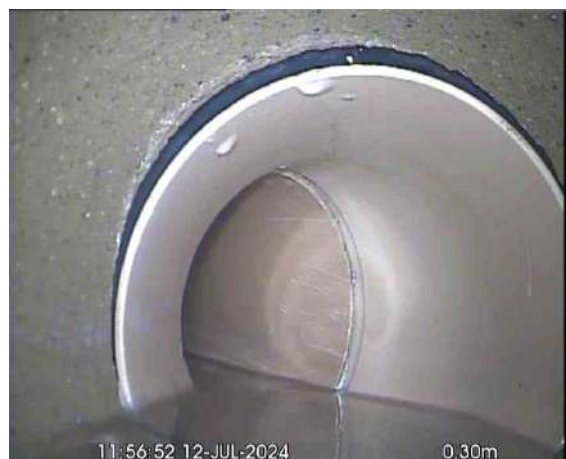
MH2X\_9e3848a9-2aef-4403-9dc0-06a55e9cccf0\_20240725\_092609\_653.jpg, 00:00:56, 0.30 m  
 Joint displaced, medium

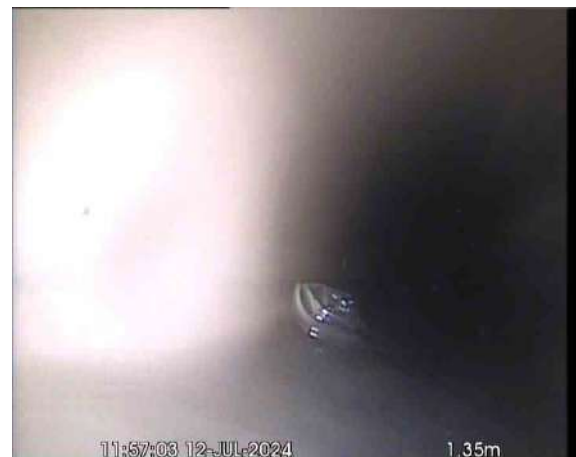
MH2X\_f65f7b8b-e9eb-42e2-bd0d-13d5b91a7f09\_20240725\_093042\_603.jpg, 00:01:07, 1.35 m  
Water level, 10% of the vertical dimension

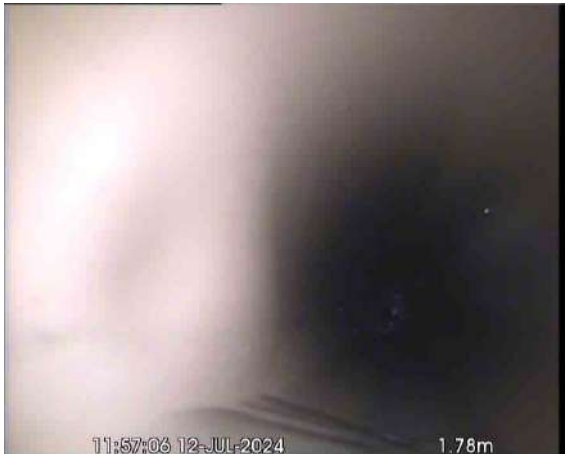
MH2X\_63ec8ede-2157-460a-bba6-3a2739af30ac\_20240725\_093101\_292.jpg, 00:01:11, 1.78 m  
 Water level, 5% of the vertical dimension

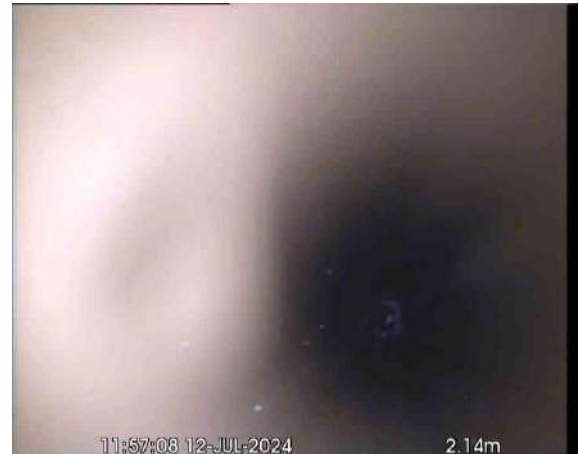
MH2X\_d8971b82-46f9-414d-a365-ee734a64b108\_20240725\_093111\_187.jpg, 00:01:12, 2.14 m  
 Water level, 0% of the vertical dimension

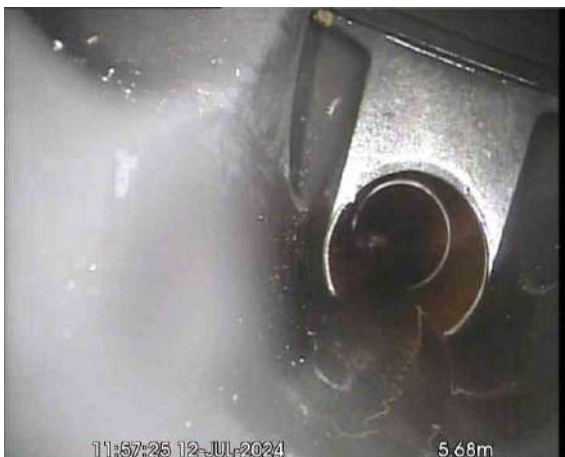
MH2X\_b55e55f8-9e05-4db8-b212-fbb573044cff\_20240725\_093147\_156.jpg, 00:01:29, 5.68 m  
 General remark, \*\*ENTERS MANHOLE 3 (MH3) - UNABLE TO LIFT

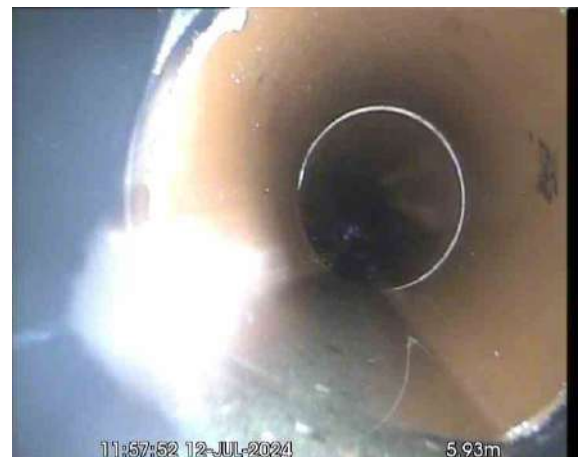
MH2X\_2c7dd602-37a2-429a-a2ab-0279f14f5071\_20240725\_093210\_012.jpg, 00:01:46, 5.93 m  
 Water level, 5% of the vertical dimension

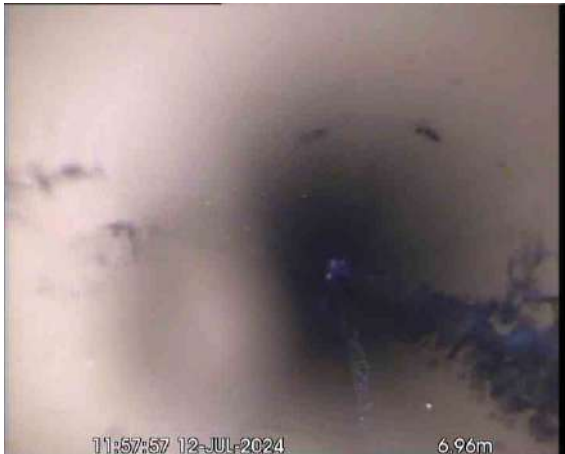
MH2X\_88b39d42-4c30-4654-8841-754422e4dc7a\_20240725\_093224\_970.jpg, 00:01:50, 6.96 m  
 Water level, 0% of the vertical dimension

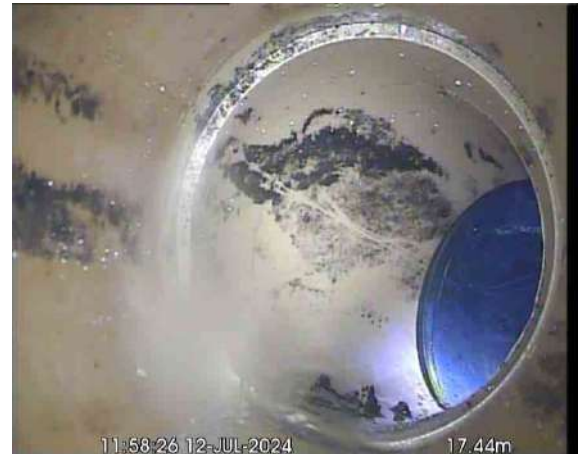
MH2X\_ecbc01d4-5401-430c-a4cc-4e8128ef4209\_20240725\_093238\_853.jpg, 00:02:20, 17.44 m  
 Line deviates right

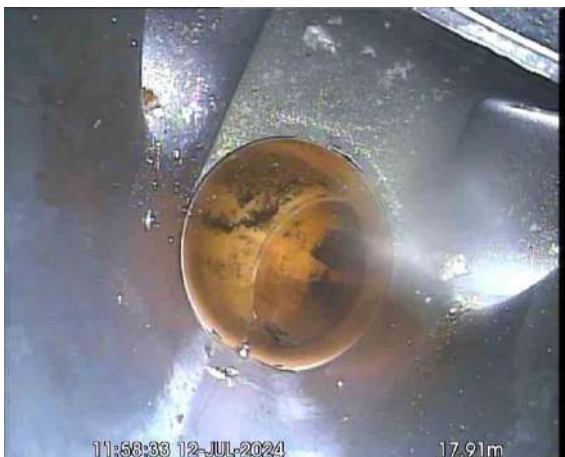
MH2X\_acdd8251-032e-4fda-a1d3-9a0cfadee0a2\_20240725\_093304\_170.jpg, 00:02:27, 17.91 m  
 Finish node, manhole, reference: MANHOLE 4 (MH4)

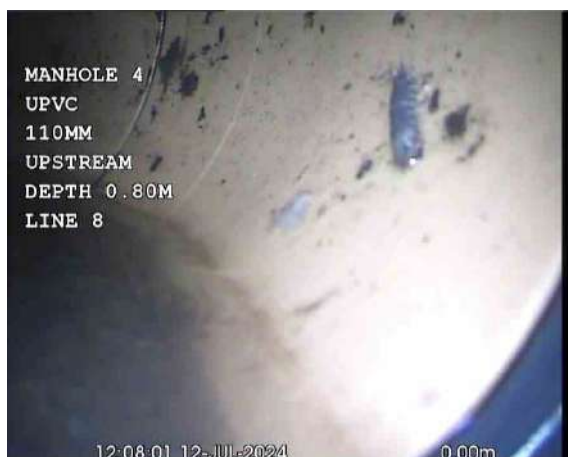
CAPPED  
OFFX\_df637ed9-d0c0-475d-a9b9-2d9c6523196d\_20240725\_093402\_548.jpg, 00:00:39, 0.00 m  
Start node, manhole, reference: MANHOLE 4 (MH4)

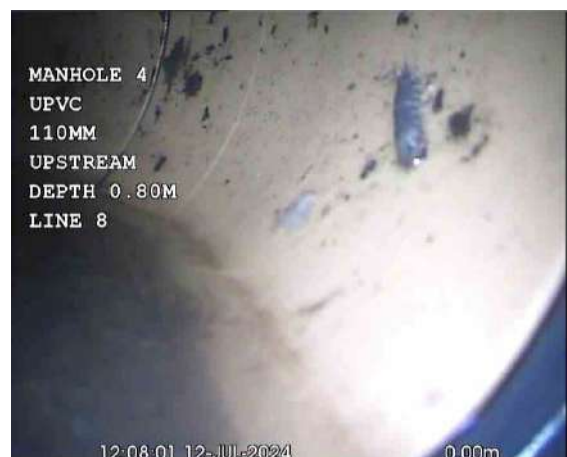
CAPPED  
OFFX\_93c2d75d-b2fd-43d0-9440-17bfa1c0c76e\_20240725\_093409\_690.jpg, 00:00:39, 0.00 m  
Water level, 5% of the vertical dimension

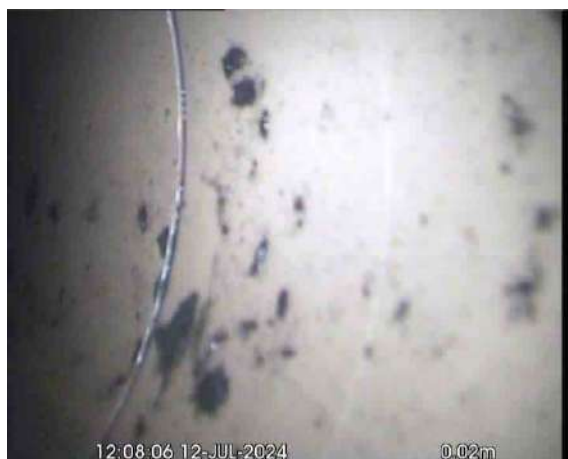
CAPPED  
OFFX\_2c61c11e-4c06-4ebc-870a-c78b293b4c99\_20240725\_093434\_293.jpg, 00:00:43, 0.02 m  
Line deviates left

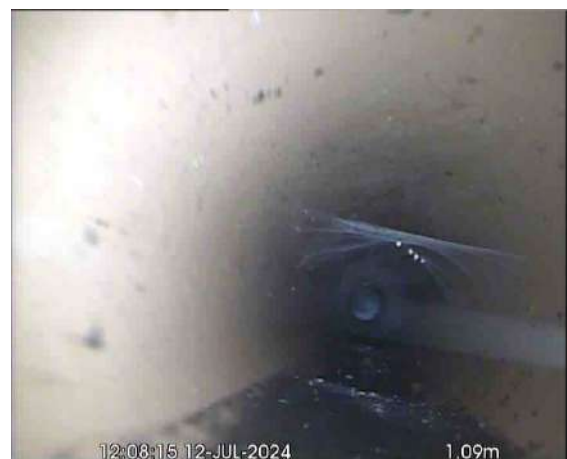
CAPPED  
OFFX\_67eeaf64-0435-43b5-8da3-b5a094747b11\_20240725\_093450\_860.jpg, 00:00:52, 1.09 m  
Water level, 5% of the vertical dimension

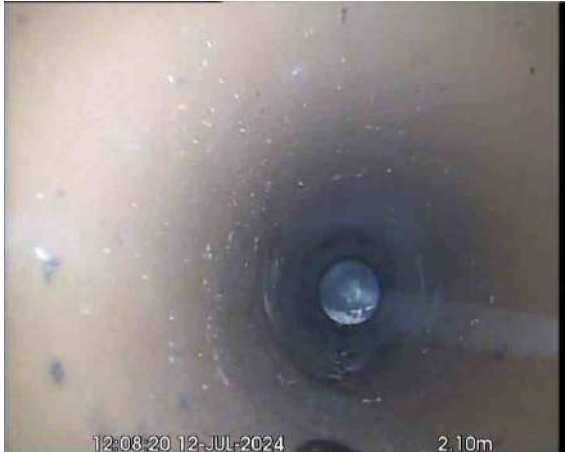
CAPPED  
OFFX\_68f25f6f-dbc4-4bd4-8f1f-8c3b8a9531e7\_20240725\_093504\_475.jpg, 00:00:57, 2.10 m  
Water level, 0% of the vertical dimension

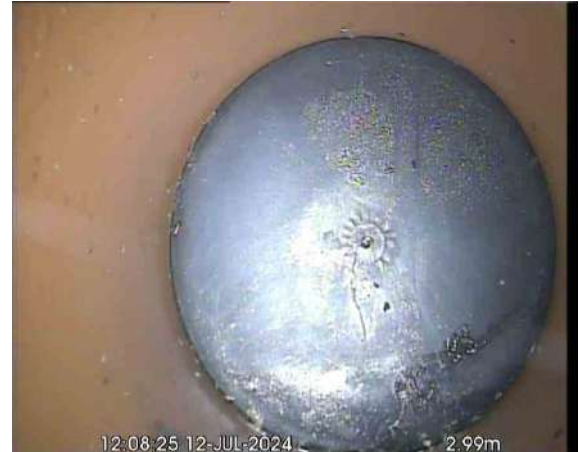
CAPPED  
OFFX\_dc97001a-2078-4b93-b9a2-163b14f502db\_20240725\_093522\_395.jpg, 00:01:03, 2.99 m  
Survey abandoned, S/A - CAPPED OFF

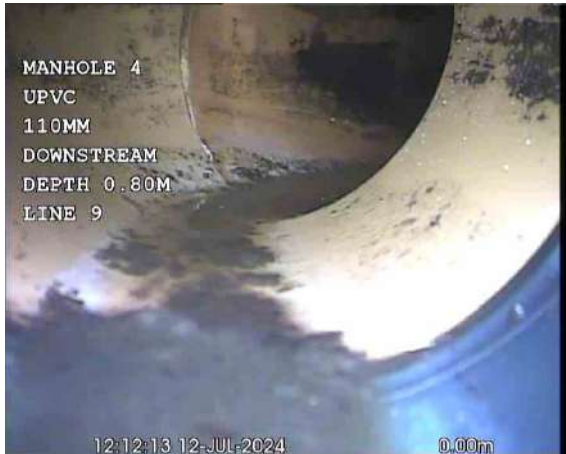
MH4X\_55d14c4d-fdbe-480a-a8d1-3ec7317d0af8\_20240725\_093843\_347.jpg, 00:00:26, 0.00 m  
Start node, manhole, reference: MANHOLE 4 (MH4)

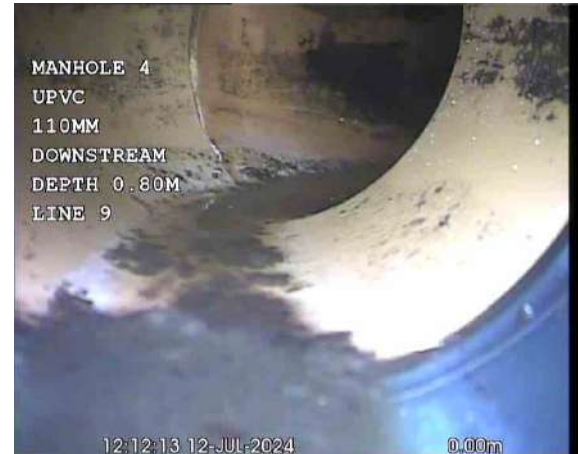
MH4X\_b15f3203-8bce-4b3c-aea4-e017105a17a3\_20240725\_093849\_179.jpg, 00:00:26, 0.00 m  
Water level, 0% of the vertical dimension

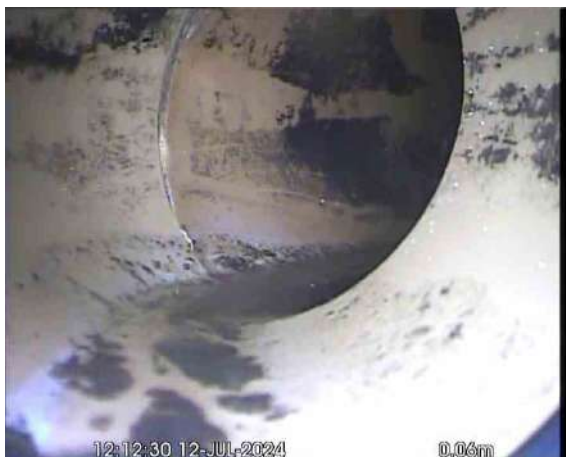
MH4X\_047d0d34-fc87-401f-a4c3-3433783703f4\_20240725\_093918\_923.jpg, 00:00:42, 0.06 m  
Line deviates right

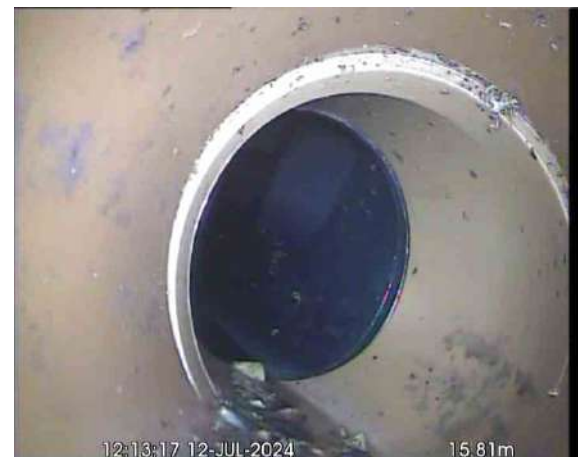
MH4X\_9d8f4504-f323-432b-9698-14d451cd618f\_20240725\_094016\_482.jpg, 00:01:29, 15.81 m  
Line deviates left

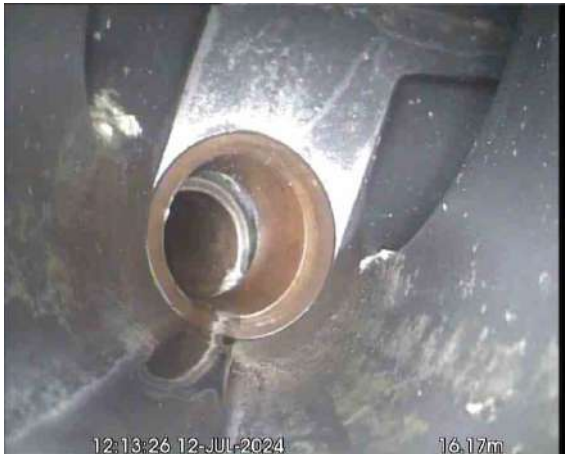
MH4X\_344678f6-6b66-4520-95ce-16ba1b185cdf\_20240725\_094041\_771.jpg, 00:01:39, 16.17 m  
Finish node, manhole, reference: MANHOLE 5 (MH5)

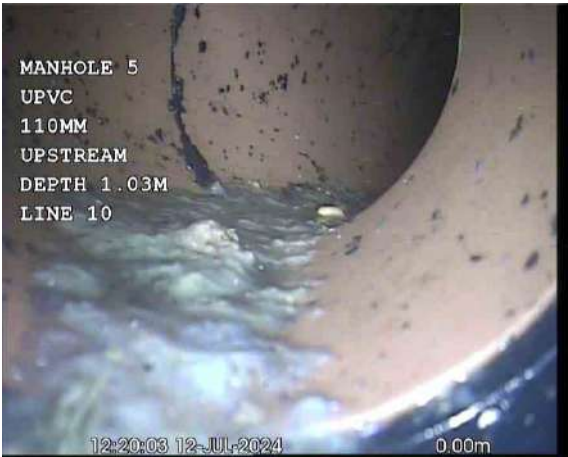
CAPPED  
 OFFX\_6c3871bb-4fd5-4855-bbb0-61d06810d0d7\_20240725\_094152\_058.jpg, 00:00:37, 0.00 m  
 Start node, manhole, reference: MANHOLE 5 (MH5)

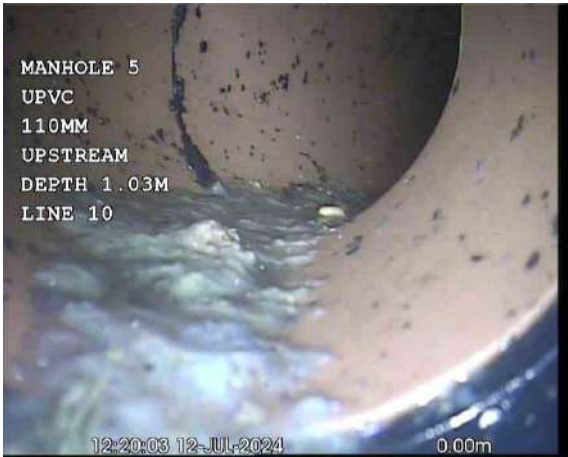
CAPPED  
 OFFX\_0b21e724-26bb-4d91-bb97-1640846d3795\_20240725\_094202\_515.jpg, 00:00:37, 0.00 m  
 Water level, 0% of the vertical dimension

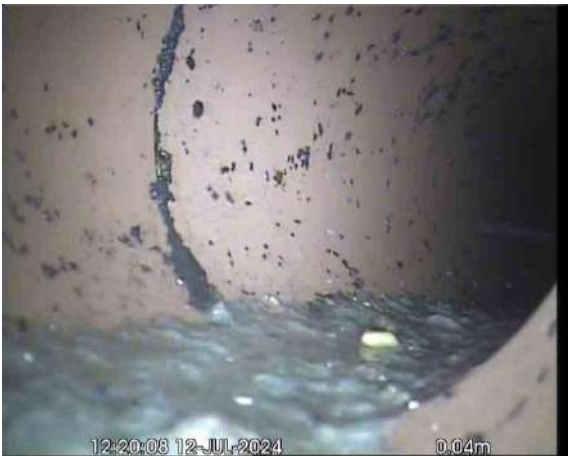
CAPPED  
 OFFX\_80832dd5-8ef6-4f5d-89c0-115ac1b2d810\_20240725\_094214\_228.jpg, 00:00:41, 0.04 m  
 Line deviates right

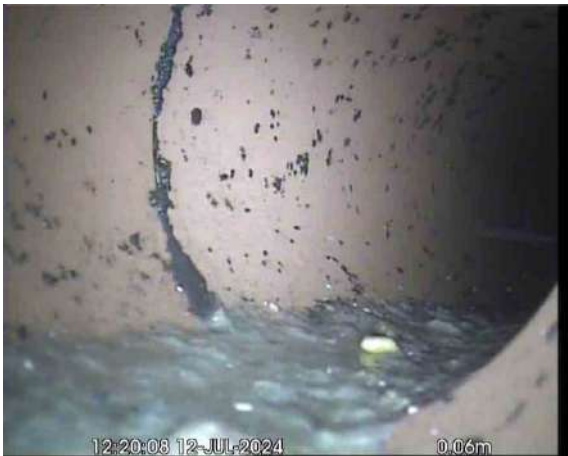
CAPPED  
 OFFX\_962b07f7-60c1-43c4-ba8a-1193030da8e6\_20240725\_094225\_233.jpg, 00:00:42, 0.06 m  
 Settled deposits, fine, 5% cross-sectional area loss

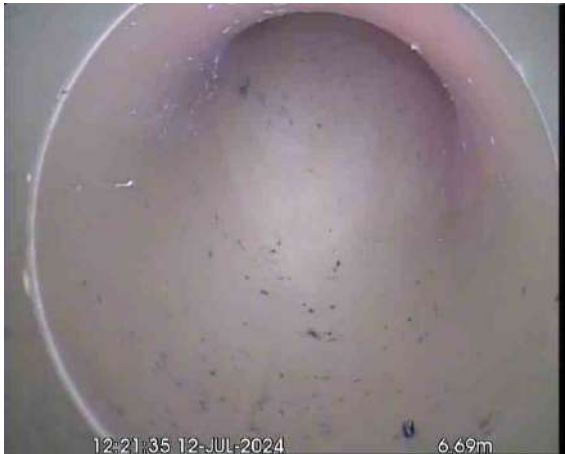
CAPPED  
OFFX\_7b6014f4-cab8-4f12-9a9c-6eb32ef0d8f9\_20240725\_09  
4246\_571.jpg, 00:02:08, 6.69 m  
Line deviates up, REST BEND

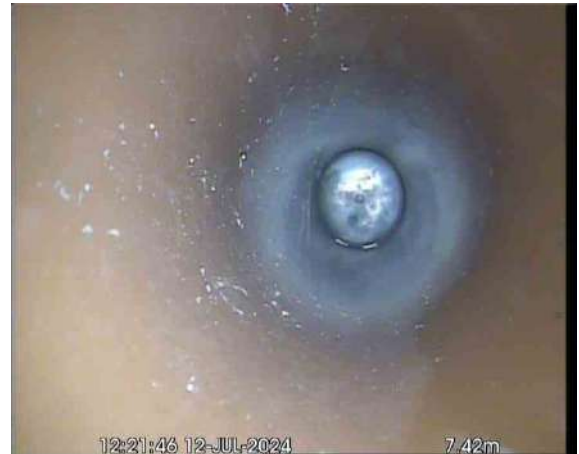
CAPPED  
OFFX\_b9c4dbb3-d9c6-4d09-9f4f-e40713d124b7\_20240725\_0  
94300\_939.jpg, 00:02:19, 7.42 m  
Survey abandoned, S/A - CAPPED OFF

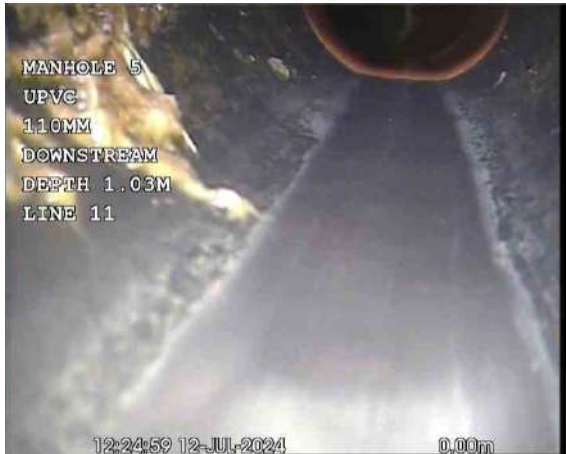
MH5X\_bd5530c6-c89a-41b5-b33d-6c50f69b0280\_20240725\_094513\_170.jpg, 00:00:29, 0.00 m  
 Start node, manhole, reference: MANHOLE 5 (MH5)

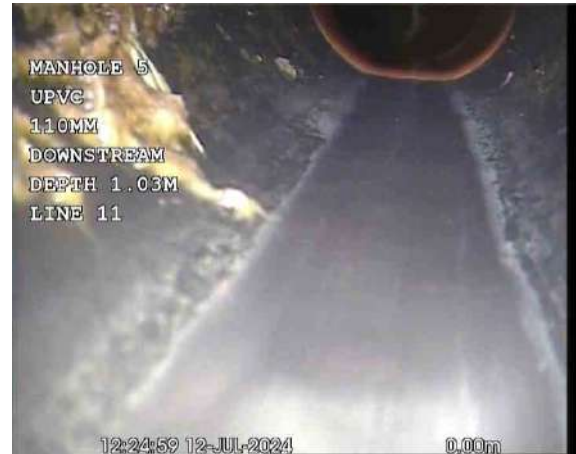
MH5X\_04a04489-4146-4ad3-b2c5-d7ff96abe544\_20240725\_094519\_970.jpg, 00:00:29, 0.00 m  
 Water level, 0% of the vertical dimension

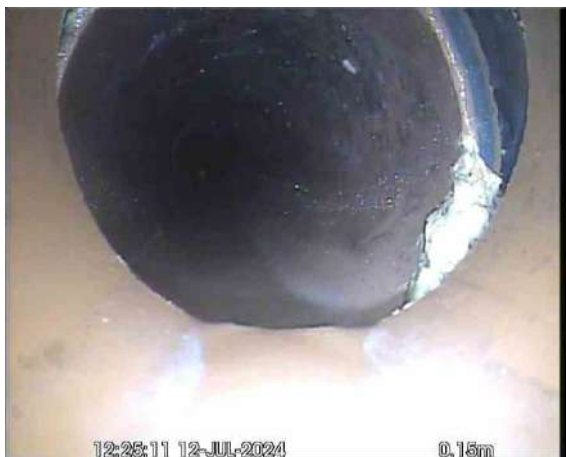
MH5X\_a67b5490-9c73-459b-9229-8a05c12ea946\_20240725\_094558\_658.jpg, 00:00:41, 0.15 m  
 Joint displaced, large

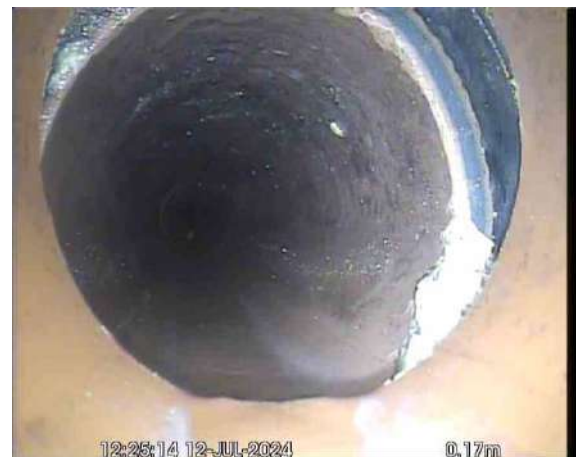
MH5X\_f2943572-daea-4cc0-b643-02d9ae5cd5ee\_20240725\_094641\_129.jpg, 00:00:44, 0.17 m  
 Material changes to vitrified clay

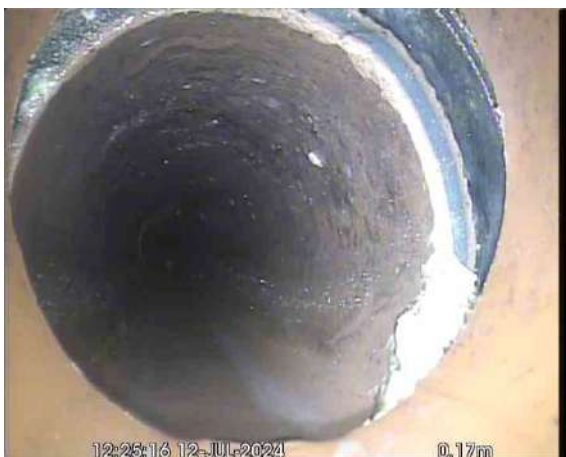
MH5X\_e186920a-c72e-48a4-9a6e-cd2a8489a0ab\_20240725\_094708\_970.jpg, 00:00:46, 0.17 m  
 Size changes, new size(s), 100mm high

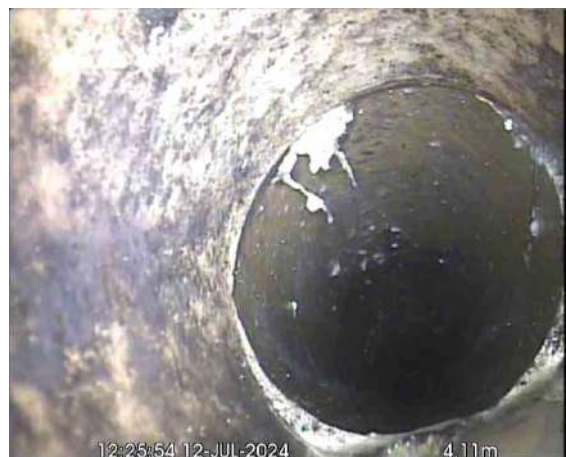
MH5X\_059f6707-2778-4d9f-998a-3e91e87c5d40\_20240725\_094727\_709.jpg, 00:01:24, 4.11 m  
 Joint displaced, medium

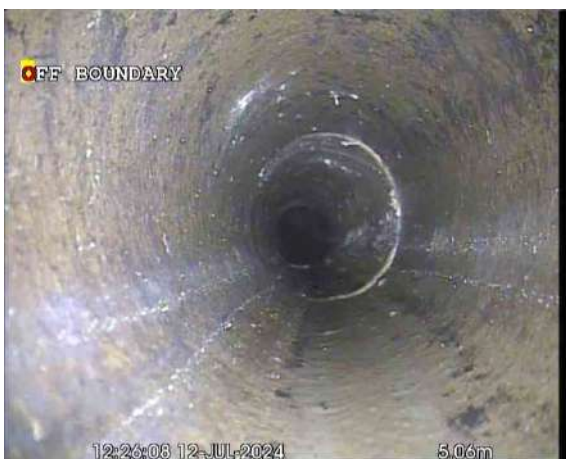
MH5X\_7a719423-7b10-4cb5-9e10-35a6d7d11f95\_20240725\_094749\_245.jpg, 00:01:36, 5.06 m  
 General remark, \*\*BOUNDARY POINT\*\*

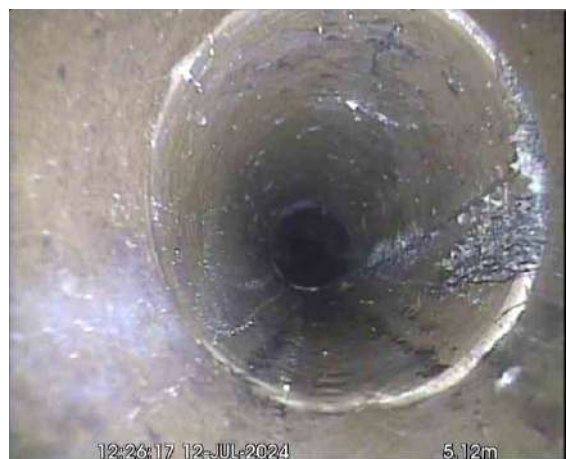
MH5X\_109efa46-164d-464f-96dd-18bcad47188e\_20240725\_094816\_811.jpg, 00:01:44, 5.12 m  
 Roots, fine at joint

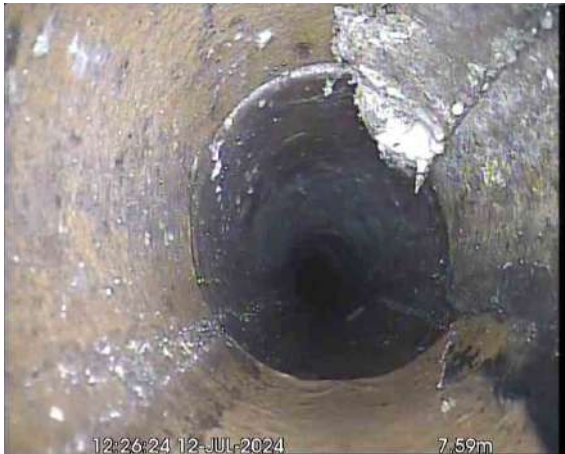
MH5X\_a25c901e-431c-4751-af44-e6286baac714\_20240725\_094843\_842.jpg, 00:01:51, 7.59 m  
 Attached deposits, grease from 12 o'clock to 5 o'clock, 5% cross-sectional area loss

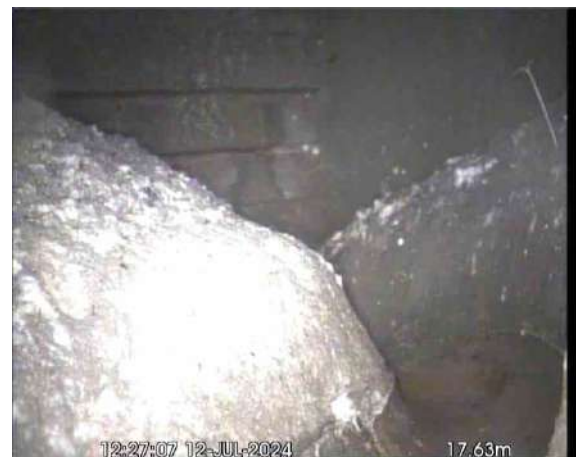
MH5X\_14be63c4-1844-4b3b-8d9d-02ec269f888d\_20240725\_095012\_235.jpg, 00:02:35, 17.63 m  
 Finish node, manhole, reference: MANHOLE A (MHA), (DAWN RISE ROAD)

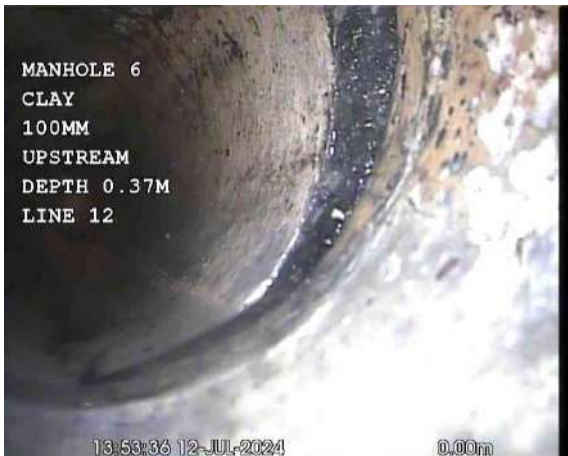
SVPX\_1032148c-1afa-44ba-b9d4-c41939b75ca1\_20240725\_095215\_787.jpg, 00:00:28, 0.00 m  
 Start node, manhole, reference: MANHOLE 6 (MH6)

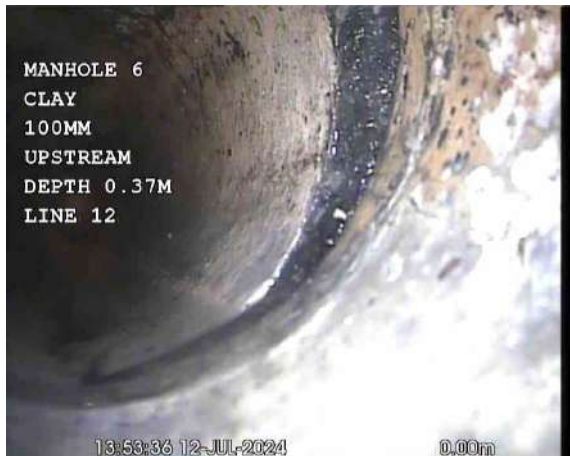
SVPX\_74d44b96-72da-442c-8602-c87605640ac0\_20240725\_095222\_464.jpg, 00:00:28, 0.00 m  
 Water level, 0% of the vertical dimension

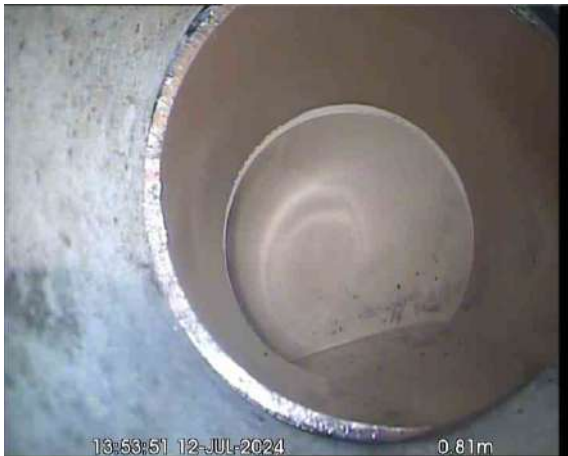
SVPX\_6126ff3a-8feb-42cf-b4a8-289a35627abd\_20240725\_095243\_344.jpg, 00:00:43, 0.81 m  
 Joint displaced, medium

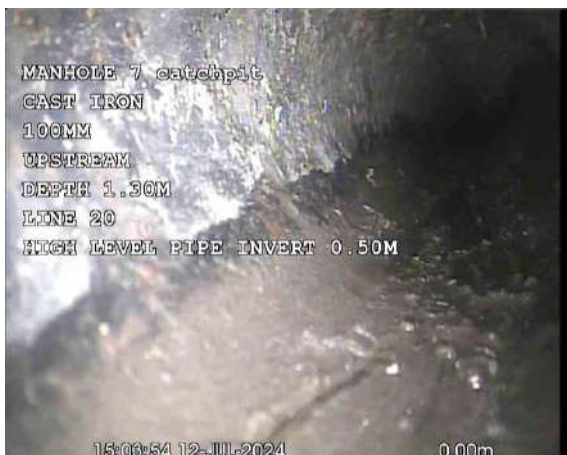
MANHOLEX\_092f6c46-9f5c-4244-a0a7-58e180fb86e7\_20240725\_102110\_815.jpg, 00:00:25, 0.00 m  
 Start node, catchpit, reference: MANHOLE 7 (MH7) - CATCHPIT (CP), (HIGH LEVEL PIPE - INVERT - 0.50M)

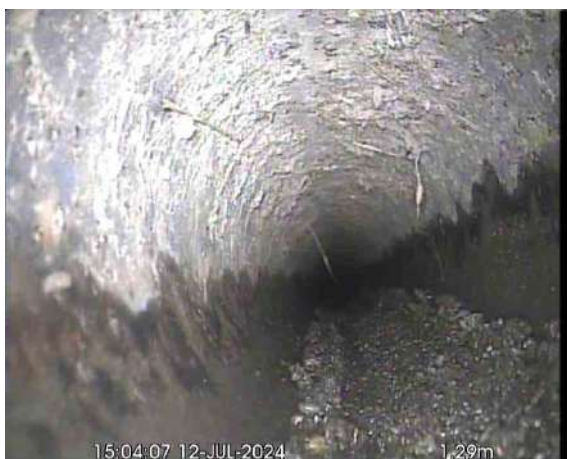
MANHOLEX\_eaa616f7-975f-4e97-ac3b-557e21e09b41\_20240725\_102200\_152.jpg, 00:00:38, 1.29 m  
 Settled deposits, fine, 10% cross-sectional area loss

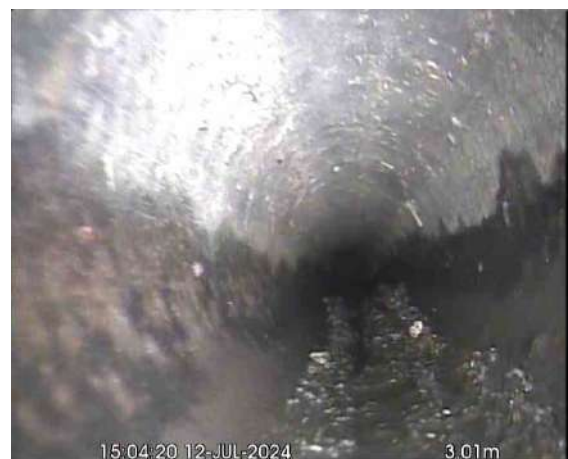
MANHOLEX\_9f739453-0b6d-4c3b-aa2f-970cef82bb99\_20240725\_102213\_871.jpg, 00:00:51, 3.01 m  
 Settled deposits, fine, 5% cross-sectional area loss

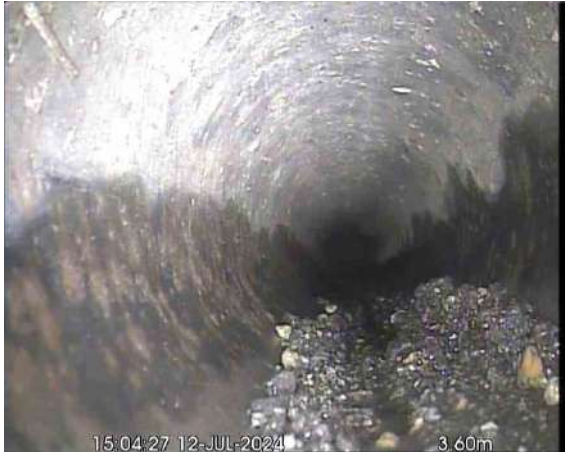
MANHOLEX\_3776ed84-49e6-4422-b862-3e0982192f67\_2024  
0725\_102228\_650.jpg, 00:00:58, 3.60 m  
Settled deposits, fine, 10% cross-sectional area loss

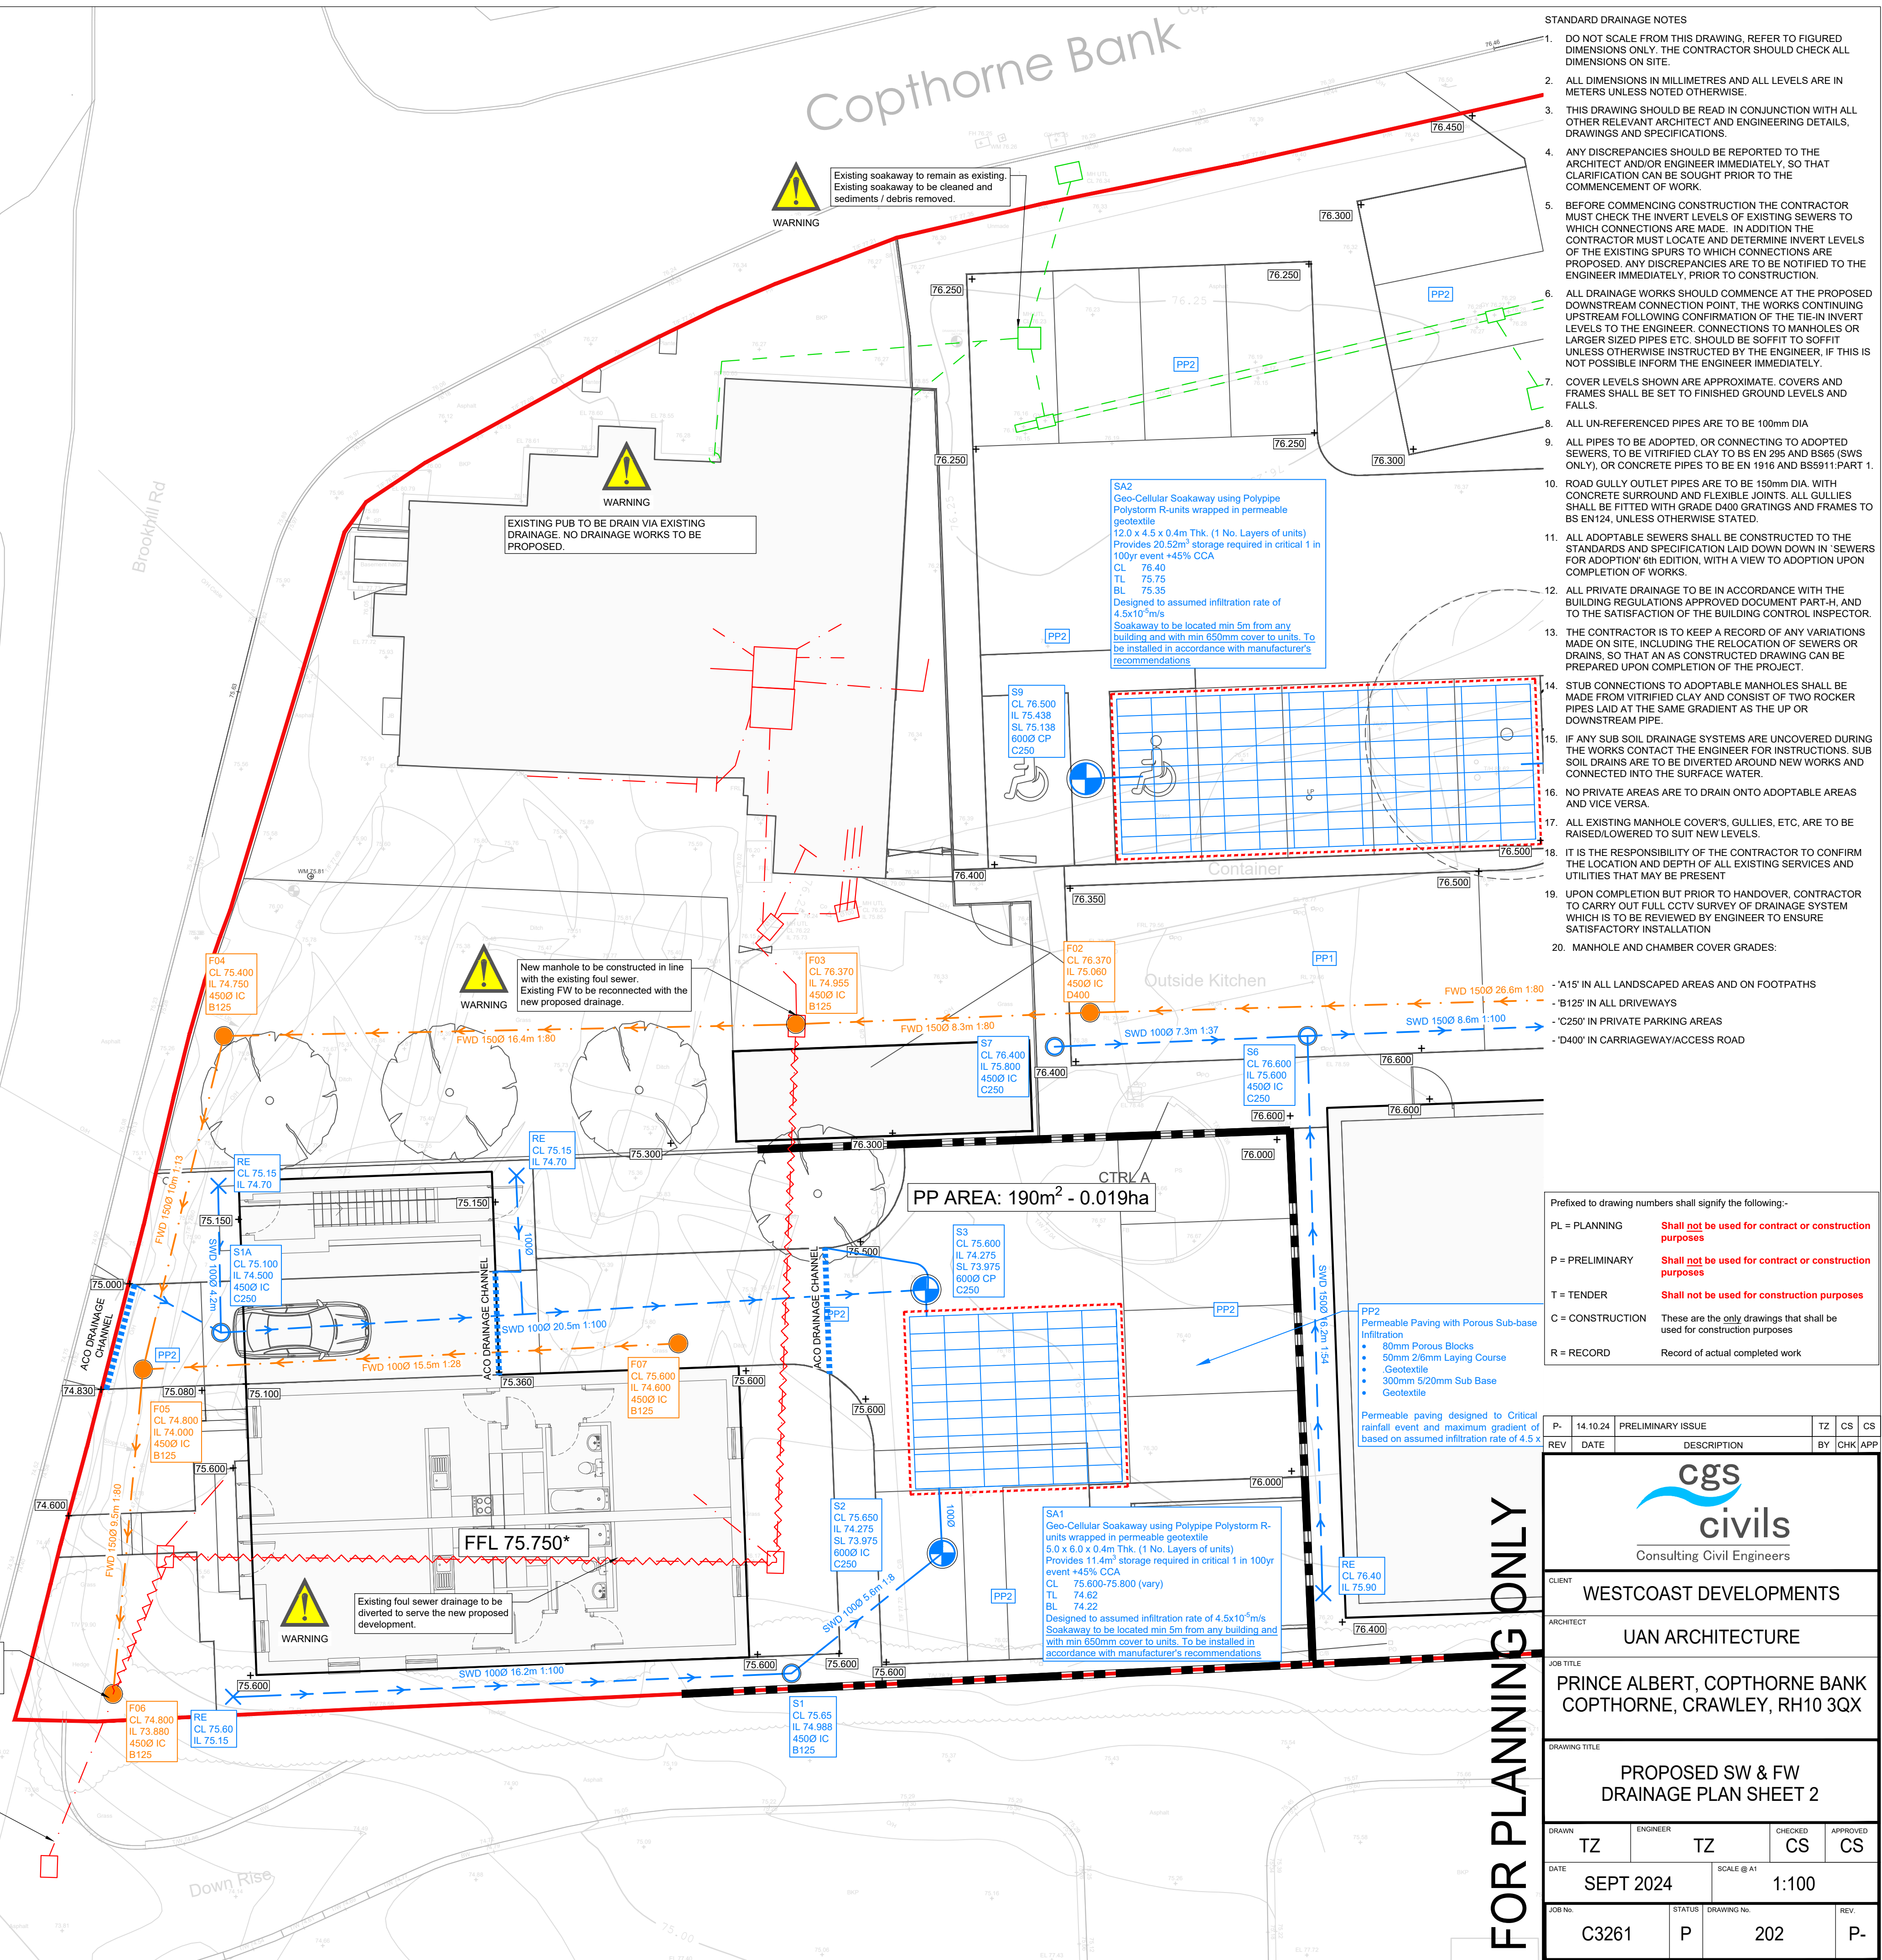
New manhole to be constructed in line with the existing foul sewer. Existing FW IL unknown and to be confirmed on site to inform detail design.

Existing foul sewer pipe to be upgraded to 150mmØ, subject to existing manhole outlet pipe diameter. Final FW pipe Ø to be confirmed on site prior works commencing.
