## **Resistograph Tree Report**

**Lindfield Primary Academy,  
Primary Academy, School Lane,  
Lindfield,  
Haywards Heath,  
RH16 2DX**

**Prepared by  
Richard Daubeney Our Ref 0825-RD  
12th August 2025**

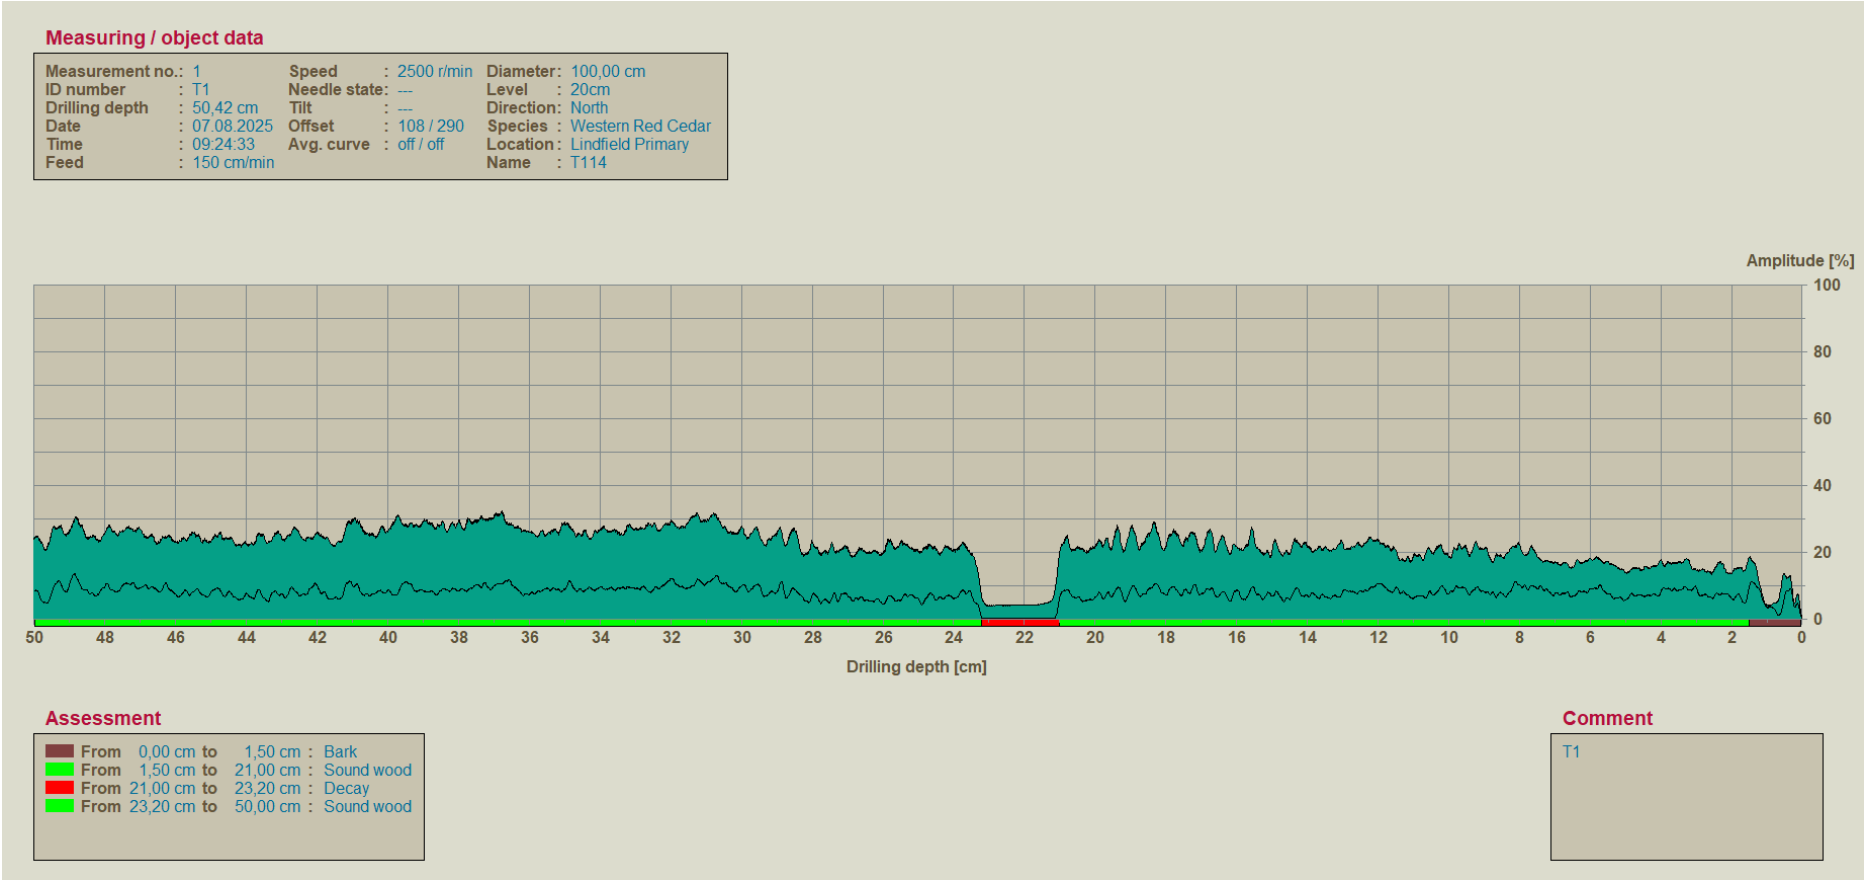
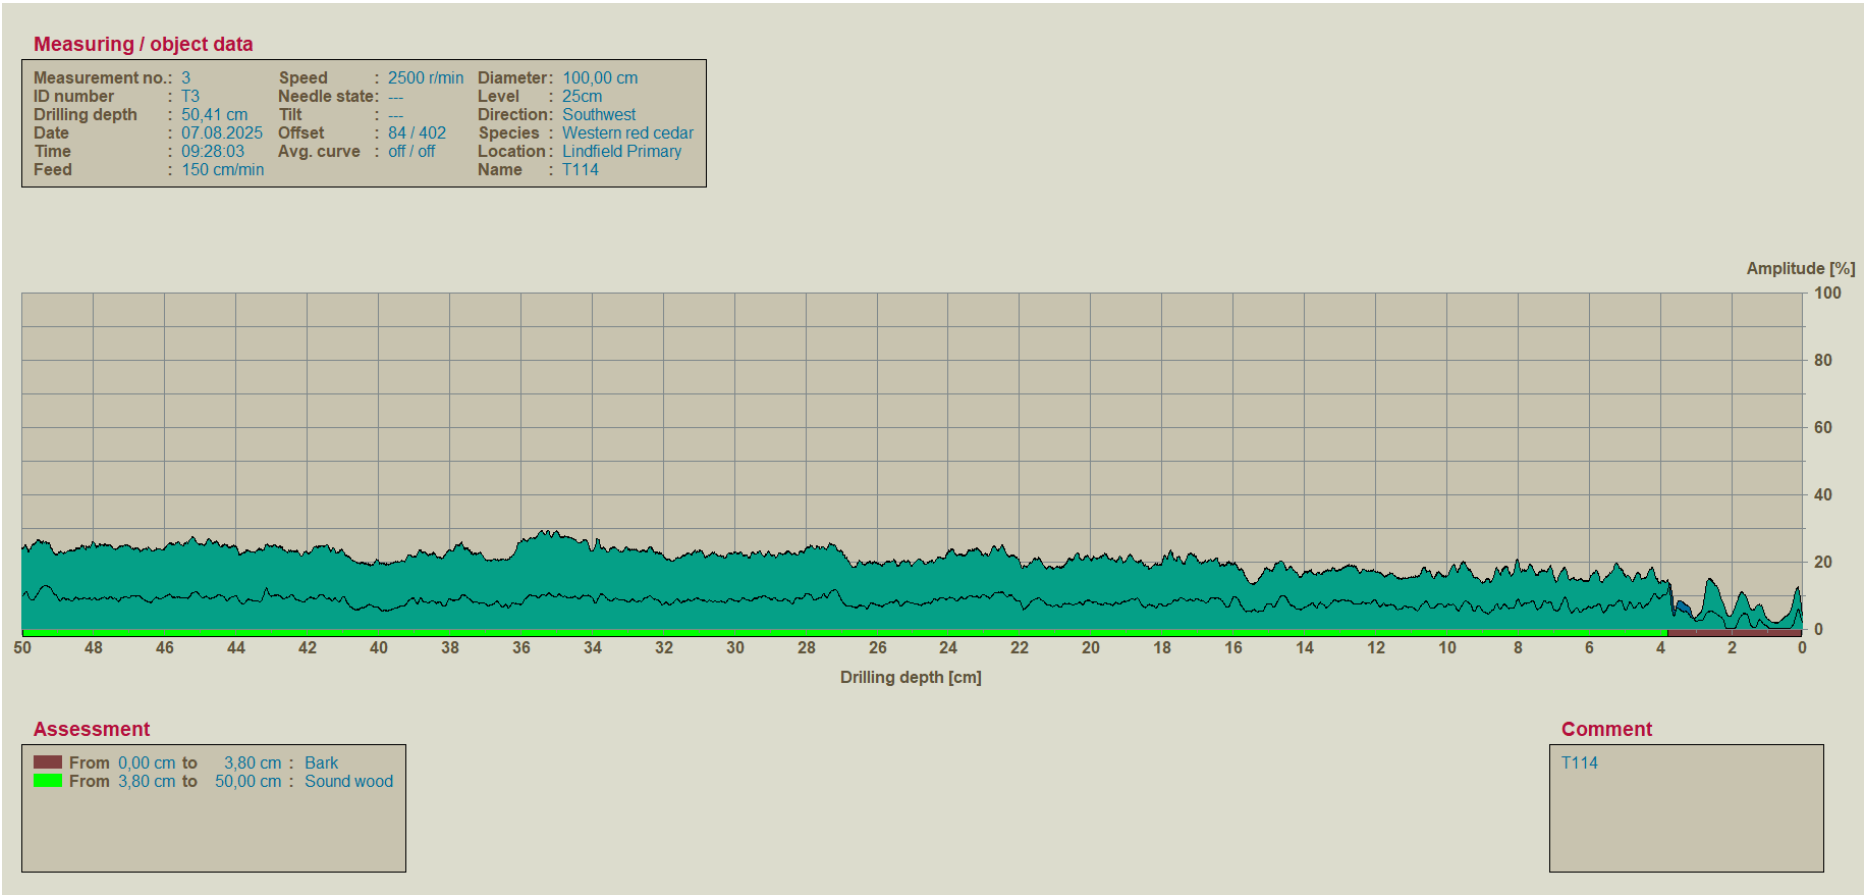
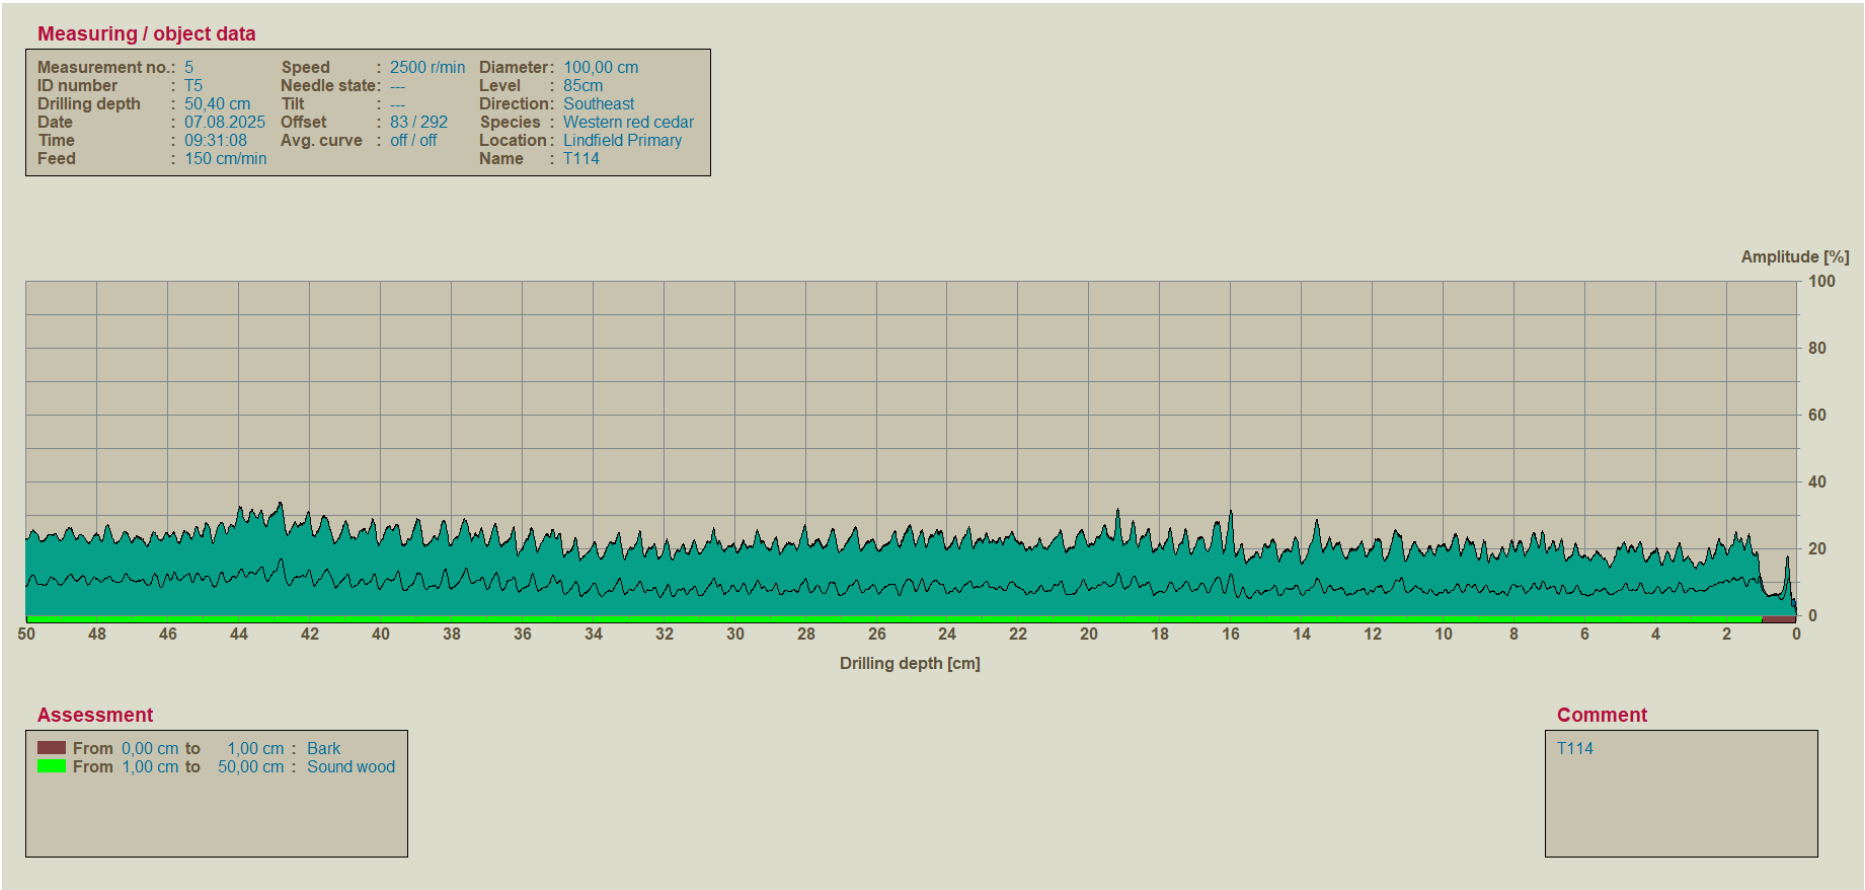
T114 Western red cedar tree measurement 1

T114 Western red cedar tree measurement 2

T114 Western red cedar tree measurement 3

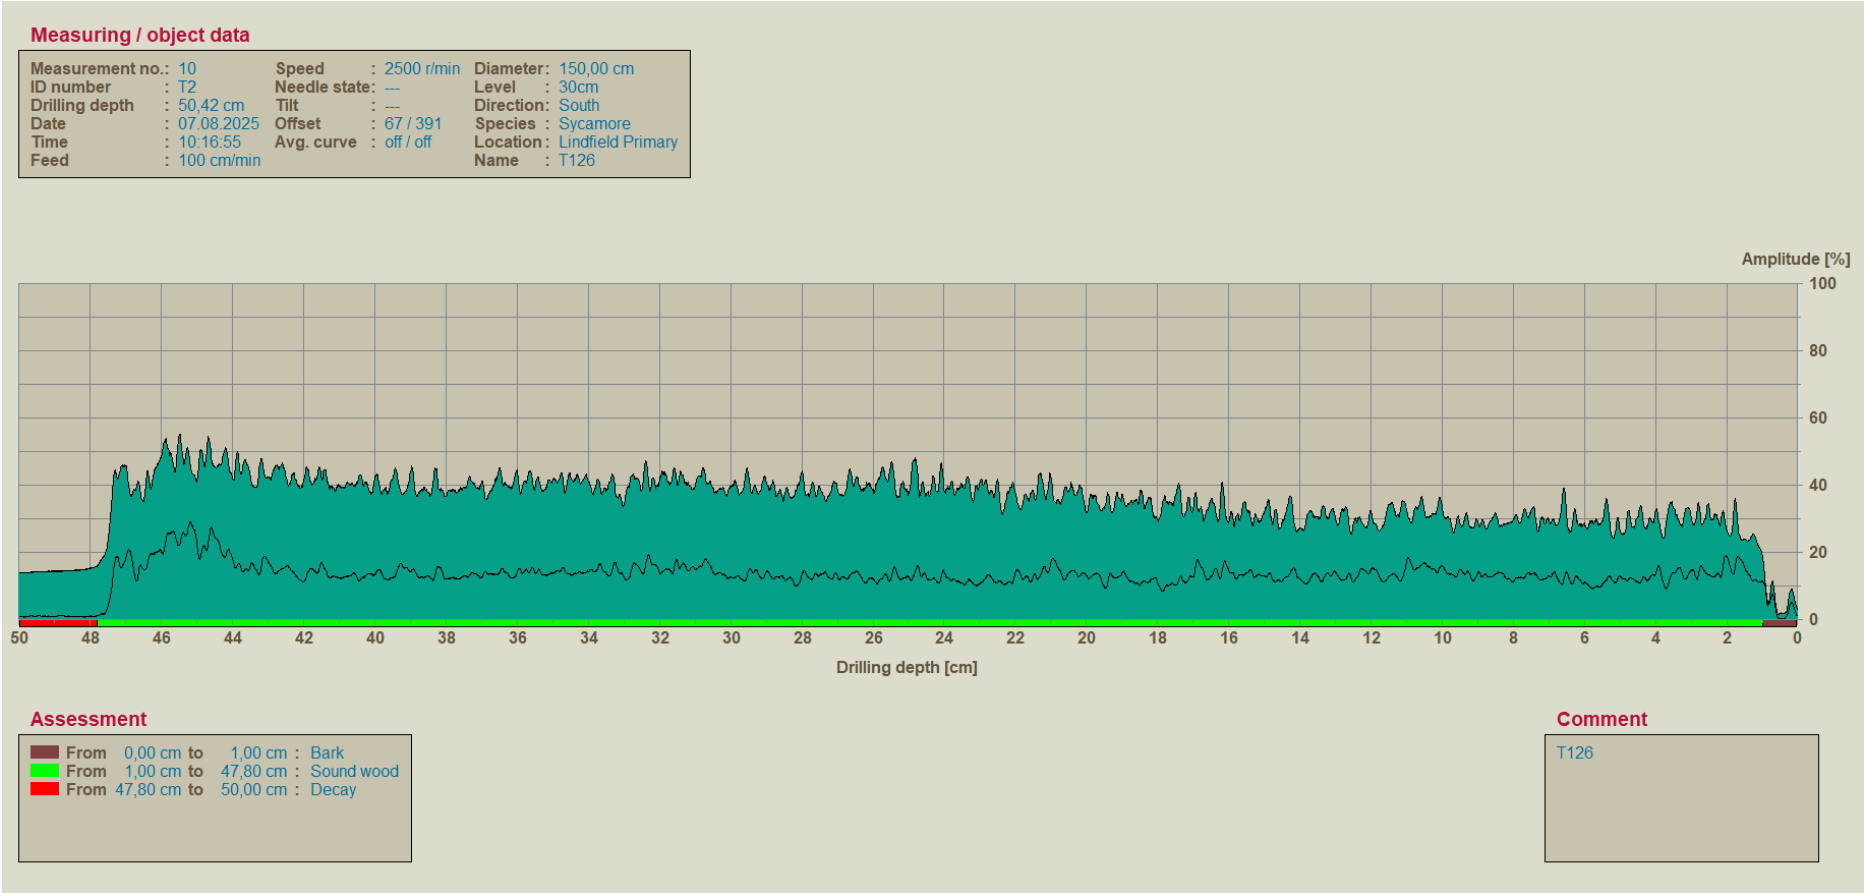
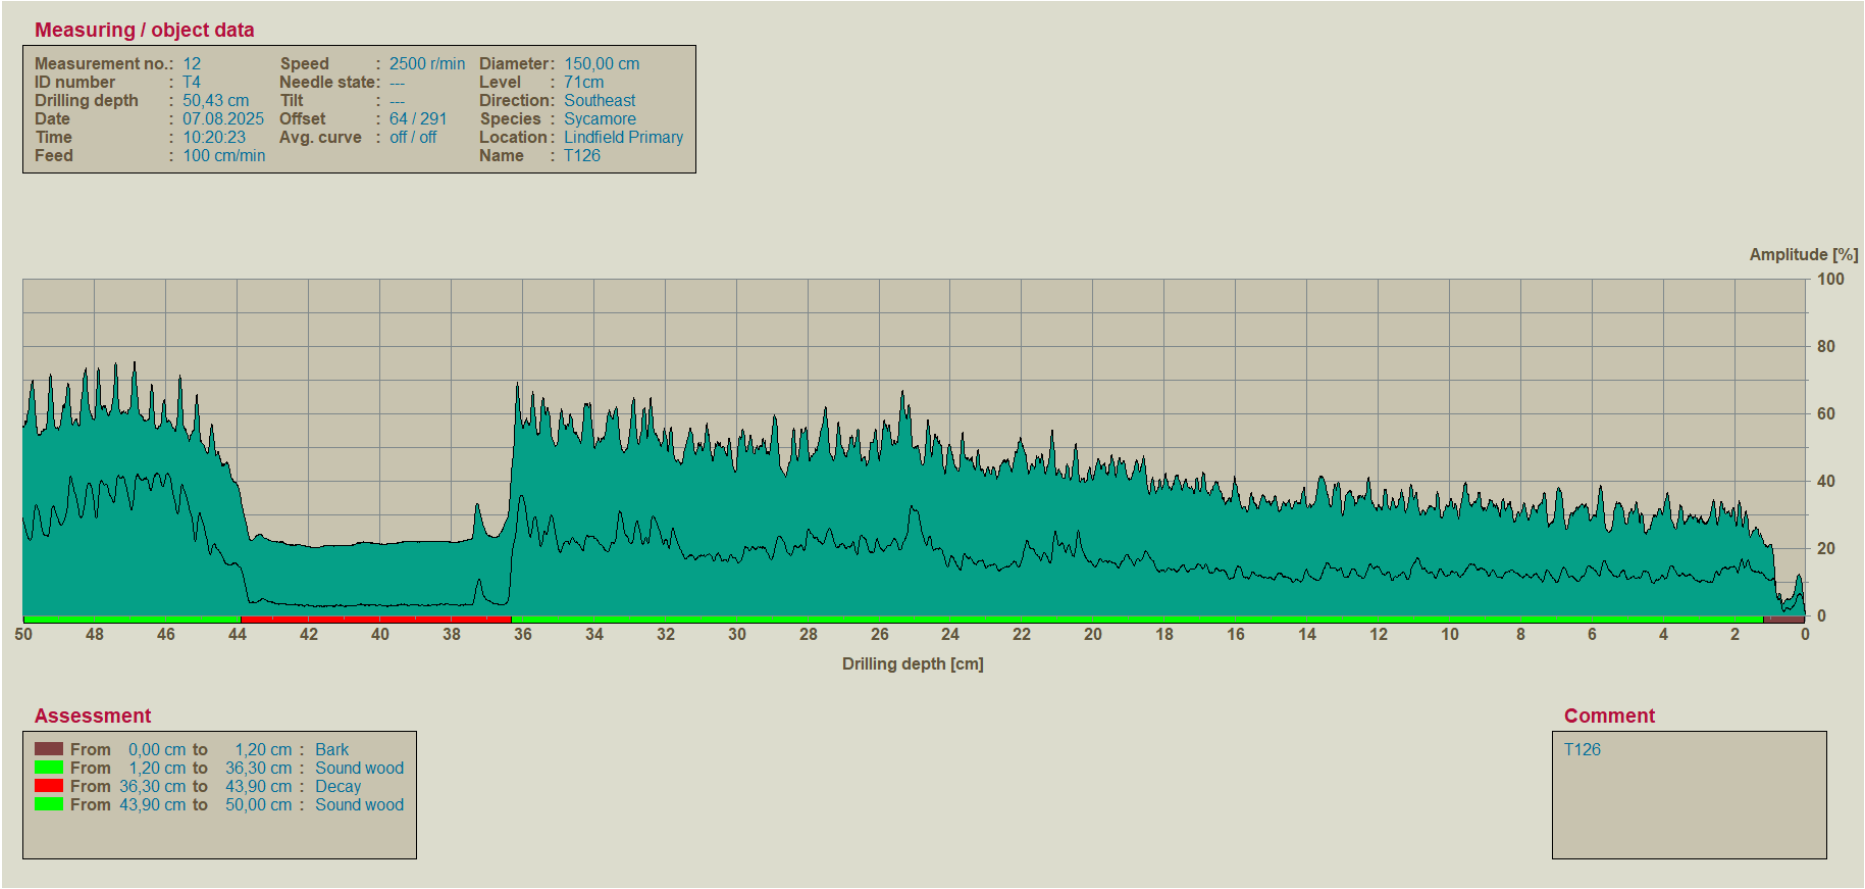
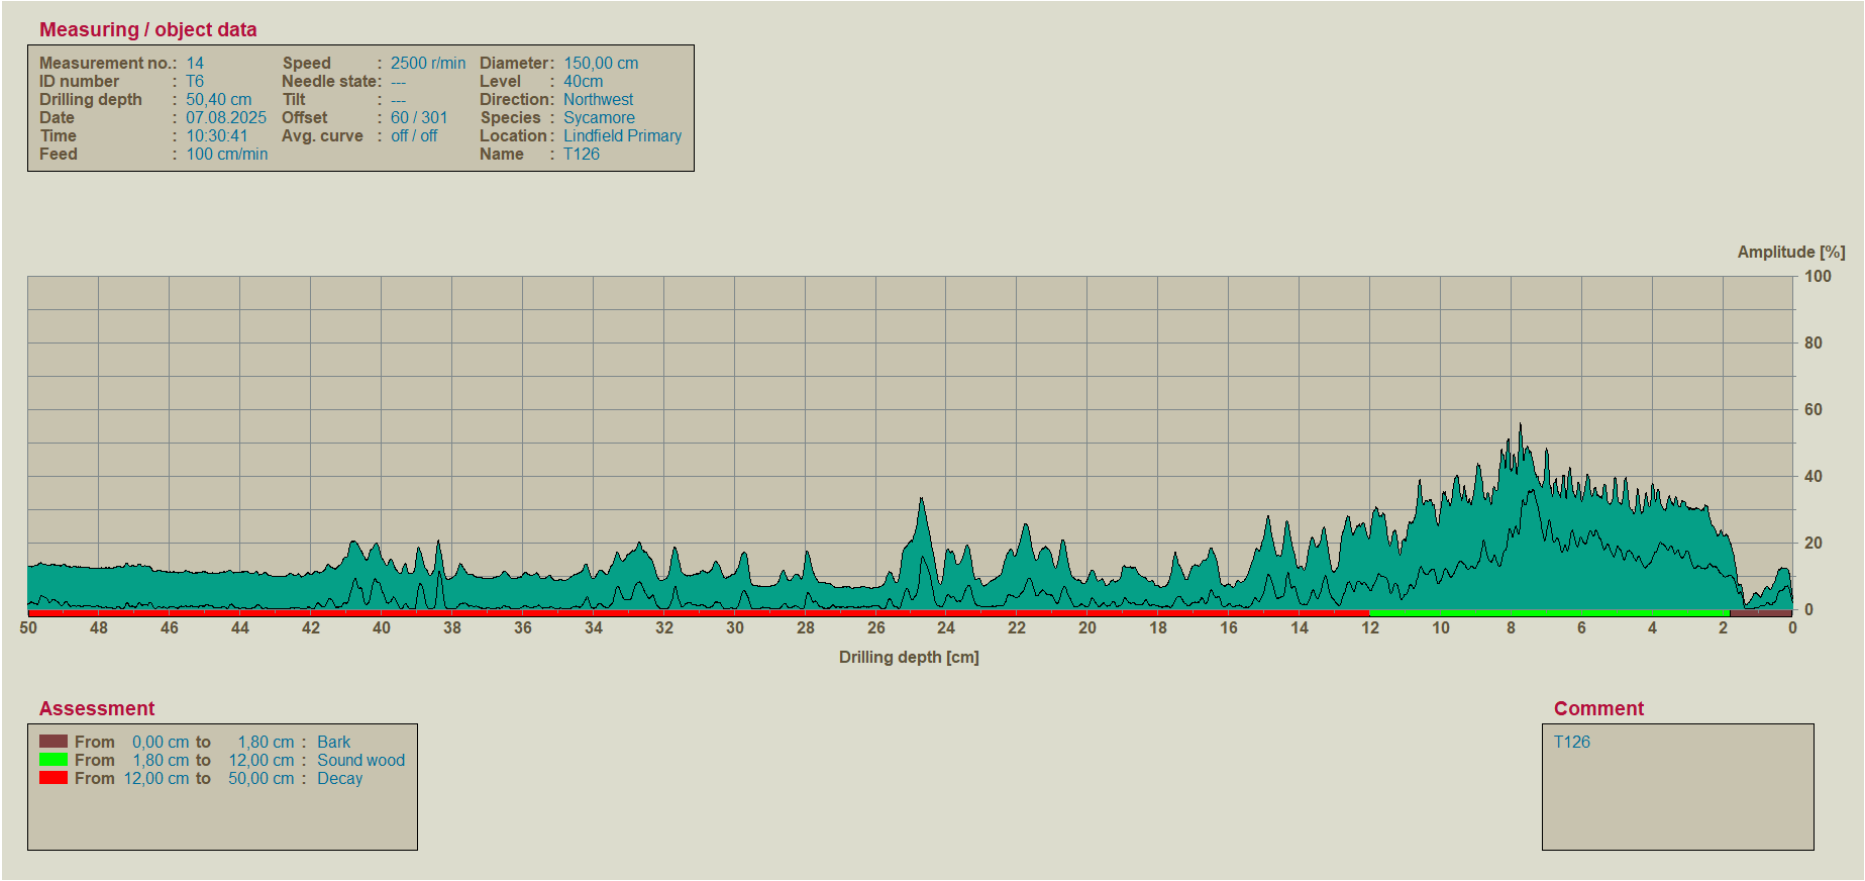
| Tree No.<br>Tree<br>Tag. | Tree<br>Species | Hgt<br>(m) | Past<br>Management | Age Class | Risk Target | TPO Status | Defects | Works | Work Priority |
|---|---|---|---|---|---|---|---|---|---|
| T126<br>Tree<br>tag: N/A | Sycamore | 5-<br>10m | Managed as<br>pollard. | Mature | High/<br>reinspect<br>July 2027 | No TPO in place<br>and Conservation<br>Area restrictions for<br>Mid Sussex District<br>Council (CA)<br><br>Botanical Name:<br>( <i>Acer<br/>pseudoplatanus</i> ) | Gross Defect Noted. Twin stemmed at<br>60cm above ground level. Fresh in<br>appearance and small fruiting bodies<br>of <i>Ganoderma spp.</i> located to North<br>and East side of stem at approx. 30cm<br>above ground level. When tapped to<br>those areas with sounding hammer,<br>was found to have slight hollow sound.<br>Historic pollard. | Re-pollard to previous pruning<br>points. | Urgent within<br>3 month. |

T126 Sycamore measurement 1

T126 Sycamore measurement 2

T126 Sycamore measurement 3

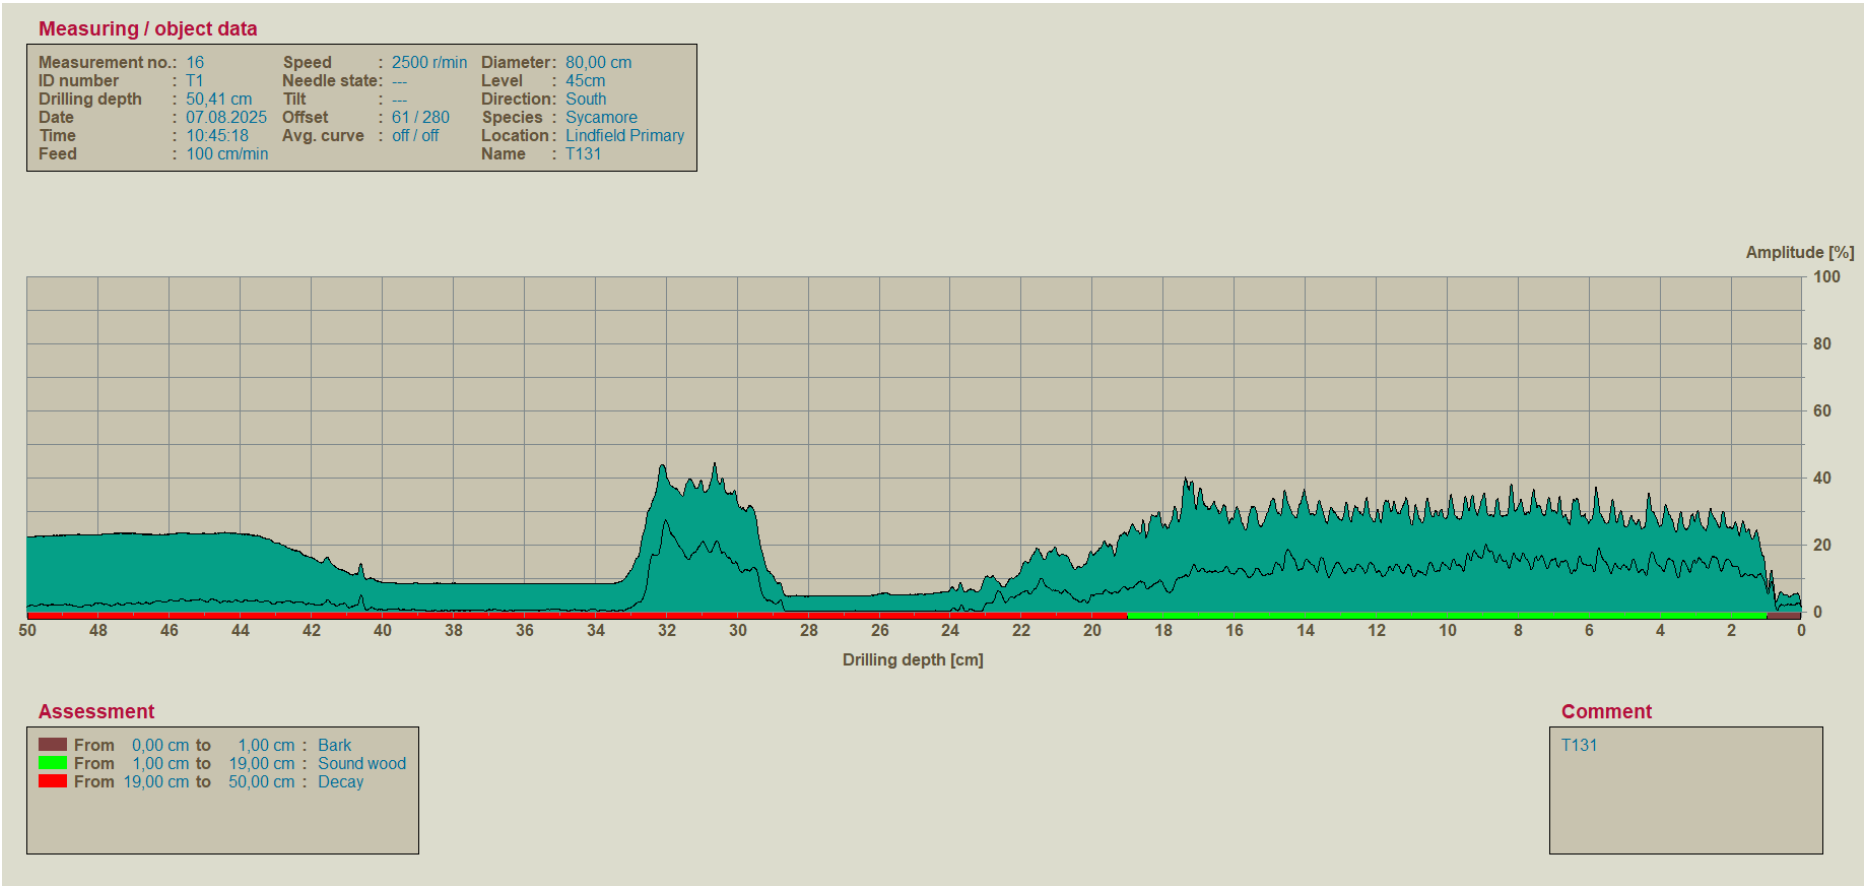
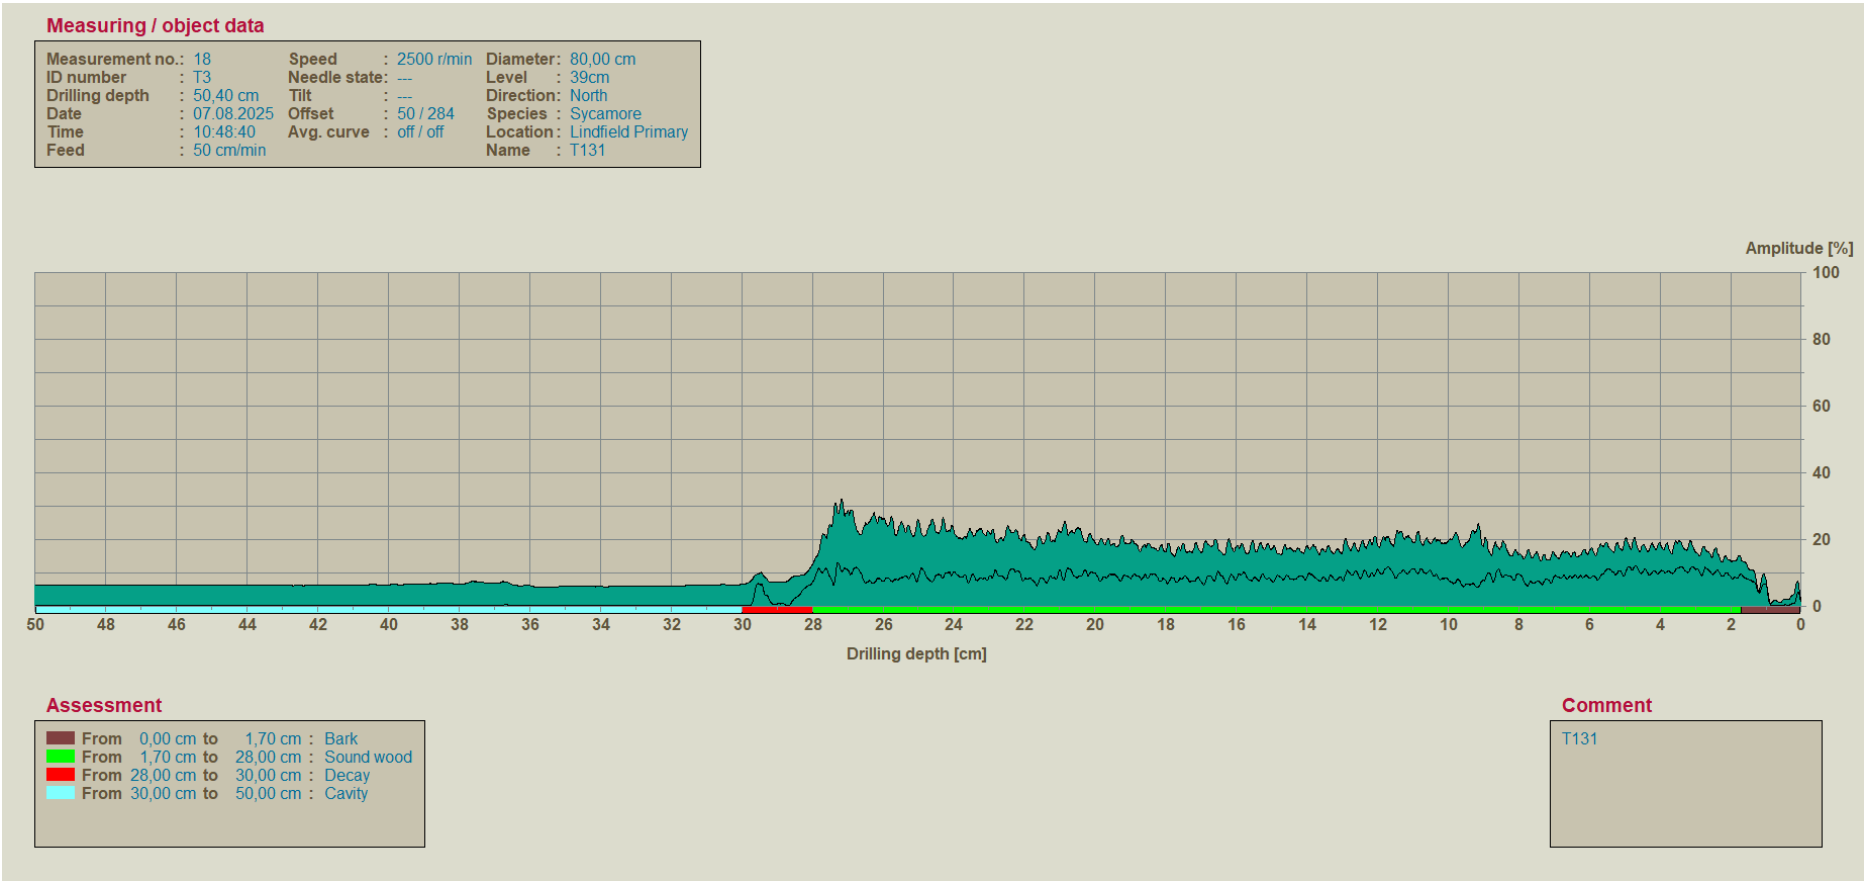
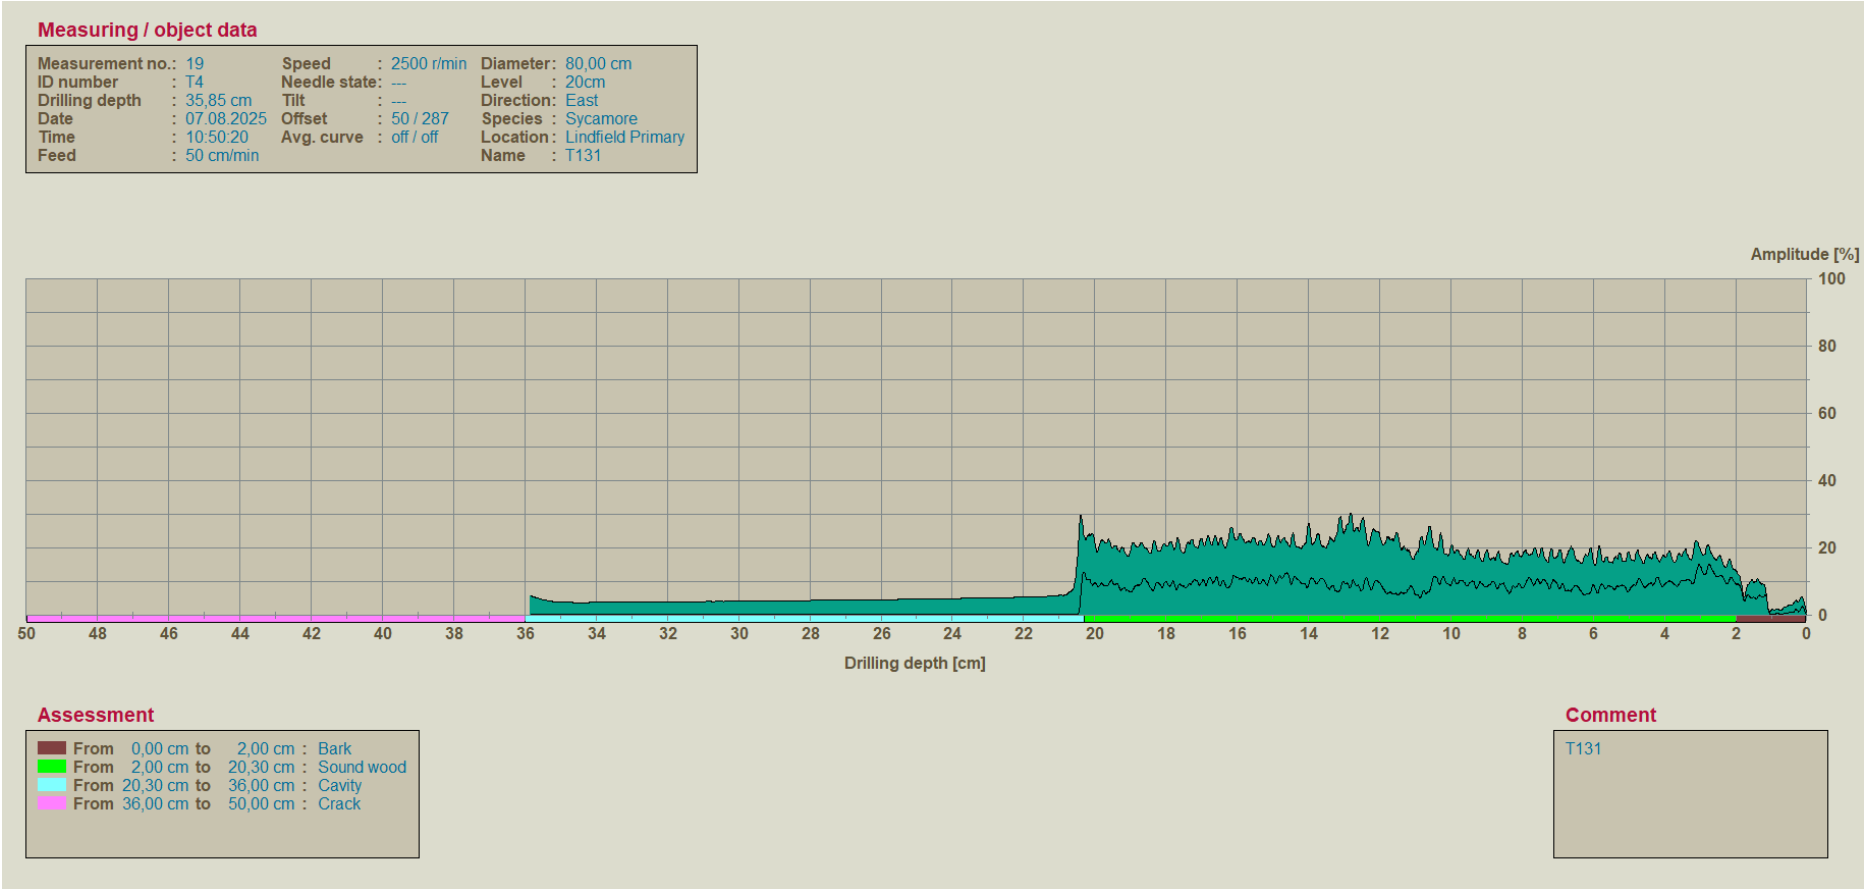
| Tree No.<br>Tree<br>Tag. | Tree<br>Species | Hgt<br>(m) | Past<br>Management | Age Class | Risk Target | TPO Status | Defects | Works | Work Priority |
|---|---|---|---|---|---|---|---|---|---|
| T131<br>Tree<br>tag: N/A | Sycamore | 15-<br>19m | Subject to<br>previous<br>pruning. | Mature | High/<br>reinspect<br>July 2027 | No TPO in place<br>and Conservation<br>Area restrictions for<br>Mid Sussex District<br>Council . (CA)<br><br>Botanical Name:<br>( <i>Acer<br/>pseudoplatanus</i> ) | Gross Defect Noted. Major cavity to<br>Southwest side at ground level. Ivy on<br>stem previously severed. Multiple<br>pruning wounds on stem. Asymmetric<br>canopy. | Fell to ground level. | Urgent within<br>3 month. |

T131 Sycamore measurement 1

T131 Sycamore measurement 2

T131 Sycamore measurement 3

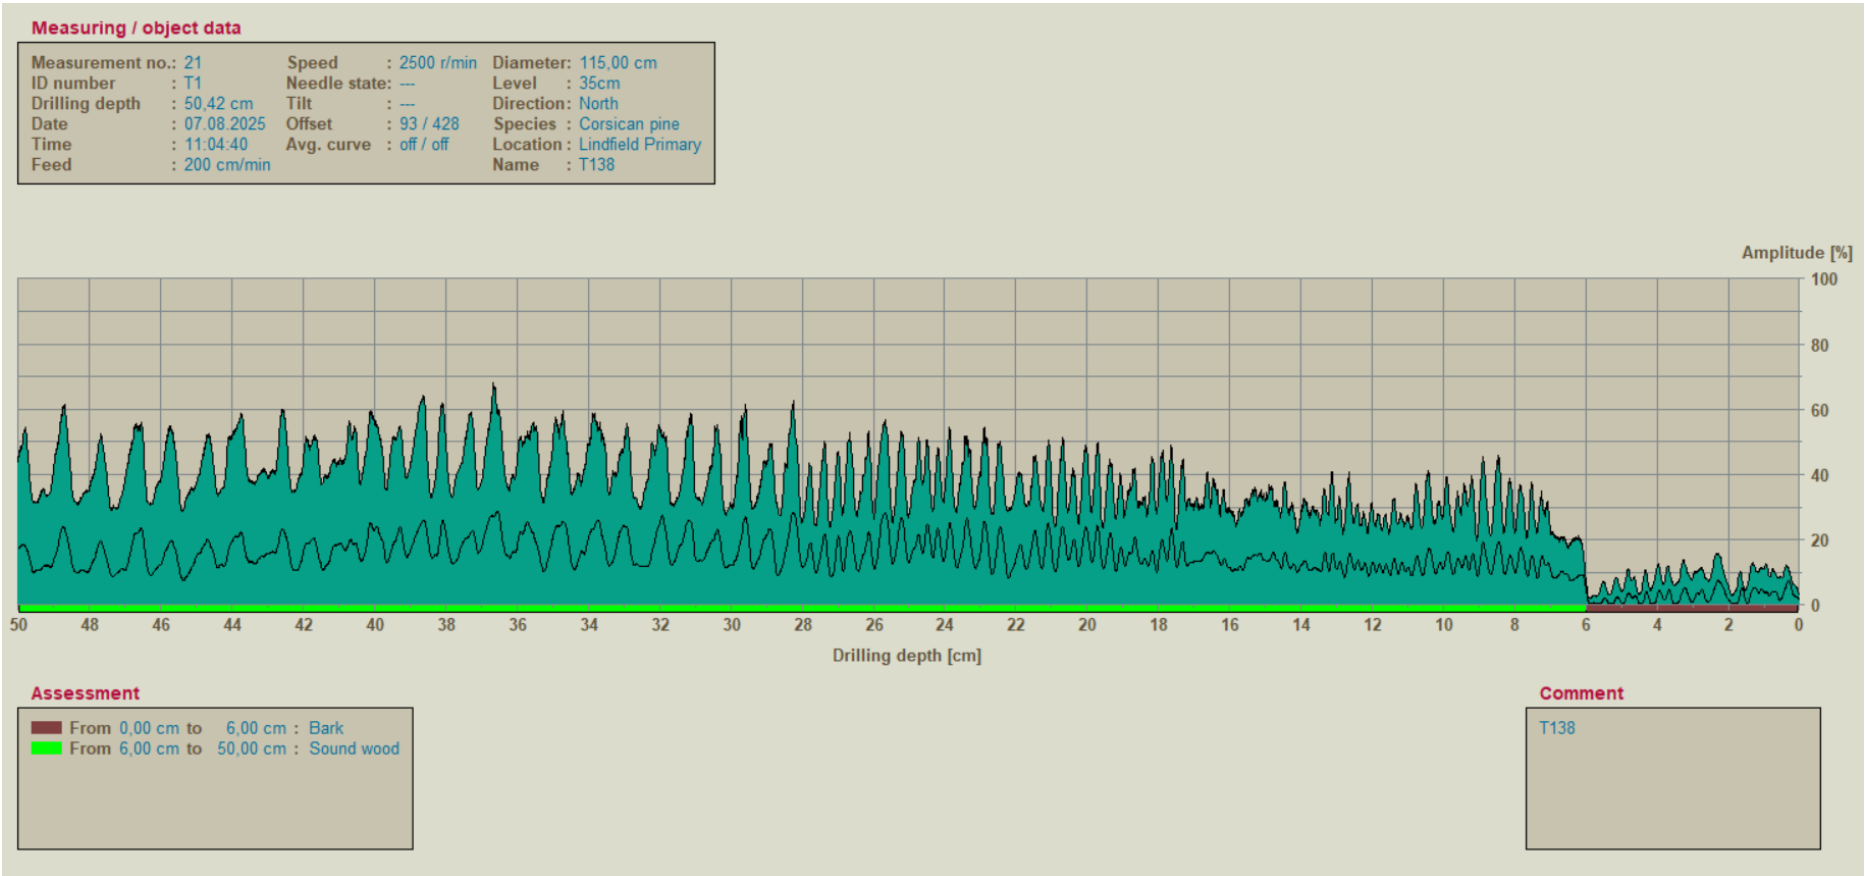
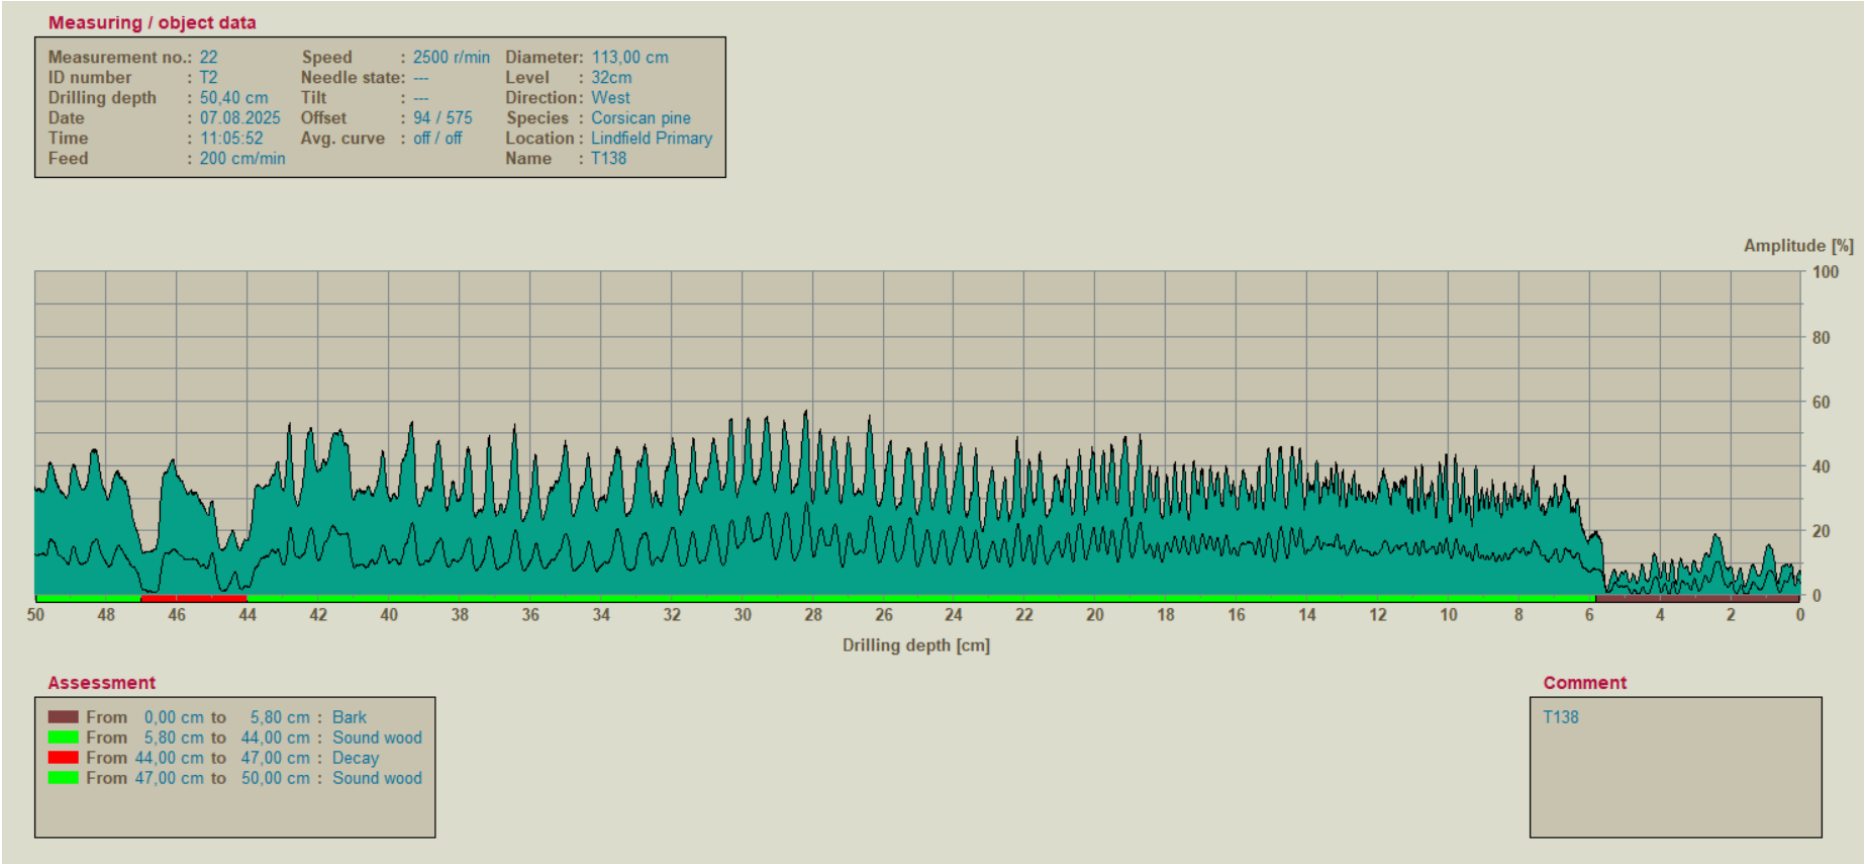
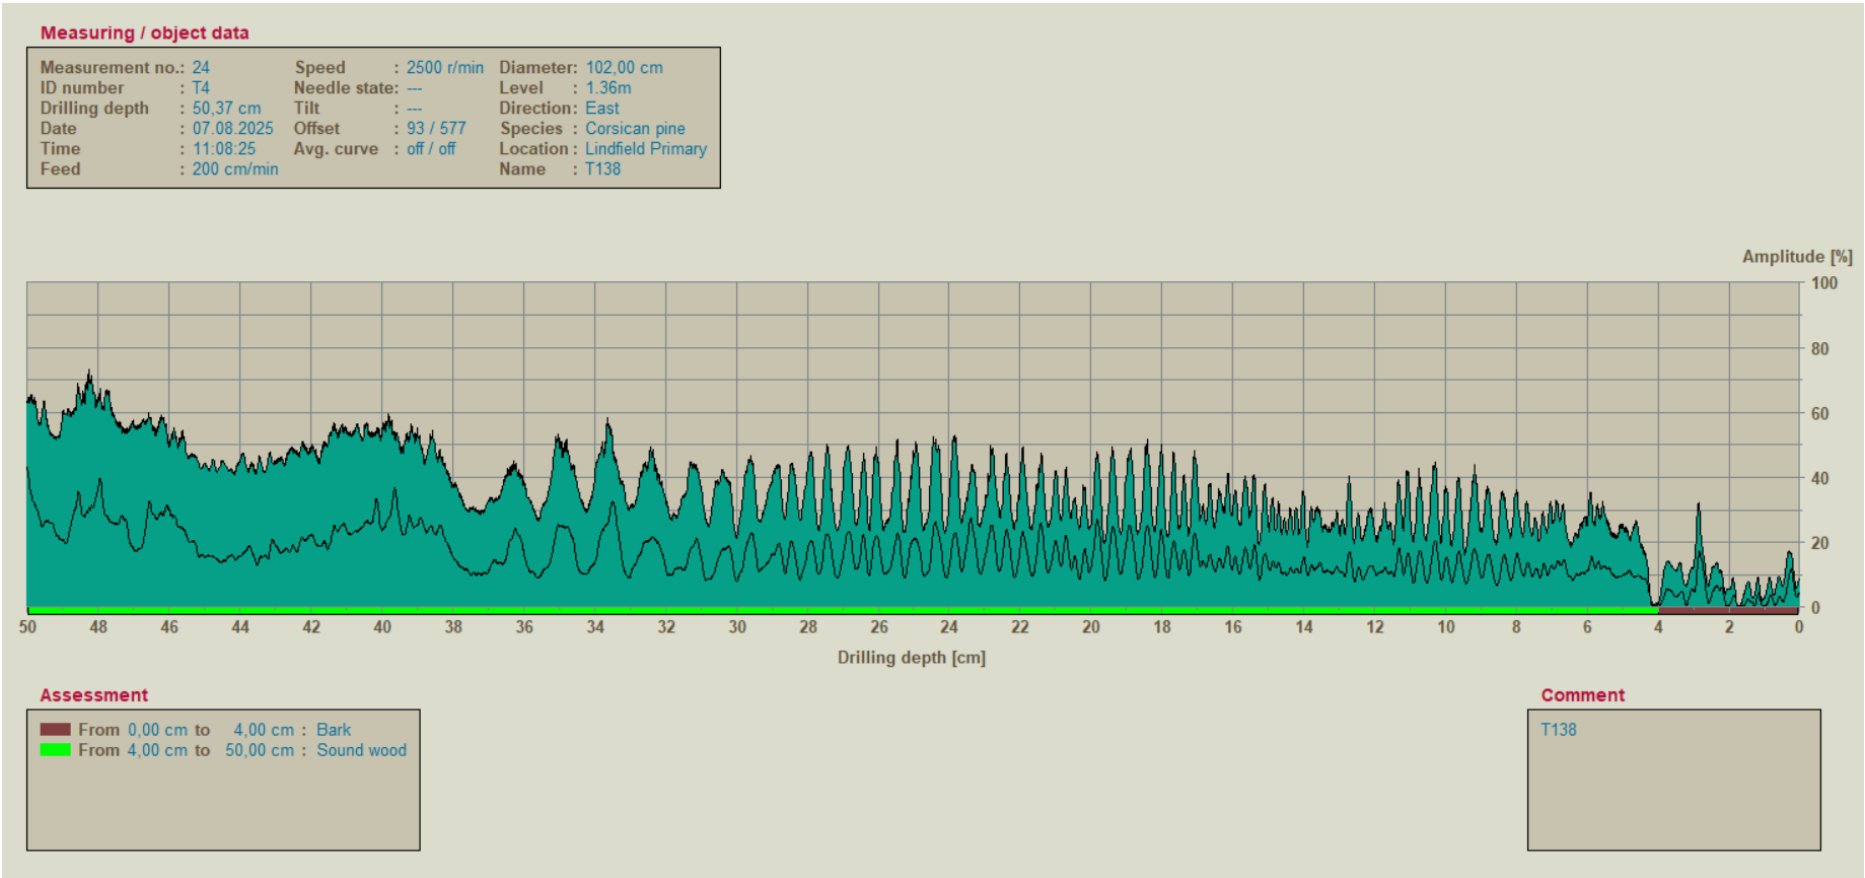
| Tree No.<br>Tree<br>Tag. | Tree<br>Species | Hgt<br>(m) | Past<br>Management | Age Class | Risk Target | TPO Status | Defects | Works | Work Priority |
|---|---|---|---|---|---|---|---|---|---|
| T138<br>Tree<br>tag: N/A | Corsican<br>pine | 20-<br>25m | Subject to<br>past<br>management | Mature | High/<br>reinspect<br>July 2027 | No TPO in place<br>and Conservation<br>Area restrictions for<br>Mid Sussex District<br>Council (CA)<br><br>Botanical Name:<br>( <i>Pinus nigra</i> ) | Hazardous Defect Noted, Fluting of<br>lower stem, Multiple pruning wounds<br>on stem. Cavity on stem at 6m above<br>ground level to Southeast side. Crown<br>dieback to 10-20%. Crown deadwood<br>present. | Removal of deadwood over<br>100mm throughout canopy.<br><br>Carry out climbing inspection for<br>cavity. Report back on outcome<br>of inspection. | Urgent within<br>3 months |

T138 Corsican pine measurement 1

T138 Corsican pine measurement 2

T138 Corsican pine measurement 3
