## **Resistograph Tree Report**

**Lindfield Primary Academy,  
Primary Academy, School Lane,  
Lindfield,  
Haywards Heath,  
RH16 2DX**

**Prepared by  
Richard Daubeney Our Ref 0825-RD  
12th August 2025**

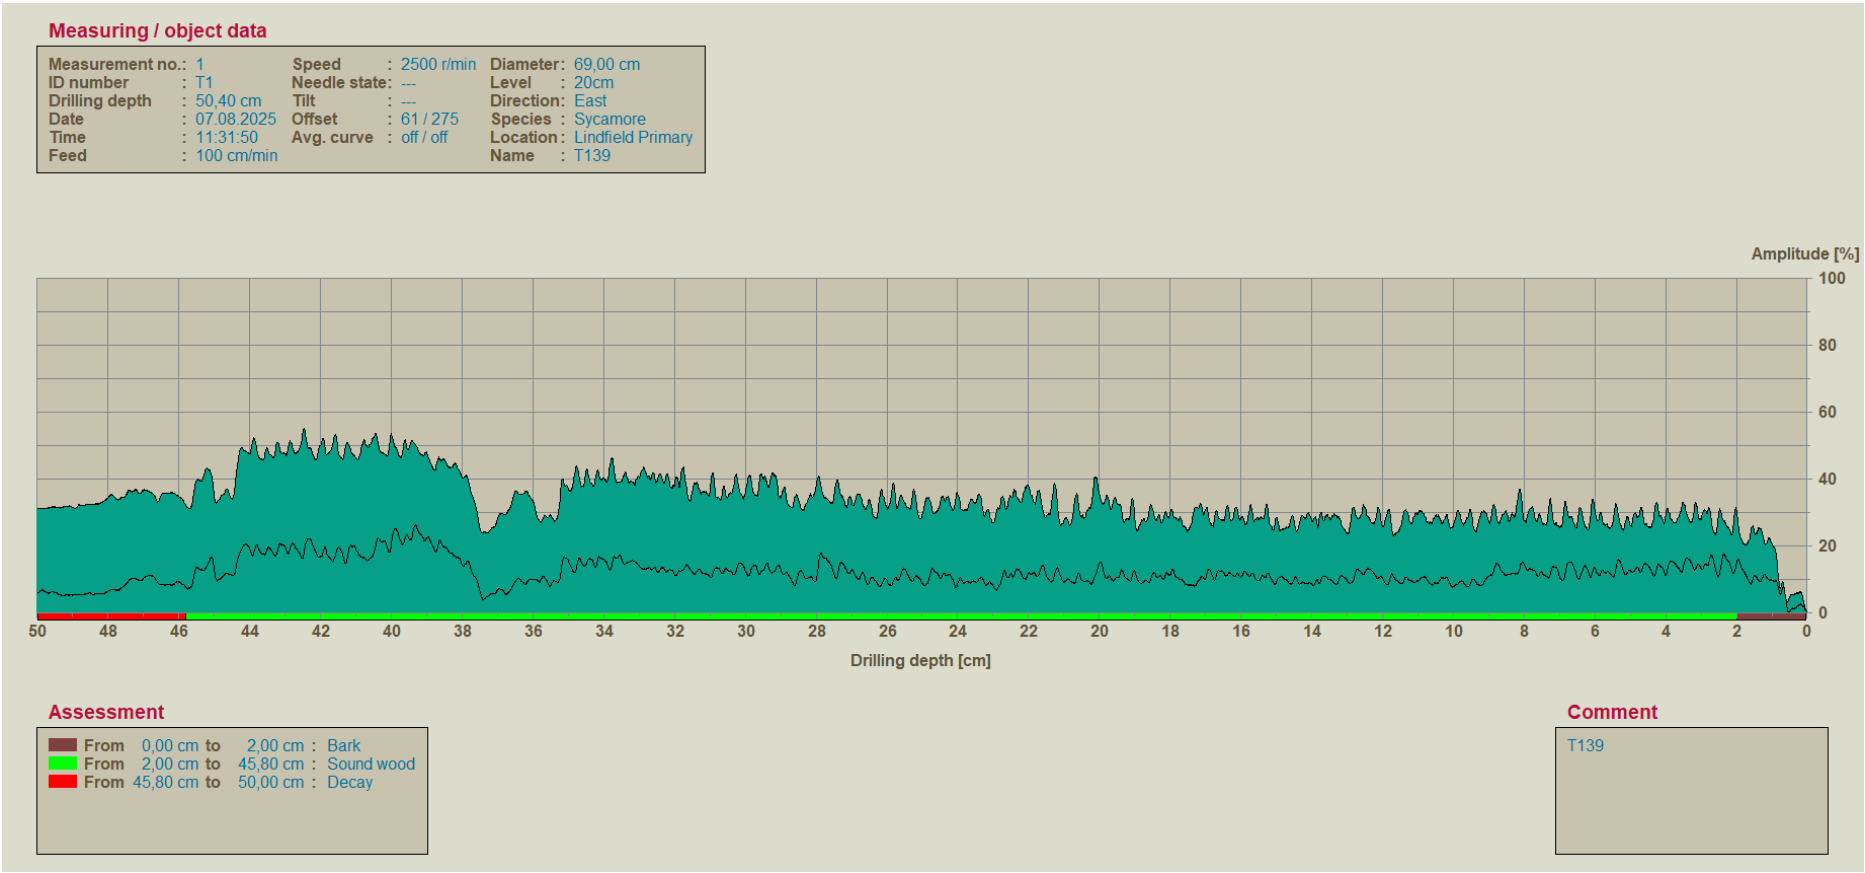
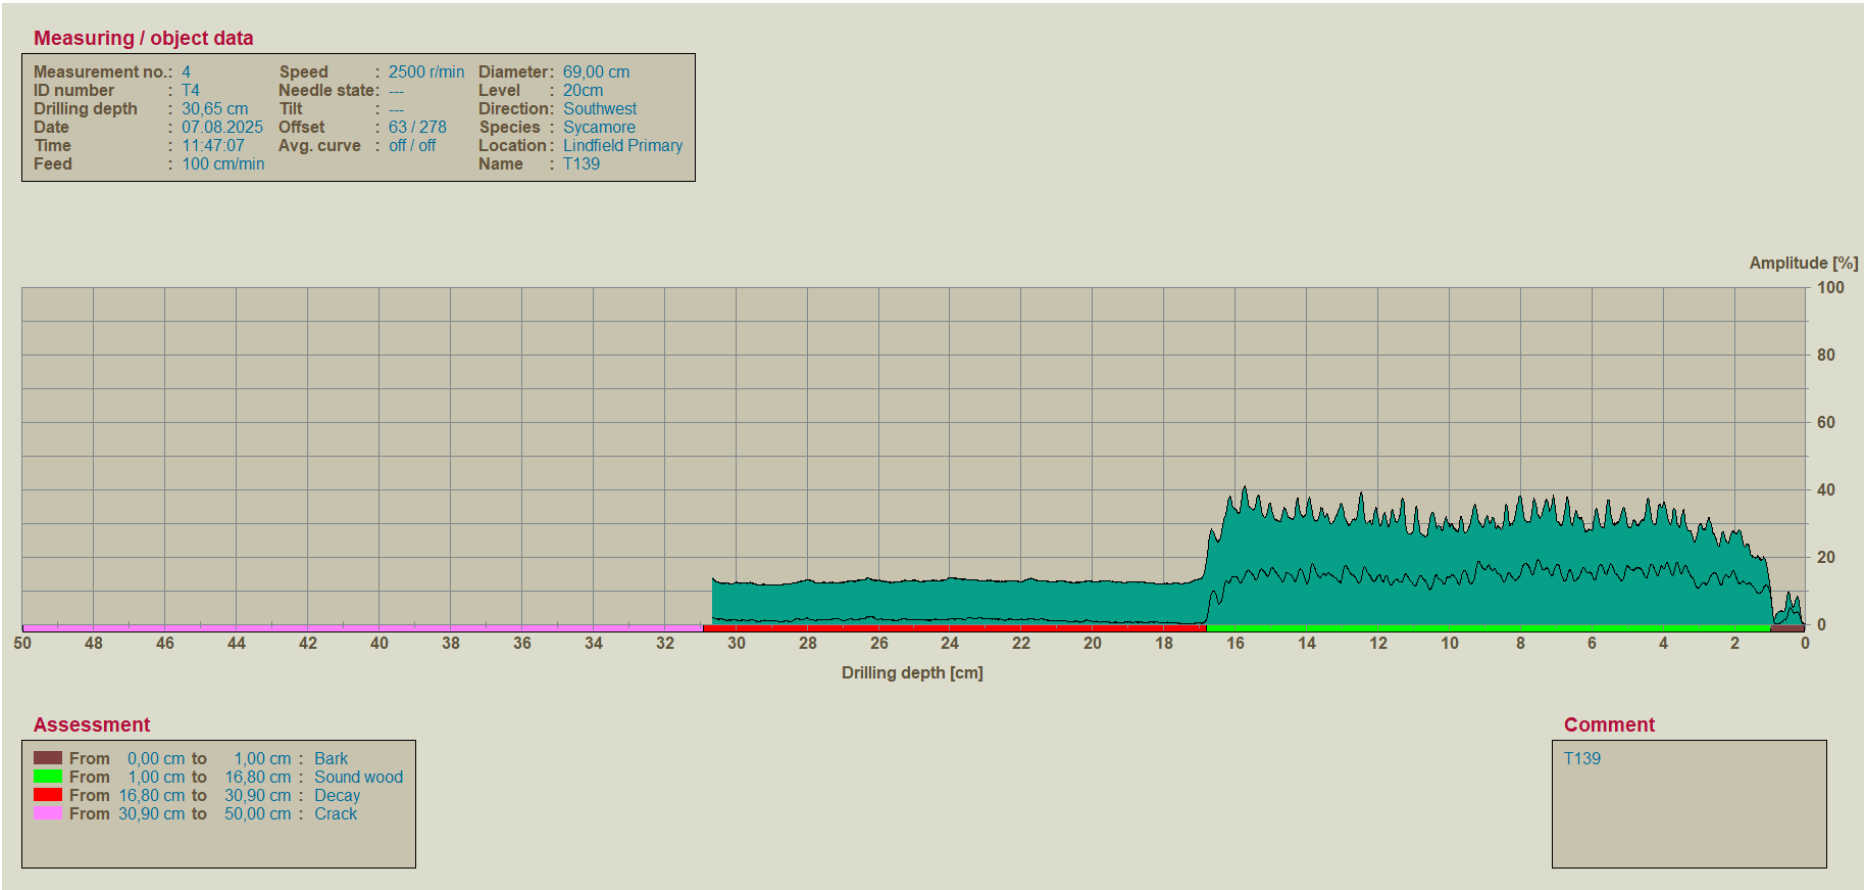
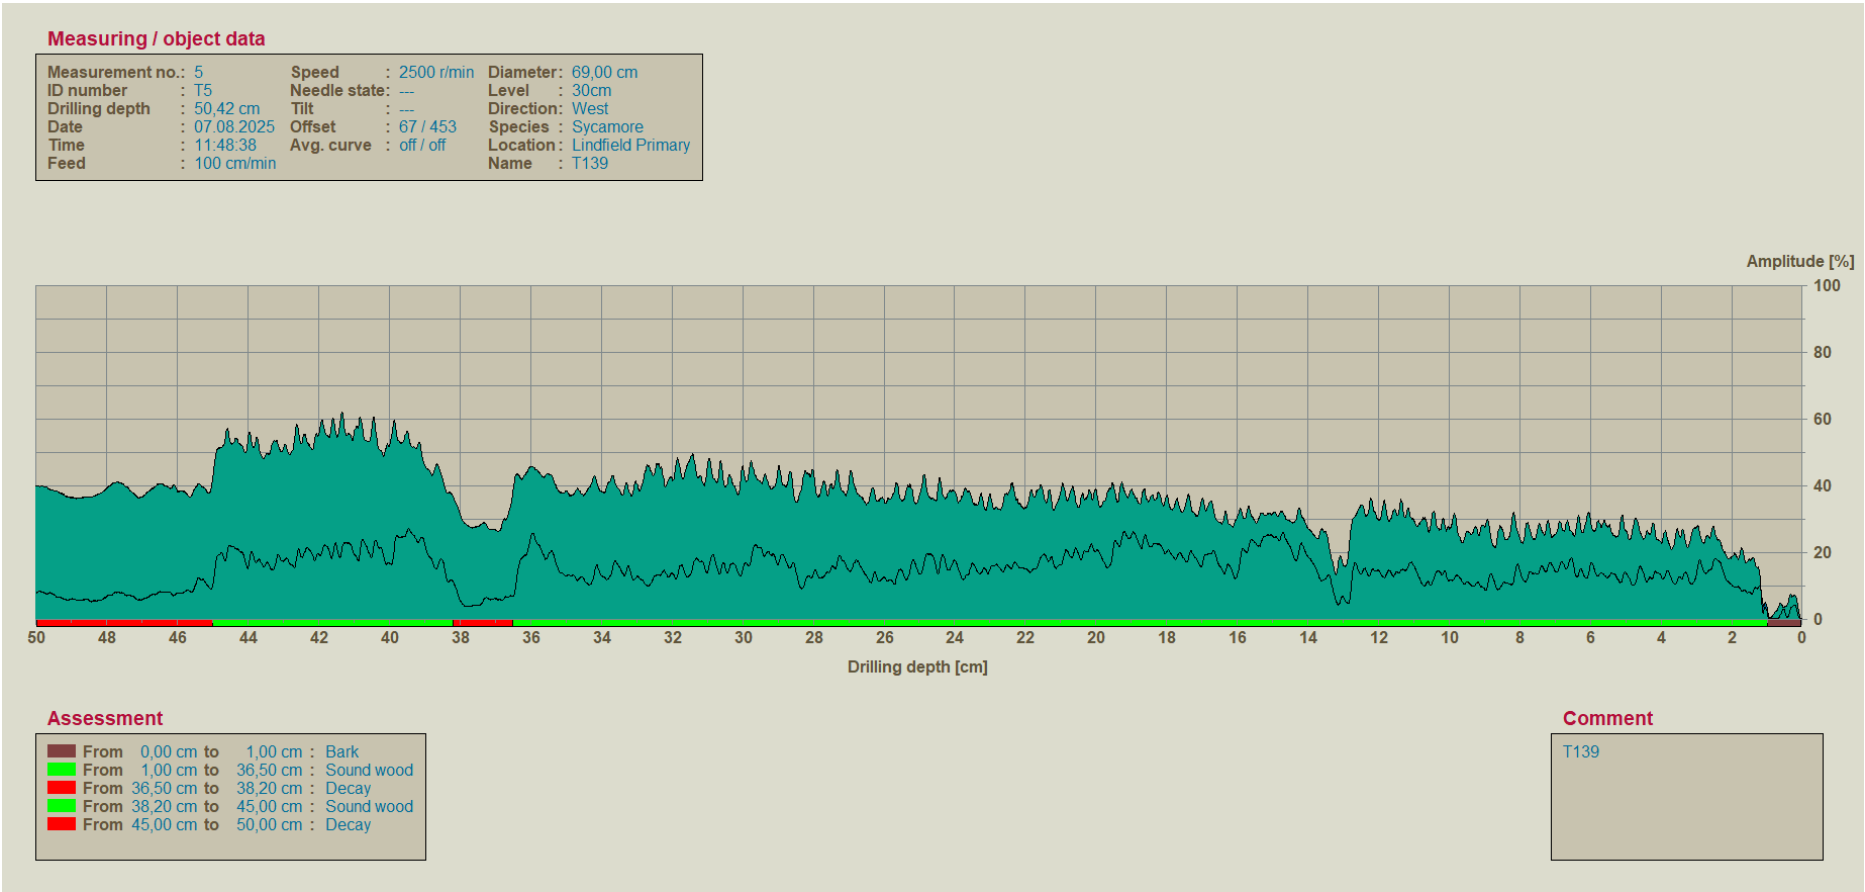
| Tree No.<br>Tree<br>Tag. | Tree<br>Species | Hgt<br>(m) | Past<br>Management | Age Class | Risk Target | TPO Status | Defects | Works | Work Priority |
|---|---|---|---|---|---|---|---|---|---|
| T139<br>Tree<br>tag: N/A | Sycamore | 15-<br>19m | Subject to<br>past<br>management | Mature | High/<br>reinspect<br>July 2027 | No TPO in place<br>and Conservation<br>Area restrictions for<br>Mid Sussex District<br>Council. (CA)<br><br>Botanical Name:<br>( <i>Acer<br/>pseudoplatanus</i> ) | Gross Defect Noted. Stem growing into<br>boundary wire mesh fencing. Slight<br>hollow sound when tapped to the<br>Southeast side of stem. Decayed<br>branch to the West side at 5m above<br>ground level. Poor shape and form.<br>Tree of this size is not suited for this<br>location. | Fell to ground level. | High within 6<br>months. |

T139 Sycamore measurement 1

T139 Sycamore measurement 2

T139 Sycamore measurement 3

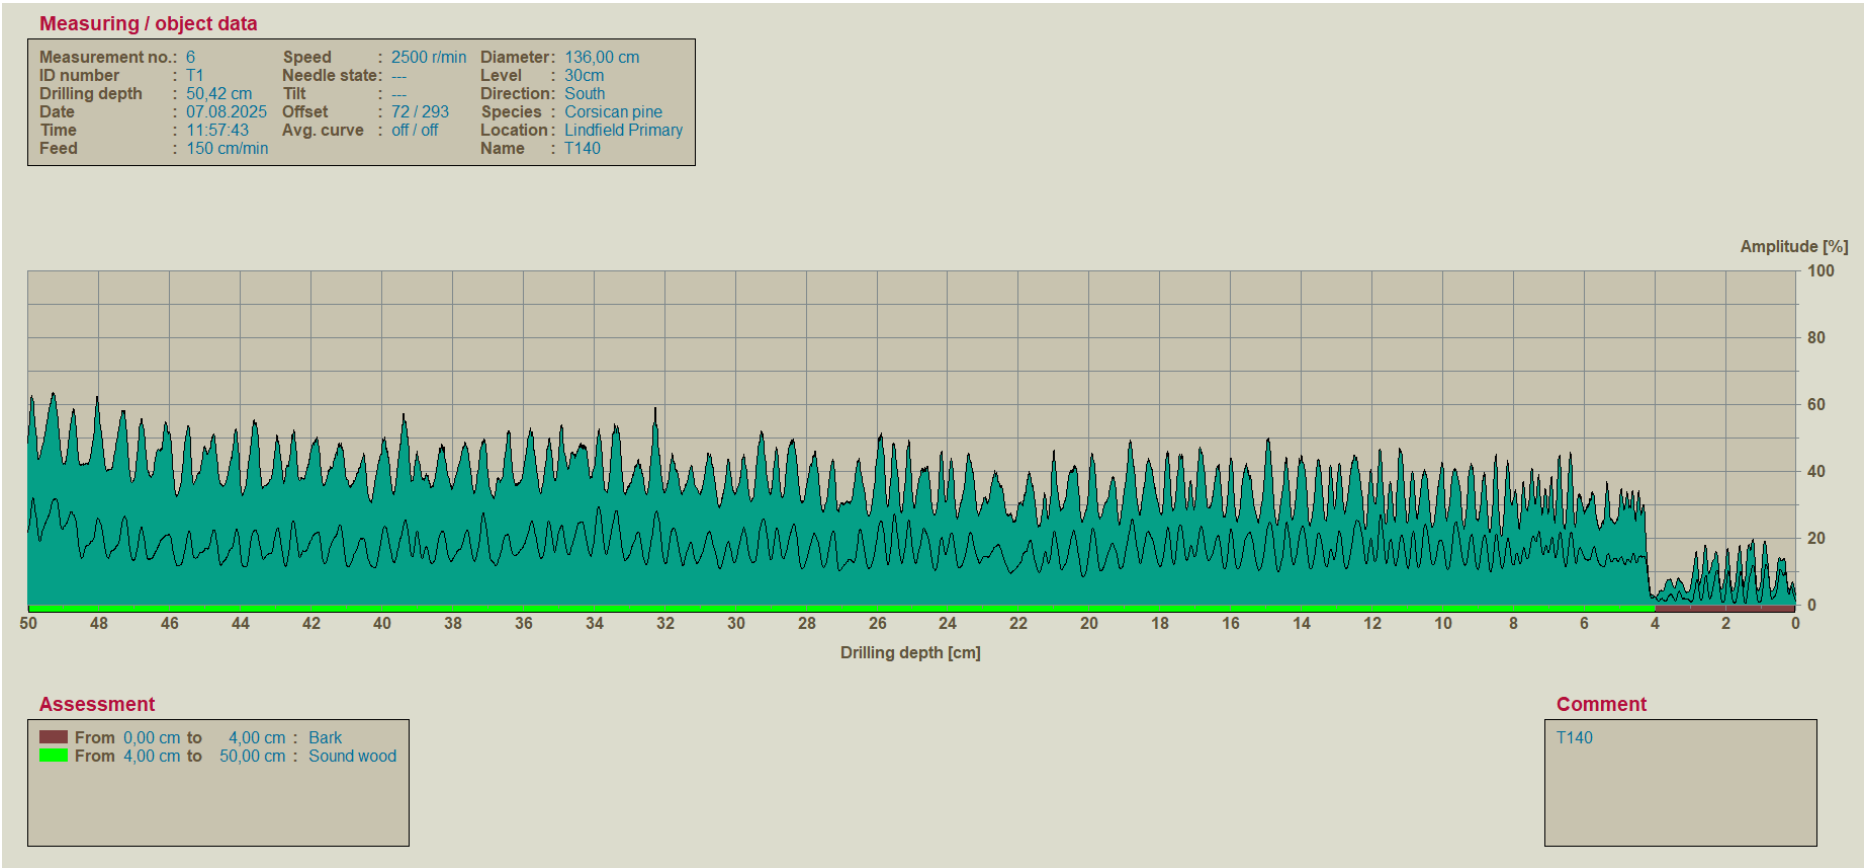
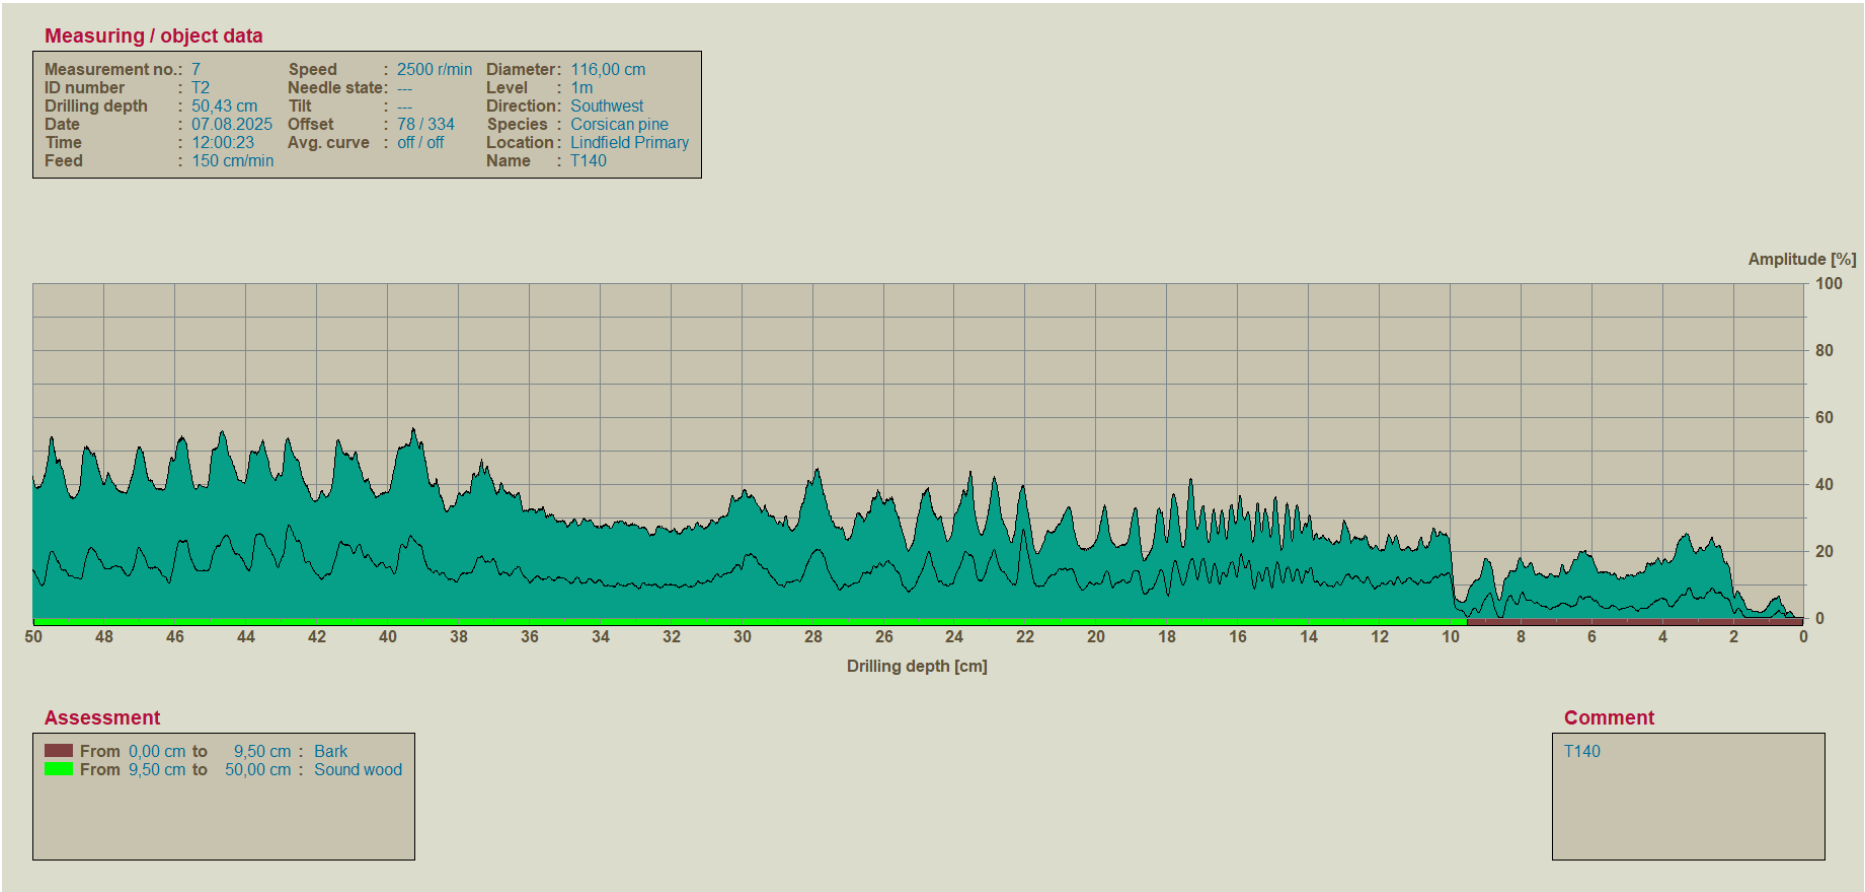
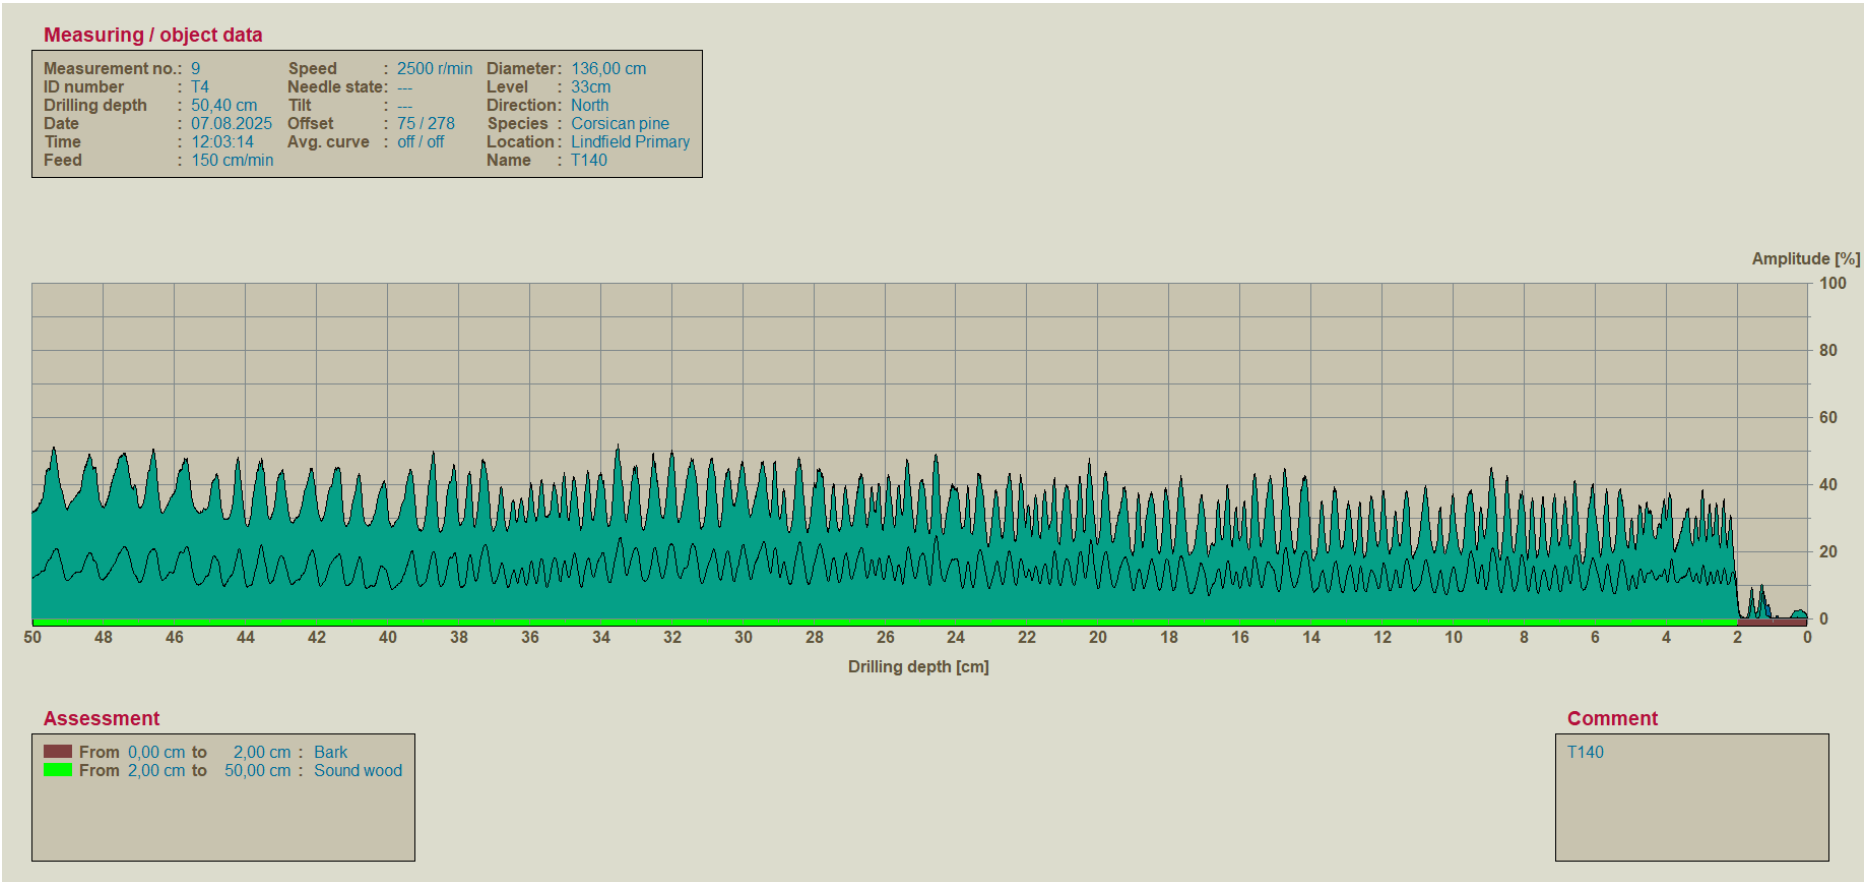
| Tree No.<br>Tree<br>Tag. | Tree<br>Species | Hgt<br>(m) | Past<br>Management | Age Class | Risk Target | TPO Status | Defects | Works | Work Priority |
|---|---|---|---|---|---|---|---|---|---|
| T140<br>Tree<br>tag: N/A | Corsican<br>pine | 20-<br>25m | Subject to<br>past<br>management | Mature | High/<br>reinspect<br>July 2027 | No TPO in place<br>and Conservation<br>Area restrictions for<br>Mid Sussex District<br>Council (CA)<br><br>Botanical Name:<br>( <i>Pinus nigra</i> ) | No gross Defect Noted. Fluting to<br>lower stem, with pockets of soft wood<br>between buttress roots. Multiple<br>pruning wounds on stem. Deadwood<br>present within canopy. | Climbing inspection throughout<br>canopy. Report back on outcome<br>of inspection.<br><br>Removal of deadwood over<br>100mm throughout canopy. | Urgent within<br>3 months |

T140 Corsican pine measurement 1

T140 Corsican pine measurement 2

T140 Corsican pine measurement 3

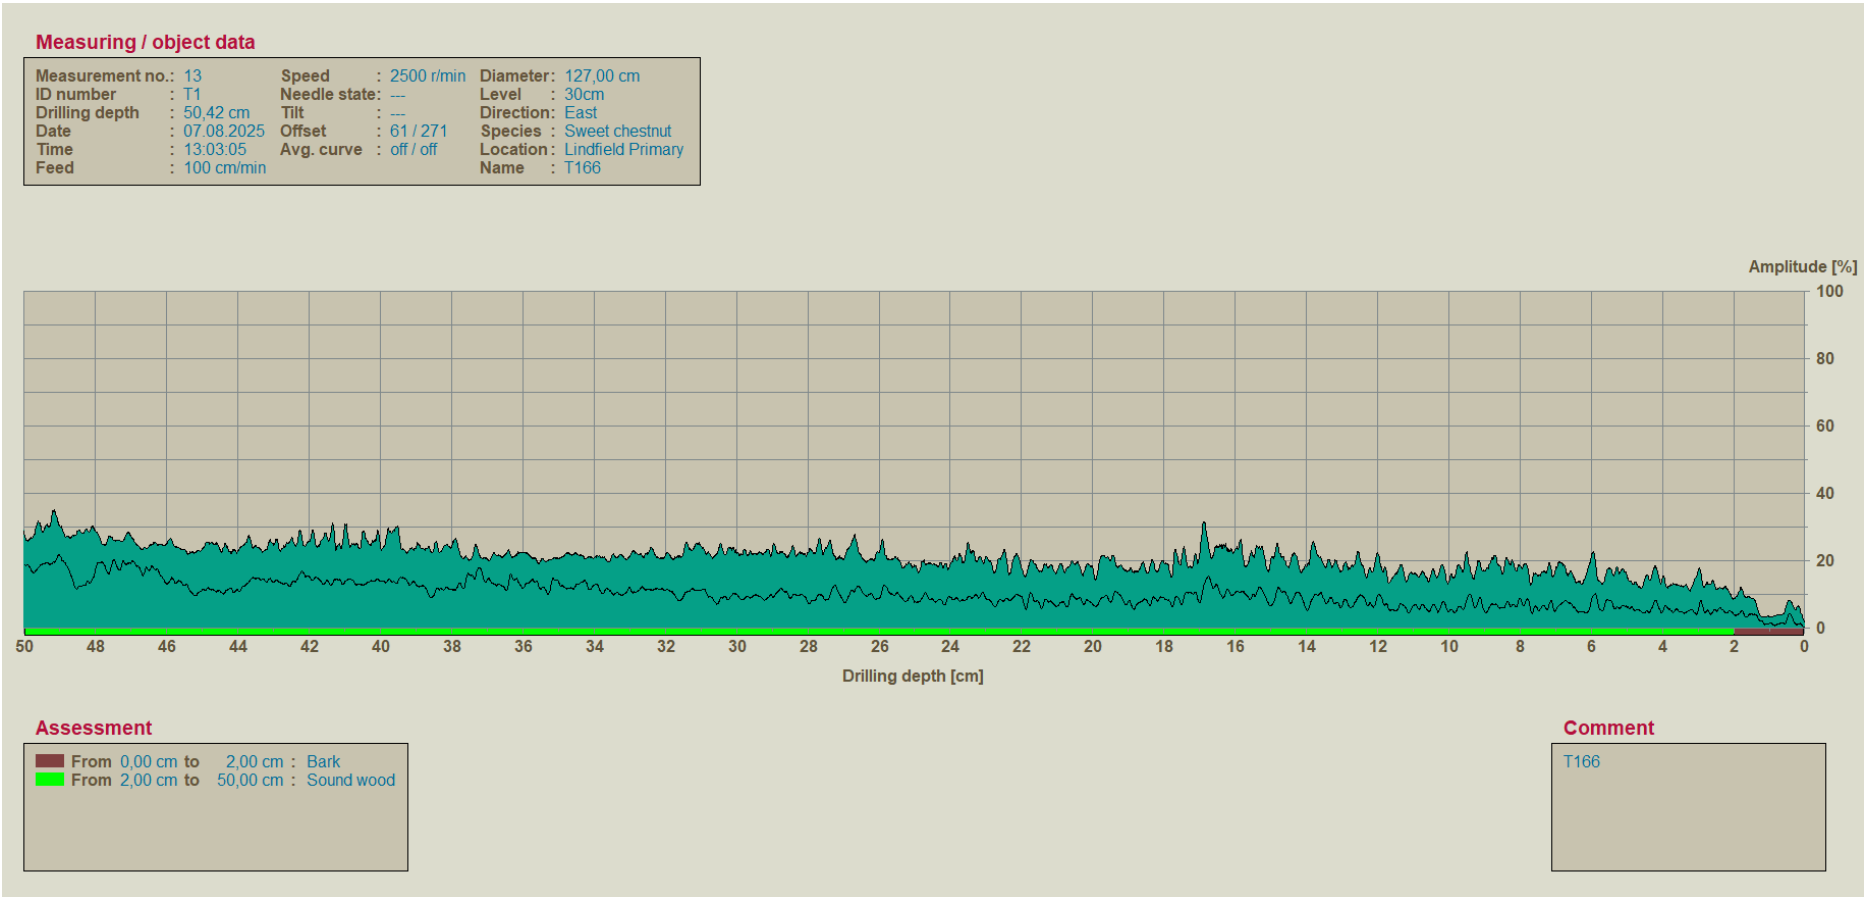
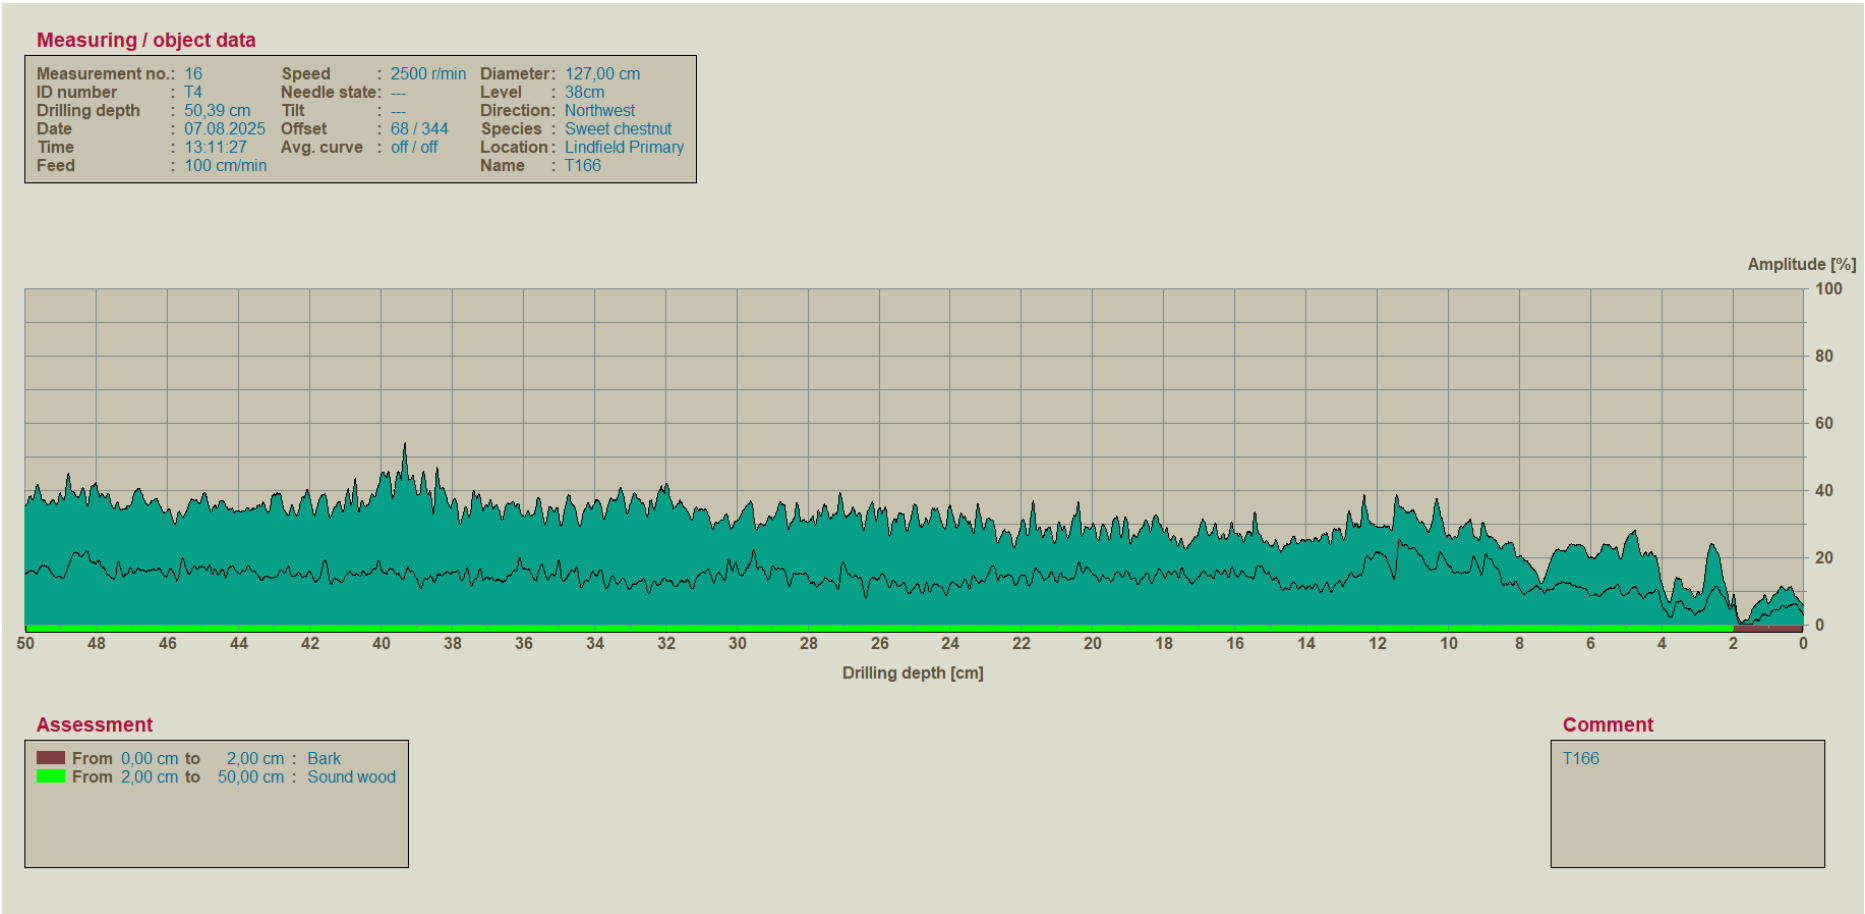
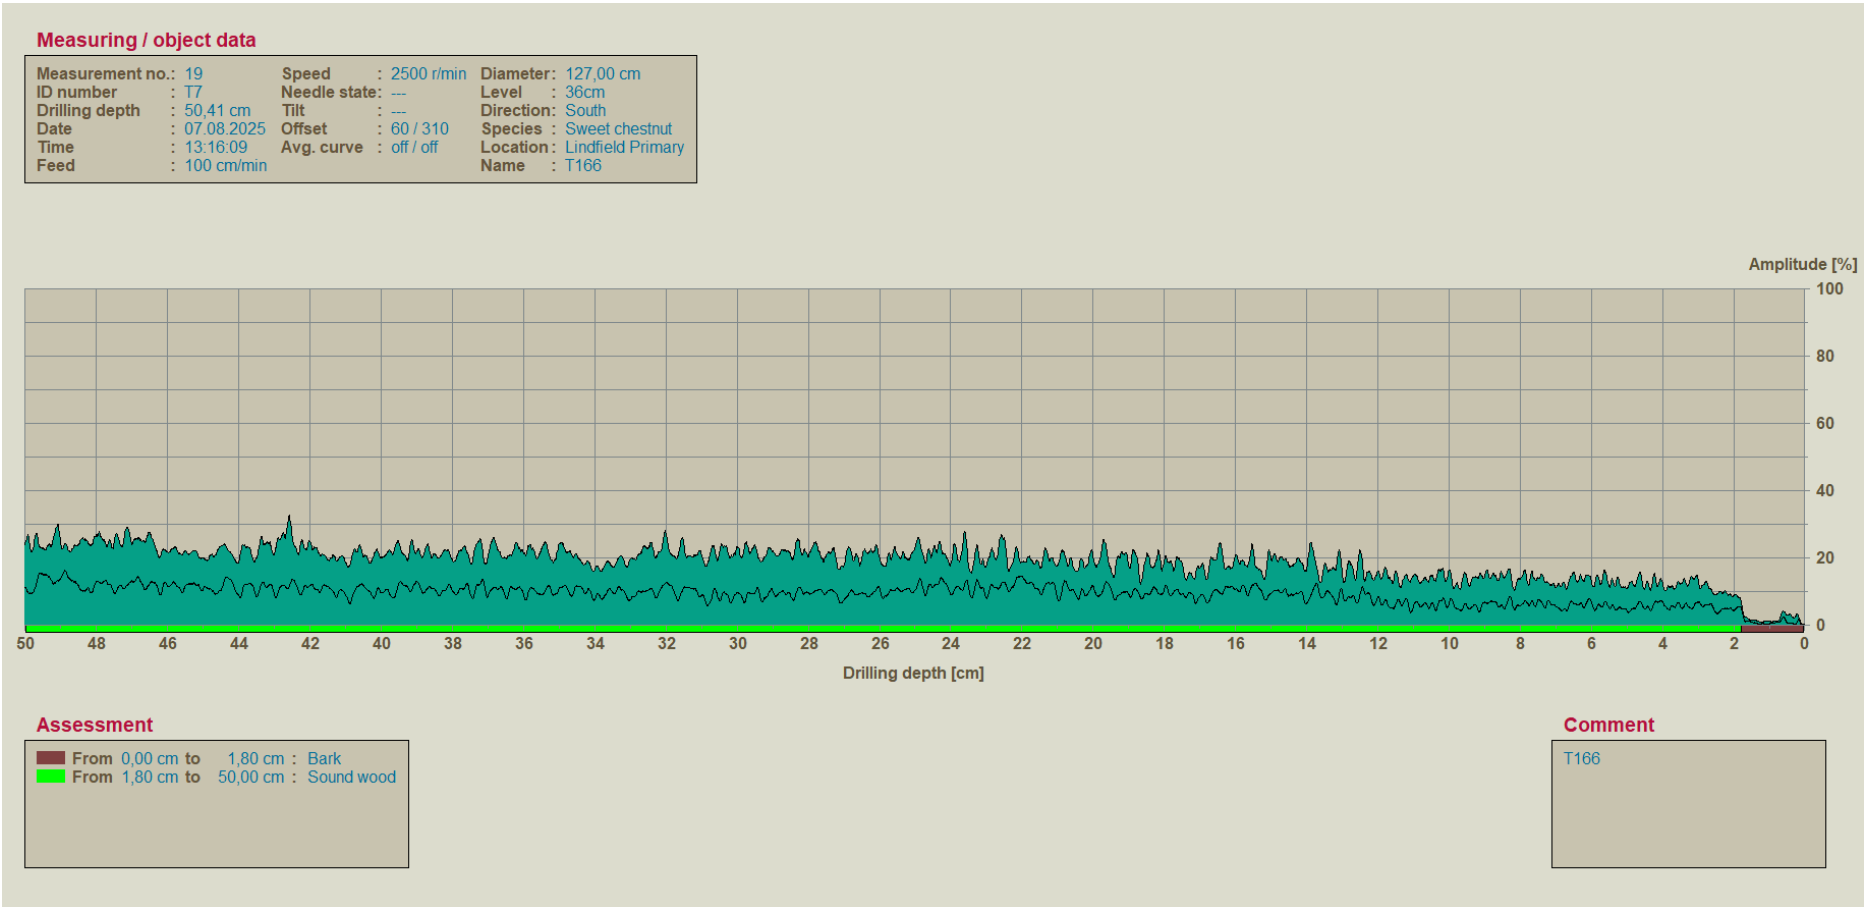
| Tree No.<br>Tree<br>Tag. | Tree<br>Species | Hgt<br>(m) | Past<br>Management | Age Class | Risk Target | TPO Status | Defects | Works | Work Priority |
|---|---|---|---|---|---|---|---|---|---|
| T166<br>Tree<br>tag: N/A | Sweet<br>chestnut | 20-<br>25m | Subject to<br>recent<br>deadwood<br>removal. | Mature | High/<br>reinspect<br>July 2027 | No TPO in place<br>and Conservation<br>Area restrictions for<br>Mid Sussex District<br>Council. (CA)<br><br>Botanical Name:<br>( <i>Castanea sativa</i> ) | No Gross Defect Noted.<br>Basal cavity to the East side, when<br>probed with probing tool, was found<br>to have depth of approx. 20-30cm,<br>with exposed heartwood, but not<br>significant at this time. Deadwood<br>within canopy recently removed.<br>Canopy inspection from ground level<br>restricted by neighbouring tree<br>growth. Crown weighted towards the<br>West due to tree group pressure from<br>South and North sides. | Climbing inspection throughout<br>canopy. Report back on outcome<br>of inspection. | Urgent within<br>3 month. |

T166 Sweet chestnut measurement 1

T166 Sweet chestnut measurement 2

T166 Sweet chestnut measurement 3

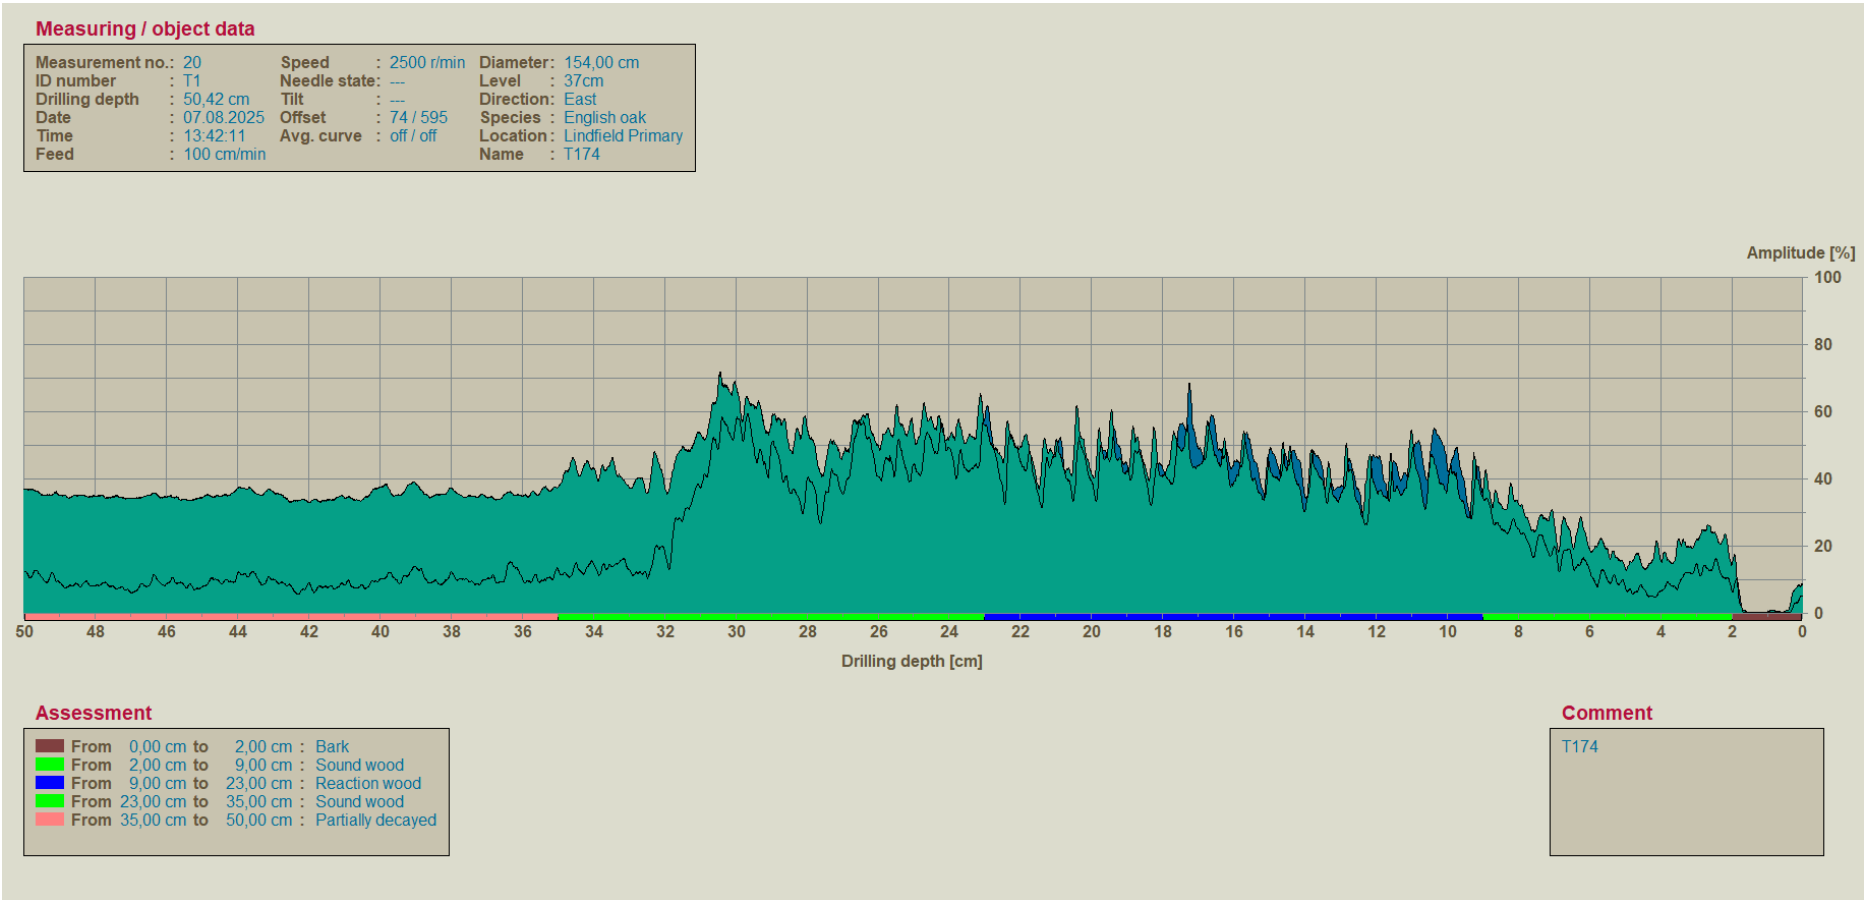
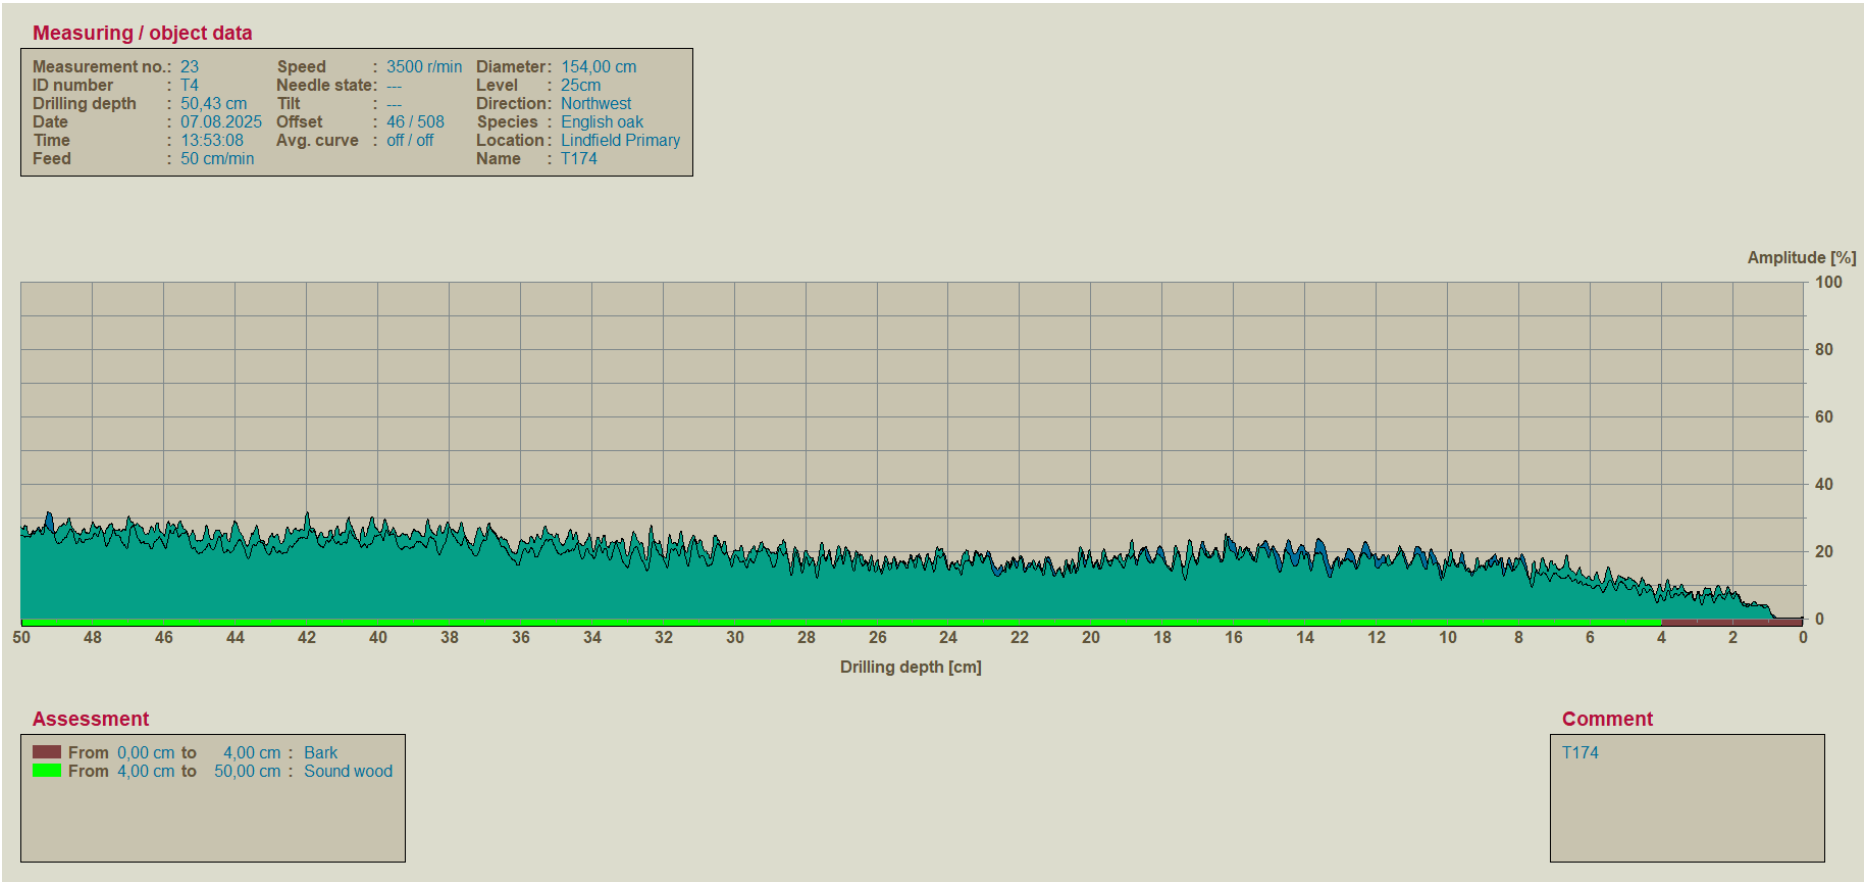
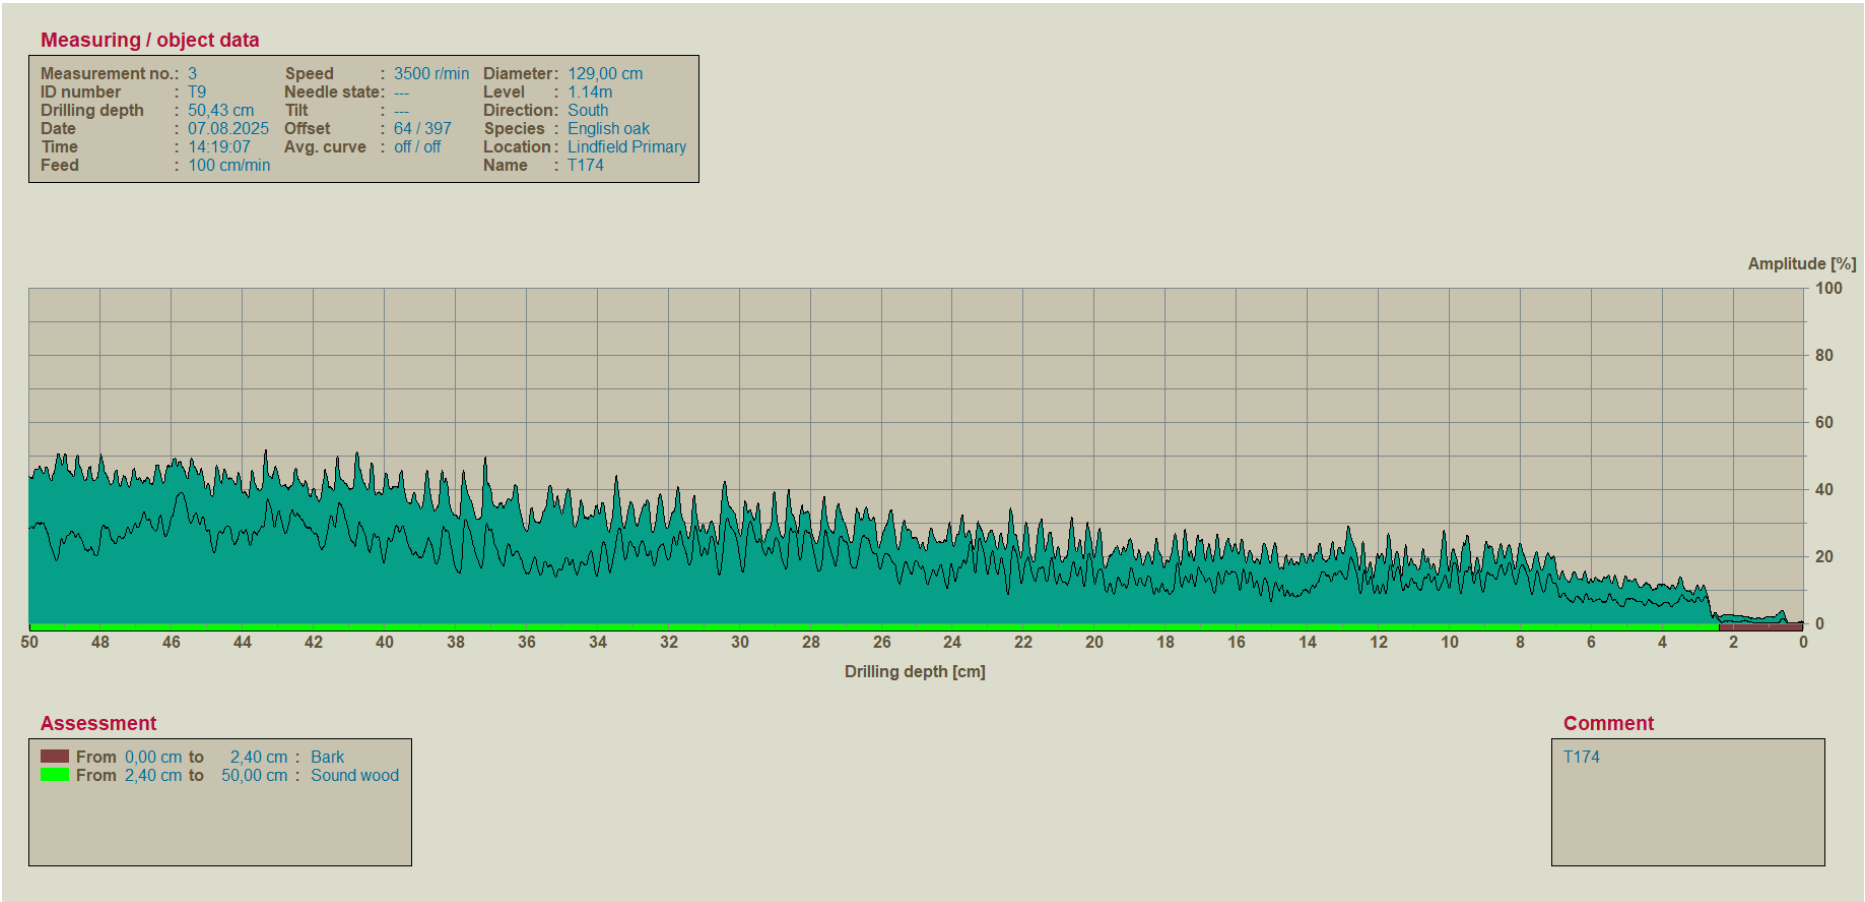
| Tree No.<br>Tree<br>Tag. | Tree<br>Species | Hgt<br>(m) | Past<br>Management | Age Class | Risk Target | TPO Status | Defects | Works | Work Priority |
|---|---|---|---|---|---|---|---|---|---|
| T174<br>Tree<br>tag: | English<br>oak | 20-<br>25m | Subject to<br>past<br>management | Mature | High/<br>reinspect<br>July 2027 | No TPO in place<br>and Conservation<br>Area restrictions for<br>Mid Sussex District<br>Council. (CA)<br><br>Botanical Name:<br>( <i>Quercus robur</i> ) | No Gross Defect Noted. Basal cavity to<br>the Southeast side, with depth of<br>40cm approx. Slight hollow sound<br>when tapped to that area. Multiple<br>pruning wounds on stem. Co dominant<br>stems at 5m above ground level.<br>Decayed stem at 16m above ground<br>level to East and 2 decayed stems to<br>West sides at 8m above ground level.<br>Deadwood present within canopy. | Climbing inspection throughout<br>canopy, report back on outcome<br>of inspection.<br><br>Removal of deadwood over<br>100mm throughout canopy. | Urgent within<br>3 month. |

T174 English oak measurement 1

T174 English oak measurement 2

T174 English oak measurement 3
