## **Resistograph Tree Report**

**Lindfield Primary Academy,  
Primary Academy, School Lane,  
Lindfield,  
Haywards Heath,  
RH16 2DX**

**Prepared by  
Richard Daubeney Our Ref 0825-RD  
12th August 2025**

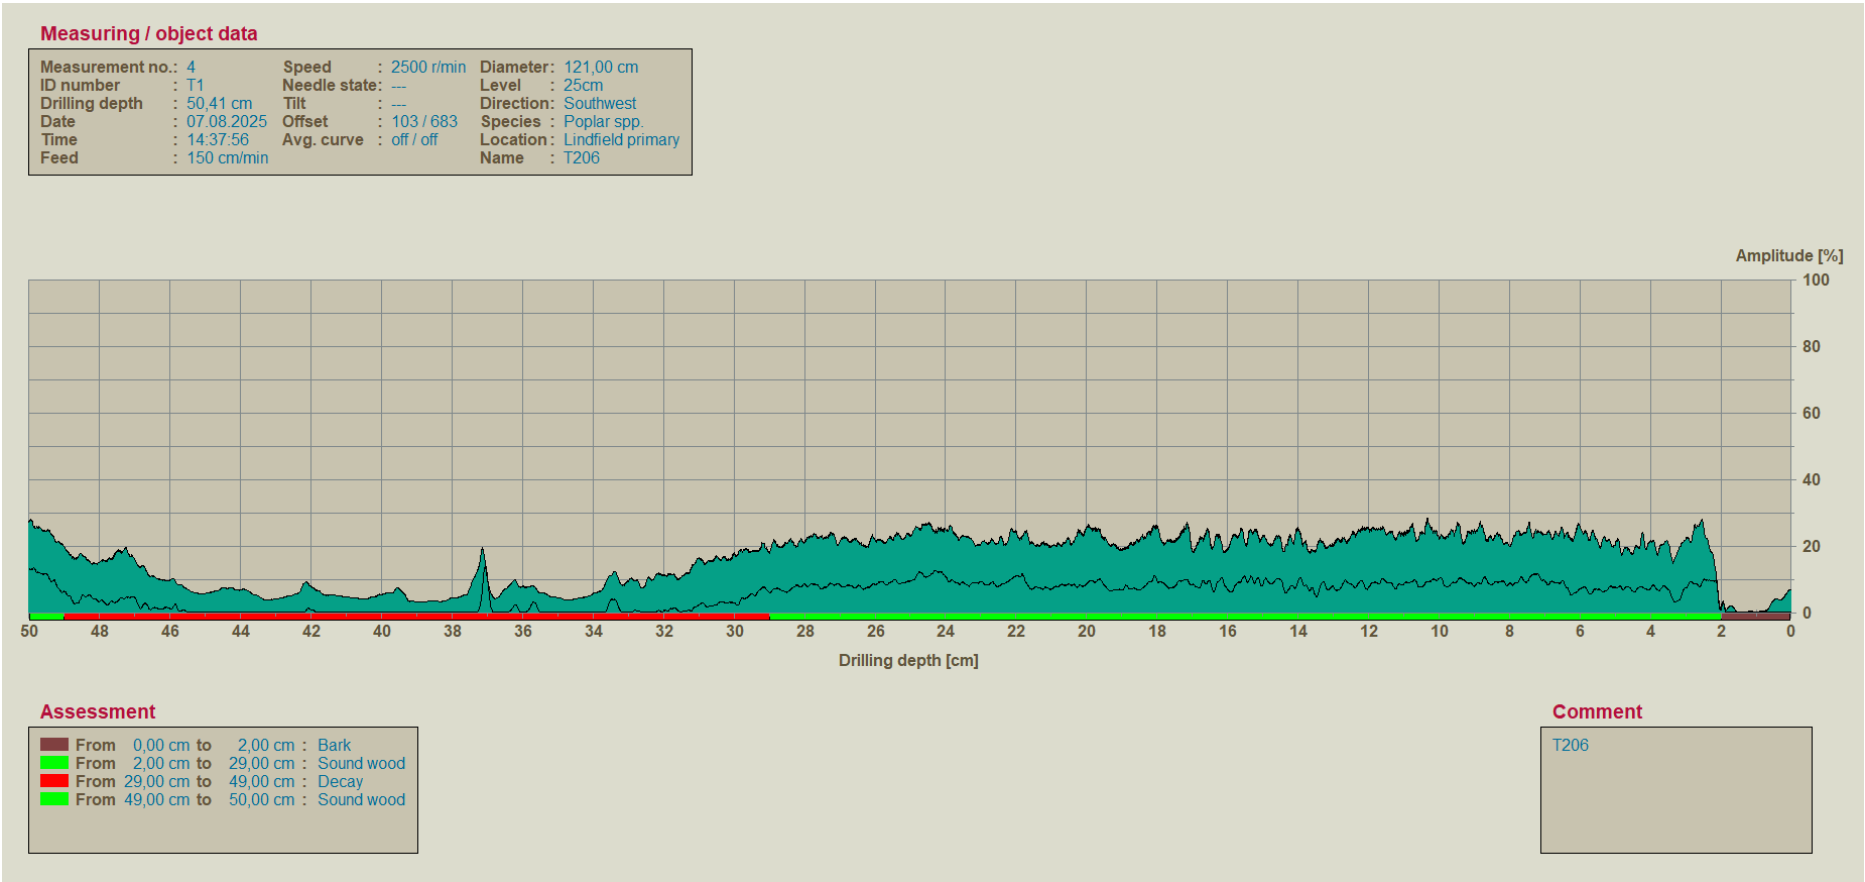
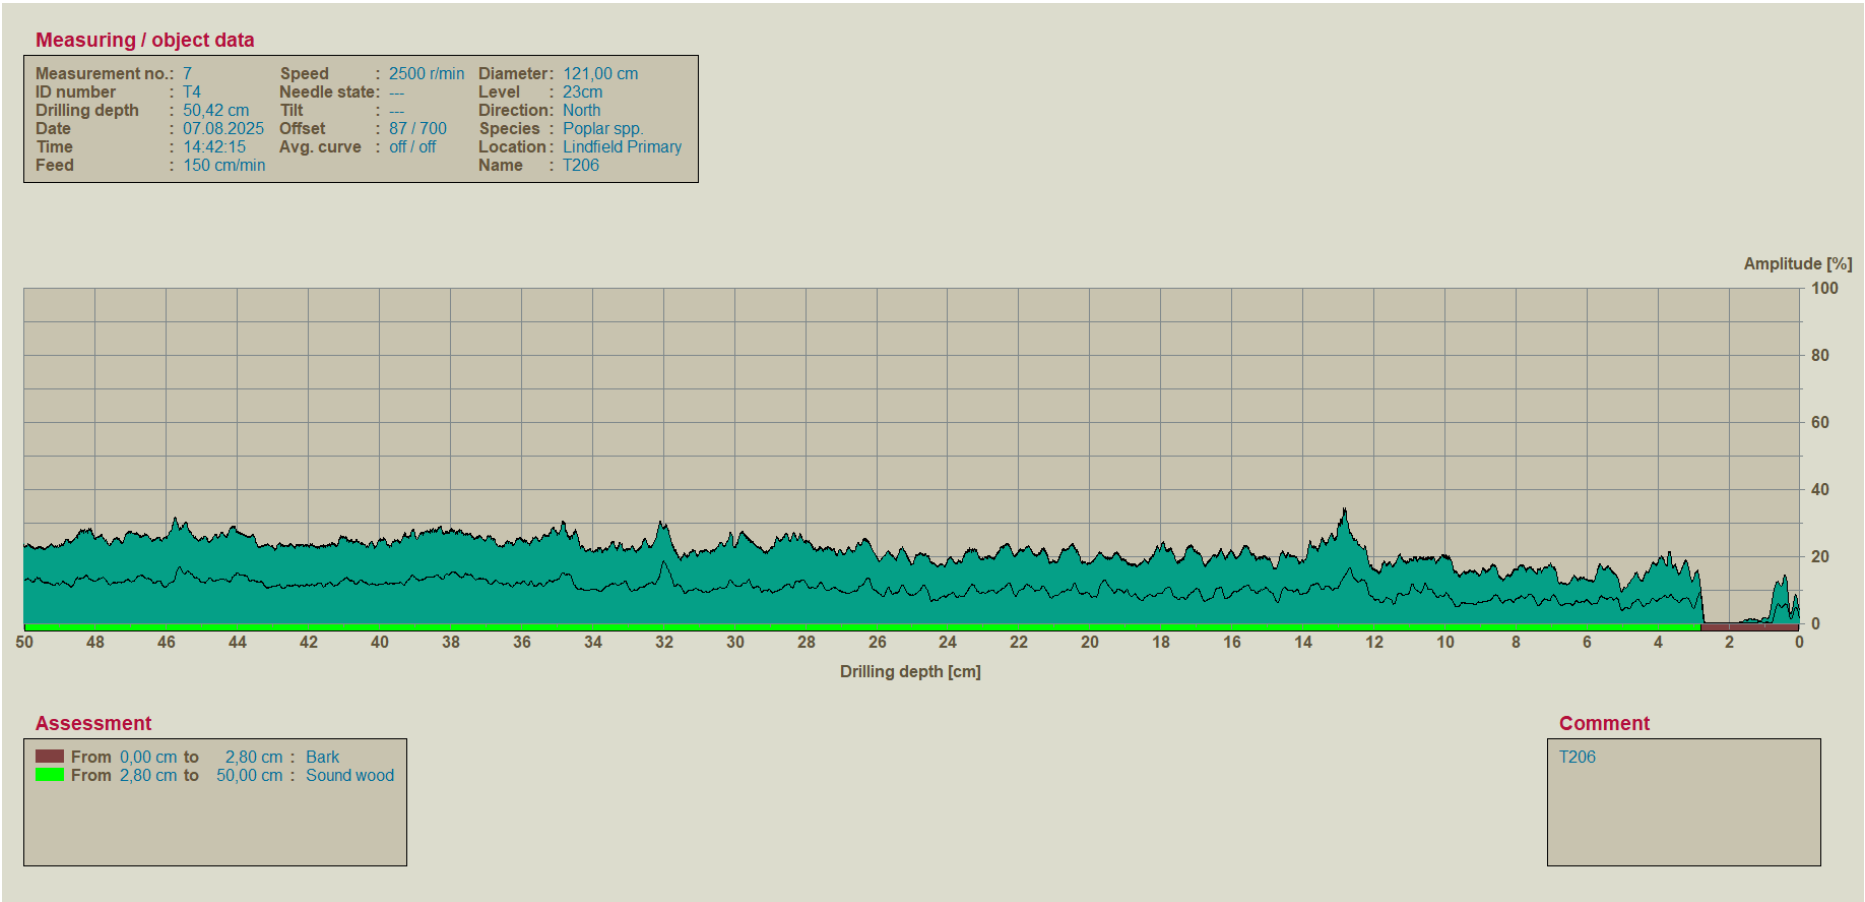
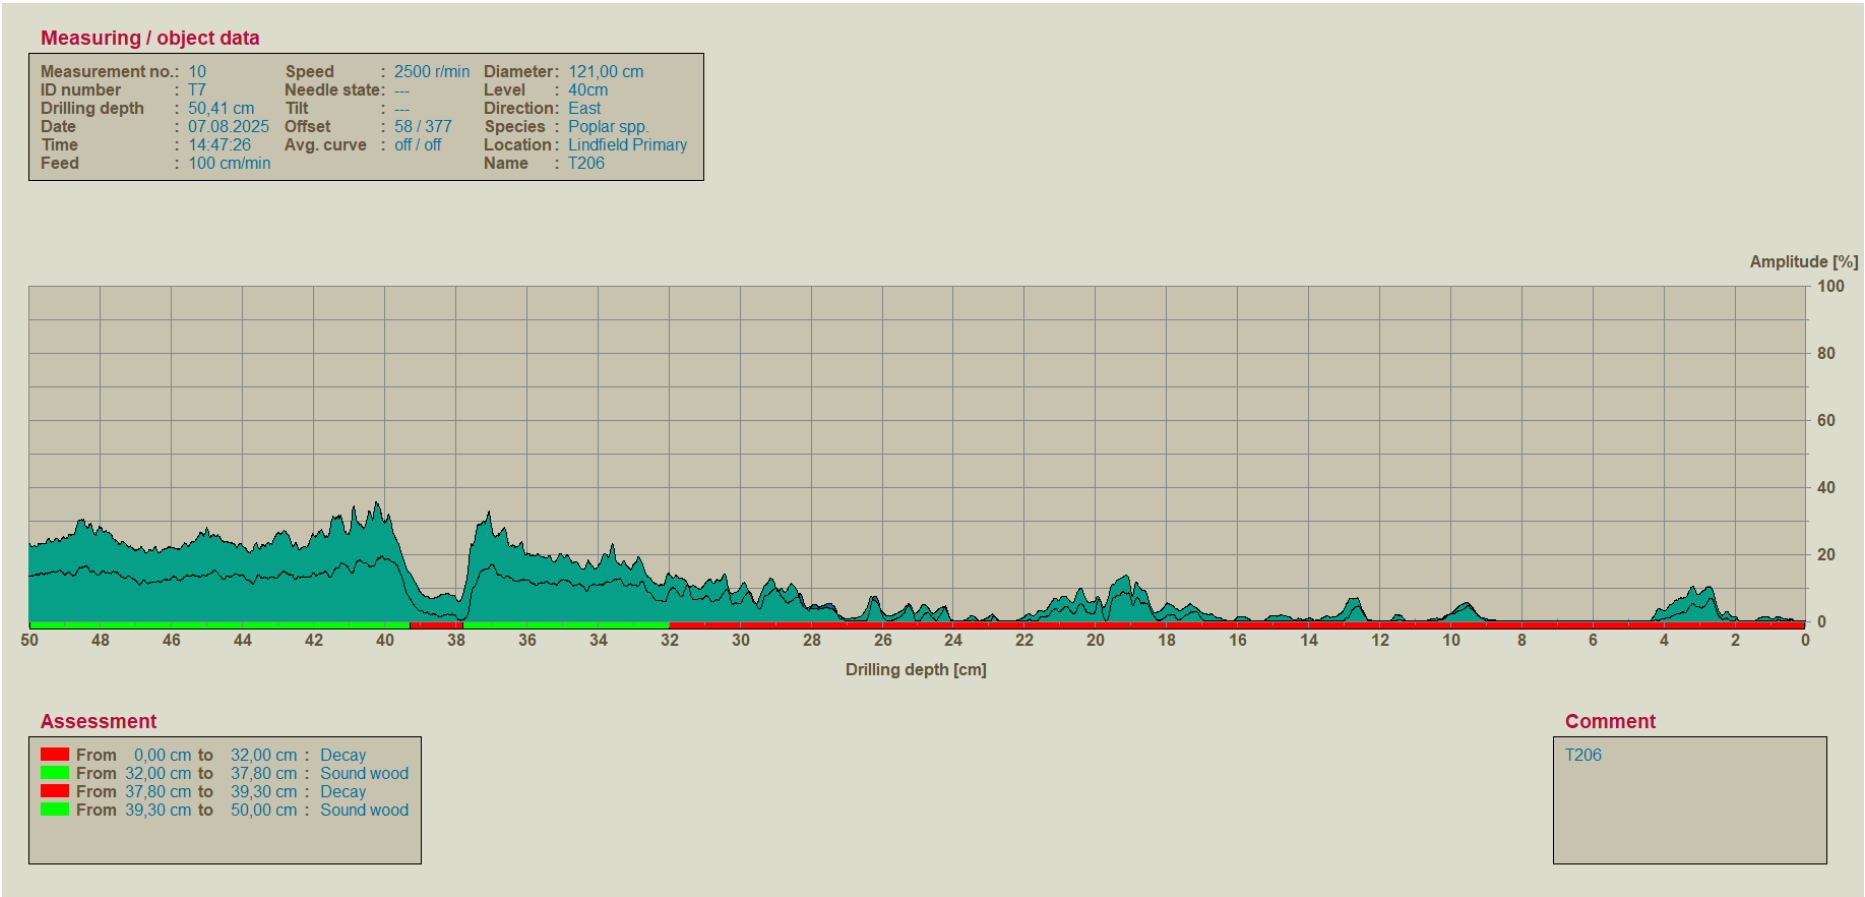
| Tree No.<br>Tree<br>Tag. | Tree<br>Species | Hgt<br>(m) | Past<br>Management | Age Class | Risk Target | TPO Status | Defects | Works | Work Priority |
|---|---|---|---|---|---|---|---|---|---|
| T206<br>Tree<br>tag: N/A | Poplar<br>spp. | 20-<br>25m | Managed as<br>high pollard | Mature | High/<br>reinspect<br>July 2027 | No TPO in place<br>and Conservation<br>Area restrictions for<br>Mid Sussex District<br>Council. (CA)<br><br>Botanical Name:<br>( <i>Populus spp</i> ) | Gross Defect Noted.<br>Major stem decay to East side, major<br>hollow sound when tapped with<br>sounding hammer to 30cm above<br>ground level. Multiple pruning wounds<br>on stem. Cavity on stem at 9m above<br>ground level towards Southwest side.<br>Historic pollard. | Climbing inspection for cavity on<br>stem. Report back on outcome of<br>inspection.<br><br>Pollard to 8m above ground level. | Urgent within<br>3 month. |

T206 Poplar spp. measurement 1

T206 Poplar spp. measurement 2

T206 Poplar spp. measurement 3
