JUSTIFICATION

TIMBER FRAME REPAIR TO MAIN PARLOUR

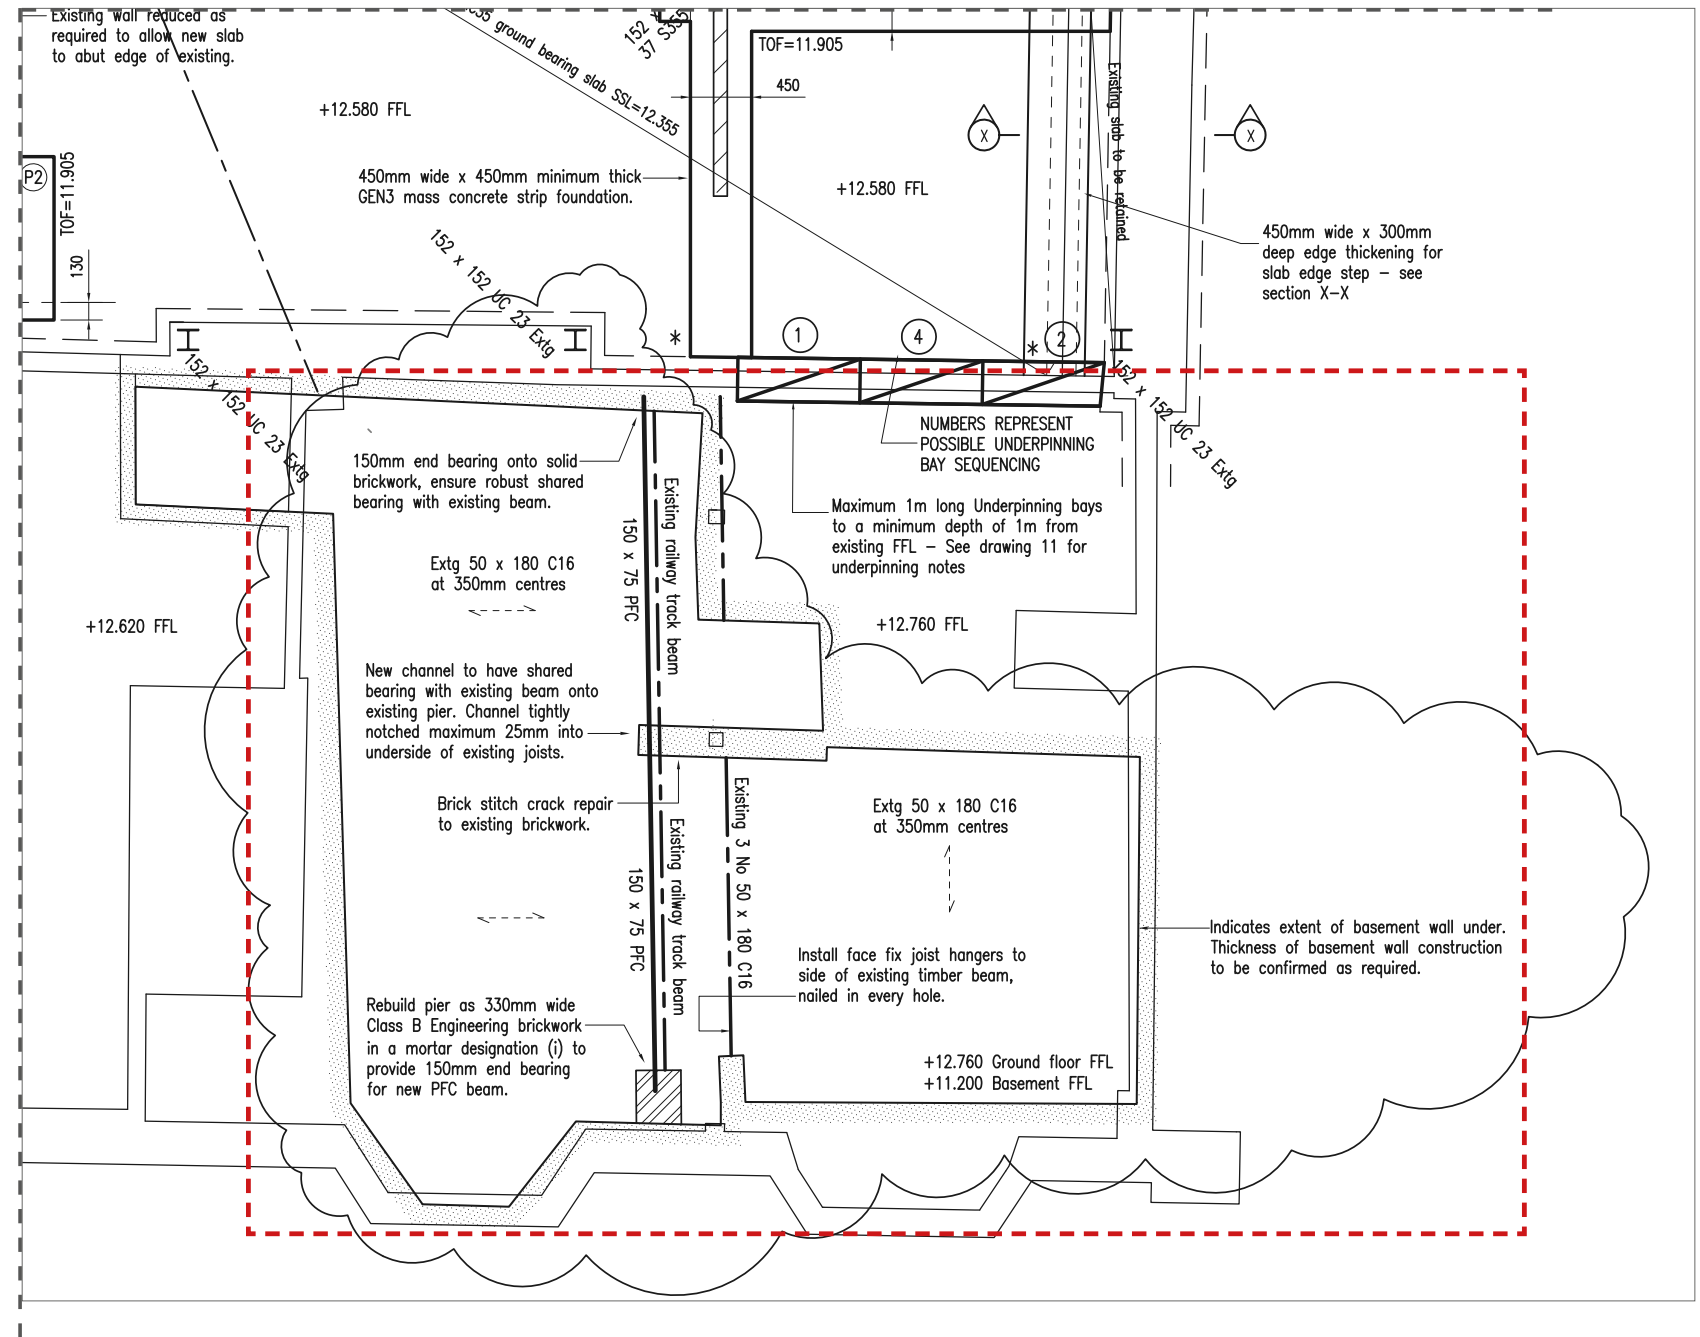
The adjacent drawing developed and provided by the Structural Engineer, illustrates proposed strengthening works to the ground floor over the basement. The railway steel member used for structural support was replaced as per Structural Engineer proposal to ensure a suitable structural stability of the building to safeguard it for the years to come.

The appearance of the cellar is commensurate with what was present when the previous tenants were stewards of the property. The cellar walls have been lined with traditional material: lime plaster. This ensures the walls can breath and the moisture escapes from the building. This has been one of the issues encountered in the historic element of the building, which is demonstrable through the rotting of the modern floor joists that had to be removed due to rotting, with the underlying issue the extreme level of damp in the cellar. The application of lime plaster on the historic building is highly critical for the ongoing health of the building – it is highly breathable, avoids trapping moisture and allows moisture within the walls to evaporate naturally. This is critical in historic buildings, where walls are often constructed from stone or solid brick without a modern damp-proof course. It’s worth noting that lime has been used in construction for centuries and is likely the original material used in the building’s construction. Its use aligns with principles of conservation by preserving traditional methods and materials and it can be removed without damaging the underlying masonry, aligning with the conservation principle of reversibility. There were no alterations done to basement floor.

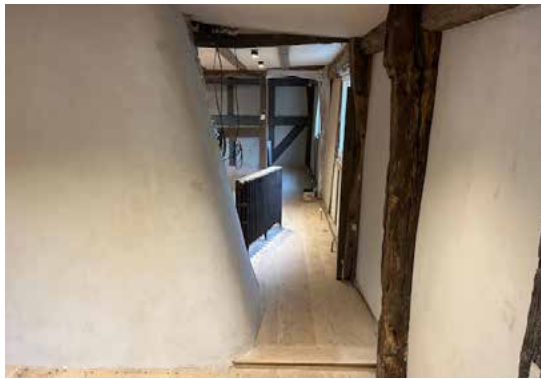
Pre-construction photograph of space between bedrooms, walls re-rendered prior to installation of fitted wardrobes

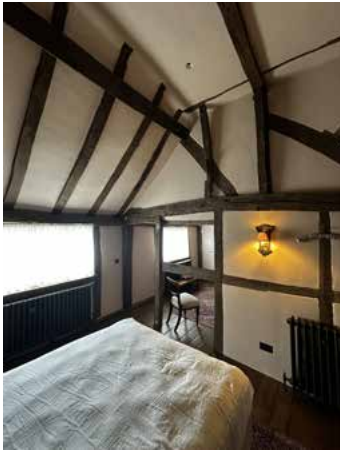
View from north bedroom towards altered wall (timber frame remaining)

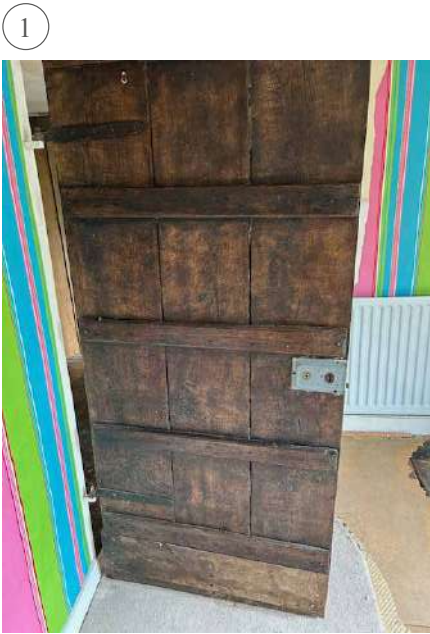
Existing timber door (to be reinstated and fixed shut)

On the first floor, an existing opening in the internal wall was blocked up. It is proposed for the doorway in question to be reinstated in the current bathroom wall, with door leaf fixed shut. As such, the legibility of horizontal movement on the first floor is still present. On the bathroom side, the doorway and associated architrave will be reinstated and current freestanding sink refitted in its current position. It should also be noted that the approved first floor plan has the sink located against an existing door that is to be locked shut, a measure that is now being proposed when reinstating the door to the opposite side (South side) of the en-suite in a revised sink position. The use of the sink in this position is reversible works and as such, should be agreeable on heritage terms.

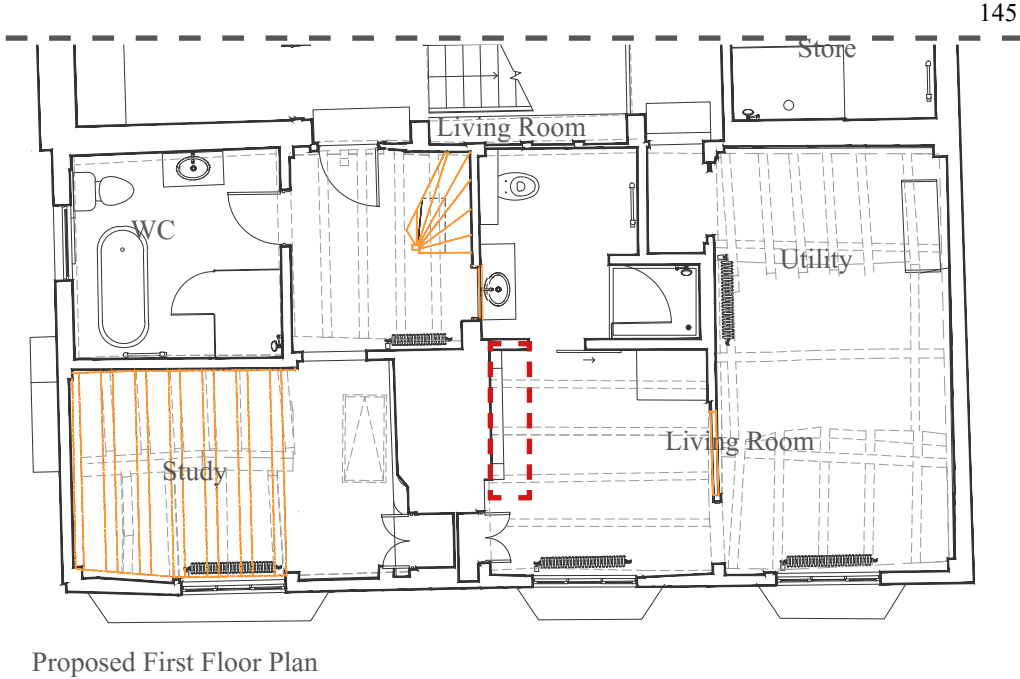
On the first floor, the fire place was modified to resemble the historic one by reinstating the hearth opening. The condition of the chimney breast has been significantly improved. The chimney breast brickwork has been cleaned and re-pointed. A new horizontal timber mantle was introduced for aesthetic reasons.

First floor bedroom fireplace and chimney breast before works

1. Existing fireplace insert removed
2. Brickwork infill around inserted fireplace removed to reinstate the historic firebox
3. Reclaimed brickwork cleaned where required across full extent of chimney prior to any repair works.
4. Any serious erosion from spalled brickwork removed, then cleaned out and infilled with new brickwork and mortar mix with colour, texture and pointing to match existing.
5. Chipped or cement coated bricks removed, cleaned out and infilled with new brickwork and mortar mix with colour, texture and pointing to match existing.
6. Any open mortar joints, if not found to be a consequence of structural defects, cleaned out and infilled with new mortar mix with colour, texture and pointing to match existing.
7. New timber mantle by Nick Cane of Cruck Frame Carpentry installed above the opening. Timber treated to match the floorboards.

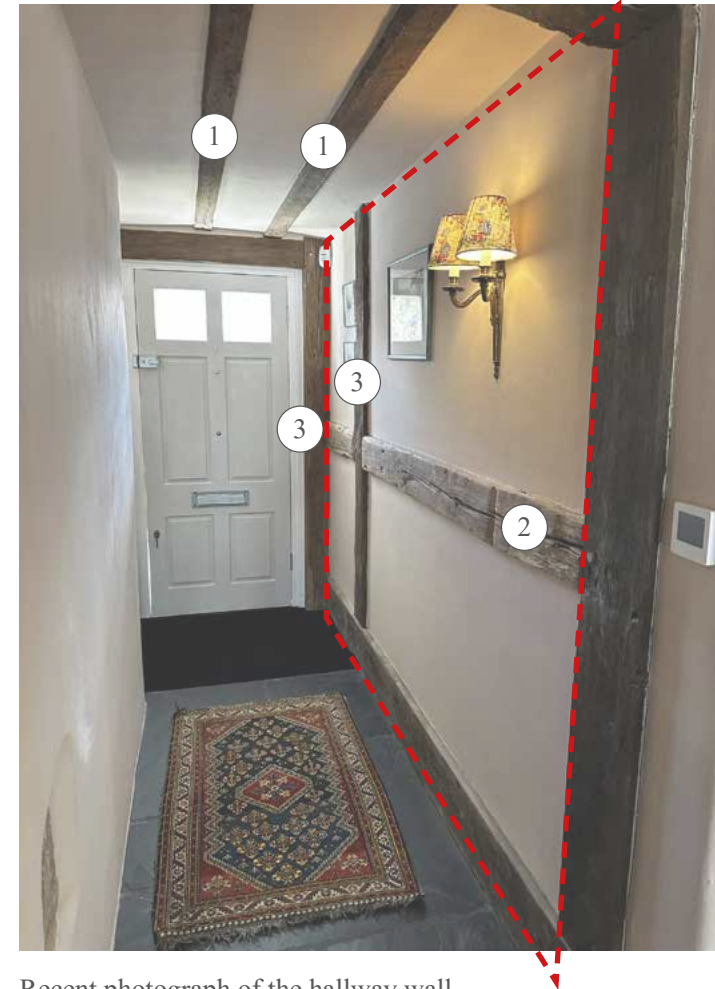
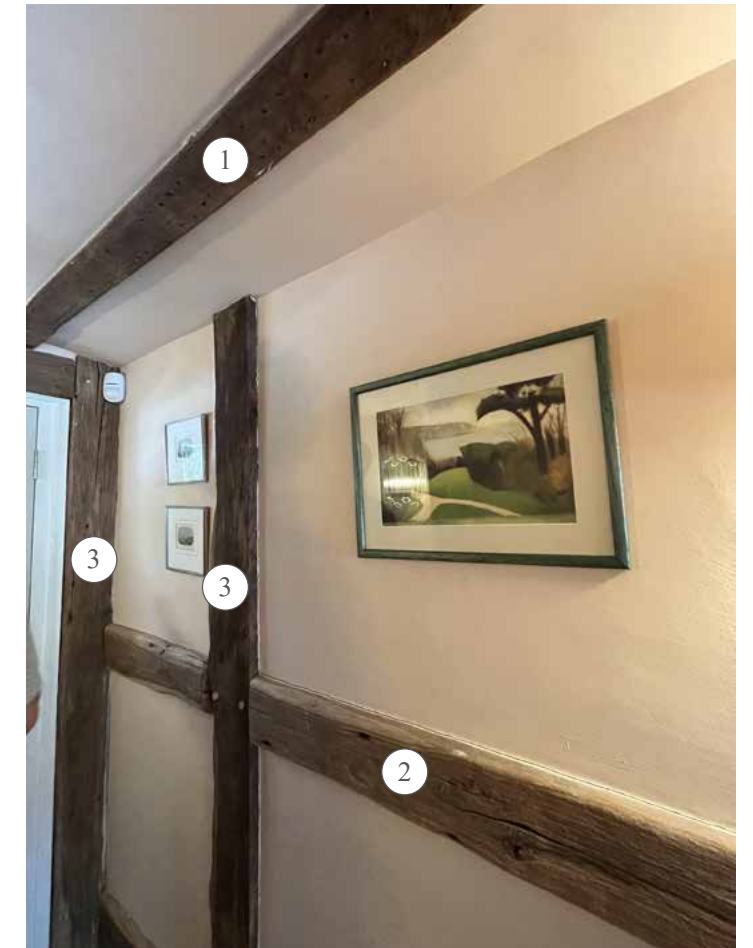
1. Historic, previously not visible timber elements exposed
2. New horizontal timber elements
3. Historic timber elements restored

Recent photograph of the hallway wall

1. Comprehensive survey of the historic timber elements to assess the condition of the oak. Timbers checked for decay, insect damage, splits, warping, or structural weakness.
2. Timber renovated using historically appropriate techniques - gentle clean using soft bristle brush. Timber left are without any coatings. The timber's patina, age marks, and tool finishes retained.
3. New elements created to restore the readability of the frame. Timber elements selected, cut to size, treated with wax to achieve colour and overall look of the historic elements. Installed without damage to the existing frame.

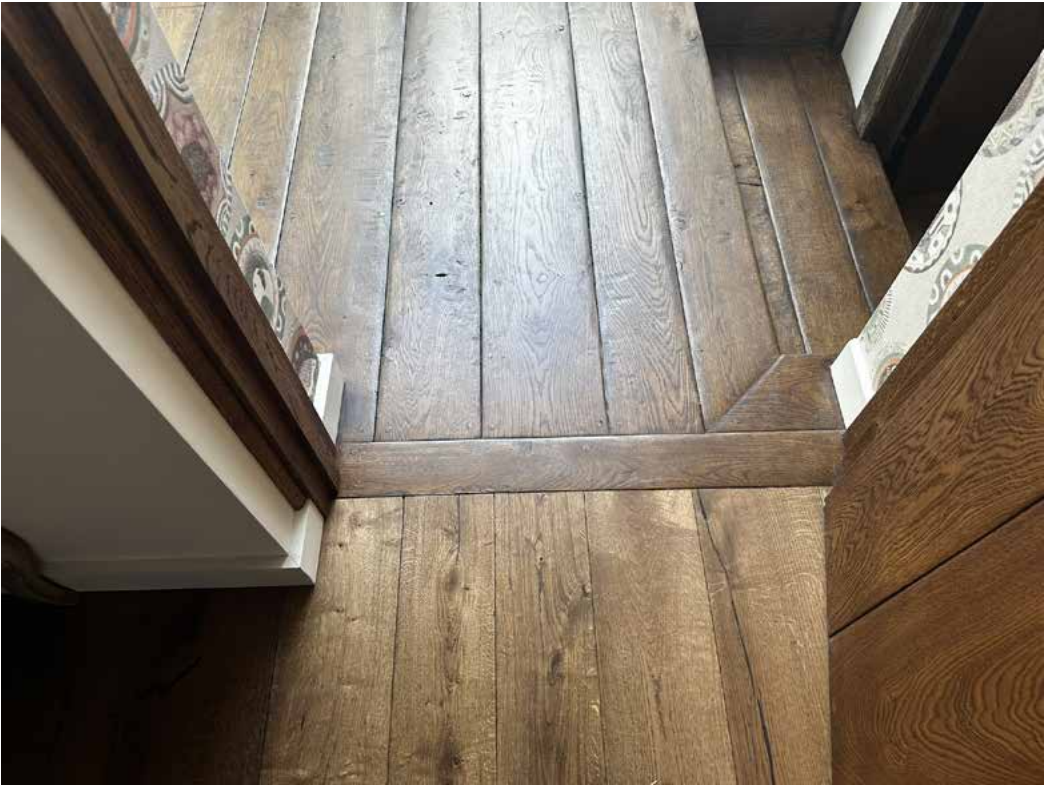
During the interview on the 10th of June 2025 it was proposed by the Applicant for the Conservation Officer and any other relevant parties to visit the building, lift the new floor boards in selected locations and inspect the state of the historic boards underneath. No contact was made since regarding this matter.

As-built oak flooring
