**Reference:** WGCS/T1/VTA/2025

**RE: Visual Tree Assessment (VTA) of Mature Oak at Grovelands Farm, Highbrook Lane, West Hoathly, RH19 4PL**

Following my site visit dated **21st November 2025**, and completion of a **ground-level Basic Visual Tree Assessment (VTA)** of the mature Oak (T1) located at **Grovelands Farm**, please find below the full written report of findings.

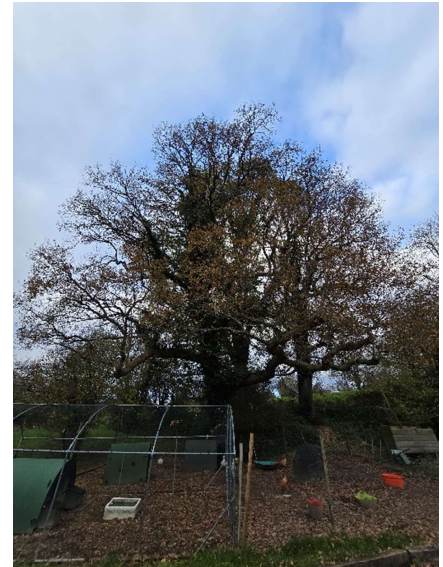
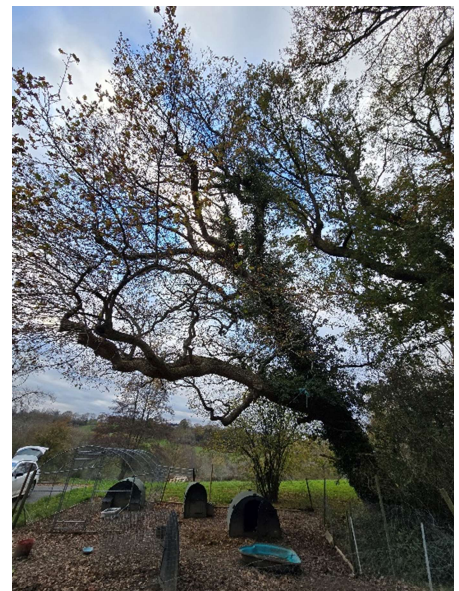
| <b>Structural<br/>Condition</b> | Westerly lean, raised ground on NE side, basal<br>Ganoderma brackets, historic pruning with reaction<br>growth, deadwood typical for species, ivy obscuring<br>unions |

Fungal brackets, consistent in appearance with Ganoderma, are present low on the east side of the stem. Probing behind the area where the bracket was observed identified a shallow pocket of decay confined to the outer section of the stem, but firm wood was encountered beyond this depth. At the time of inspection, this decay did not appear to be causing significant structural compromise, although ongoing monitoring will be required.

Several older pruning wounds were noted on the lower southern and western limbs. These wounds exhibit normal reactionary growth, with callus tissue forming around the cut surfaces. Some exposed heartwood is still visible, with minor cracking that is typical of historic pruning rather than indicative of active decay. No major dysfunctional wood or cavities were identified around these pruning sites.
