**Arboricultural Impact Assessment**

**Vine House**

| <b>Document ref:</b> | ARB1412 Vine House Arboricultural Impact Assessment |

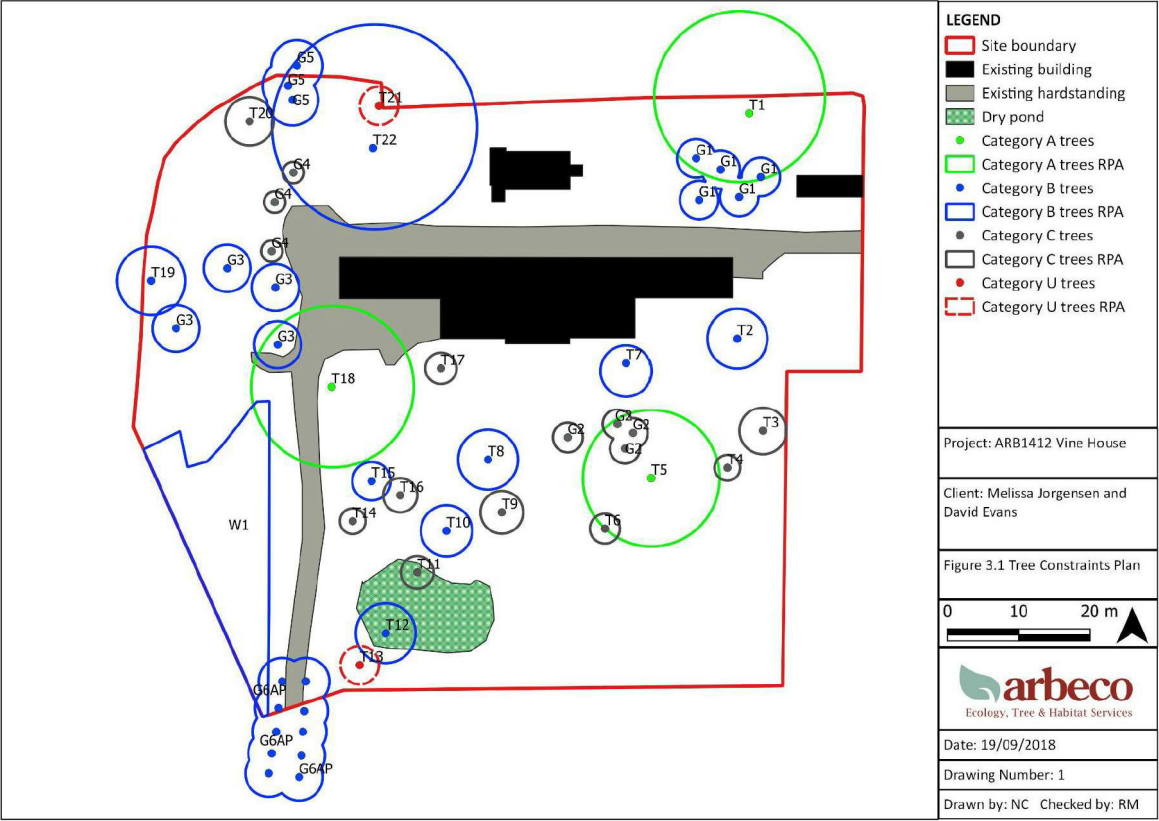
Figure 3.1: Tree Constraints Plan

- 2.12 The results of the Arboricultural Survey were used to evaluate the direct and indirect effects of the proposed design on the existing trees and identify appropriate mitigation measures.
- 2.13 The locations of the recorded trees and of their RPAs were digitised in the Tree Constraints Plan (Figure 3.1) to identify the constraints posed by the existing trees and inform the site layout design.
- 2.14 The final layout design and the locations and specifications of protective barriers, which create a Construction Exclusion Zone (CEZ) were digitised in the draft Tree Protection Plan (Figure 3.2).
