## TANYARD MANOR

Repair and Renewal of  
Roof Coverings

HERITAGE  
STATEMENT

July 2025  
v1

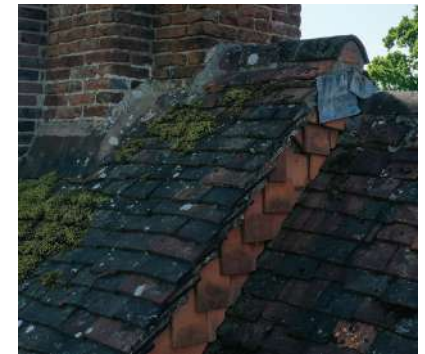
*double lap tiles evident at verge*

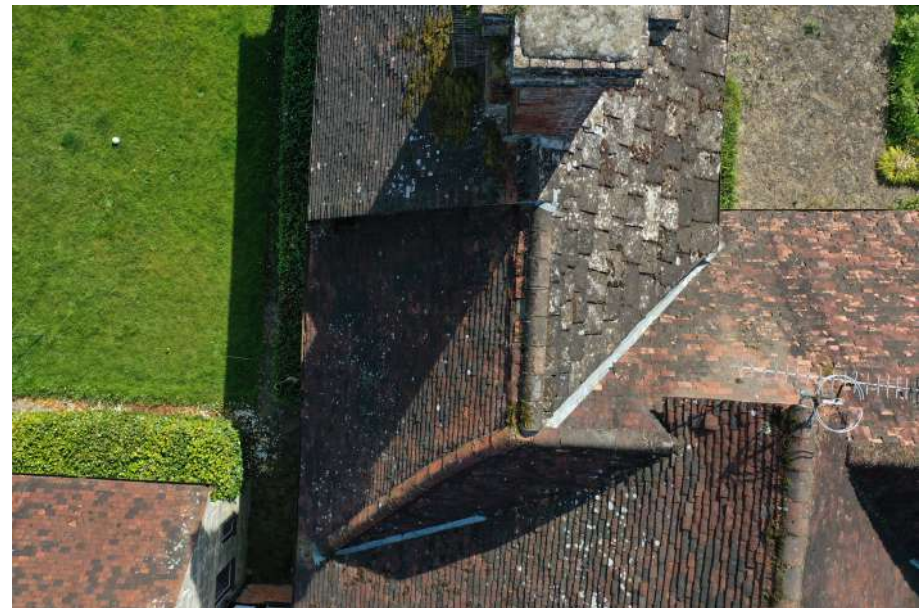
*lead valley and abutments*

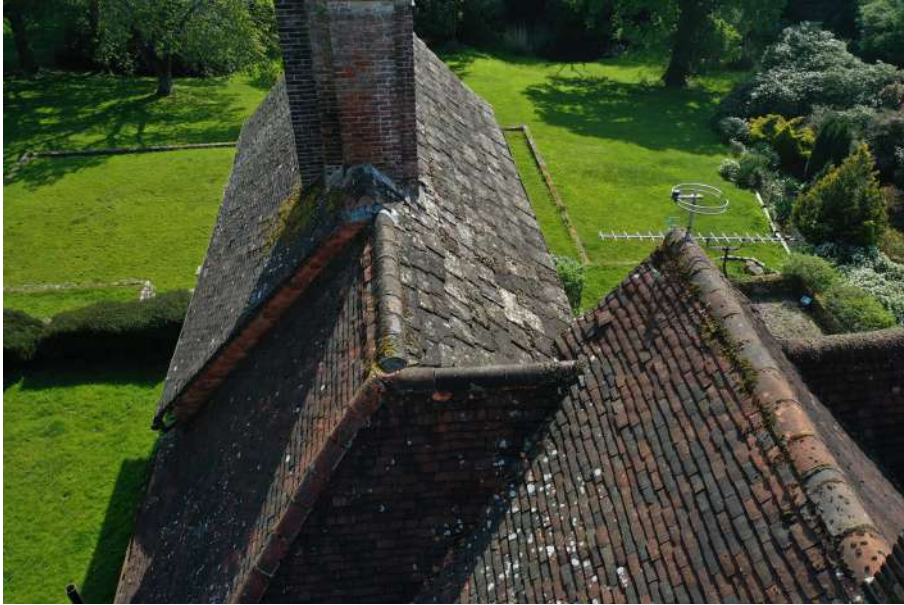
The roof abuts the C17th range with a lead lined valley to the south slope and to the north the roof surface forms a shallow step down with short tiled upstand to the abutment before forming a hip with bedded half round tiles at the junction with the adjoining C17th range. Limited internal inspection of the loft space reveals the historic roof frame is covered in a hessian based bitumen impregnated impermeable roofing felt presumably finished in battens securing the slates and tiles. As access was very limited it is not possible to determine the condition of the rafters, which appear post medieval, possibly C18th or later, suggesting they are not original to the form.

*abutment of C15th roof to C17th roof*
