**Tree Report**  
**Picus Testing – Very Mature Oak at Oak Lee, Compton Road,**  
**Hayward Heath RH16 2PF**

**1.1 Inspection date:** 19<sup>th</sup> November 2025 by Mr. Kim Gifford, undertaken in the area of test and at the time of inspection.

## **1.6 Oak (Quercus robur) Rear Garden by fence**

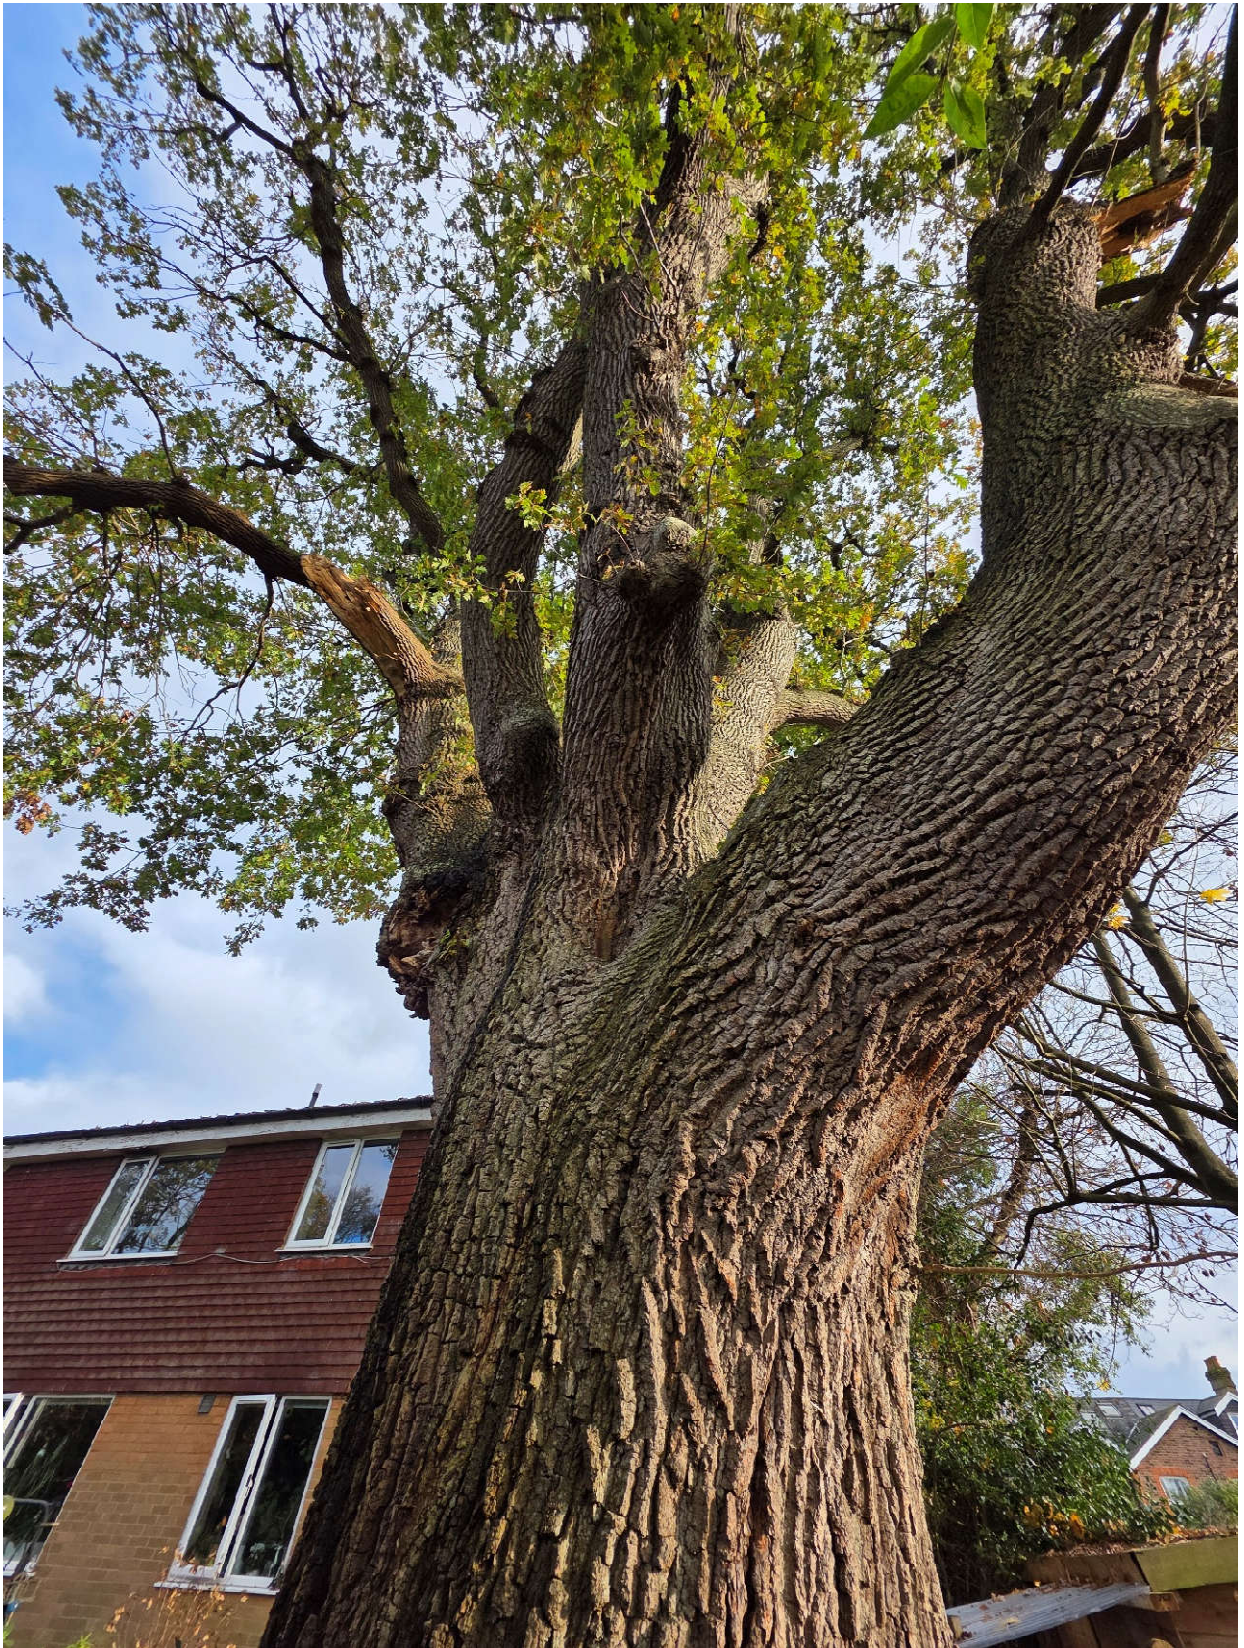
The measuring point readings give evidence of low velocities overall in the area of test representation showing decayed timber. The tomographic image shown above has a large percentage of 35% decayed timber. With reference to the 'colour chart see figure 2', the slower sonic speed of sound is represented by three bands of data representation blue/violet/white being the slowest altered/decayed timber, green being faster altered timber, brown being fast sonic-speeds solid timber.

The Picus test at the base shows decayed timber adjacent to the fungal brackets. It would be appropriate to reduce this specimen overall by to previous pruning points by 4 to 5m.

Crown reduce overall by 4-5m. Continue to monitor on an annual basis.

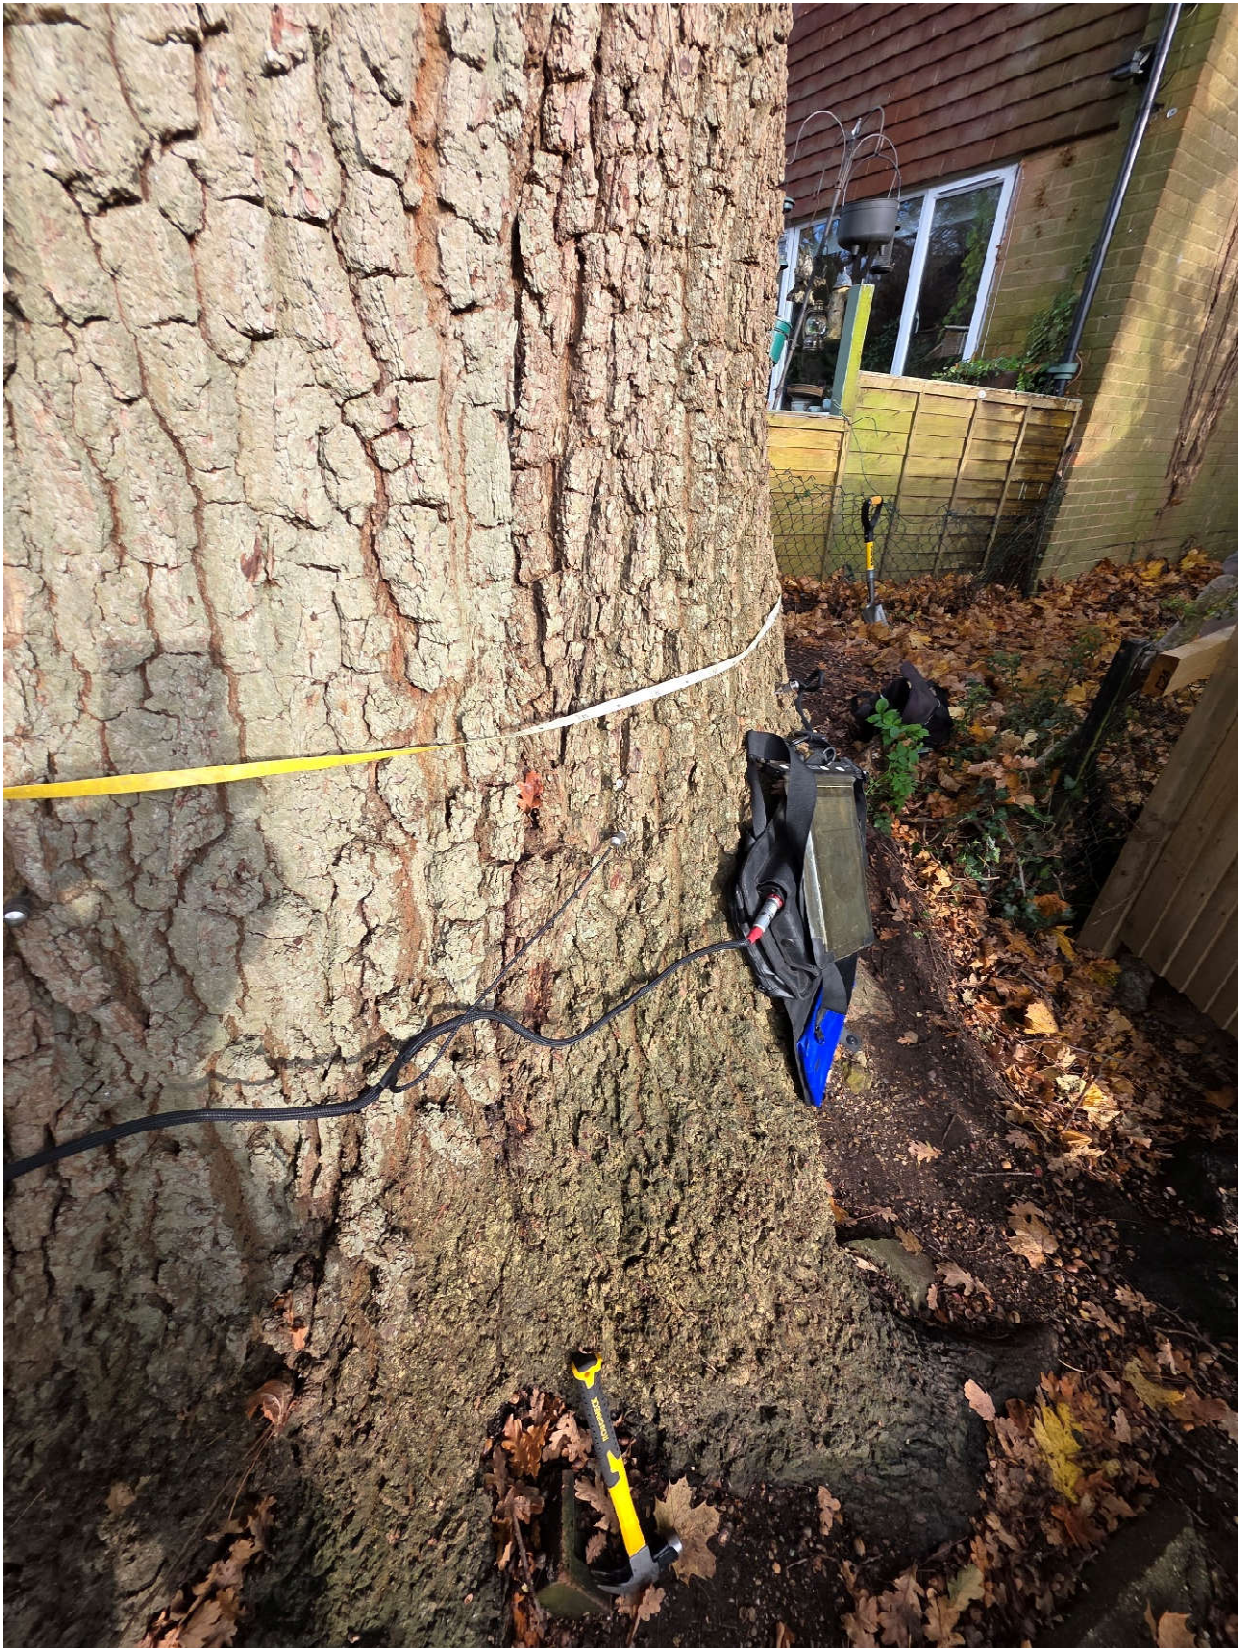
(see Picus sonic representation chart figure 3).

The resulting Picus tests are of acceptable limits in relation to the altered timber. This ratio called a 'trunk ratio' TR (*reference Claus Mattheck*) has been calculated to be a guideline in terms of stability and rigidity of cylindrical structure. Although a debated theory in arboriculture in general terms the TR of 30% is an average.
