## **CONDITION REPORT**

**MARLOW HOUSE  
107 HIGH STREET  
LINDFIELD  
WEST SUSSEX  
RH16 2HR**

**GH342**

**October 2022**

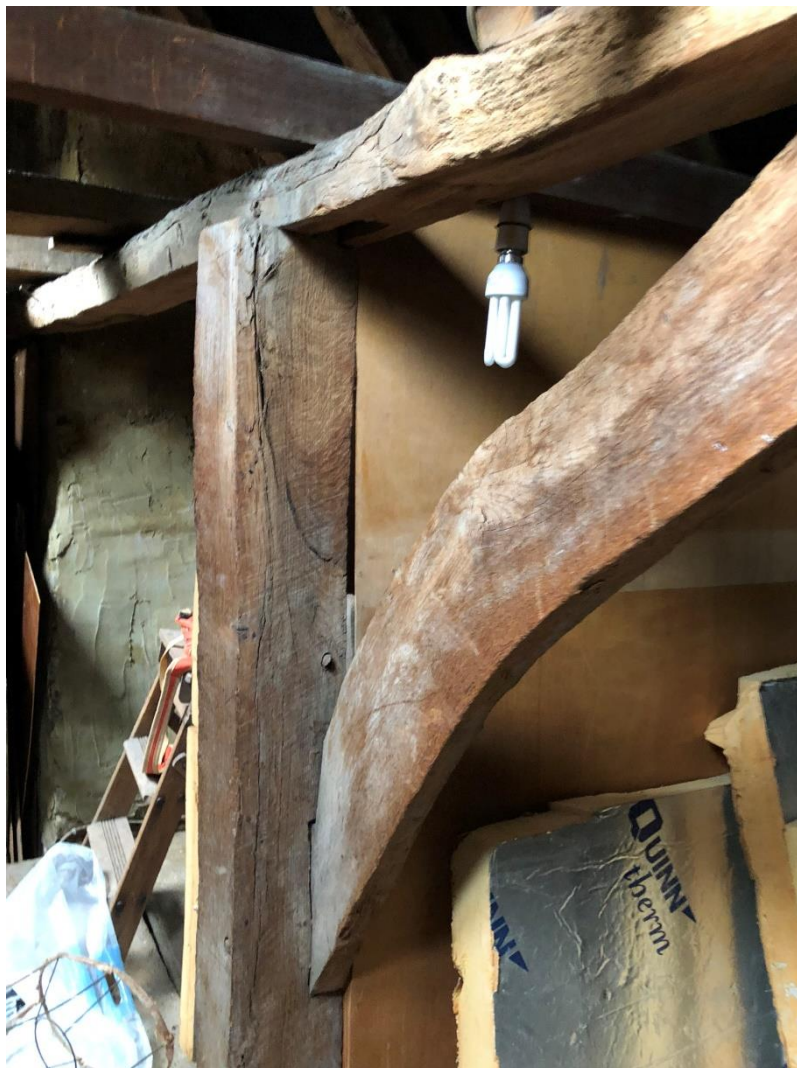
- 1.66 The roof structure has undergone extensive alternations, we suspect when the roof coverings have been replaced, to include the provision of a ridge board, furring pieces and new rafters to supplement existing. We also suspect down braces have also been removed from the crown posts to free up additional space.
- 1.67 The addition of a dropped ceiling has been provided above the master bedroom. The dropped ceiling is comprised of high level collars secured to the rafters and finished with painted plasterboard.

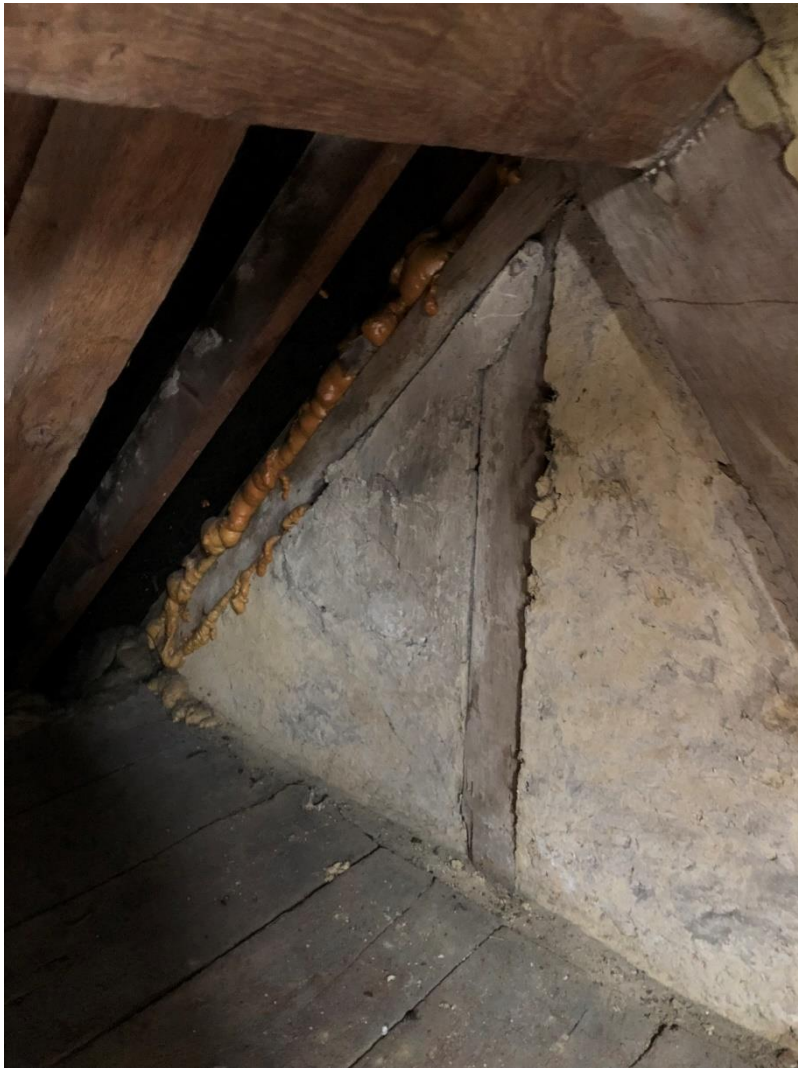
11. As noted previously in the report, evidence of damp penetration was noted to the ceiling adjacent the chimney stack. Our recommendation is to renew the flashing to provide a weathertight detail.
12. Some sections of original wattle and daub panels are visible within the roof void, on the south facing gable end. The panels remain reasonably well fixed but with some deterioration noted, with evidence of poorly applied expanding foam repairs present. Allowances should be made for isolated repairs.

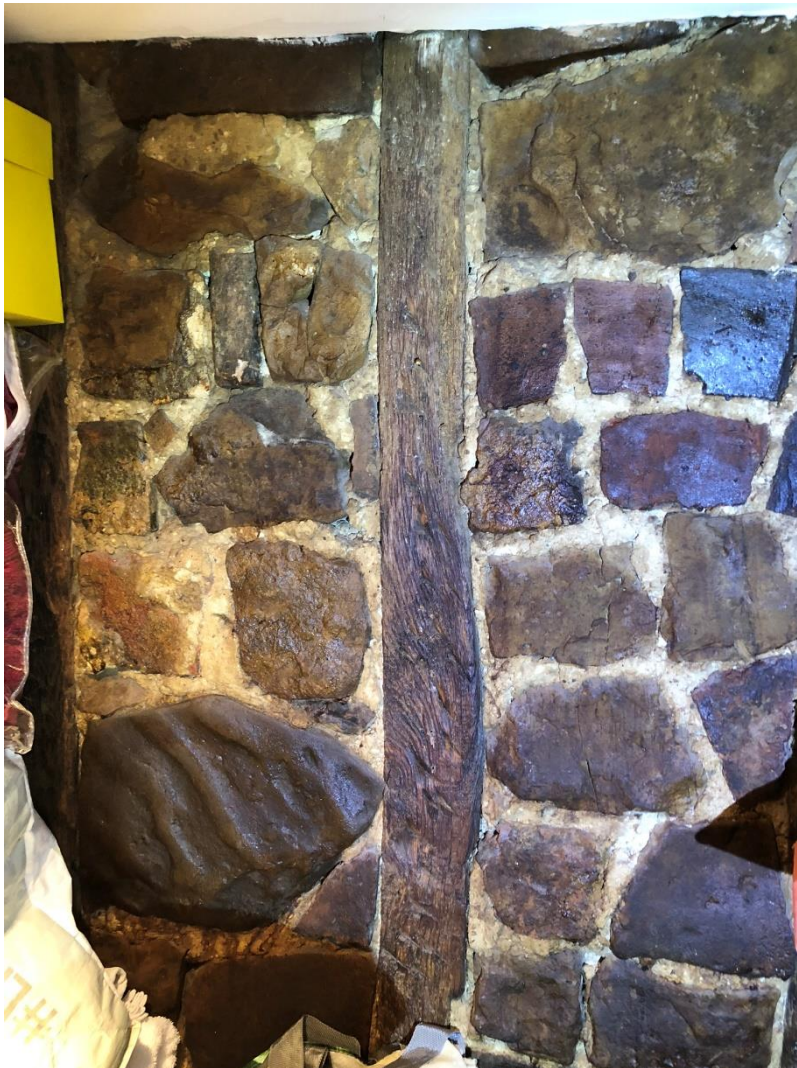
- 1.77 The original oak frame structure of the property will have been an integral frame with posts and beams tied together to provide a stable oak superstructure.
- 1.78 Visibility of the internal walls and partitions was largely obstructed by resident's items and restricted survey conditions, as such further inspection will be required to ascertain the full scope of repairs necessary.
- 1.79 Based upon our limited visual inspection we would make the following observations:
1. The oak framing where visible internally appears to reasonable condition.

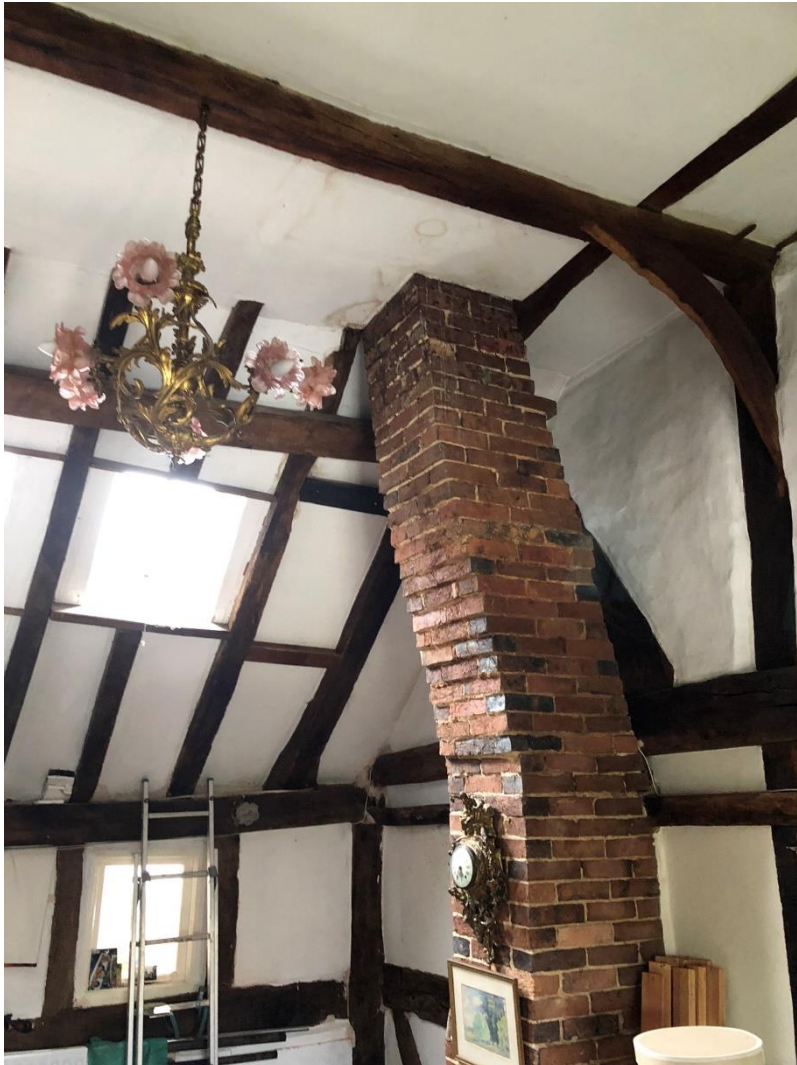
- 1.82 Furthermore, the structural stability of the raking chimney flue routing up diagonally through the master bedroom should be reviewed.

- 1.83 Notwithstanding the above, we noted no signs of progressing structural movement to the raking chimney stack at the time of the inspection.

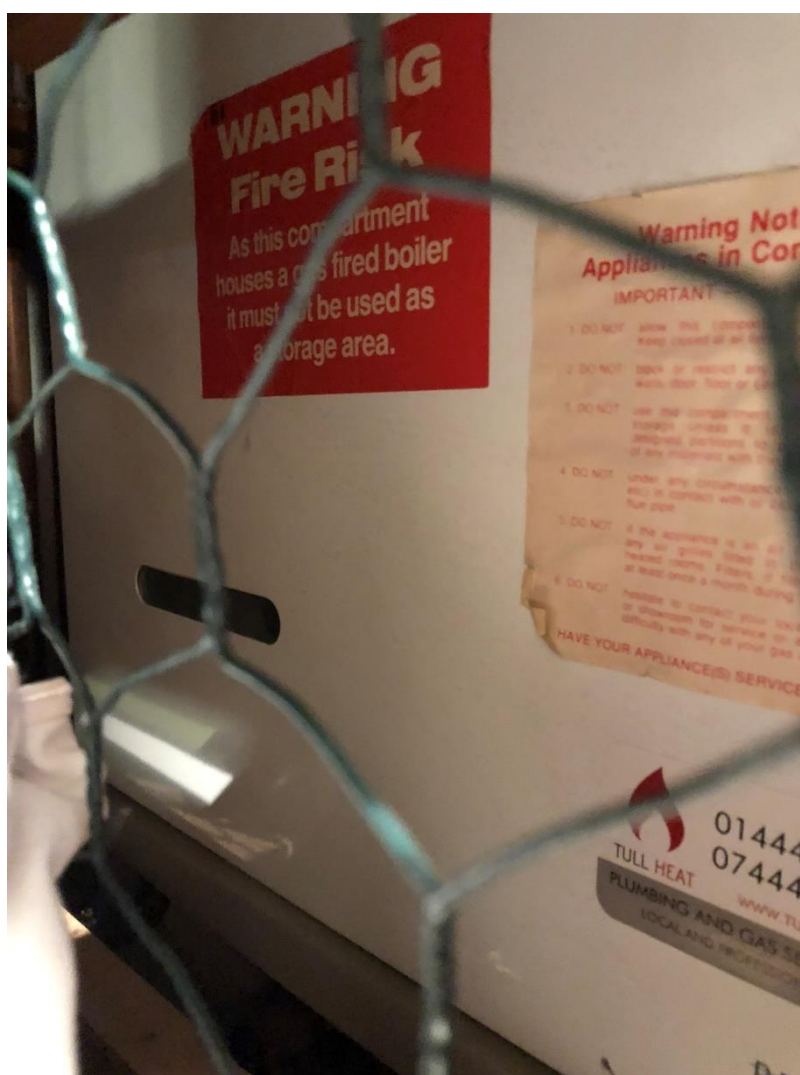
- 1.99 The boilers serve pressed steel radiators. Pipework where visible was run in copper.
- 1.100 We were unable to inspect the condition of the heating system in detail due to the vendor's items preventing access, however where visible radiators and boilers appeared to be of an age considered beyond their useful life expectancies.
- 1.101 In our opinion allowances will need to be made for a new central heating installation throughout, to extend to the proposed new rear extension.

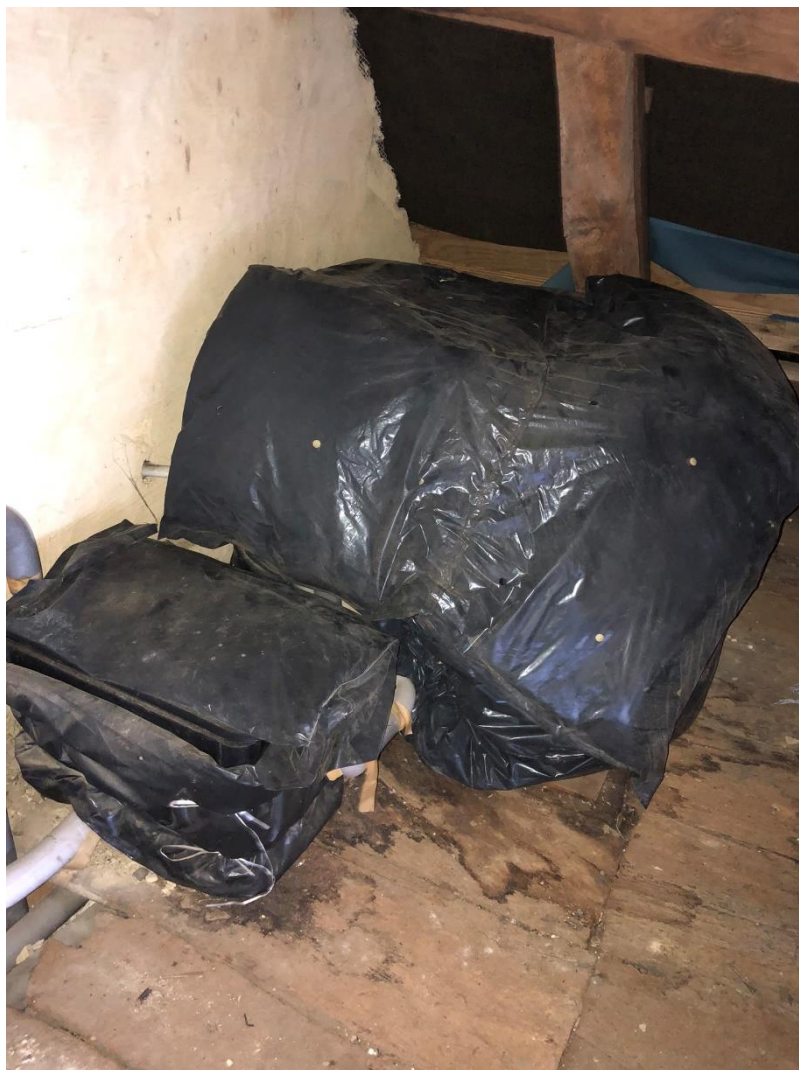
- 1.105 The tank distributes cold water throughout the original portion of the house.
- 1.106 A pre-lagged hot water cylinder is provided within the bathroom cupboard.
- 1.107 We were unable to inspect much of the plumbing installations as access was prevented or items were concealed with lagging. As such we cannot advise fully on the visual condition of the plumbing system or materials used. It is anticipated that the plumbing system will be replaced as part of the proposed internal alterations and extension works.
- 1.108 The sanitary fittings are now somewhat dated and showing signs of wear and tear, and will need to be upgraded to suit your requirements.
