The external foul drainage system (underground) is mostly constructed of cast iron, with existing connections from the main house connected via "Burns Chambers", these are enclosed chambers with cast iron plates bolted on-top. These bolts remain in place and are likely to be seized due to corrosion. As a result, some connections could not be accessed and surveyed.

Project Pictures:

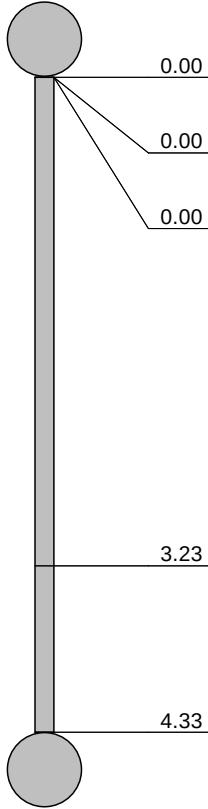
| Scale: 1:50 | Position [m] | Code | Observation | Grade |
|---|---|---|---|---|
| | 0.00 | IC | Start node, inspection chamber, reference: IC1 | |
| | 0.00 | WL | Water level, 0% of the vertical dimension | |

- All burns covers should be made accessible for maintenance and unblocking.
- All cast iron pipework should be de-scaled using milling machine.
- IC1 – IC2: Root cutting
- IC5 – BR3: Patch repair due to fracture.
- IC14 – IC12: Root cutting and patch repair.
- Catch-pit-3 – Lake: Jetting & Root cutting to restore full flow.

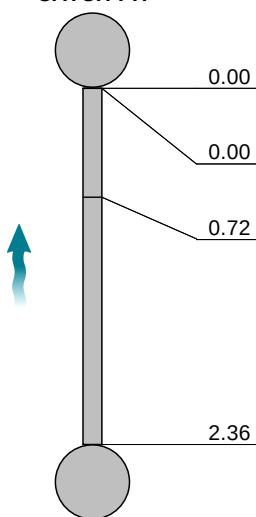
| Scale: 1:50 | Position [m] | Code | Observation | Grade |
|---|---|---|---|---|
| <p>Depth: 0.80 m</p> <p>CATCH-PIT</p> | | | | |

| Scale: 1:50 | Position [m] | Code | Observation | Grade |
|---|---|---|---|---|
| | 0.72 | CC | Crack, circumferential from 1 o'clock to 12 o'clock | 2 / 2 |

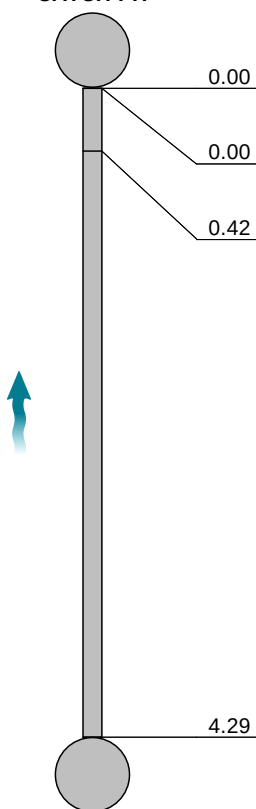
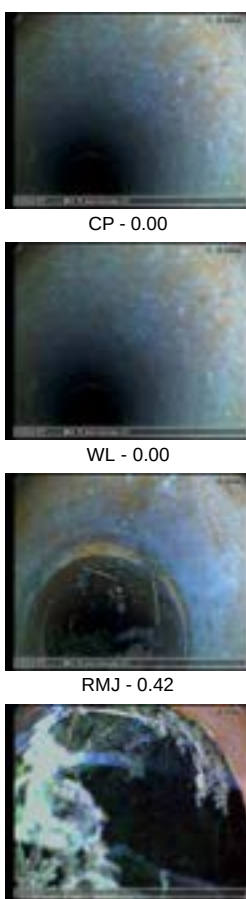
| Scale: 1:50 | Position [m] | Code | Observation | Grade |
|---|---|---|---|---|
| <p>Depth: 0.80 m</p> <p>CATCH-PIT</p> | | | | |

| Scale: 1:50 | Position [m] | Code | Observation | Grade |
|---|---|---|---|---|
| 0.00 | CP | Start node, catchpit, reference: CATCH-PIT | | |
| 4.29 | GYF | Finish node, gully, reference: BR2: GULLY | | |

| STR No. Def | STR Peak | STR Mean | STR Total | STR Grade | SER No. Def | SER Peak | SER Mean | SER Total | SER Grade |
|---|---|---|---|---|---|---|---|---|---|
| 0 | 0.0 | 0.0 | 0.0 | 1.0 | 1 | 10.0 | 2.3 | 10.0 | 5.0 |

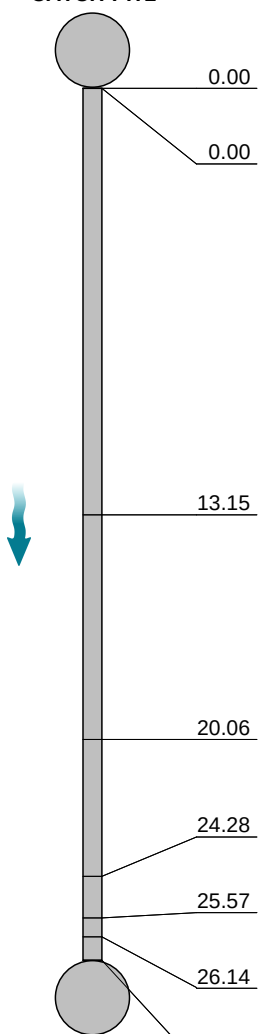
| Scale: 1:233 | Position [m] | Code | Observation | Grade |
|---|---|---|---|---|
| <p>Depth: 0.73 m</p> <p><b>CATCH-PIT2</b></p> | | | | |

| Scale: 1:233 | Position [m] | Code | Observation | Grade |
|---|---|---|---|---|
| | 20.06 | CM | Cracks, multiple from 1 o'clock to 12 o'clock | 3 / 2 |
| | 24.28 | CC | Crack, circumferential from 1 o'clock to 3 o'clock | 2 / 2 |

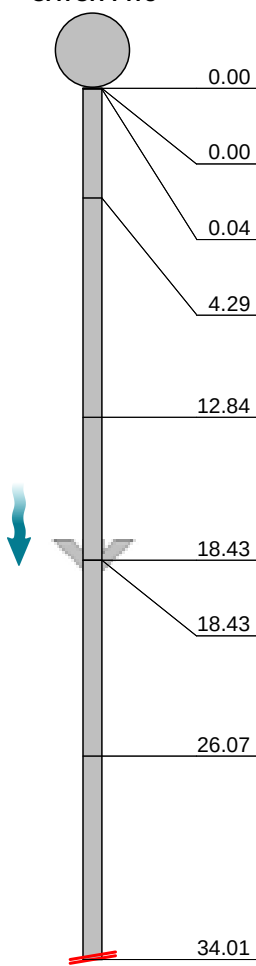
| Scale: 1:295 | Position [m] | Code | Observation | Grade |
|---|---|---|---|---|
| <b>Depth: 0.73 m</b><br><b>CATCH-PIT3</b> | | | | |

| Scale: 1:295 | Position [m] | Code | Observation | Grade |
|---|---|---|---|---|
| | 0.00 | CP | Start node, catchpit, reference: CATCH-PIT3 | |

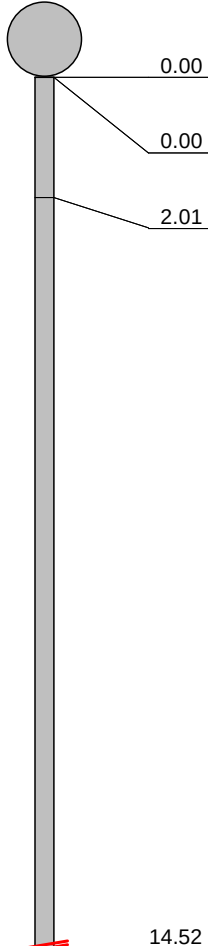
| Scale: | 1:126 | Position [m] | Code | Observation | Grade |
|---|---|---|---|---|---|
| <p>Depth: 0.55 m</p> <p>CATCHI-PIT</p> | | | | | |

| Scale: | 1:126 | Position [m] | Code | Observation | Grade |
|---|---|---|---|---|---|
| | 2.01 | CC | Crack, circumferential from 1 o'clock to 12 o'clock 2 / 2 | | |
