## Preliminary Roost Assessment

Hurstpierpoint College, Hurstpierpoint, Hassocks, West Sussex BN6 9JS

This report is prepared to inform two separate planning applications with the Mid-Sussex District Council. The proposal is described as:  
The demolition of a swimming pool and pavilion.

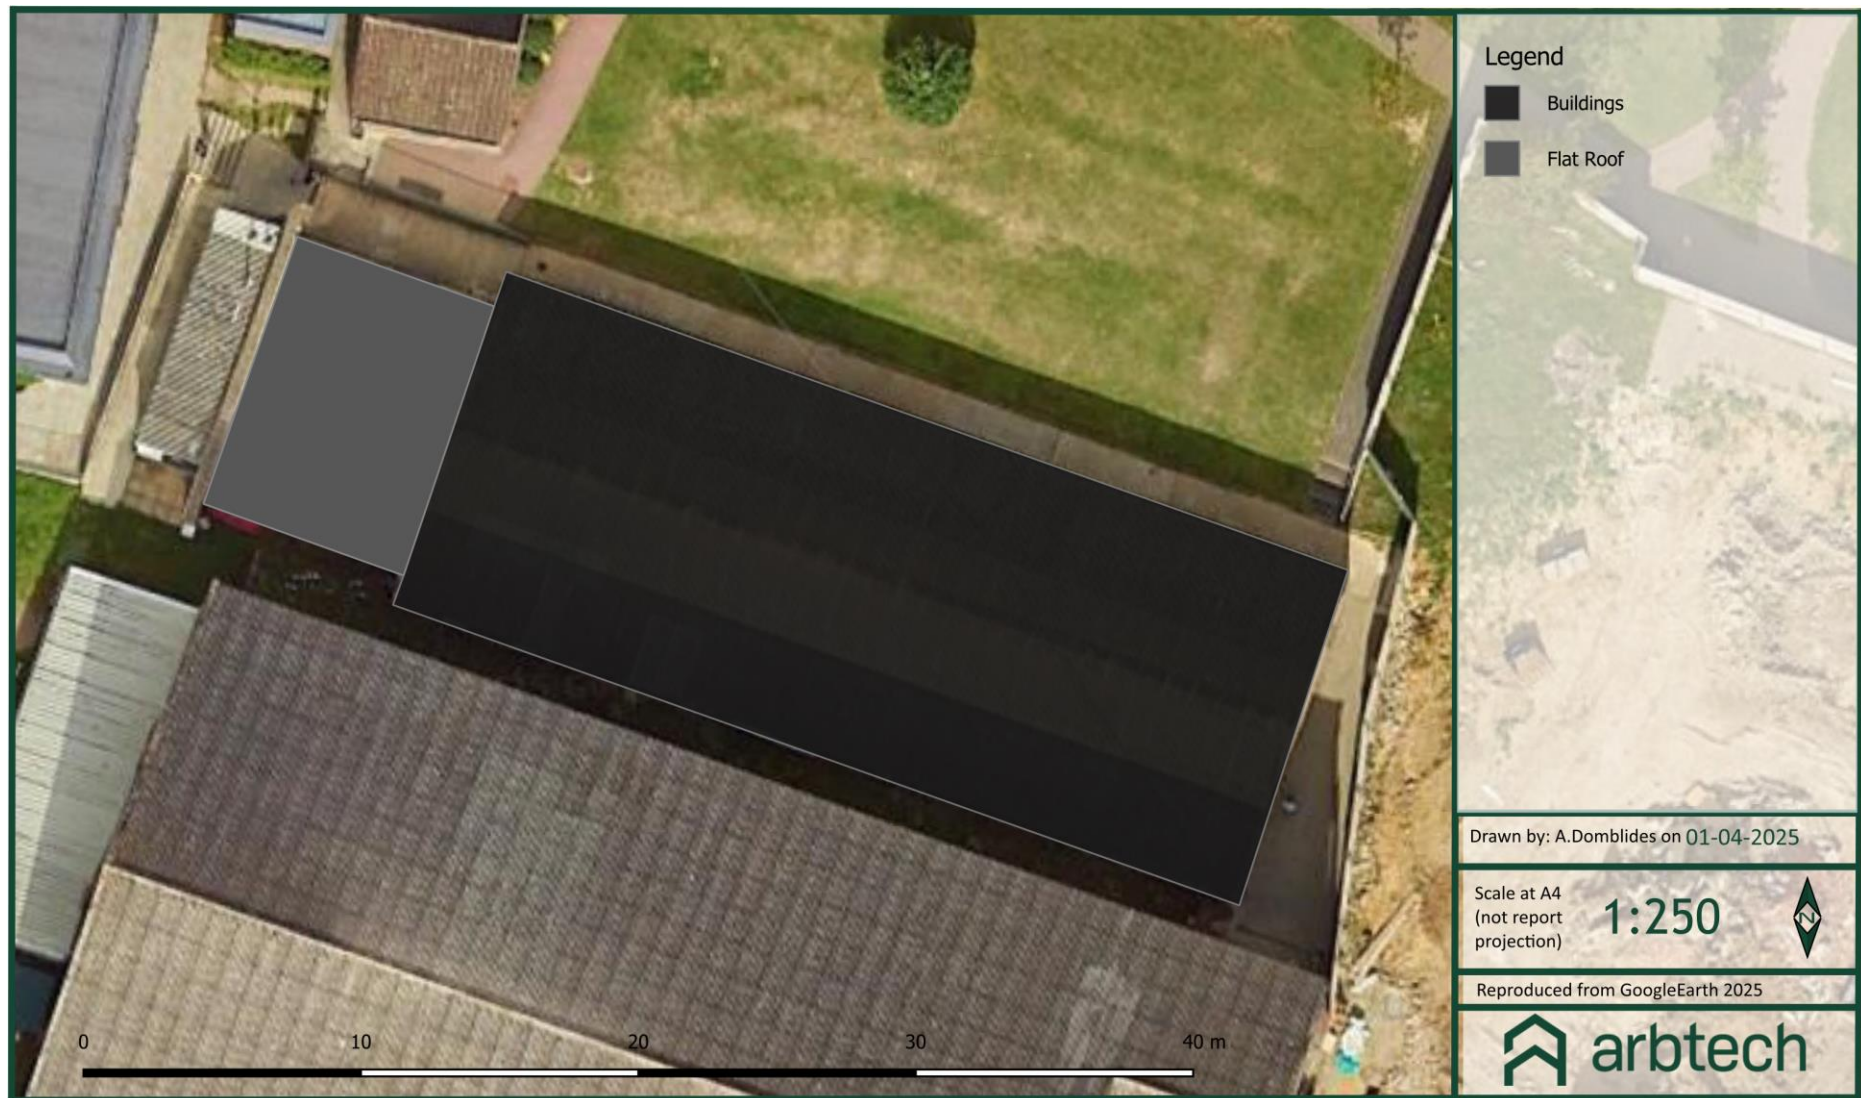
## Appendix 1: PRA plan – B1

| B1 – exterior | <p>The brick and mortar (Fig 2) and windows (Fig 3) appear to be in good condition and tightly fitting, leaving no gaps. There is one small area of lifted fascia board (Fig 4), however, this is blocked by a cable and is therefore not considered to be a suitable roosting feature.</p> <div style="display: flex; justify-content: space-around; align-items: flex-end;"> <div style="text-align: center;"> <p><b>Fig 2</b></p> </div> <div style="text-align: center;"> <p><b>Fig 3</b></p> </div> <div style="text-align: center;"> <p><b>Fig 4</b></p> </div> </div> <p>The asbestos roof appears tightly fitting with no gaps between sheets or at the ridge (Fig 5). There are occasional gaps beneath the asbestos sheet at the eaves (Fig 6), providing access to the interior of B1. As the roof is skinned, this does not provide any roosting opportunities for crevice dwelling bat species. The bitumen felt also appears to be in good condition and tightly fitting (Fig 7), leaving no gaps.</p> |

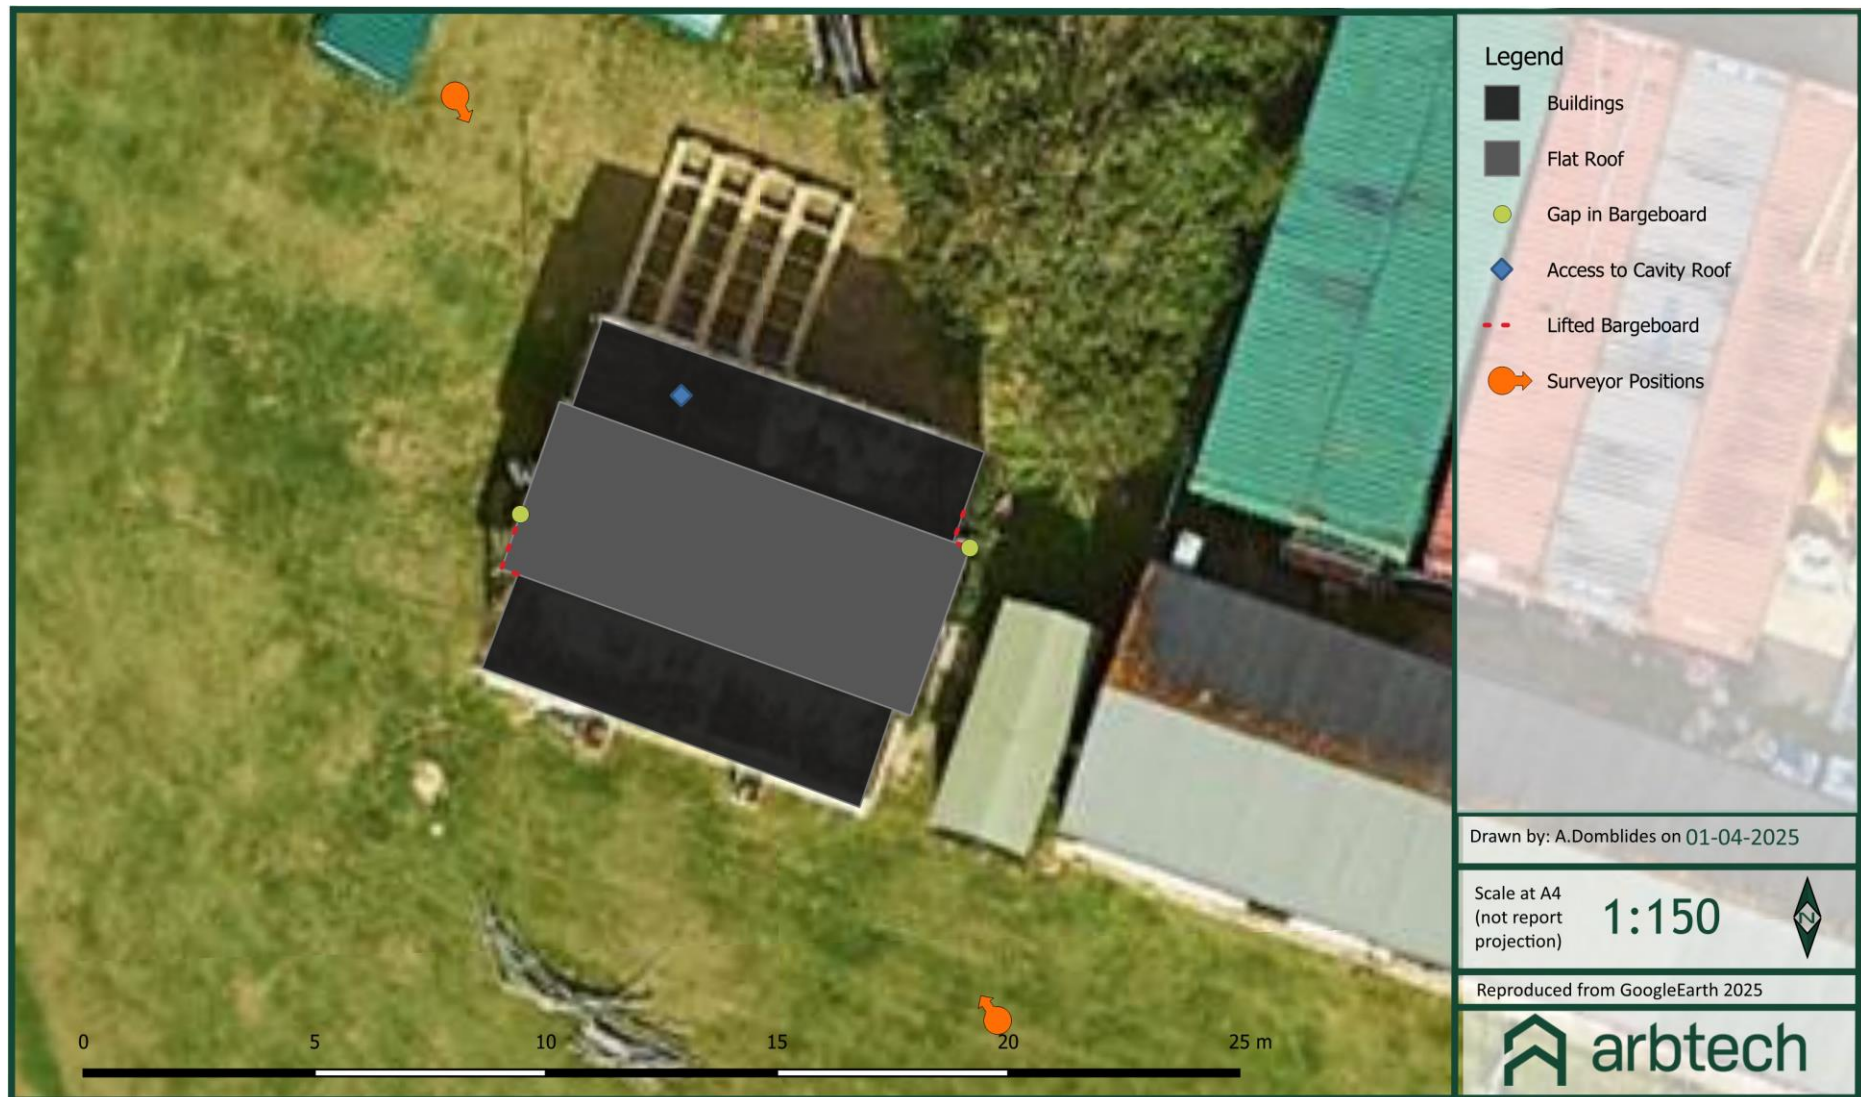
## PRA plan – B2

The bargeboard is lifted in places (Fig 15), leaving a gap between the bargeboard and wall. This provides a suitable roosting feature for crevice dwelling bat species. The timber bargeboard is also damaged in places (Fig 16, Fig 17), providing access to the cavity roof above the main portion of the building. As this cavity is a crawl space only with a false ceiling below, this is considered to be a suboptimal roosting location for void dwelling bat species due to minimal space for warm up flights.

| B2 – interior | <p>Due to high levels of light and frequent use (Fig 18), the interior of B2 is not considered to be suitable for roosting bats. While the crawl space between the false roof internally and the main roof was not accessed, it is considered to be sub-optimal for void dwelling bat species due to limited space for warm up flights. However, as access to the void was identified via damaged bargeboard, it is still possible that roosting bats may utilise this space.</p> <p><b>Fig 18</b></p> |

| <i>Recommendations</i> | <p>Two bat emergence surveys are required on B2 during the active bat season (May – September) to confirm presence/likely-absence of bats roosting in or on the building. These survey visits should be completed during the optimal survey period mid-May to August inclusive. The survey visits should be at least three weeks apart.</p> |
