# Flood Risk Assessment

Furlong House, Pitt Lane, Furlong House, Pitt Lane,  
Hurstpierpoint BN6 9QA

**Ref:** 10517

**Date:** September 2026

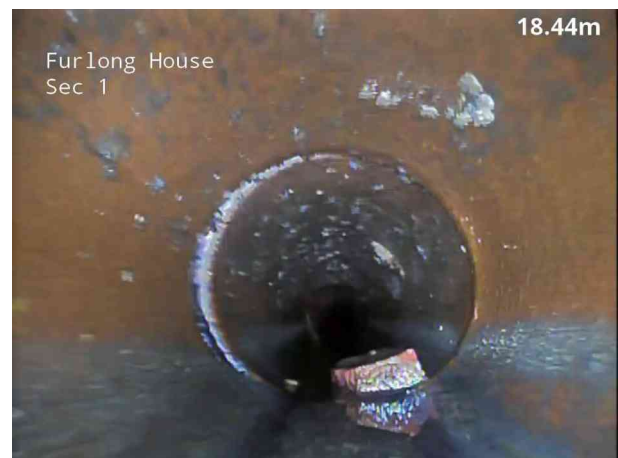
4, 00:03:19, 18.60 m  
Other obstacles, brick or masonry in invert at 5 o'clock, 5% cross-sectional area loss

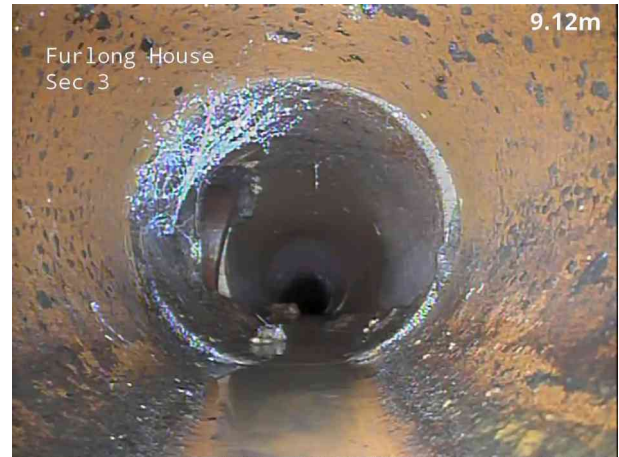
2, 00:01:08, 9.30 m  
Connection other than junction at 10 o'clock, 100mm dia

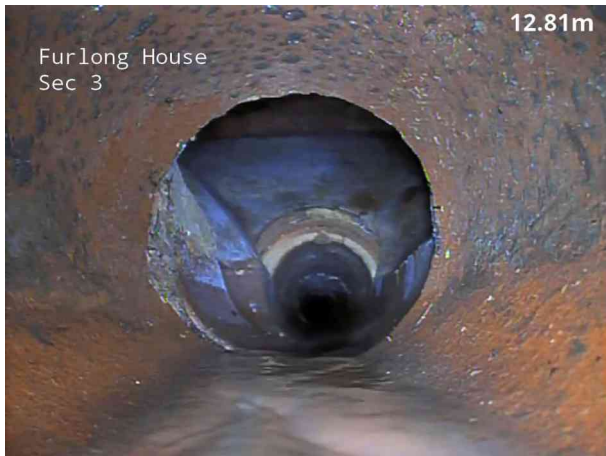
3, 00:01:43, 13.00 m  
Finish node, manhole, reference: EXFMH1403

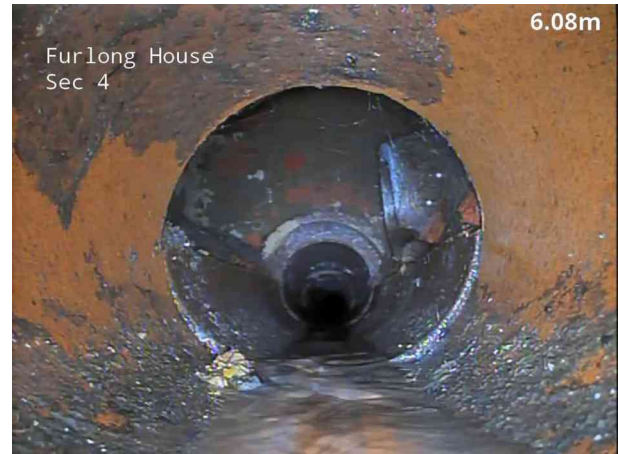
2, 00:00:50, 6.30 m  
Finish node, manhole, reference: EXFMH1403a

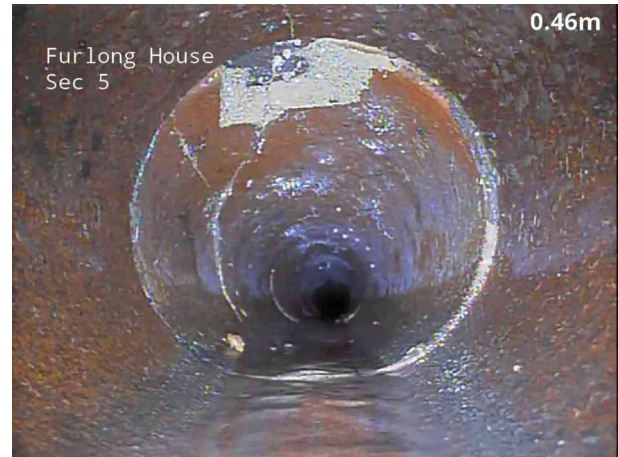
| No. | m+ | Code | Observation |
|---|---|---|---|
| 3 | 0.60 | FC | Fracture, circumferential from 7 o'clock to 12 o'clock |

2, 00:00:12, 0.60 m  
Fracture, circumferential from 7 o'clock to 12 o'clock

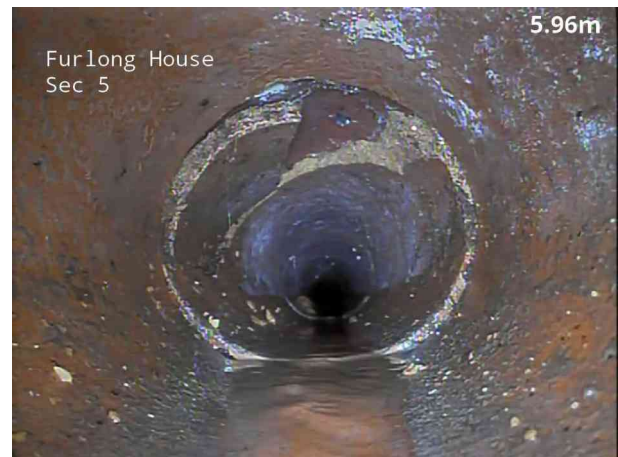
| No. | m+ | Code | Observation |
|---|---|---|---|
| 7 | 6.10 | FCJ | Fracture, circumferential at joint from 9 o'clock to 1 o'clock |

6, 00:00:57, 6.10 m  
Fracture, circumferential at joint from 9 o'clock to 1 o'clock

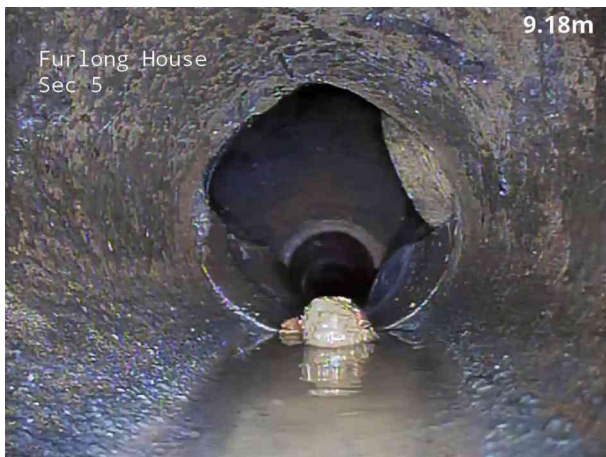
11, 00:01:59, 9.35 m  
Finish node, manhole, reference: EXFMH1403b

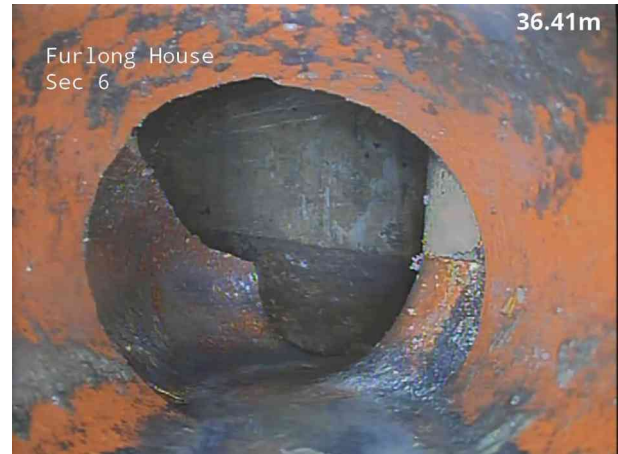
2, 00:04:44, 36.55 m  
Finish node, manhole, reference: F08a

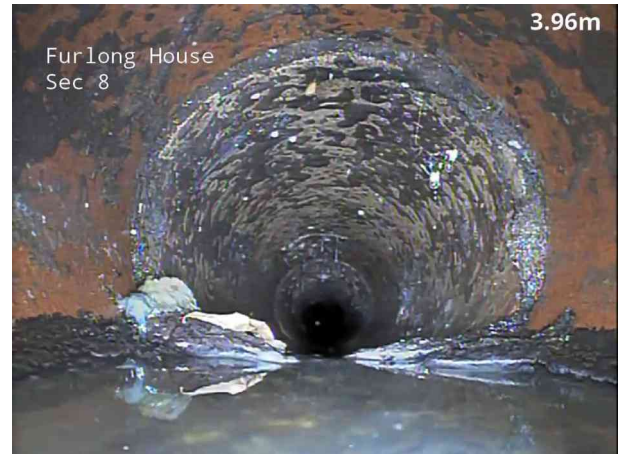
2, 00:00:41, 4.00 m  
Attached deposits, encrustation at joint from 4 o'clock to 8 o'clock, 5% cross-sectional area loss

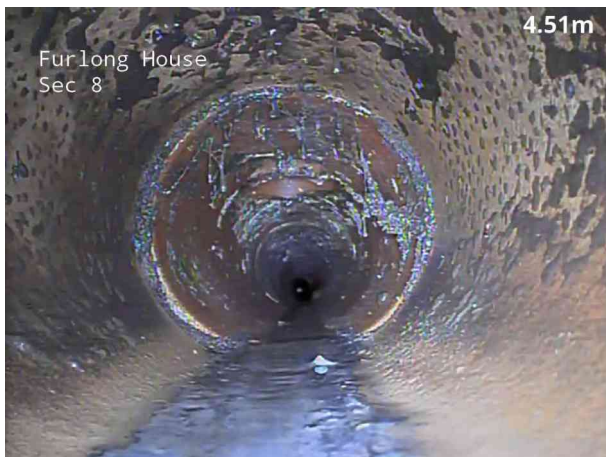
5, 00:00:52, 4.70 m  
Connection other than junction at 12 o'clock, 100mm dia

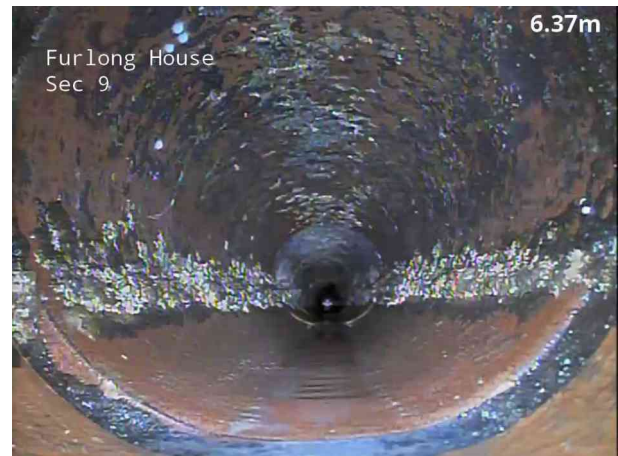
2, 00:00:50, 6.37 m  
Attached deposits, grease at 9 o'clock, 5% cross-sectional area loss, start

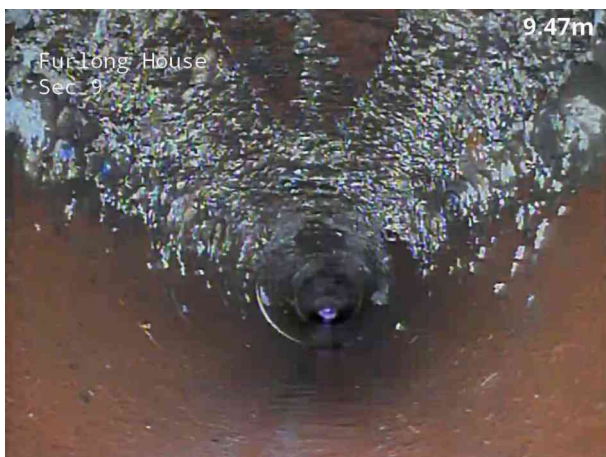
5, 00:01:13, 9.47 m  
Attached deposits, grease at 3 o'clock, 5% cross-sectional area loss, finish

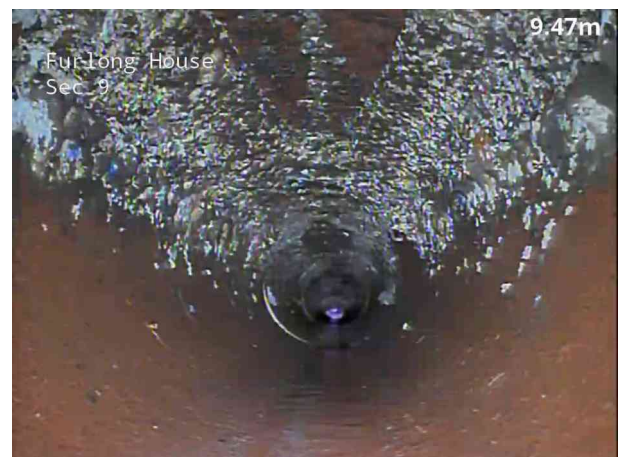
6, 00:01:13, 9.47 m  
Attached deposits, grease from 9 o'clock to 3 o'clock, 10% cross-sectional area loss, start

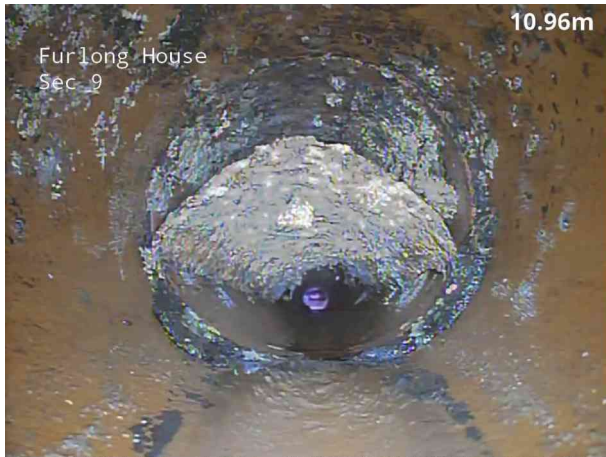
7, 00:01:30, 10.96 m  
Attached deposits, grease from 9 o'clock to 3 o'clock, 10%  
cross-sectional area loss, finish

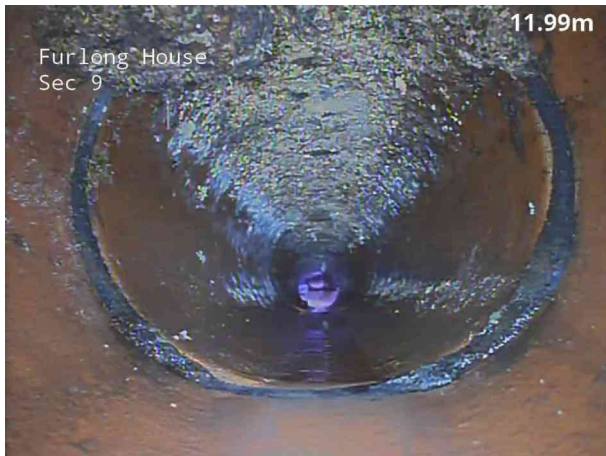
9, 00:01:42, 12.00 m  
Attached deposits, grease from 8 o'clock to 4 o'clock, 70%  
cross-sectional area loss, finish

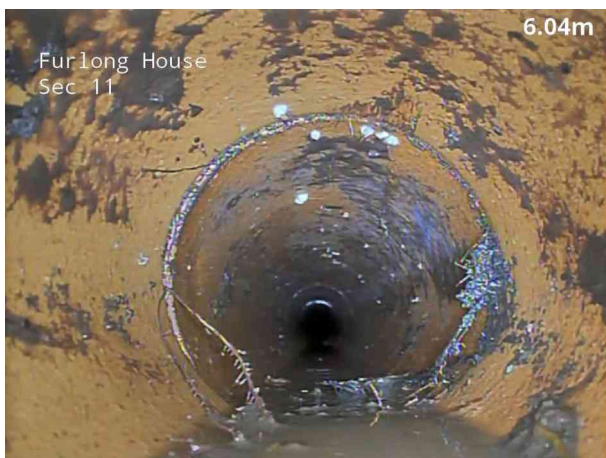
3, 00:00:47, 6.15 m  
Roots, fine at joint
