## **Sunte House & Outbuildings: Initial Structural Assessment**

22 11 24 .V1

Prepared By: Elizabeth Cattle MEng GMICE  
Checked By: Steve Atkinson BEng CEngMIStructE

**BUILT ENGINEERS**

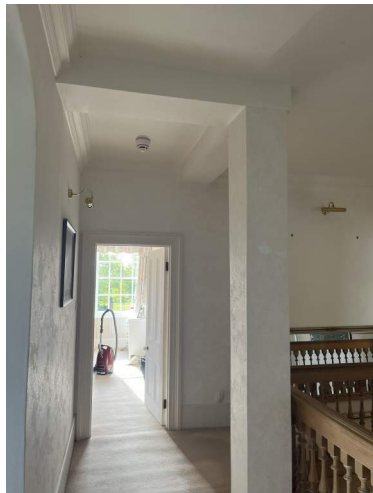
1 Boxed out downstand beam & column

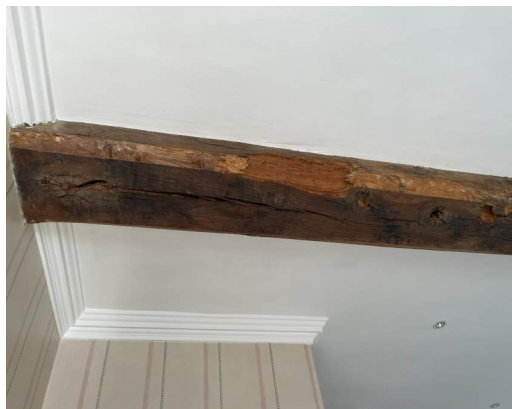
7 Downstand timber beam

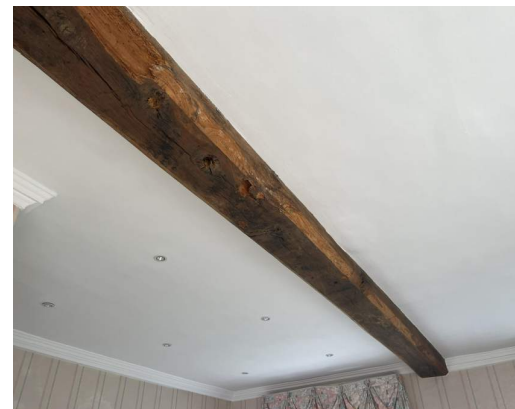
8 Downstand timber beam

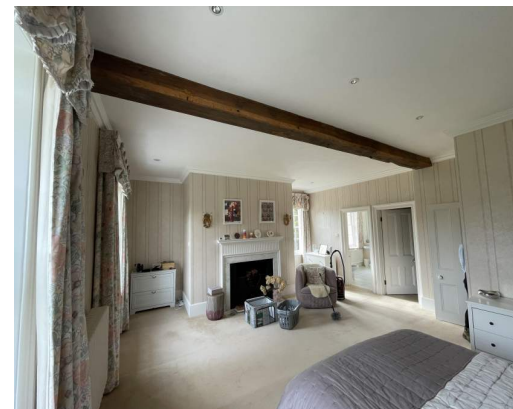
9 Downstand timber beam

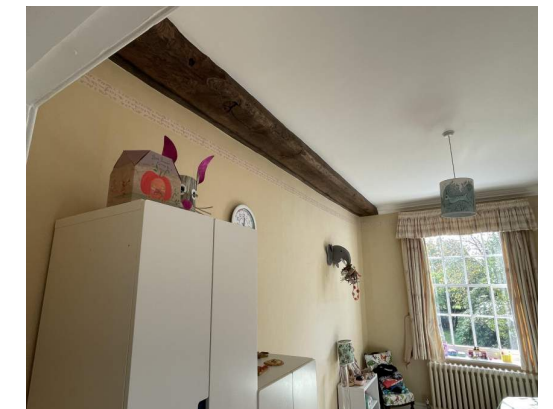
11 Non-load bearing partition built to underside of downstand timber beam

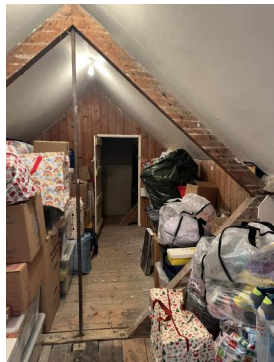
1 Late C19th addition roof truss

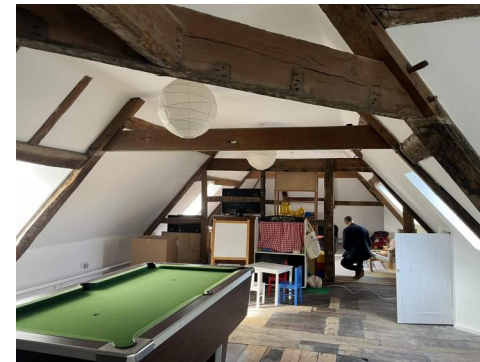
5 Staggered butt purlin roof with oak pegged tenons

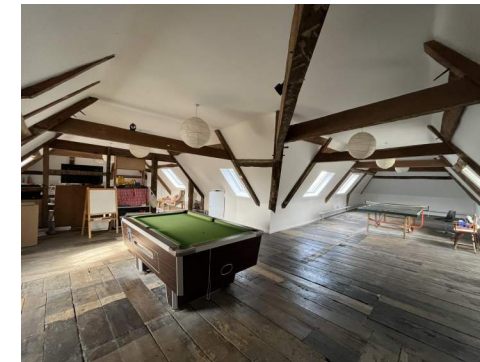
6 Principle rafters, purlins & ties partially visible below plaster

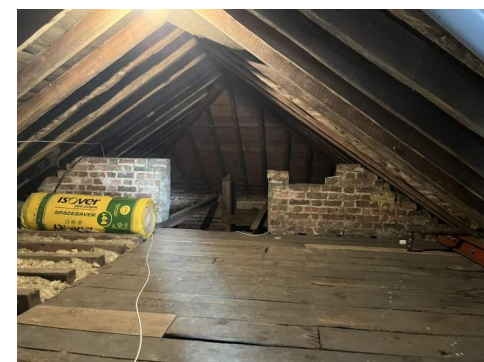
15 Original external wall parapet with later roof addition beyond

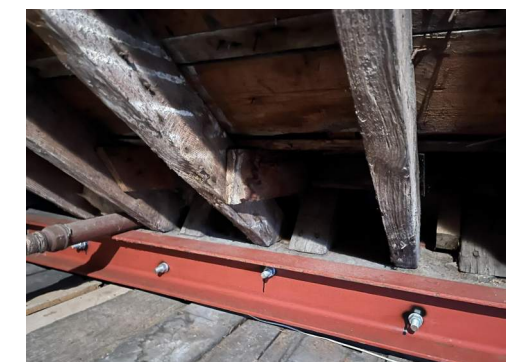
18 PFC either side of timber

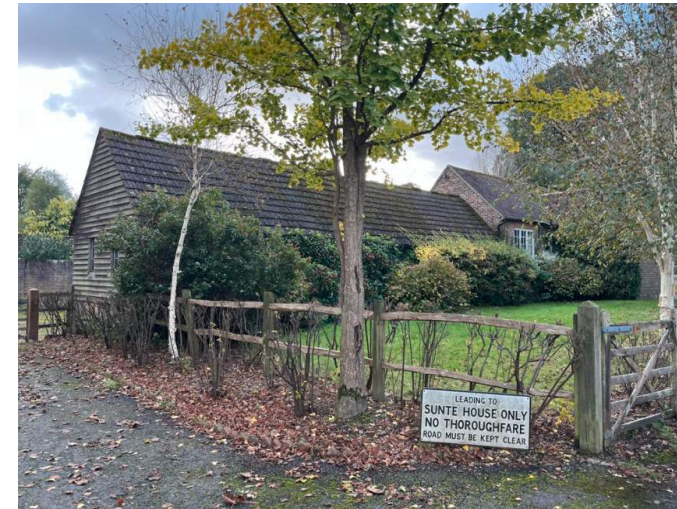
3 Northern elevation with extensive vegetation & Cottage gable wall

- areas of vegetation along the northern wall invading roof verges harbouring damp and causing physical damage, to be carefully cut back and managed as a matter of urgency with the external northern wall then inspected

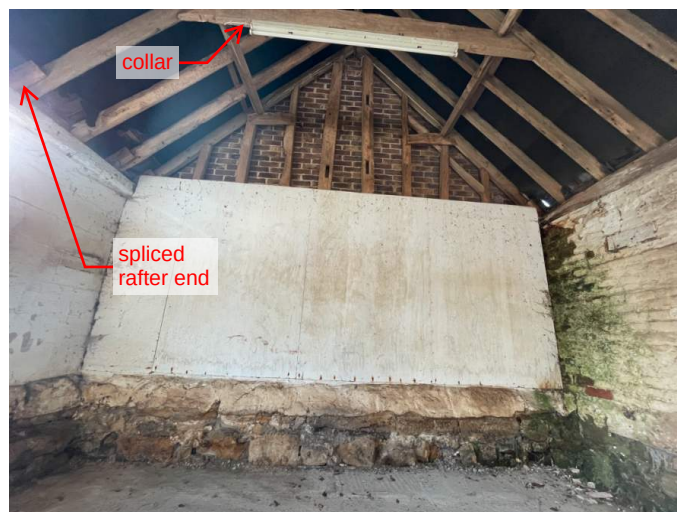
6 Original timber framed stable external wall, cottage wall built against stables

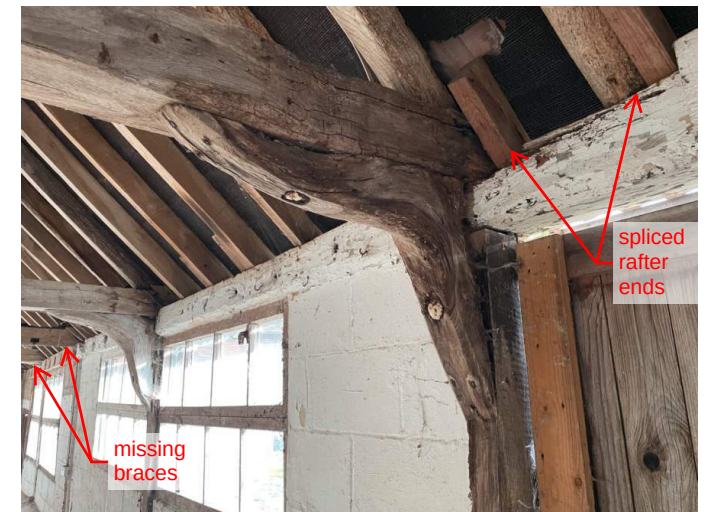
9 Typical timber framing on southern wall

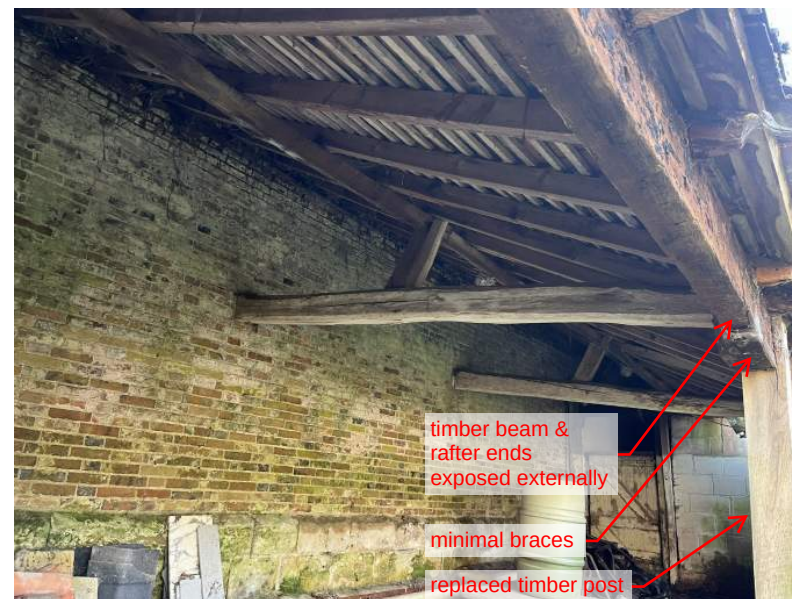
6 Typical roof construction & rear wall

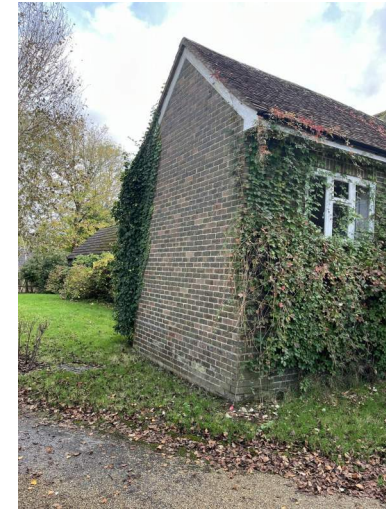
3 Gabled extension; appears to be a later addition in cavity masonry

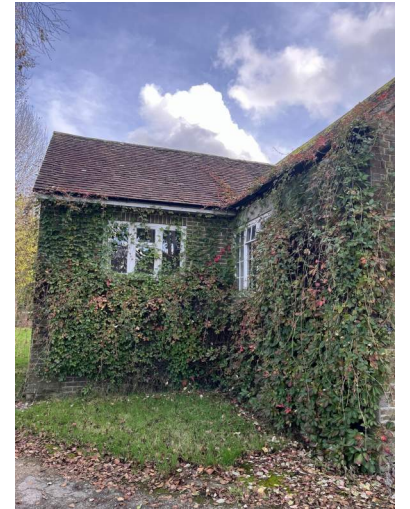
4 Extension - roof hipped onto original

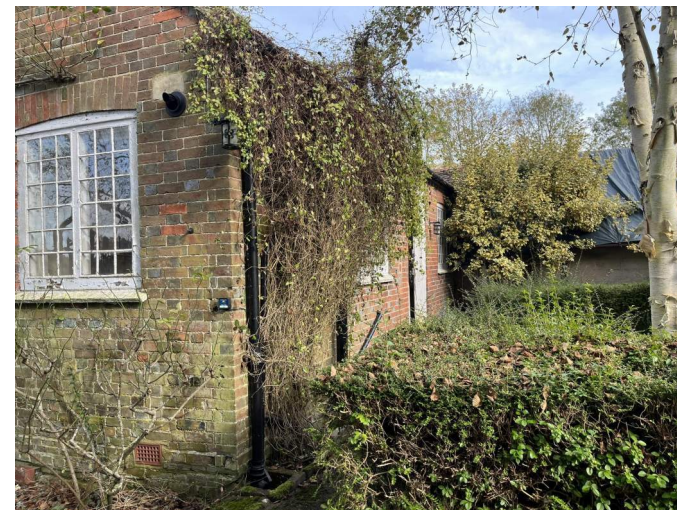
7 Southern elevation facing garage

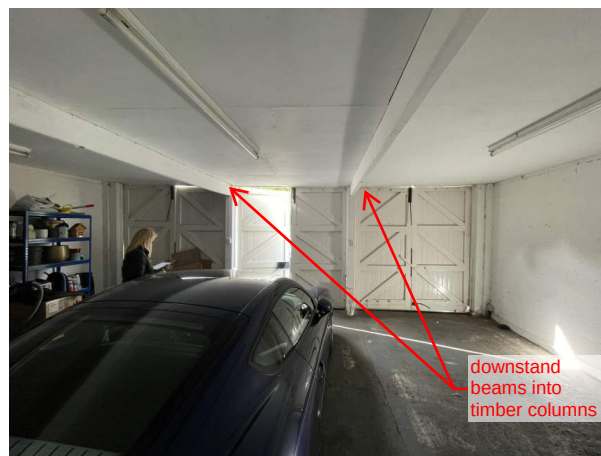
6 2no. downstand beams into timber columns

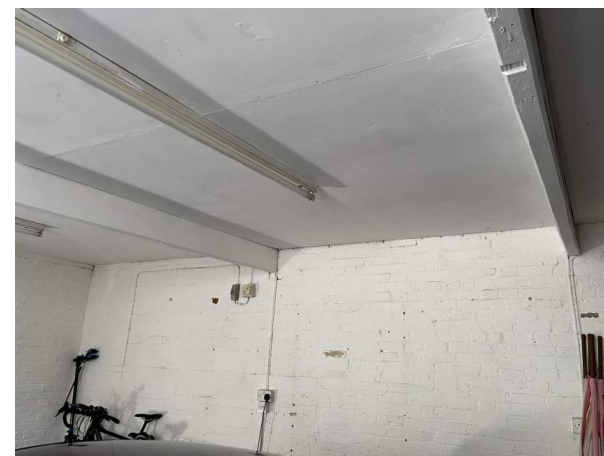
7 Downstand beams bear into rear elevation masonry

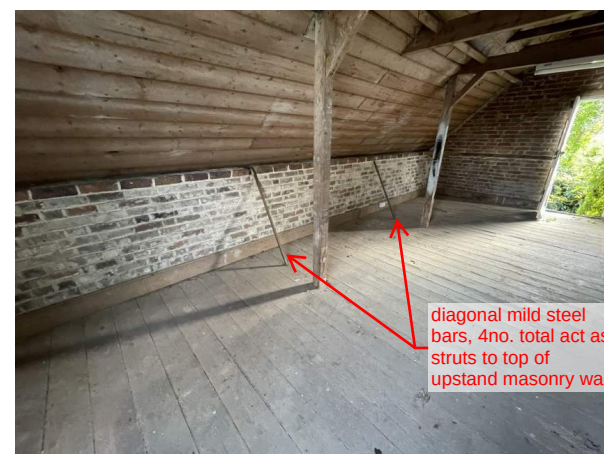
11 Historic ties from roof to floor

- historic remedial work to restrain the flank walls and prevent outwards lateral movement, with steel diagonal ties from the top of the flank walls to the floor
- infestations of damp and wood worm to be surveyed by conservation specialist
- areas of vegetation also invading roof verges harbouring damp and causing physical damage along south & east walls roof edge needs to be carefully cut back and managed as a matter of urgency
- cracking (C) to solid brick northern elevation: brick stitching repairs will be required
- slab throughout: level accuracy, dpm, reinforcement and sub base unknown

timber floor to be retained, condition and dimensional flatness of existing joists to be reviewed with Architect, allow for replacement or provision of extensive firrings, historic ties to be retained, floor feels springy underfoot and may require structural strengthening if more permanent residential usage function required

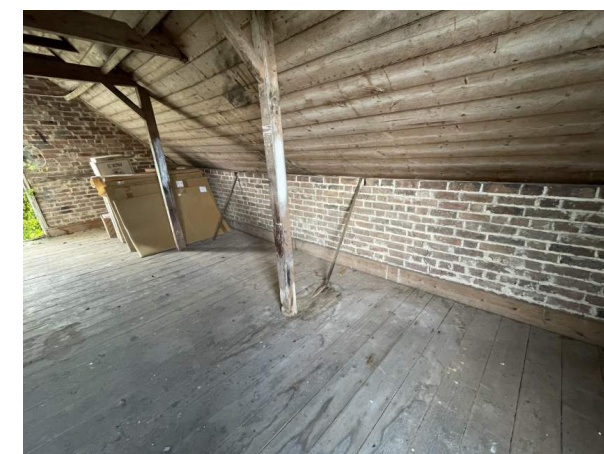
12 Remedial struts & timber structure

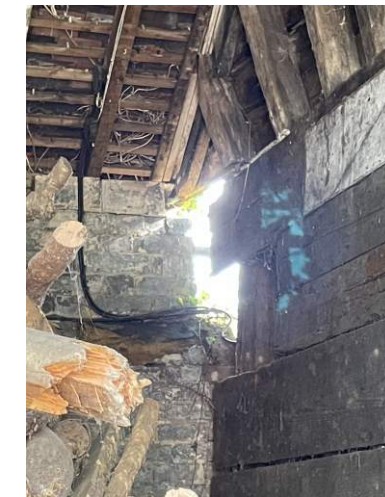
10 Hole in southern wall

- masonry typically in good condition but some local repointing required, with loose joints specifically noted on the rear wall
- hole in southern wall, to be made weather proof as a matter of urgency
- timber walls and roof framing generally in a good condition although infestations of damp and wood worm should be surveyed by conservation specialist

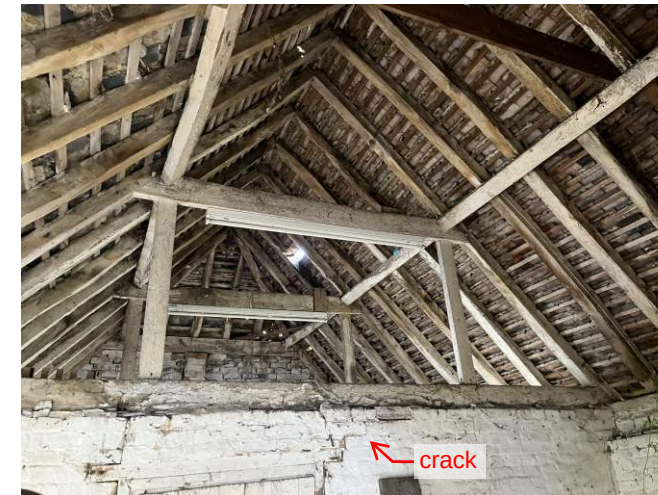
3 Internal dividing wall with timber framing over

- cracking (C) and open mortar joints in internal dividing brick wall, brick stitching repair / rebuilding will be required

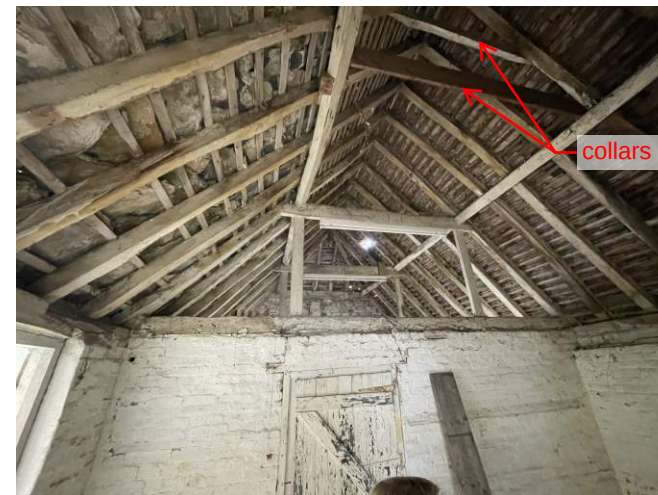
5 Timber framing & internal wall

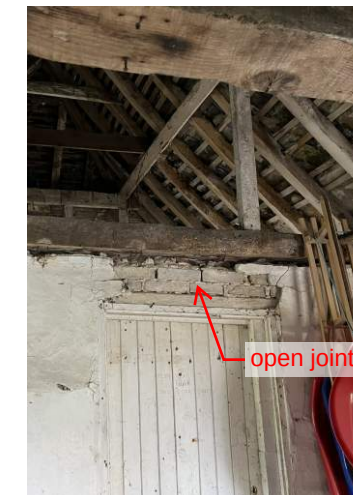
7 Lintel in internal wall

existing brick wall under truss, plastered on northern face, damage / cracks (C) over door lintel - plaster to be removed to fully reveal condition of wall and the requirement for repair / remediation to suit the proposed scheme, assume opening infilled in fully toothed and bonded matching brick with cracked areas rebuilt and timber lintel removed, lightweight timber infill to truss above existing brick wall, new lintel to new opening

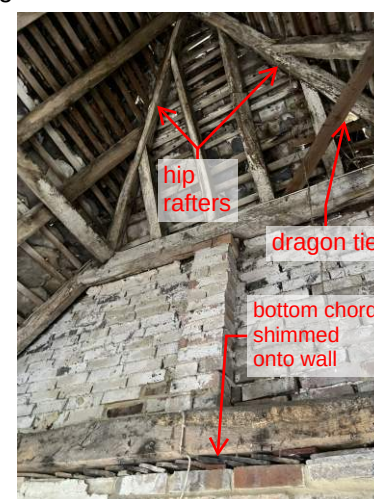
9 Northern gable end wall

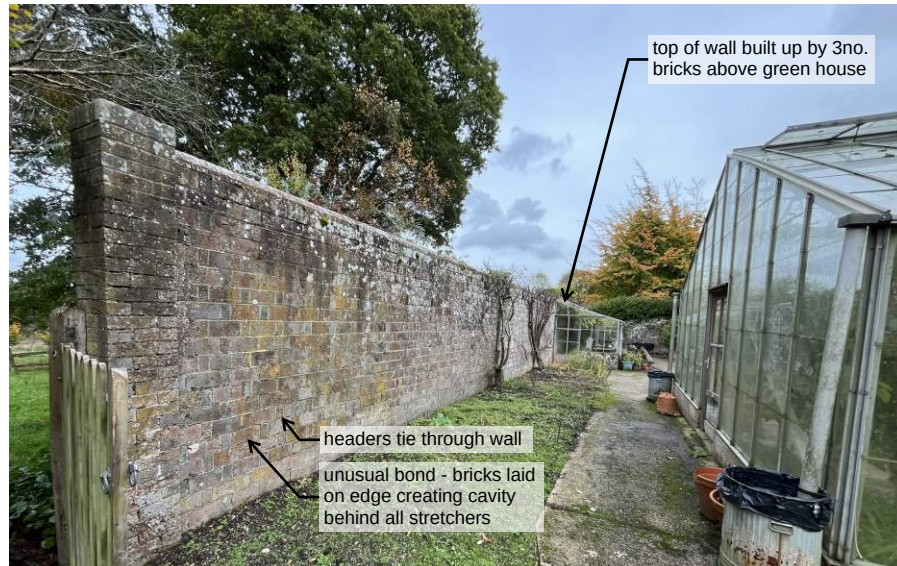
1 Wall behind green houses, to form rear wall of swimming pool building

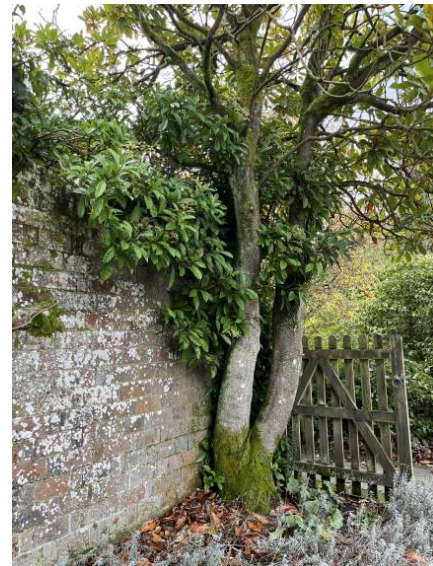
2 Laurel tree at wall end has grown against wall & is causing wall to lean

A 9" brick wall forms the boundary on two sides to the kitchen garden. The length of the wall appears to have been constructed with the bricks on edge leaving a cavity behind stretcher bricks with the headers tying the leaves together. The bricks in the piers are conventionally orientated creating solid brick piers. The wall is generally in good condition along the northern boundary but there is evidence of previous stabilising measures with 2no. pattress plates on the eastern wall. The wall end is unstable at the end where the close proximity to a Laurel tree has caused the top of the wall to lean out.

Urgent stabilising work is required to the wall end where damaged and leaning due to the laurel tree.

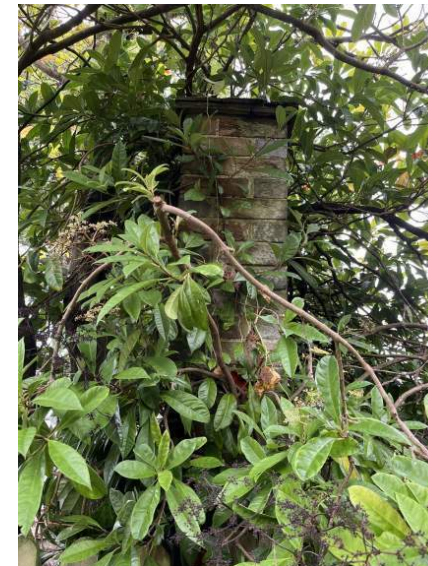
3 Visible excessive lean to wall end, not measured but approx 50-75mm over full height

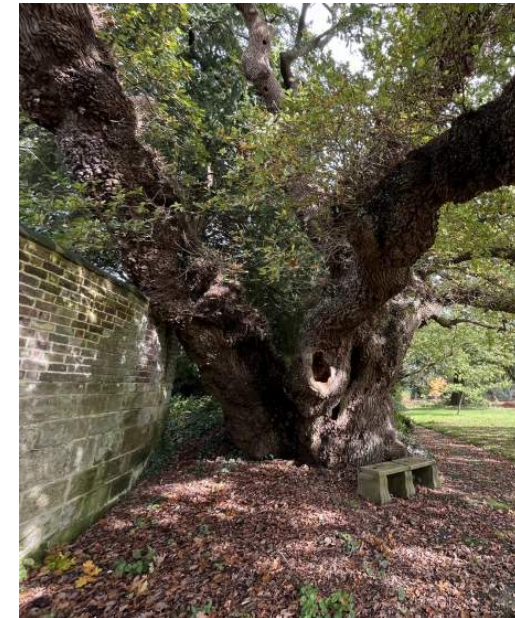
2.2 Visible distortion of wall by the oak tree

- the oak has 3 substantial main stems growing out of a hollow and decayed main trunk and these 3 main stems and the wall appear to be at risk of collapse
- it is recommended that the tree be stabilised by insertion of steel tie bars or cables
- the advice of a specialist tree surgeon should be sought, area around wall to be cordoned off as a matter of urgency
- further measure for the repair and stabilisation of the wall to be developed in ensuing design stages
