## Preliminary Roost Assessment

12 & 14 Eastern Road, Haywards Heath, West Sussex RH16 3NN

Proposed demolition of existing lean to stores at the rear of each house and erection of two storey rear and side extensions with recessed balconies in order to enlarge the existing 4x flats. Loft conversions and roof extensions that include front dormers and rooflights. New dropped kerb and parking area to the front for 5 cars.

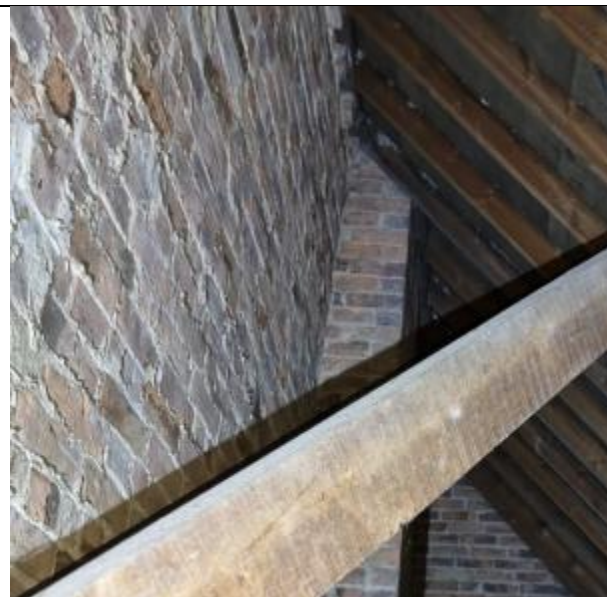
| Lofts/Internal voids |
|---|
| <p>The loft space is half-cross-shaped, and separated from the mirror-image loft of B2 by a brick wall. Several bricks in the wall are missing, presumably to aid air-flow, which could connect the space for bats.</p> <p>The NW-SE portion of the loft measures approximately 12.5m (L) x 3m (W) with a maximum height of 3m sloping to the floor. The 3m height continues throughout the NE-facing gable section, which measures 7m (L) x 5m (W) from the dividing wall.</p> <p>The loft is ridge-and-rafters, though the central ridge is completely covered by the dividing wall. There is a chimney built into the dividing wall which is well-sealed.</p> <p>The lining is Type 1-F bitumen felt and is in excellent condition with no visible tears. The gables are all well-sealed and heavily cobwebbed. The floor is thickly covered with mineral wool. No evidence of bat usage was found on the walls, nor either atop nor underneath the mineral wool. There was no light ingress into the loft.</p> |

Missing bricks in dividing wall

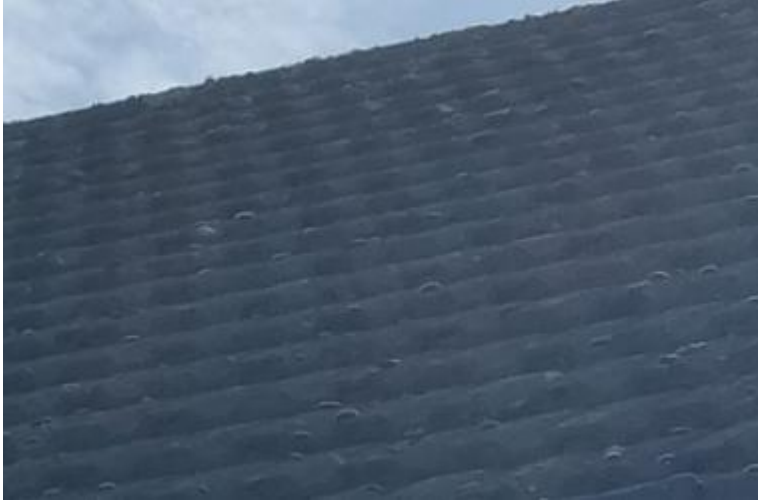
| <p>Roof tiles</p> | | |

The roof is covered with interlocking concrete tiles which are in good condition and offer no roosting opportunities for crevice-dwelling species. The only exception to this is an area of the central roof where the cross-ridges meet. There is an area of raised tiles and flashing approximately four feet long under the apex which provides roosting opportunity for crevice-dwelling species.

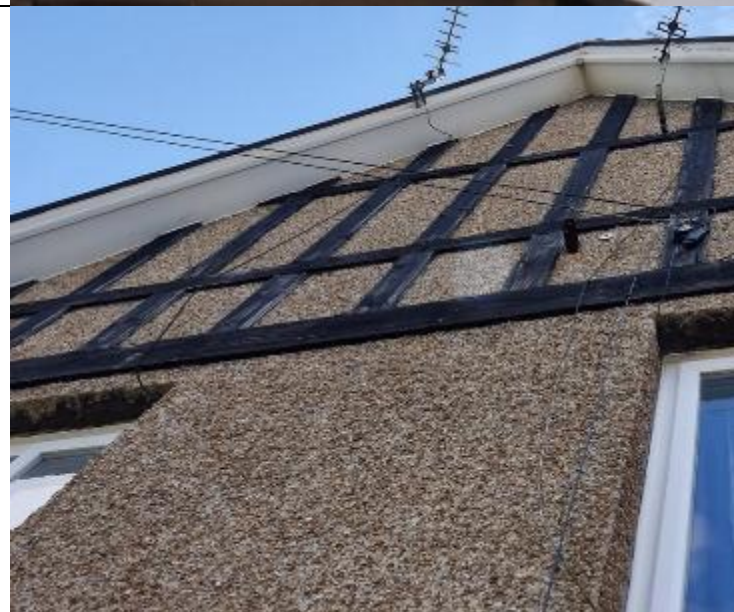
The walls are of brick construction, with pebble-dashing on all of the walls above the ground floor. The NW-facing gable is adorned with crossed wooden panelling, but do not leave any space underneath for bat access.

Front gable with crossed boarding

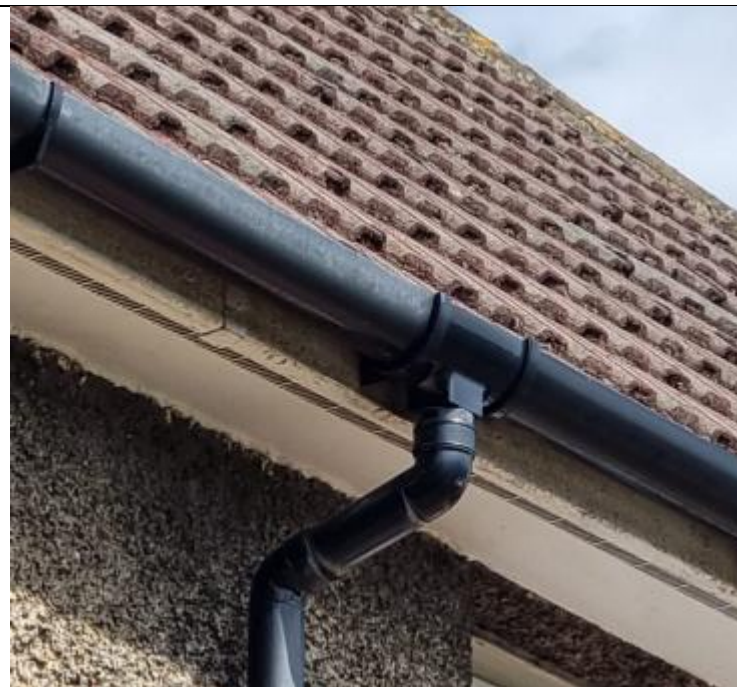
The soffits and boarding at eaves level, including at each gable, are very well sealed, providing no access for bats to internal spaces or to the wall-tops. The chimney is well-sealed all the way around with the flashing flush to the tiles around it.

Eaves

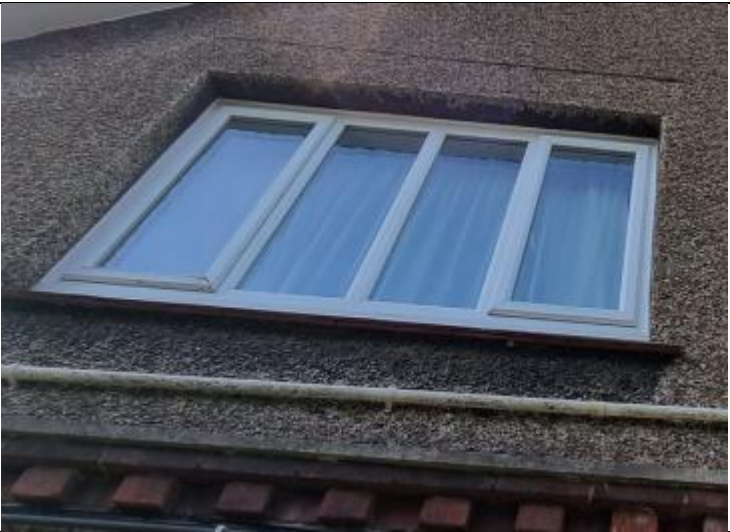
The windows are all tightly sealed with no gaps above the lintels or below the sills.

| <p>Windows</p> | |

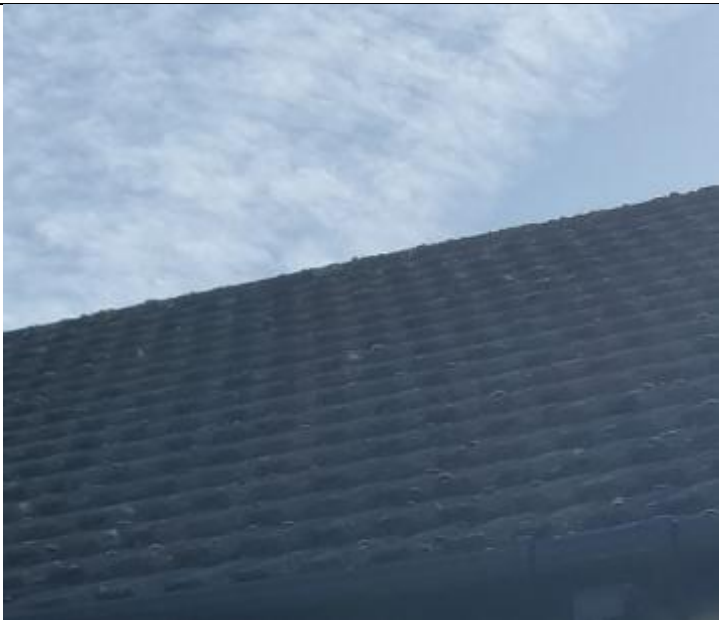
| <p>Roof tiles</p> | |

The roof is covered with interlocking concrete tiles which are in good condition and offer no roosting opportunities for crevice-dwelling species apart from the following exceptions:

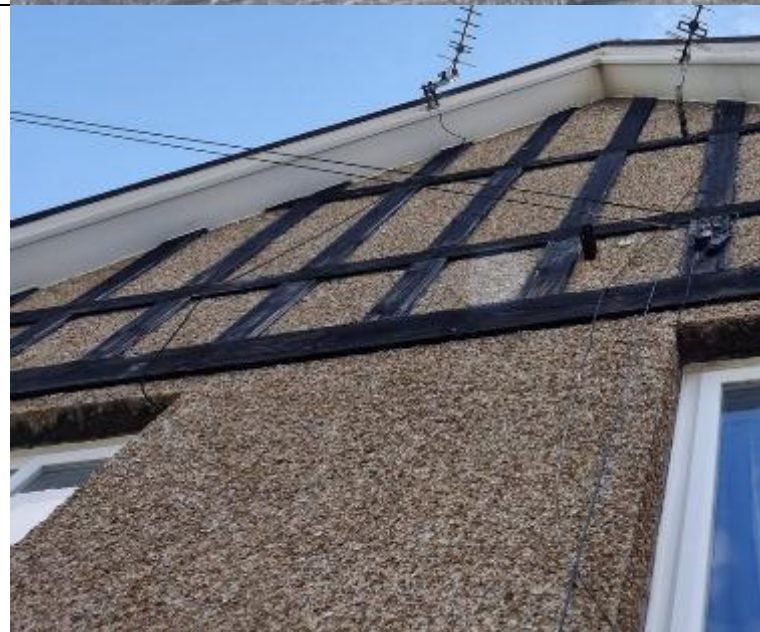
The walls are of brick construction, with pebble-dashing on all of the walls above the ground floor. The NW-facing gable is adorned with crossed wooden panelling, but do not leave any space underneath for bat access.

Front gable with crossed boarding

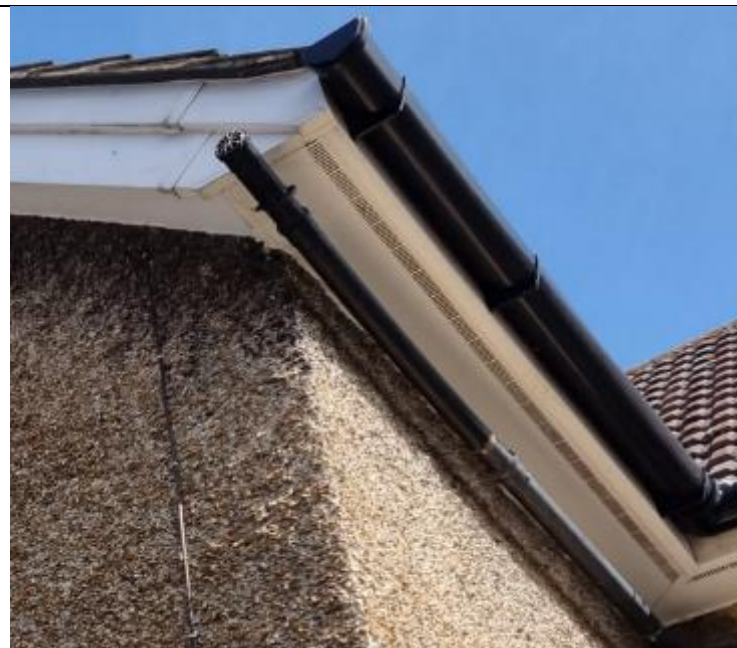
The soffits and boarding at eaves level, including at each gable, are very well sealed, providing no access for bats to internal spaces or to the wall-tops. The chimney is well-sealed all the way around with the flashing flush to the tiles around it.

Eaves

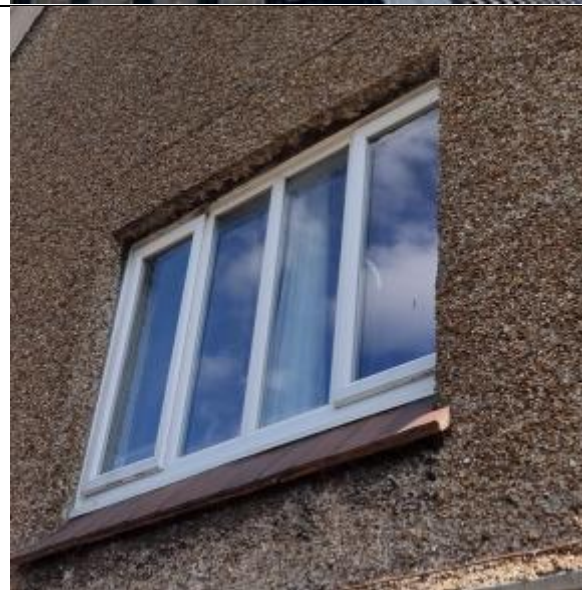
The windows are all tightly sealed with no gaps above the lintels or below the sills.

Windows
