# flood risk assessment

PROJECT  
**Crabbet Park (Unit 5), Mid Sussex**

REFERENCE  
**CCE/ZG181/FRA-01**

DATE  
**June 2025**

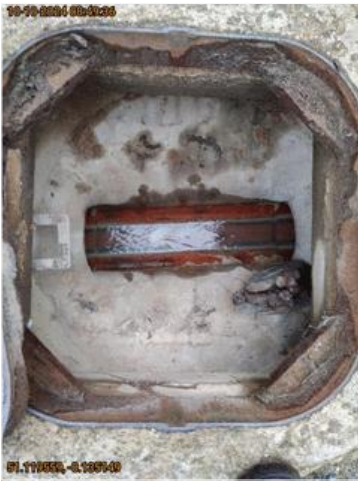
| Sheet A1 | | Photo | | | |

| Sheet A1 | | Photo | | | |
|---|---|---|---|---|---|
| Inspection Chamber | MH1 | | | | |
| Condition | Good | | | <input checked="" type="checkbox"/> | |
| Details | | No recommendations | | | |

| Sheet A1 | | Photo | | | |
|---|---|---|---|---|---|
| Recommendations | | No recommendations | | | |

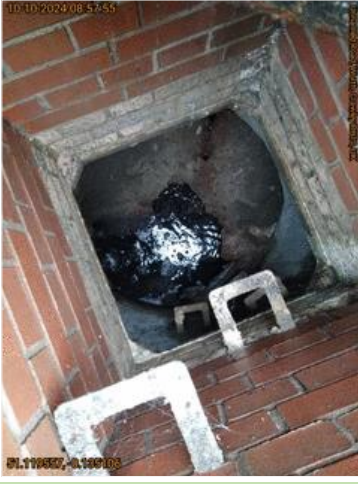
| Sheet A2 | | Photo | | | |
|---|---|---|---|---|---|
| Inspection Chamber | MH2 | | | | |
| Condition | Good <input checked="" type="checkbox"/><br>Fair <input type="checkbox"/><br>Poor <input type="checkbox"/> | | | | |

| Sheet A2 | | Photo | | | |
|---|---|---|---|---|---|
| Recommendations | | No recommendations | | | |

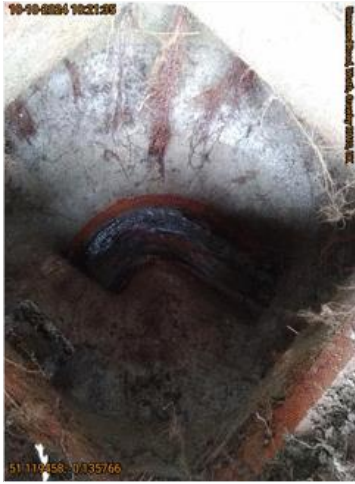
| Sheet A3 | | Photo | | | |

| Sheet A3 | | Photo | | | |
|---|---|---|---|---|---|
| Inspection Chamber | MH3 | | | | |
| Details | | No recommendations | | | |

| Sheet A3 | | Photo | | | |
|---|---|---|---|---|---|
| Recommendations | | No recommendations | | | |

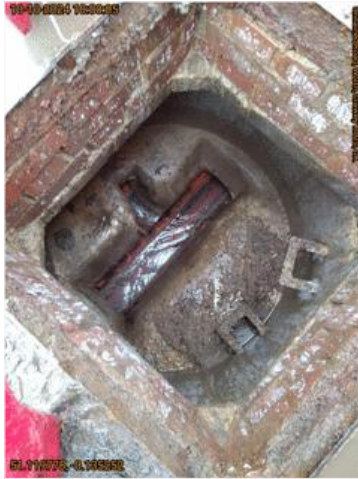
| Sheet A4 | | Photo | | | |

| Sheet A4 | | Photo | | | |
|---|---|---|---|---|---|
| Inspection Chamber | MH4 | | | | |
| Condition | Good | | | <input checked="" type="checkbox"/> | |
| Details | | No recommendations | | | |

| Sheet A4 | | Photo | | | |
|---|---|---|---|---|---|
| Recommendations | | No recommendations | | | |

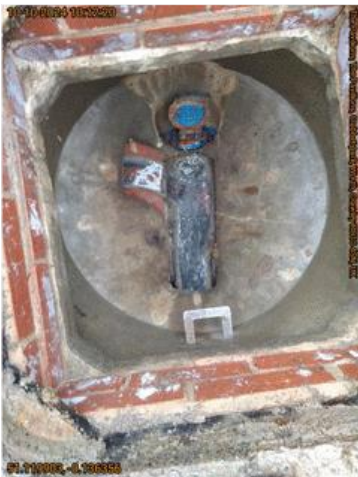
| Sheet A5 | | Photo | | | |

| Sheet A5 | | Photo | | | |
|---|---|---|---|---|---|
| Inspection Chamber | MH5 | | | | |
| Condition | Good | <input checked="" type="checkbox"/> | | | |
| Details | | No recommendations | | | |

| Sheet A5 | | Photo | | | |
|---|---|---|---|---|---|
| Recommendations | | No recommendations | | | |

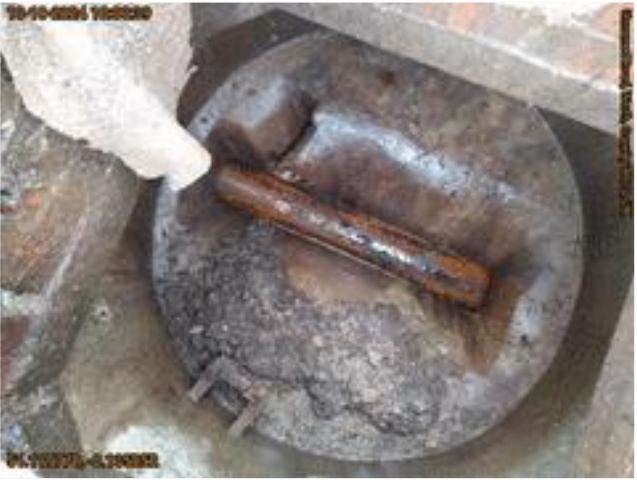
| Sheet A6 | | Photo | |

| Sheet A6 | | Photo | |
|---|---|---|---|
| Inspection Chamber | MH6 | | |
| Condition | Good | <input checked="" type="checkbox"/> | |
| Details | | No recommendations | |

| Sheet A6 | | Photo | |
|---|---|---|---|
| Recommendations | | No recommendations | |

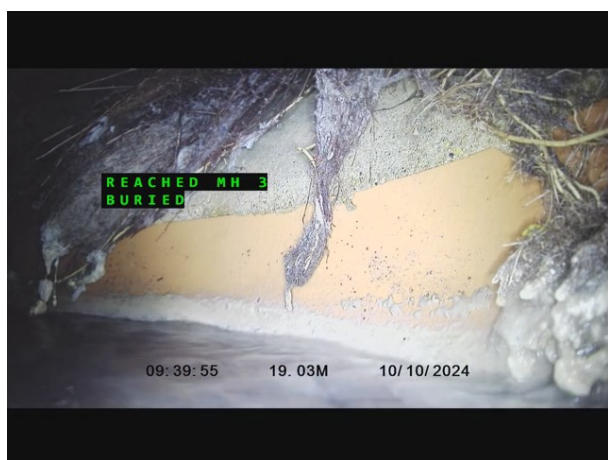
3, 00:00:51, 19.02 m  
Finish node, manhole, reference: MH3, Buried

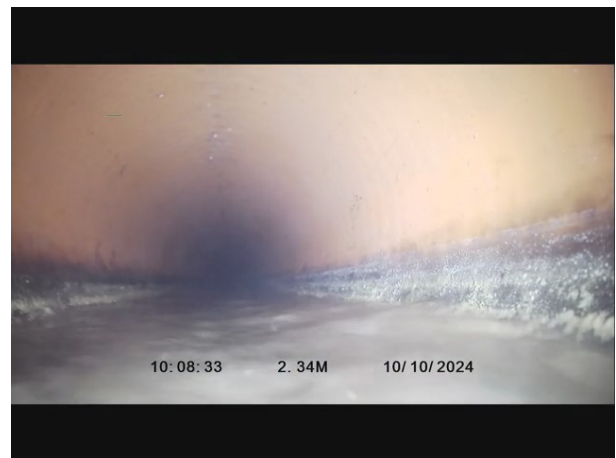
4, 00:00:14, 2.34 m  
Water level, 15% of the vertical dimension

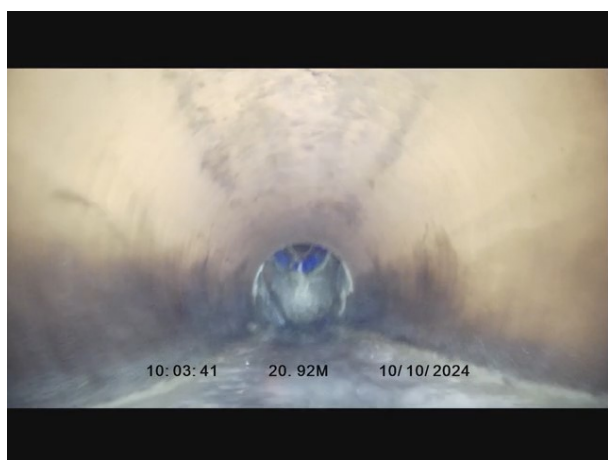
3, 00:01:05, 20.92 m  
Water level, 5% of the vertical dimension

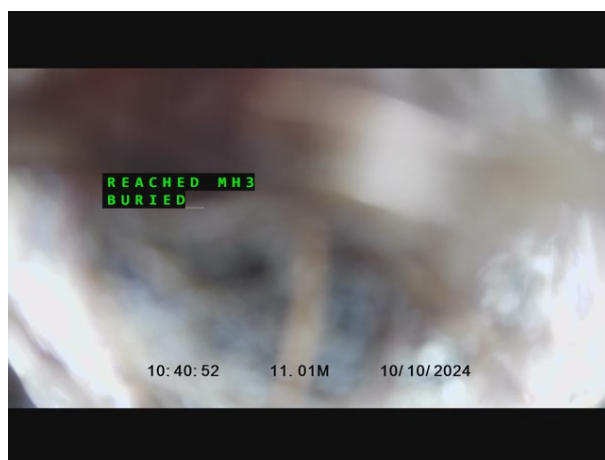
4, 00:01:00, 11.01 m  
Finish node, manhole, reference: MH3, Buried

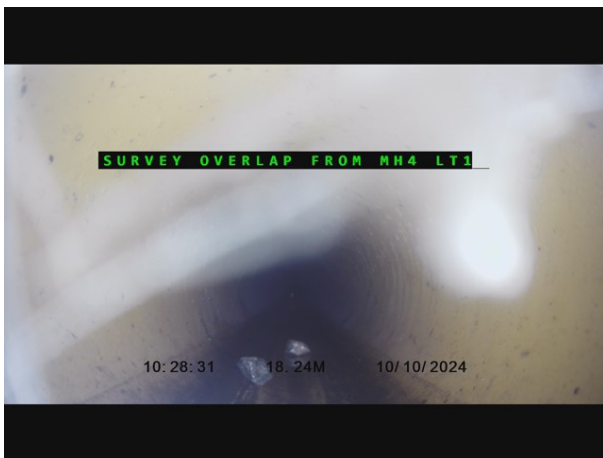
3, 00:01:15, 18.24 m  
Survey abandoned, Overlap of MH4 Lateral 1 Completed

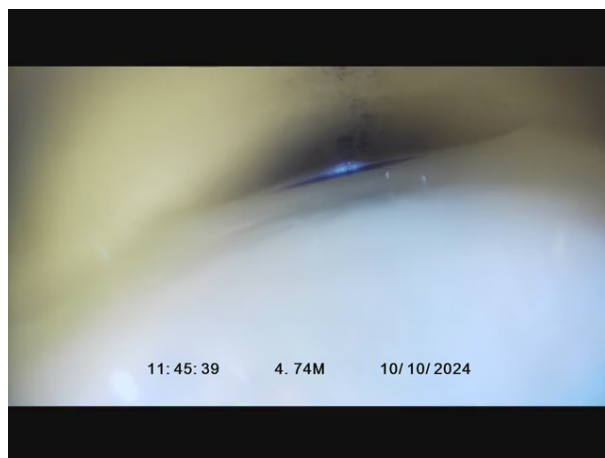
4, 00:00:44, 4.74 m  
Water level, 80% of the vertical dimension
