## Arboricultural Report

Date: 18/03/2025

Site Address: 14 Lucastes Road, Haywards Heath

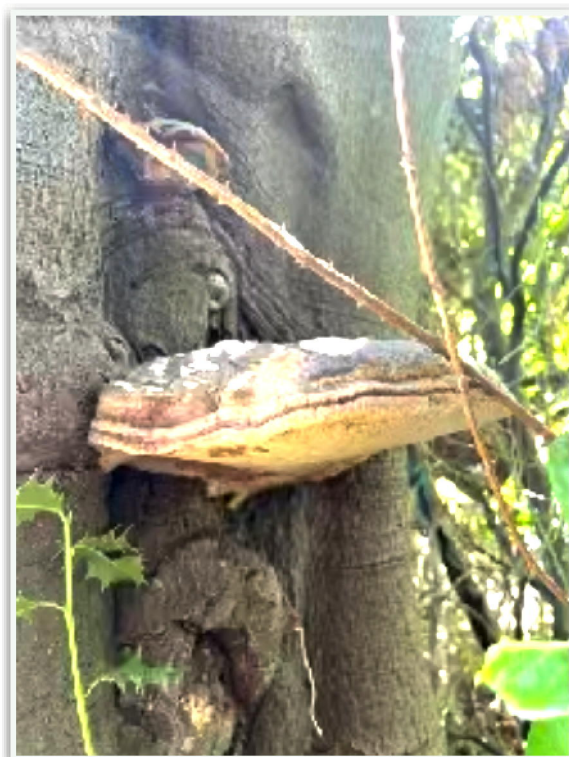
There are also some areas of *Kretschmeria deusta* present at base/rootplate and on the stem at 2.5m, a fungi particularly associated with failure in Beech trees.

*Ganoderma ssp. fungal fruiting bodies.*

**I therefore recommend that the tree is felled within 6 months.**
