Supporting Statement for Applications  
[refs. DM/25/2654 and 2655]  
**Wykehurst House, nr Bolney RH17 5QQ**

### **Introduction**

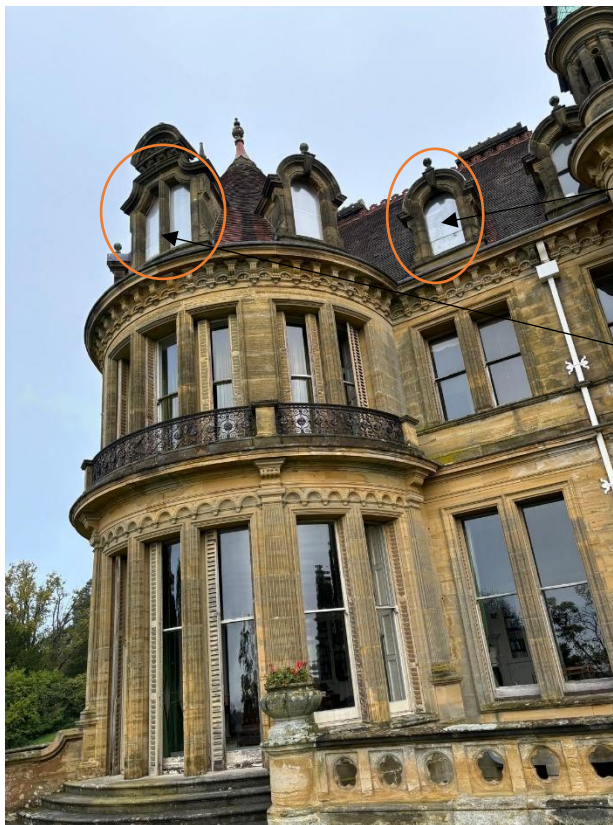
We also attach photographs of original window locations; at the time the building was acquired. Although we do not have records of every window (due to repairs being initiated prior to our engagement) the images show that many window frames had already been removed, with simple softwood frames being installed to support polycarbonate sheeting (inside and out) for basic, but insufficient, weather protection.

Type 2 -  
W2.07

Type 1 -  
W2.08

Our client states that in-situ windows were repaired and new windows, crafted to match the originals, were installed where frames were missing. They considered this a necessity for weather protection and noted that the window repairs offered better value than full replacement. Although we do not have historic record of the original windows, we are inclined to accept this explanation, due to the photographic evidence and our client's general philosophy of preservation, as observed in other window repairs and to the original internal door joinery generally.

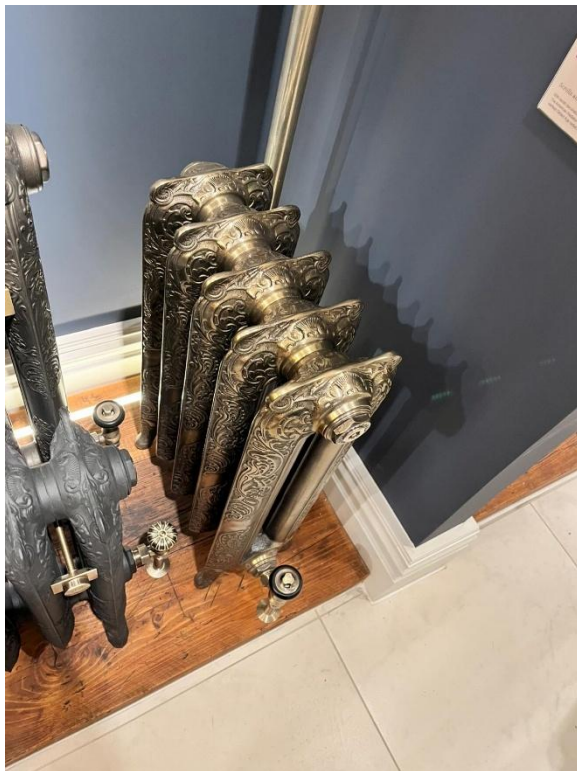
Proposed floor standing cast iron radiator

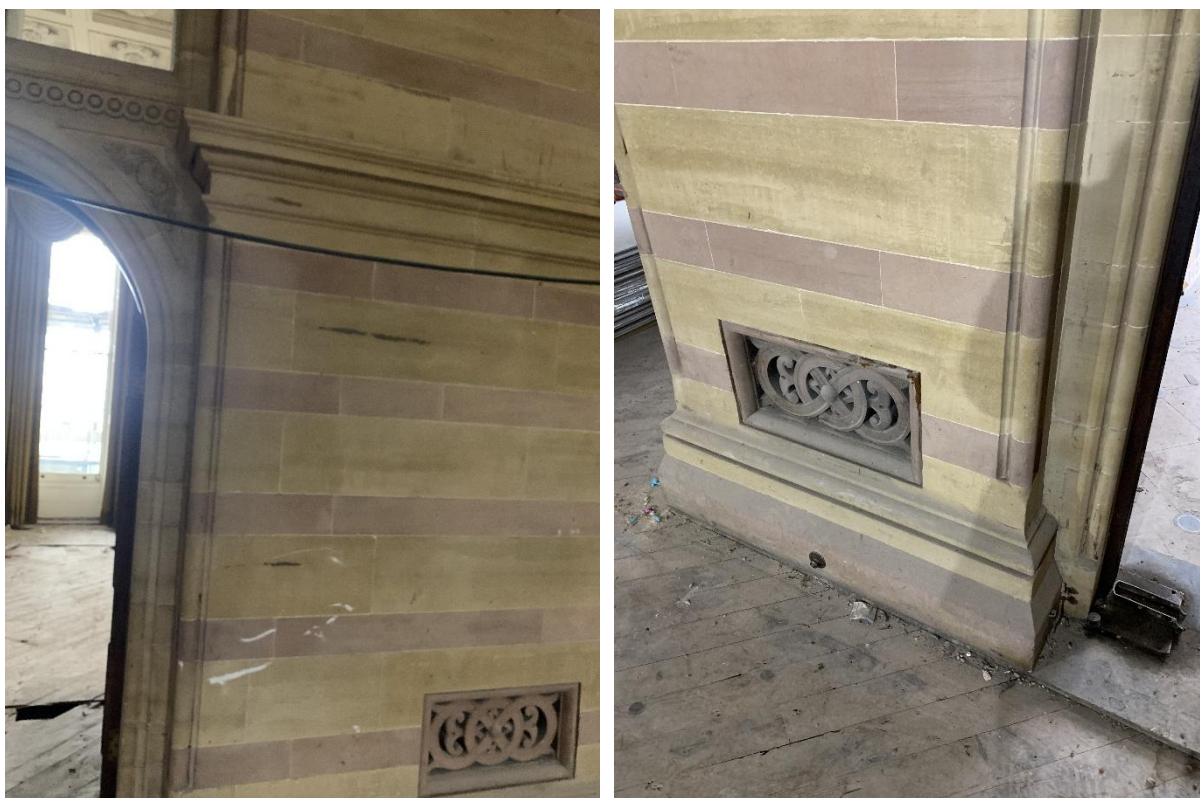
Retained existing stone grilles in the entrance hallway

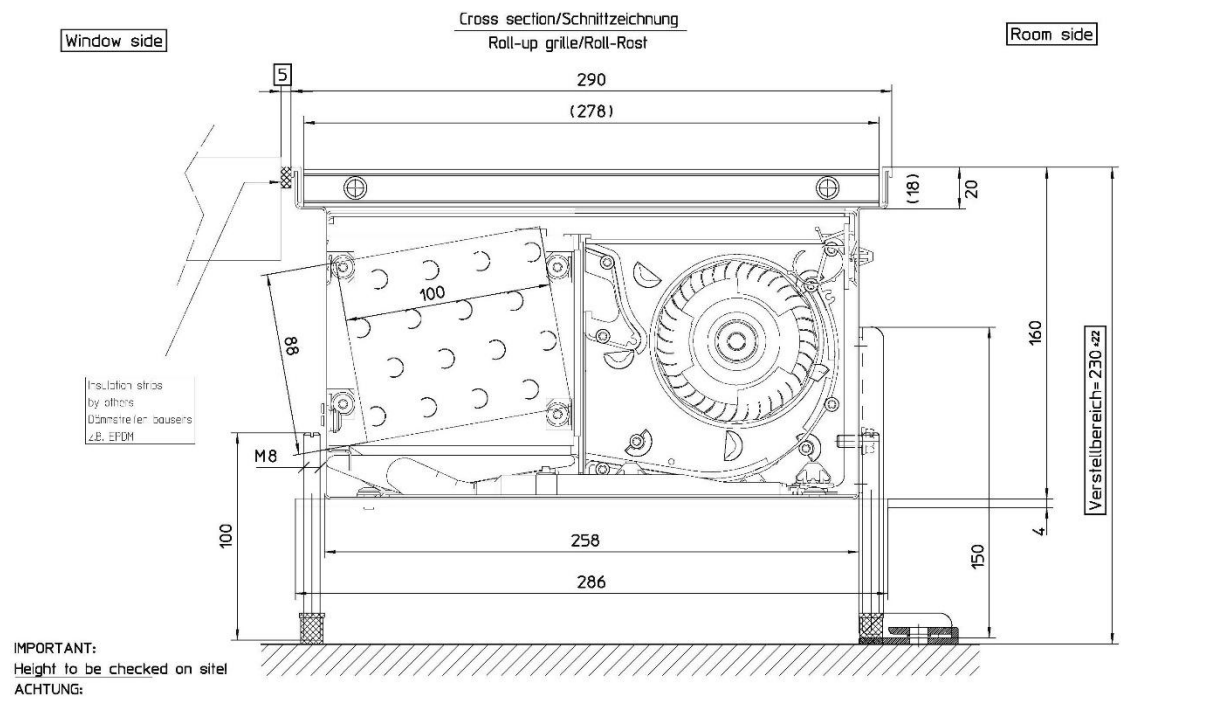
The adjacent photograph shows exploration of the existing dining room floor void, revealing modern timber supports below and a void of sufficient depth to hold the proposed trench heater product. Only the grille being visible, flush to the floor.

The floor joists below will be 'trimmed' locally to provide space for the heater, requiring one joist to be cut-out, with the ends re-supported by perpendicular double timbers, spanning between the remaining joists.
