**Project Name:** Cuckfield Rd - Ansty  
**Project Description:** CCTV Survey, Trace & Plot  
**Project Status:** Complete  
**Project Date:** 04/06/2026  
**Inspection Standard:** MSCC5 Sewers & Drainage GB (SRM5 Scoring)

# **EYES ON DRAINAGE**

## **CCTV-Trace-Plot-Map-Repair**

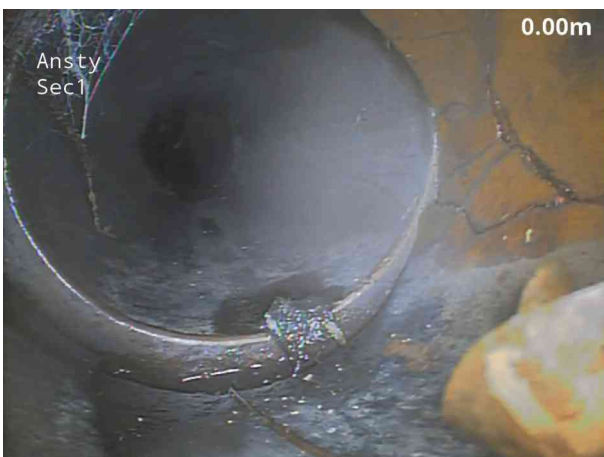
| No. | m+ | Code | Observation |
|---|---|---|---|
| 4 | 0.10 | JDM | Joint displaced, medium, start |

5, 00:00:52, 0.10 m  
Joint displaced, medium, start

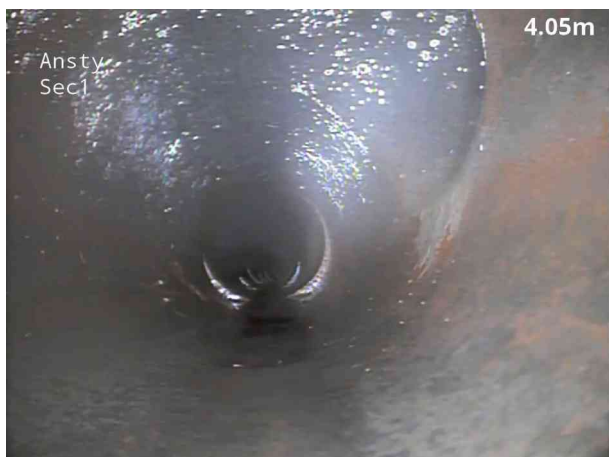
7, 00:01:05, 4.30 m  
Junction at 2 o'clock, 100mm dia

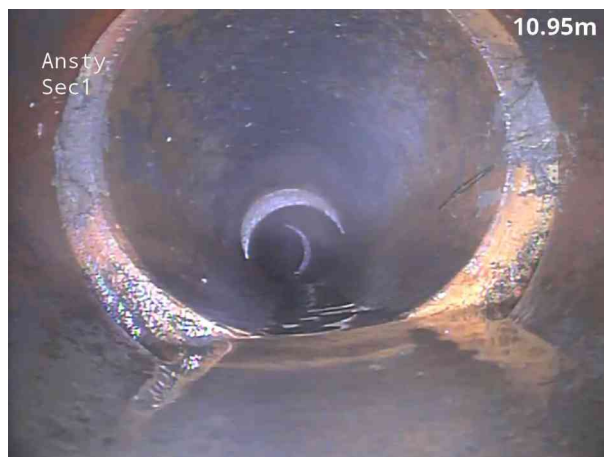
8, 00:01:42, 11.10 m  
Roots, fine at joint

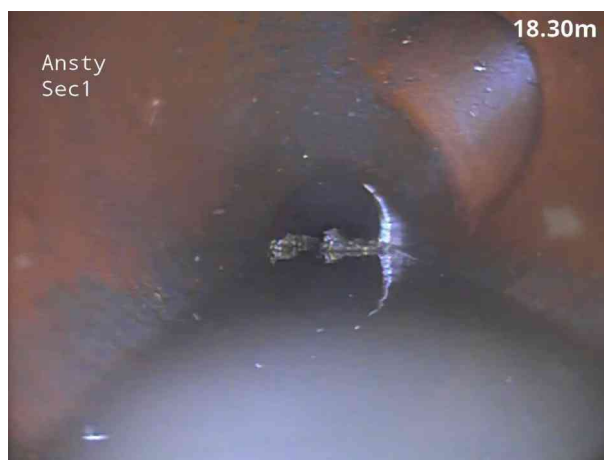
10, 00:02:08, 18.40 m  
Junction at 2 o'clock, 100mm dia

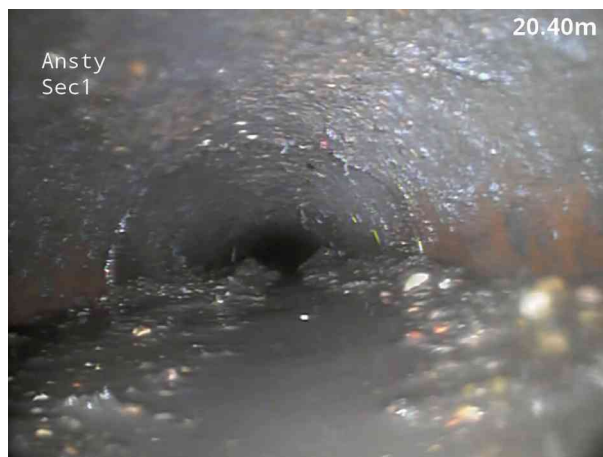
| Section | PLR | Grade | Description |
|---|---|---|---|
| 1 | RG1X | 4 | Settled deposits, coarse, 60% cross-sectional area loss, finish |

14, 00:02:27, 19.30 m  
Settled deposits, coarse, 60% cross-sectional area loss, start

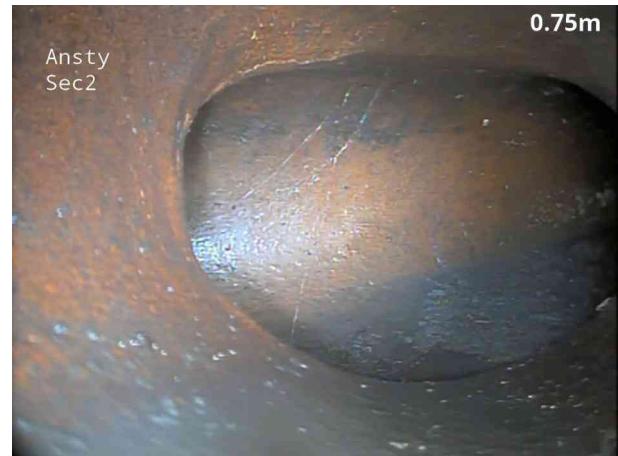
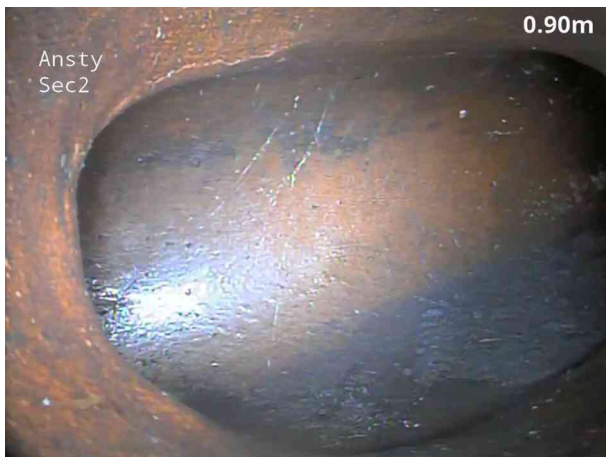
4, 00:00:22, 0.90 m  
Line deviates right, Junction onto carrier drain

5, 00:00:22, 0.90 m  
Line deviates right, Junction onto carrier drain

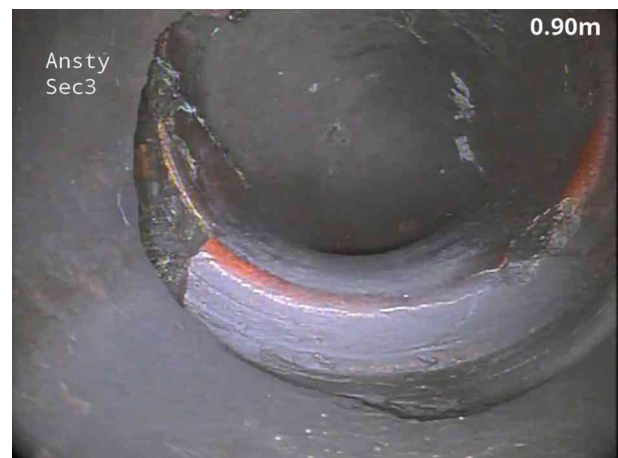
4, 00:00:29, 0.80 m  
Line deviates down

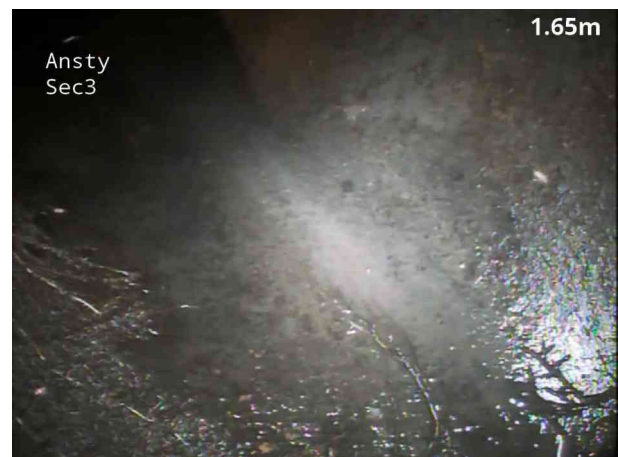
6, 00:00:43, 1.50 m  
Line deviates right, Junction onto carrier drain

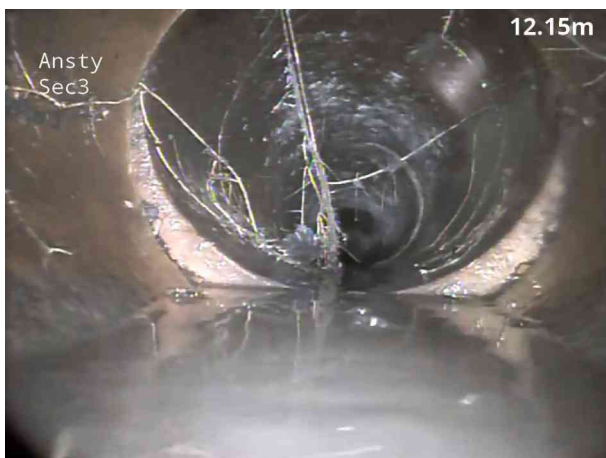
9, 00:01:44, 12.60 m  
Junction at 2 o'clock, 100mm dia

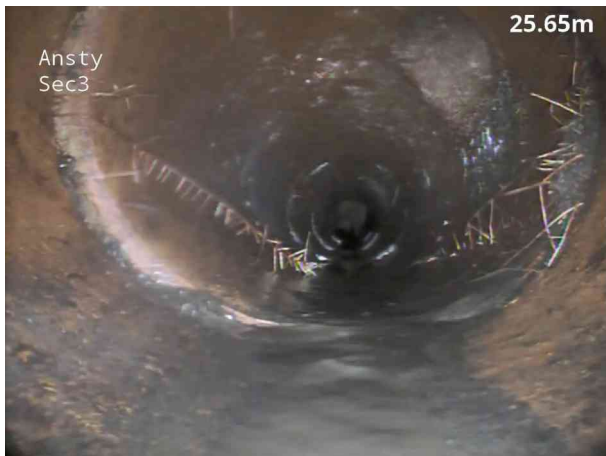
13, 00:02:42, 26.00 m  
Junction at 2 o'clock, 100mm dia

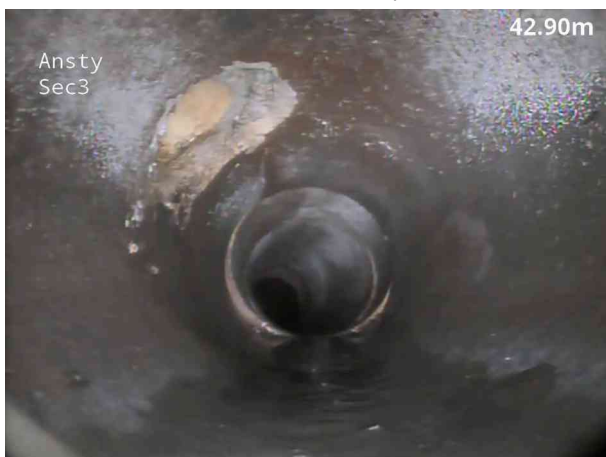
17, 00:03:51, 43.20 m  
Connection other than junction at 10 o'clock, 100mm dia
