MS07801/DS

**Structural Appraisal of Proposed Conversion of Barn & out-buildings at Birchgrove Farm, Horsted Keynes**

Showing the  
Existing Plans and Sections  
Showing Structural Site  
Notes

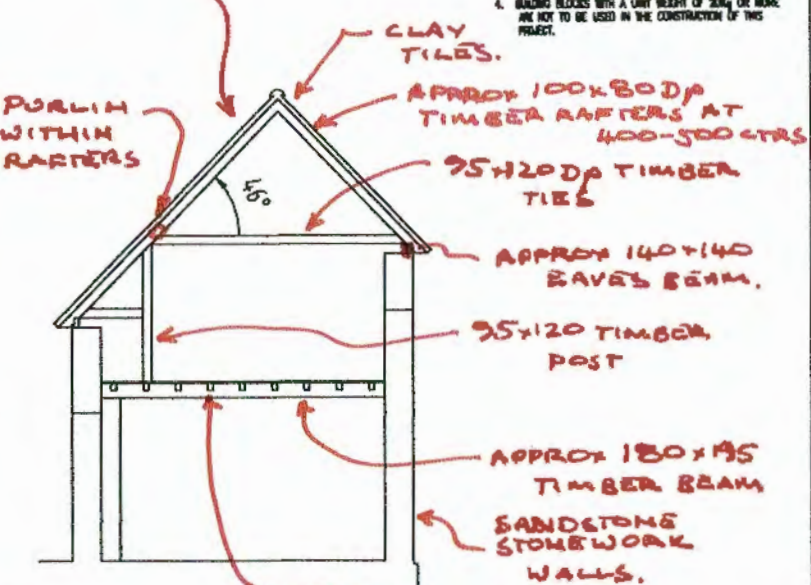
Section A

REPLACED SORTWOOD RAFTERS TO THIS BAY.

SOME SORTWOOD 50x100 TIMBERS ALONGSIDE & REPLACING ORIGINAL 80x100 OAK JOISTS IN THIS BAY ONLY.

175x175 TIMBER POSTS
