## Foul and Surface Water Drainage Report

**Prince Albert, Copthorne**

**Westcoast Developments Ltd**

Reference **C3261**

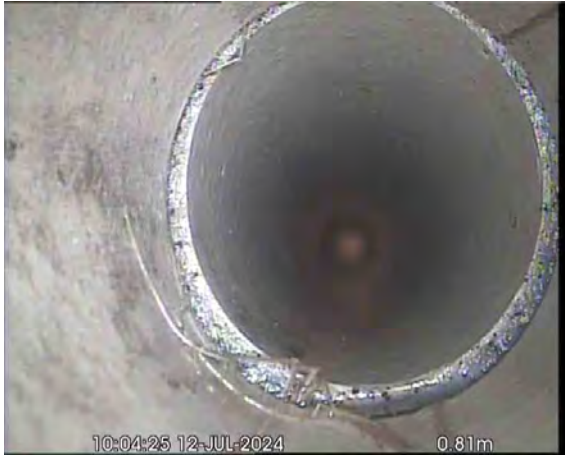
GULLYX\_be408751-b267-4dcb-87b2-47920da53df0\_20240725\_090226\_317.jpg, 00:01:01, 0.81 m  
Joint displaced, medium

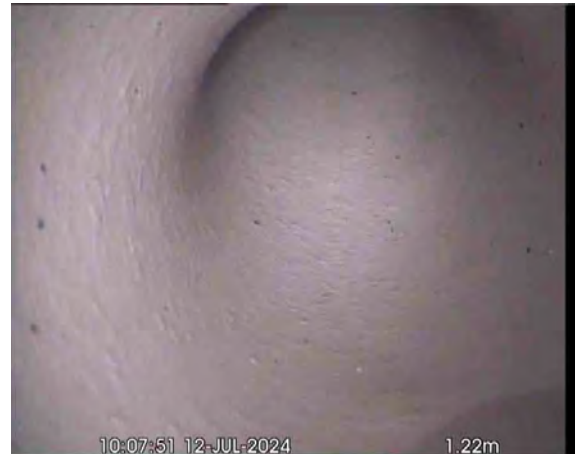
W\_CX\_e67dc308-cdad-4b4f-8f22-12bae3fd920a\_20240725\_090718\_061.jpg, 00:00:43, 1.22 m  
Line deviates up, REST BEND

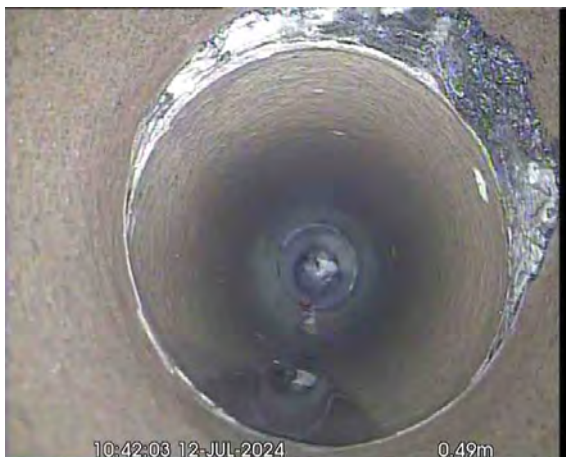
REDUNDANTX\_0df9520d-4cc8-45ca-b8b9-6ea8c8cc1138\_20  
240725\_091130\_965.jpg, 00:00:34, 0.49 m  
Joint displaced, large

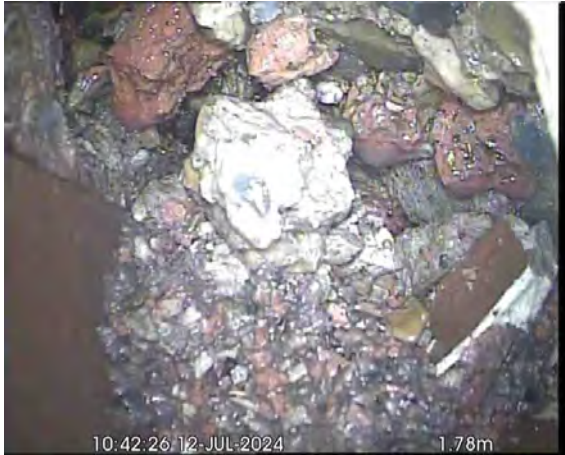
REDUNDANTX\_716789ca-25ee-4cc2-8135-a7bc7aff19d4\_20  
240725\_091212\_524.jpg, 00:00:56, 1.78 m  
Settled deposits, hard or compacted, 100% cross-sectional  
area loss

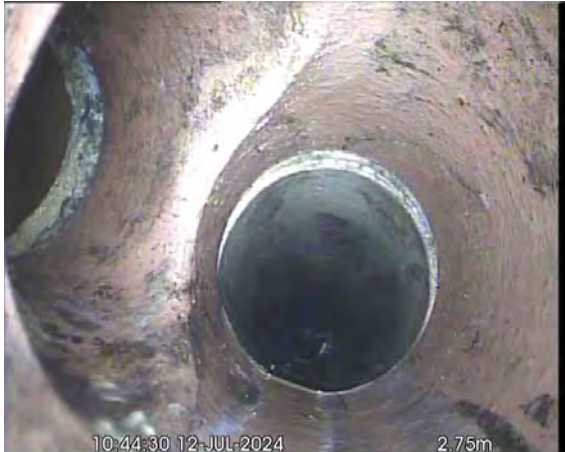
MH6X\_522ba9e2-59fb-4d77-8b4f-20a3a199147f\_20240725\_092301\_286.jpg, 00:00:56, 2.75 m  
Junction at 9 o'clock, diameter: 100mm, UNKNOWN

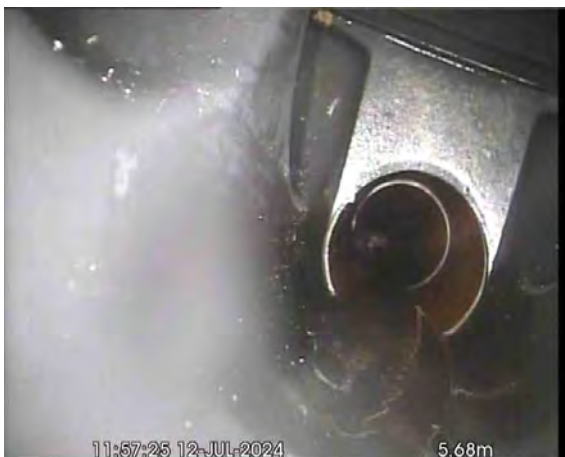
MH2X\_b55e55f8-9e05-4db8-b212-fbb573044cff\_20240725\_093147\_156.jpg, 00:01:29, 5.68 m  
General remark, \*\*ENTERS MANHOLE 3 (MH3) - UNABLE TO LIFT

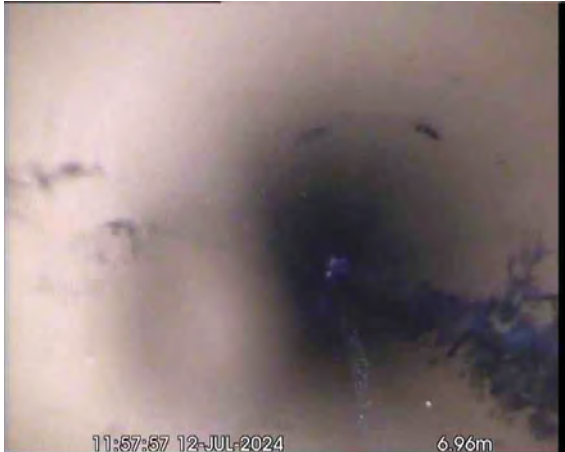
MH2X\_88b39d42-4c30-4654-8841-754422e4dc7a\_20240725\_093224\_970.jpg, 00:01:50, 6.96 m  
Water level, 0% of the vertical dimension

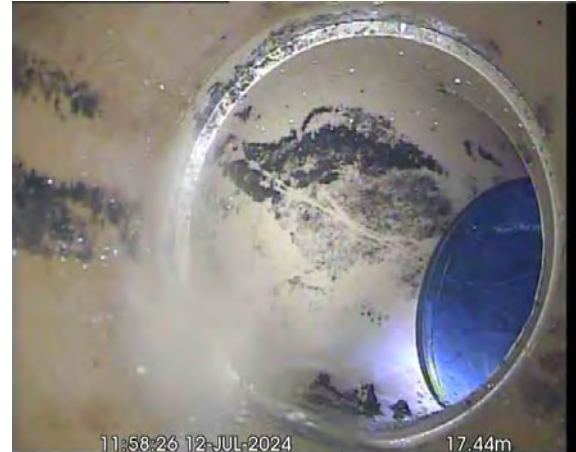
MH2X\_ecbc01d4-5401-430c-a4cc-4e8128ef4209\_20240725\_093238\_853.jpg, 00:02:20, 17.44 m  
Line deviates right

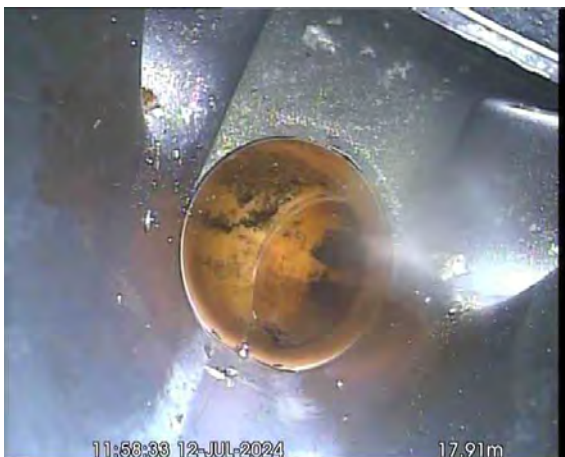
MH2X\_acdd8251-032e-4fda-a1d3-9a0cfadee0a2\_20240725\_093304\_170.jpg, 00:02:27, 17.91 m  
Finish node, manhole, reference: MANHOLE 4 (MH4)

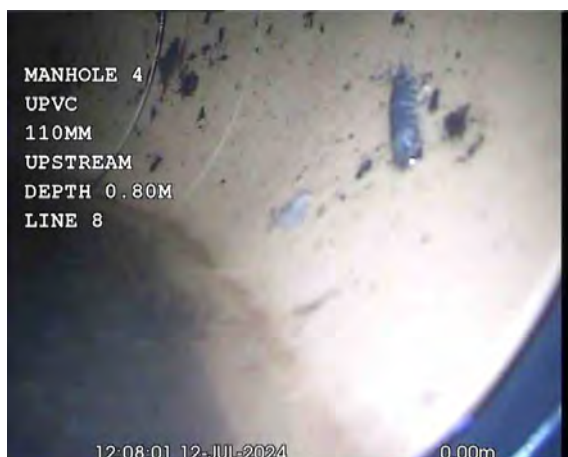
CAPPED  
OFFX\_df637ed9-d0c0-475d-a9b9-2d9c6523196d\_20240725\_093402\_548.jpg, 00:00:39, 0.00 m  
Start node, manhole, reference: MANHOLE 4 (MH4)

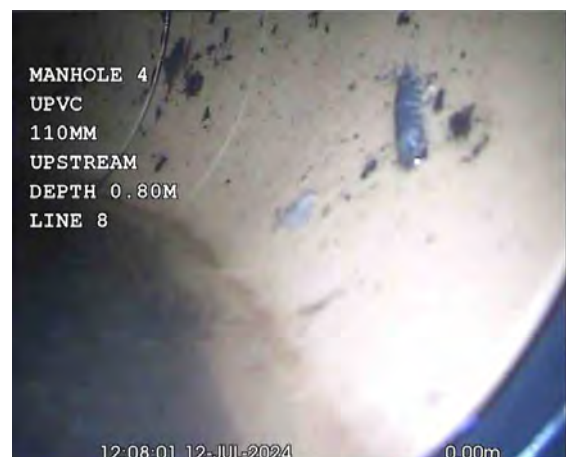
CAPPED  
OFFX\_93c2d75d-b2fd-43d0-9440-17bfa1c0c76e\_20240725\_093409\_690.jpg, 00:00:39, 0.00 m  
Water level, 5% of the vertical dimension

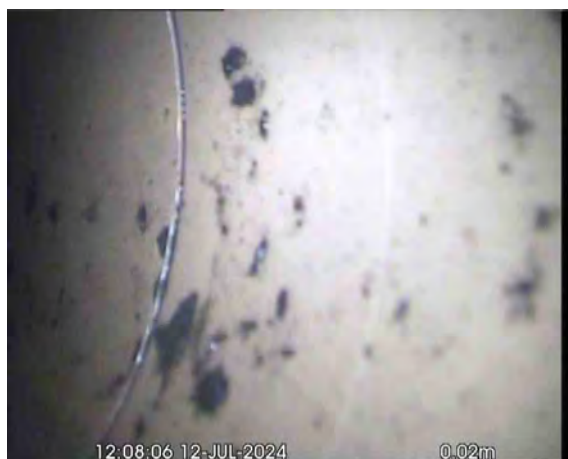
CAPPED  
OFFX\_2c61c11e-4c06-4ebc-870a-c78b293b4c99\_20240725\_093434\_293.jpg, 00:00:43, 0.02 m  
Line deviates left

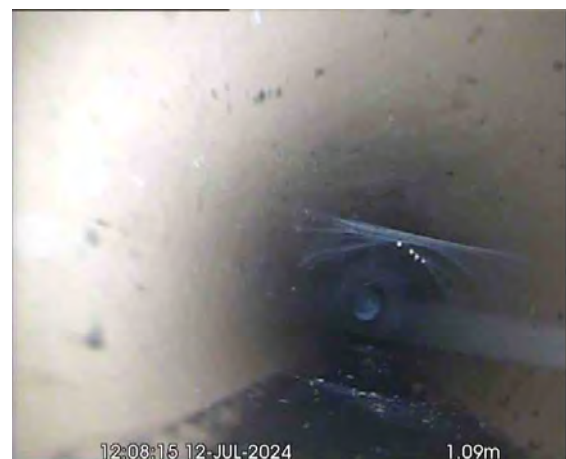
CAPPED  
OFFX\_67eeaf64-0435-43b5-8da3-b5a094747b11\_20240725\_093450\_860.jpg, 00:00:52, 1.09 m  
Water level, 5% of the vertical dimension

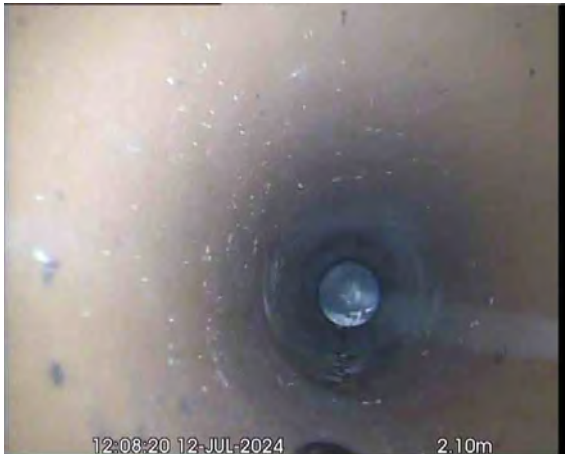
CAPPED  
OFFX\_68f25f6f-dbc4-4bd4-8f1f-8c3b8a9531e7\_20240725\_09  
3504\_475.jpg, 00:00:57, 2.10 m  
Water level, 0% of the vertical dimension

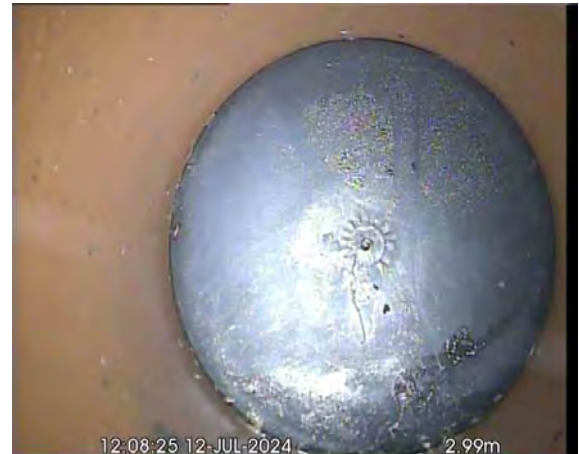
CAPPED  
OFFX\_dc97001a-2078-4b93-b9a2-163b14f502db\_20240725\_  
093522\_395.jpg, 00:01:03, 2.99 m  
Survey abandoned, S/A - CAPPED OFF

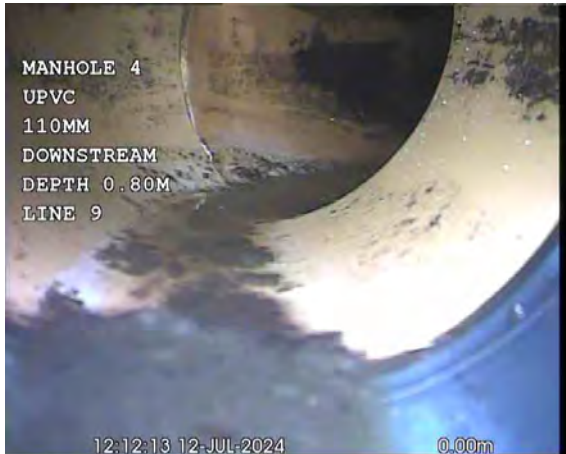
MH4X\_55d14c4d-fdbe-480a-a8d1-3ec7317d0af8\_20240725\_093843\_347.jpg, 00:00:26, 0.00 m  
Start node, manhole, reference: MANHOLE 4 (MH4)

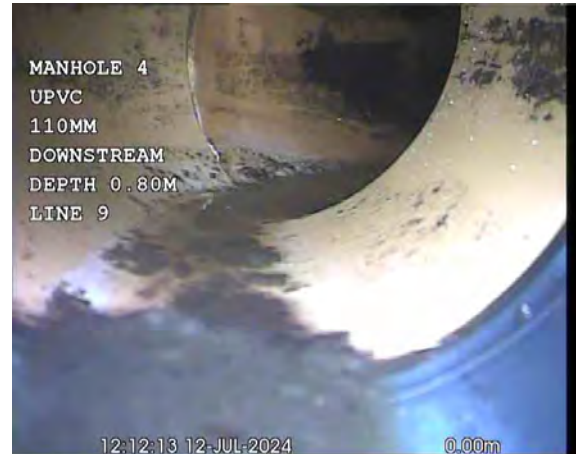
MH4X\_b15f3203-8bce-4b3c-aea4-e017105a17a3\_20240725\_093849\_179.jpg, 00:00:26, 0.00 m  
Water level, 0% of the vertical dimension

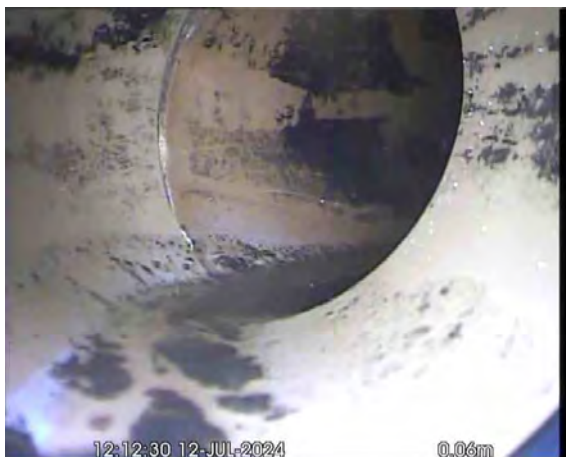
MH4X\_047d0d34-fc87-401f-a4c3-3433783703f4\_20240725\_093918\_923.jpg, 00:00:42, 0.06 m  
Line deviates right

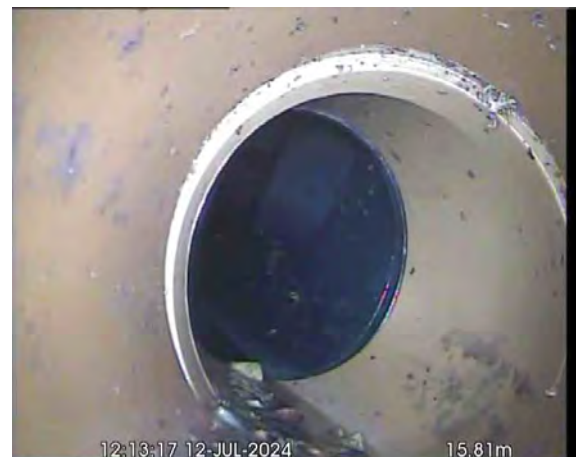
MH4X\_9d8f4504-f323-432b-9698-14d451cd618f\_20240725\_094016\_482.jpg, 00:01:29, 15.81 m  
Line deviates left

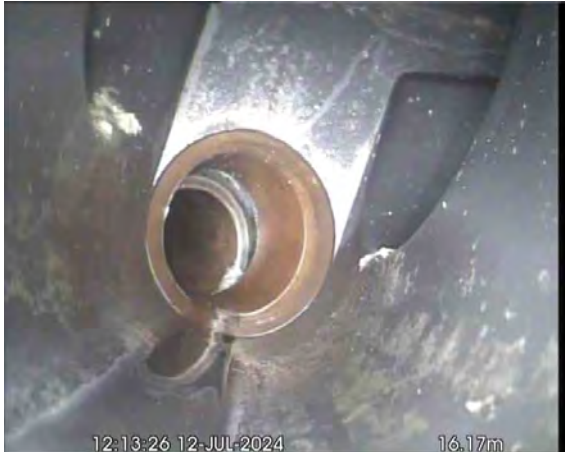
MH4X\_344678f6-6b66-4520-95ce-16ba1b185cdf\_20240725\_094041\_771.jpg, 00:01:39, 16.17 m  
Finish node, manhole, reference: MANHOLE 5 (MH5)

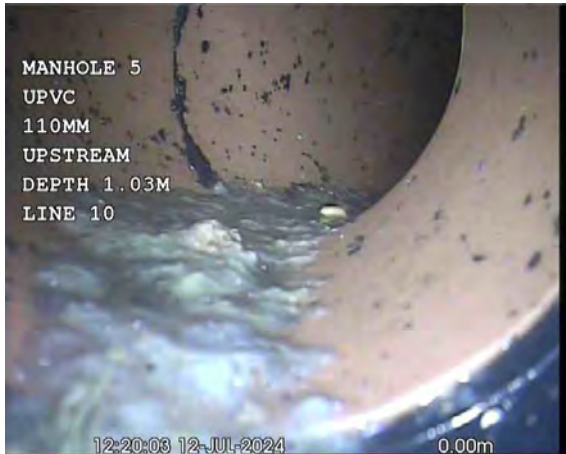
CAPPED  
OFFX\_6c3871bb-4fd5-4855-bbb0-61d06810d0d7\_20240725\_094152\_058.jpg, 00:00:37, 0.00 m  
Start node, manhole, reference: MANHOLE 5 (MH5)

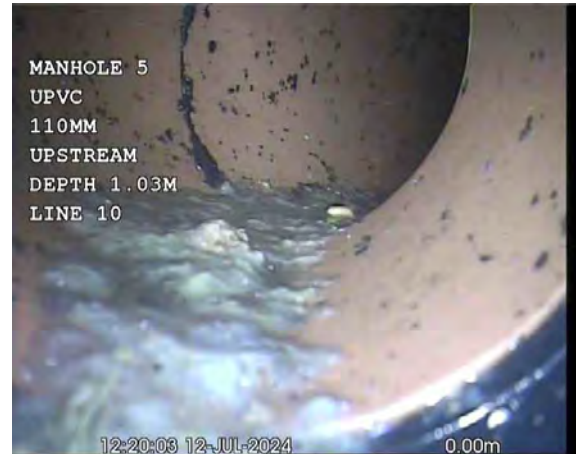
CAPPED  
OFFX\_0b21e724-26bb-4d91-bb97-1640846d3795\_20240725\_094202\_515.jpg, 00:00:37, 0.00 m  
Water level, 0% of the vertical dimension

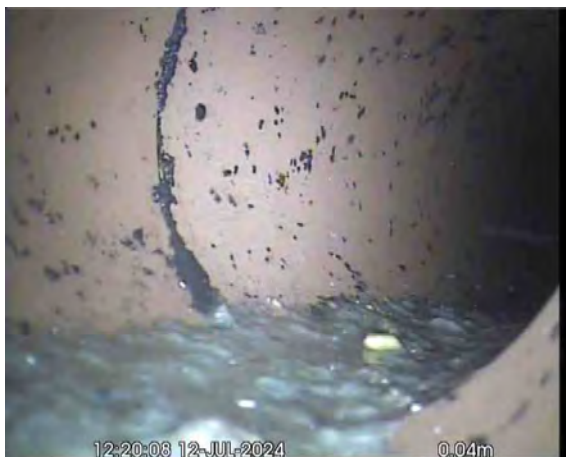
CAPPED  
OFFX\_80832dd5-8ef6-4f5d-89c0-115ac1b2d810\_20240725\_094214\_228.jpg, 00:00:41, 0.04 m  
Line deviates right

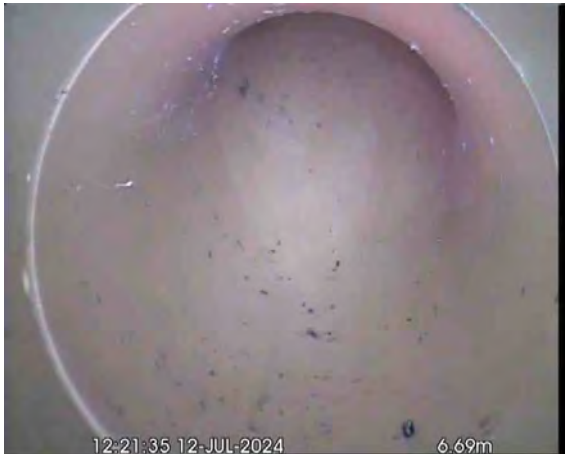
CAPPED  
OFFX\_7b6014f4-cab8-4f12-9a9c-6eb32ef0d8f9\_20240725\_09  
4246\_571.jpg, 00:02:08, 6.69 m  
Line deviates up, REST BEND

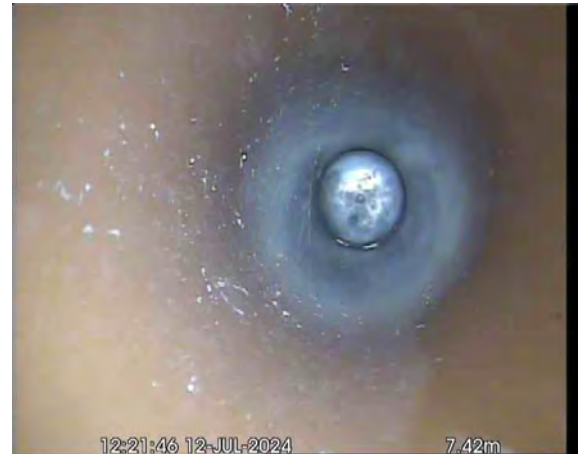
CAPPED  
OFFX\_b9c4dbb3-d9c6-4d09-9f4f-e40713d124b7\_20240725\_0  
94300\_939.jpg, 00:02:19, 7.42 m  
Survey abandoned, S/A - CAPPED OFF

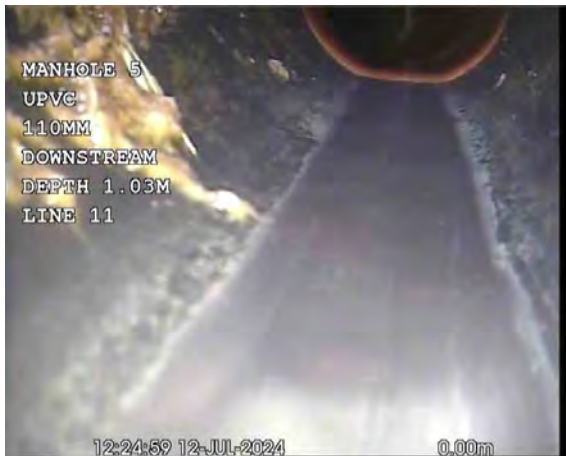
MH5X\_bd5530c6-c89a-41b5-b33d-6c50f69b0280\_20240725\_094513\_170.jpg, 00:00:29, 0.00 m  
 Start node, manhole, reference: MANHOLE 5 (MH5)

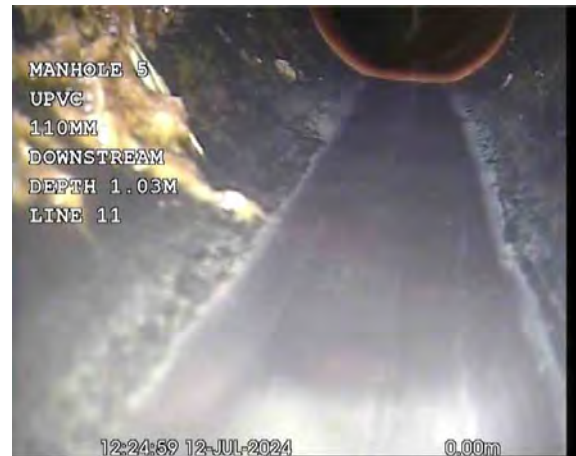
MH5X\_04a04489-4146-4ad3-b2c5-d7ff96abe544\_20240725\_094519\_970.jpg, 00:00:29, 0.00 m  
 Water level, 0% of the vertical dimension

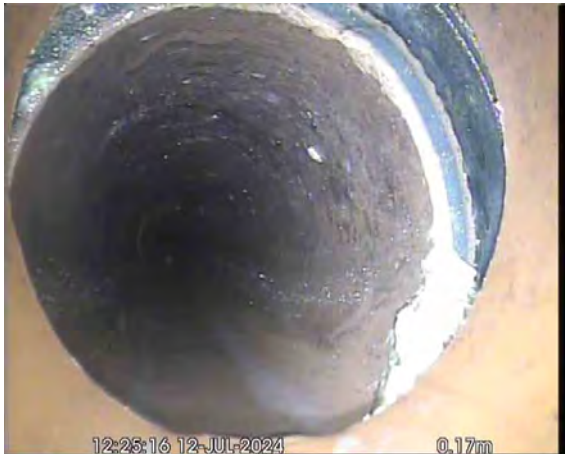
MH5X\_e186920a-c72e-48a4-9a6e-cd2a8489a0ab\_20240725\_094708\_970.jpg, 00:00:46, 0.17 m  
Size changes, new size(s), 100mm high

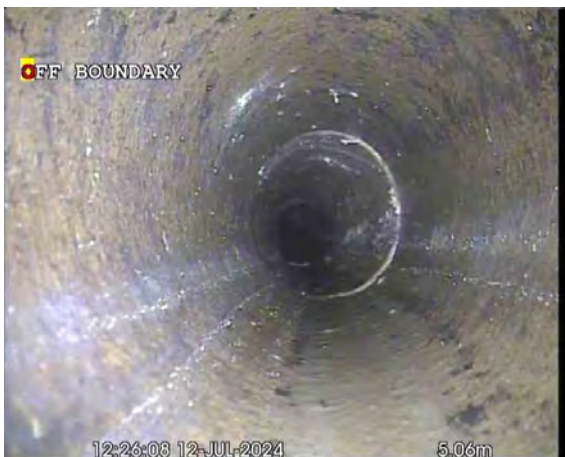
MH5X\_7a719423-7b10-4cb5-9e10-35a6d7d11f95\_20240725\_094749\_245.jpg, 00:01:36, 5.06 m  
General remark, \*\*BOUNDARY POINT\*\*

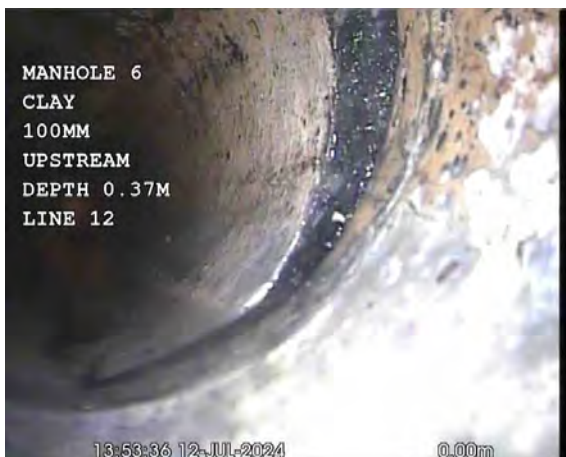
SVPX\_1032148c-1afa-44ba-b9d4-c41939b75ca1\_20240725\_095215\_787.jpg, 00:00:28, 0.00 m  
Start node, manhole, reference: MANHOLE 6 (MH6)

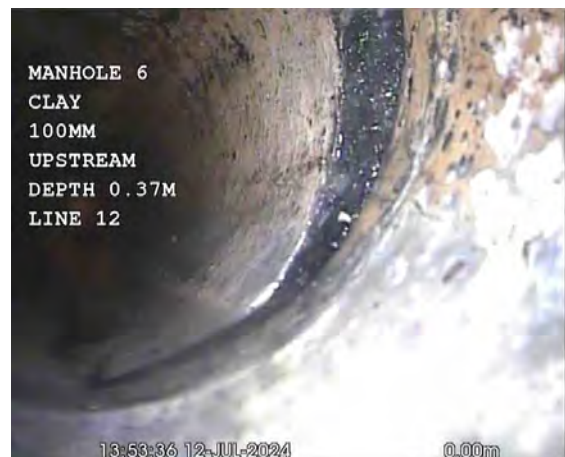
SVPX\_74d44b96-72da-442c-8602-c87605640ac0\_20240725\_095222\_464.jpg, 00:00:28, 0.00 m  
Water level, 0% of the vertical dimension

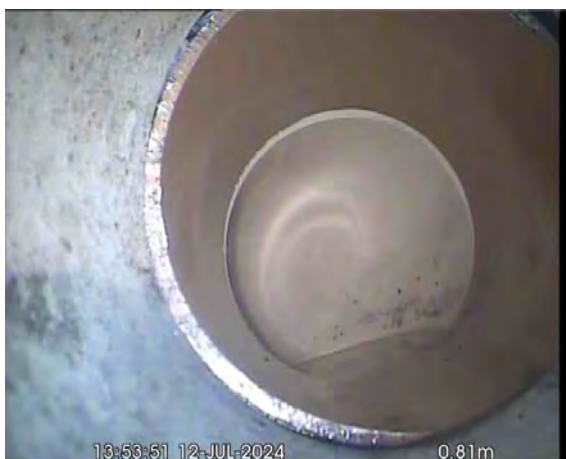
SVPX\_6126ff3a-8feb-42cf-b4a8-289a35627abd\_20240725\_095243\_344.jpg, 00:00:43, 0.81 m  
Joint displaced, medium

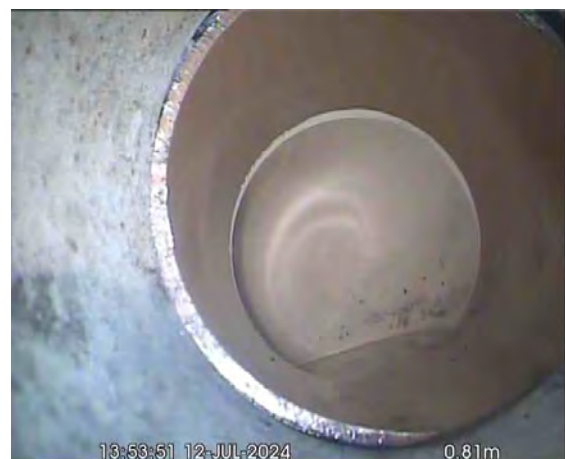
SVPX\_6dc84003-04ba-4f4b-a2bc-ade636d85d44\_20240725\_095258\_153.jpg, 00:00:43, 0.81 m  
Material changes to polyvinyl chloride

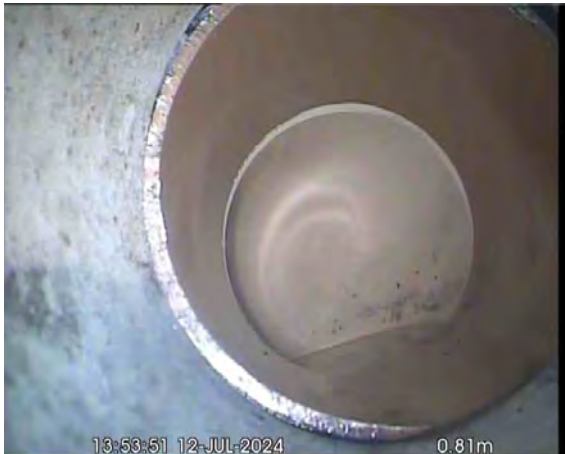
SVPX\_37643050-054d-409b-a034-ef1a40900360\_20240725\_095307\_792.jpg, 00:00:43, 0.81 m  
Size changes, new size(s), 110mm high

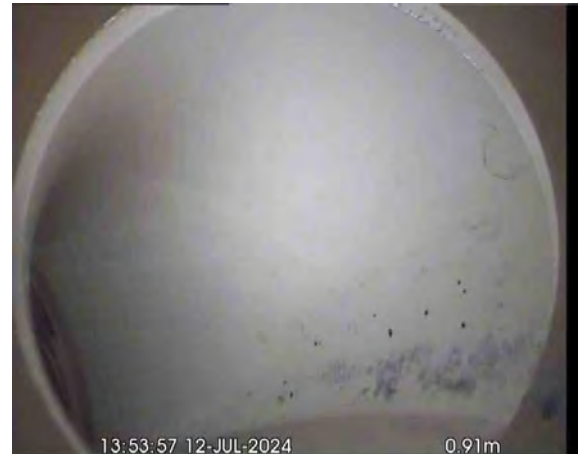
SVPX\_1a7c91c5-7811-4395-aac0-3828833b4982\_20240725\_095342\_984.jpg, 00:00:49, 0.91 m  
Line deviates left

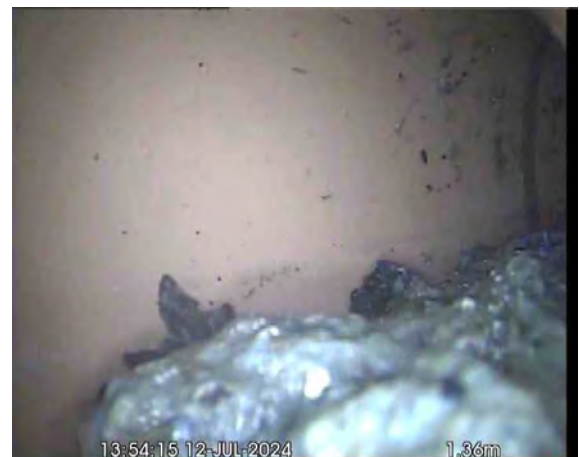
SVPX\_7b6e8666-8fb9-44b5-8e1a-aafe5937a5df\_20240725\_095424\_962.jpg, 00:01:07, 1.36 m  
Line deviates right

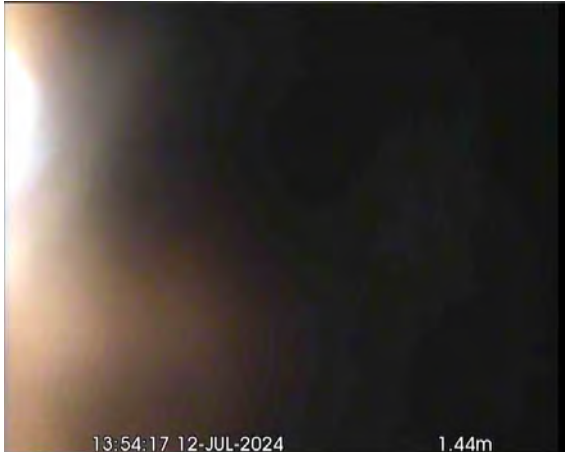
SVPX\_4b44048b-62fa-45c3-ad0b-12c365183034\_20240725\_095440\_985.jpg, 00:01:10, 1.44 m  
Loss of vision, other, DEBRIS

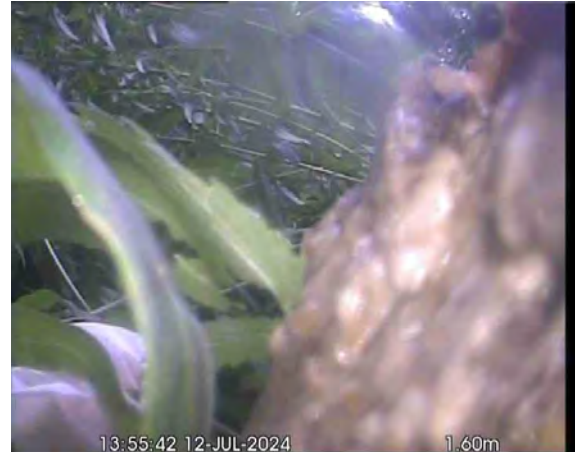
SVPX\_9d8768b1-86dd-4d7b-b136-613c52434c58\_20240725\_095530\_137.jpg, 00:01:28, 1.60 m  
Survey abandoned, S/A - OPEN PIPE - SOIL VENT PIPE NOT CONNECTED UP

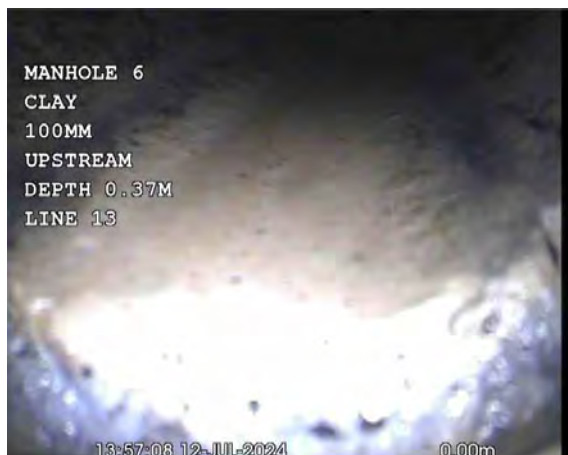
GULLYX\_3ca80480-fda7-476d-bdd4-121782959120\_20240725\_095710\_019.jpg, 00:00:22, 0.00 m  
Start node, manhole, reference: MANHOLE 6 (MH6)

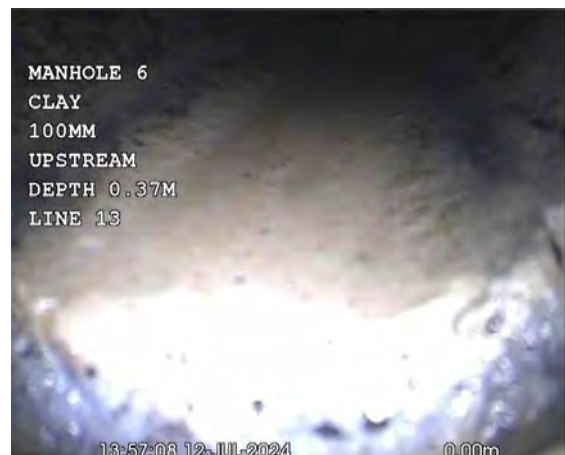
GULLYX\_b46c2eaf-a3f2-43f6-8702-b889b9e7cbee\_20240725\_095719\_471.jpg, 00:00:22, 0.00 m  
Water level, 0% of the vertical dimension

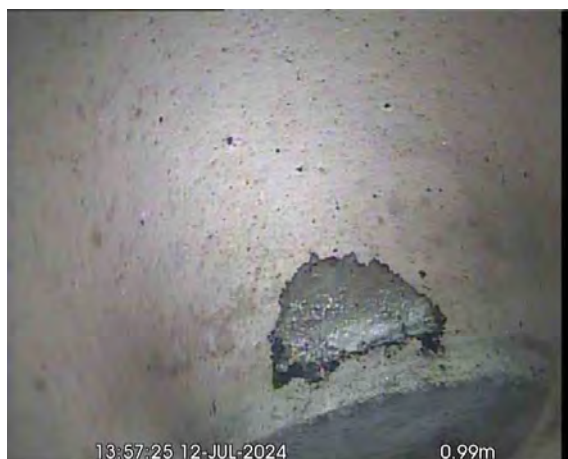
GULLYX\_6d63e6bc-a192-46ee-bb28-5b54a1a3e0d8\_20240725\_095748\_794.jpg, 00:00:39, 0.99 m  
Finish node, gully, reference: GULLY
