## TANYARD MANOR

Repair and Renewal of  
Roof Coverings

HERITAGE  
STATEMENT

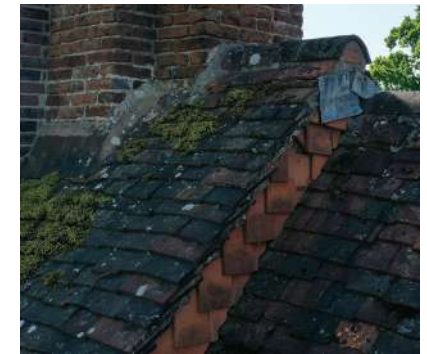
It is not evident how the tiles are secured although the plain clay tiles are evidently conventionally double-lapped and, given the presence of the roofing felt, which was commonly in use from the mid-C20th onwards, are likely secured with metal nails or drops rather than traditional timber pegs. The nails may be ferrous and corroded but this was not evident from the available drone survey information or inspection of the roof void.

*double lap tiles evident at verge*

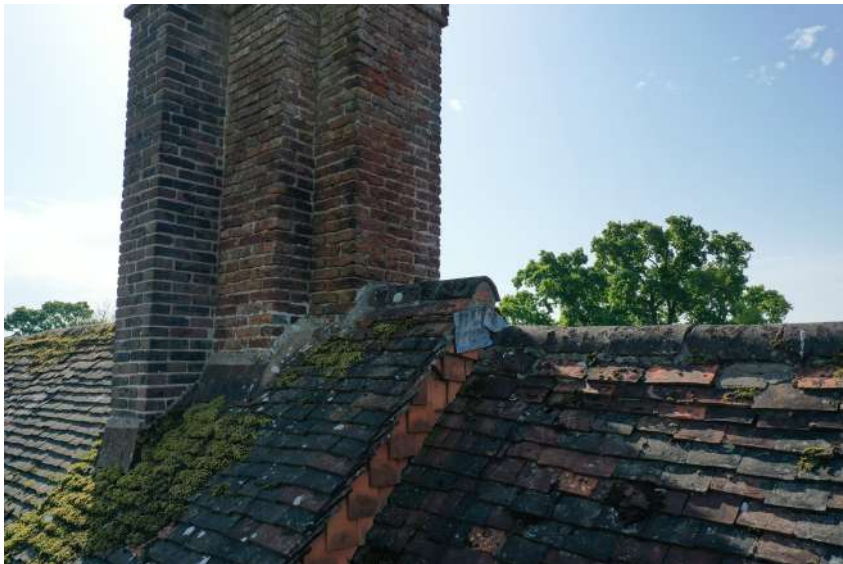
*lead dressings and tiled fillets to chimney*

- generally like for like repairs to repointing and flashing and tiled fillets to abutments
- survey of flue linings and re-pargetting as necessary to flues or otherwise install new flue liners with new clay pots bedded onto flues.

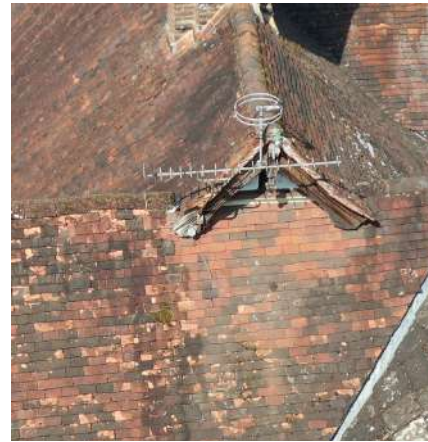
Notably the verge tiles to west end abutting the C17th range are tile and half rather than cut tiles. The verges and half round ridge tiles are bedded in mortar with tiled fillets to the chimney abutments bedded in mortar (cement content unknown). The north slope exhibits moss and lichen consistent with its shaded orientation and there is extensive evidence of spalling consistent with freeze thaw action due to water sitting on the relatively uncambered tiles, as well as cracked, broken, missing and slipped tiles. There are lead dressings consistent with modern good practice and all suggestive of a circa mid-early-late C20th reroofing.

*verge of gablet to east elevation of C17th range*

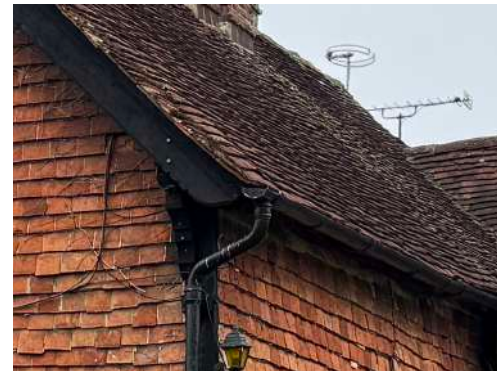
*verge and eaves to west elevation of C17th range*

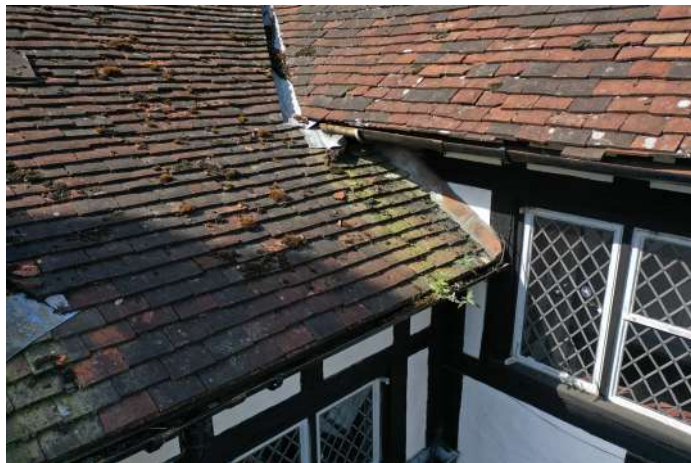
*valley & abutment to north elevation of C17th range*

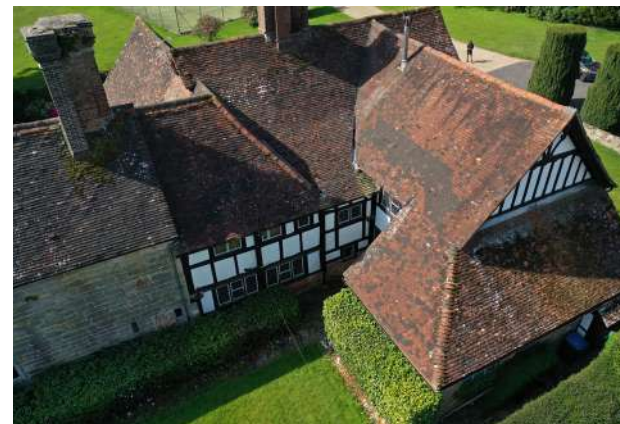
*east elevation of C20th range*

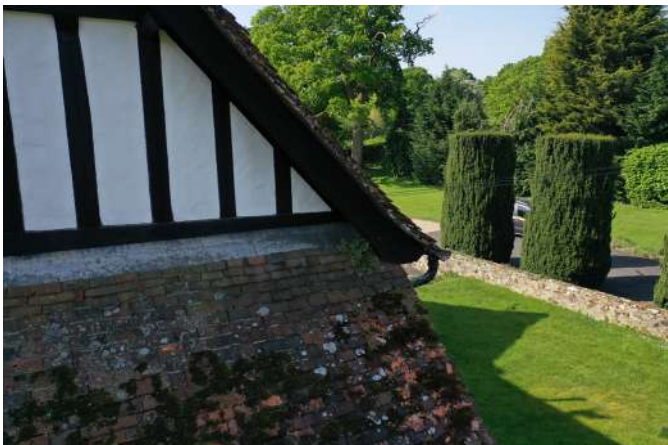
*lead flashed abutment to gable*

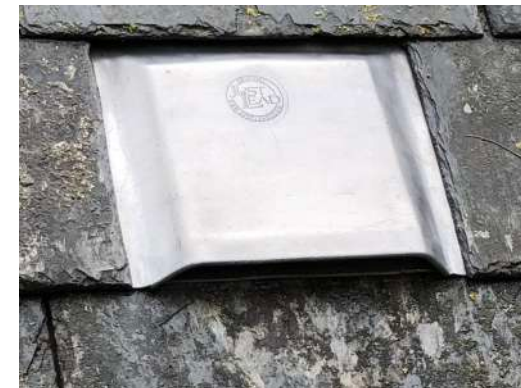
*lead bat arch installed in plain clay tile and slate roof*

- The PEA and bat emergence surveys revealed the presence of potential roosts and although the spaces will be retained for roosts, the following mitigation measures will be incorporated in the proposals:
  - partitioning of the unconverted loft spaces in the roof apex with panels to provide roost opportunities.
  - installation of 2no. crevice style bat boxes within the loft spaces
  - insulation in the unconverted loft spaces to be at floor level only
  - access to the unconverted loft spaces to be via lead bat arches to each slope.
  - a new external crevice box fixed to the west facing gable
  - replacement/installation of roofing membrane with type 1F felt only.
