EXPOSURE TIMBER FRAMES - FIRST FLOOR - WALLS - DRESSER

107 HIGH STREET, LINDFIELD, HAYWARDS HEATH, RH16 2HR

AS IMPLEMENTED PHOTOGRAPHIC DOCUMENTATION

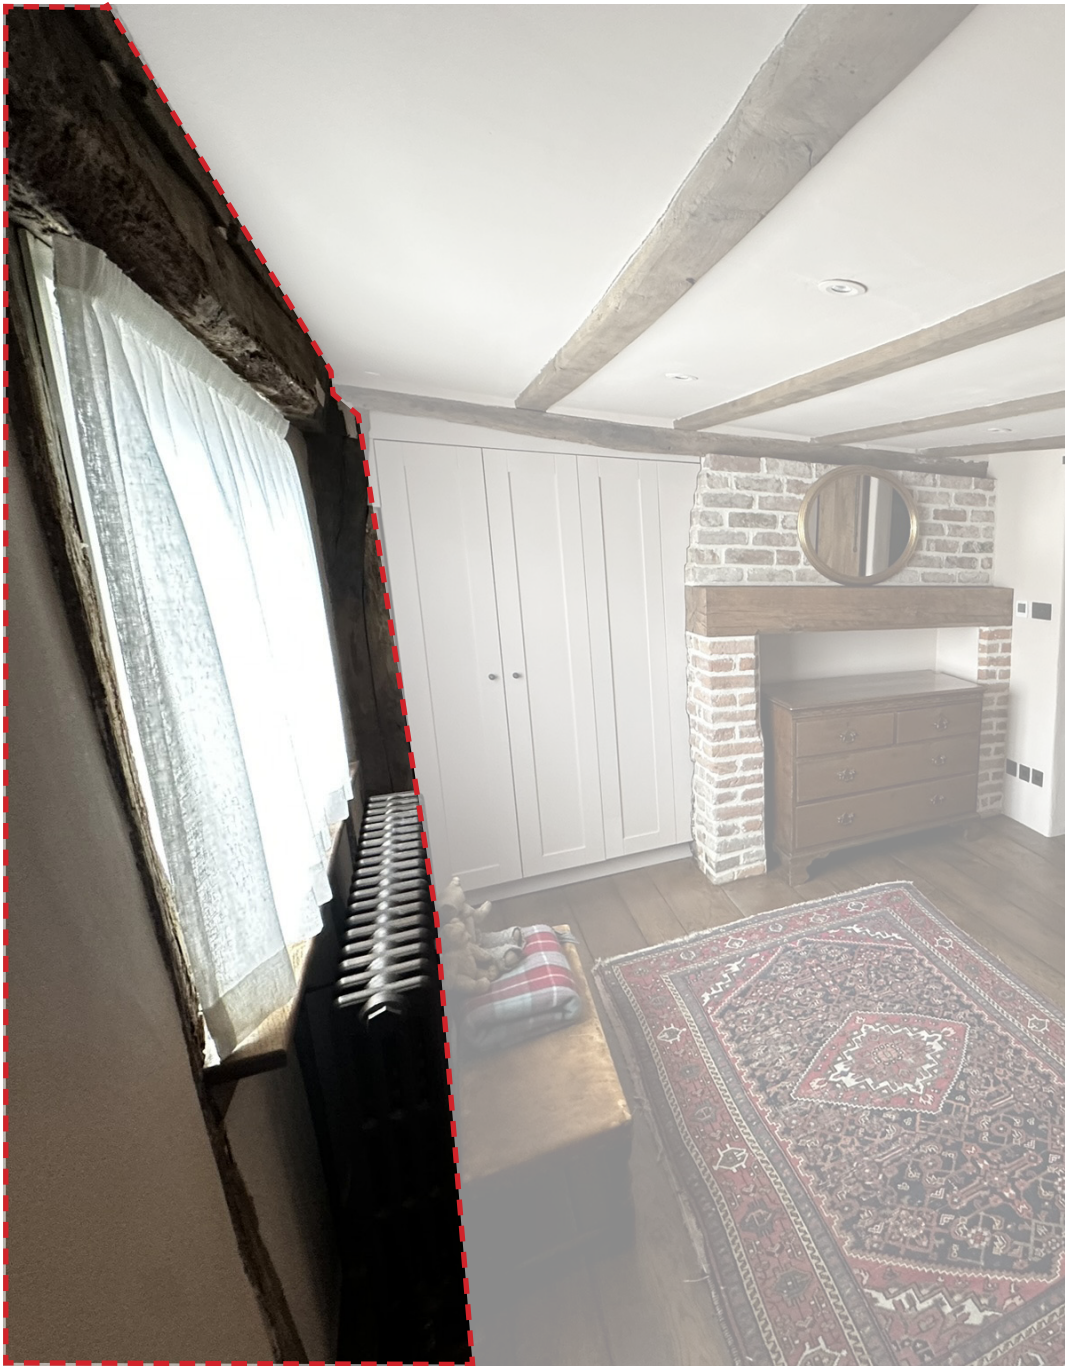
Figure 1. East wall

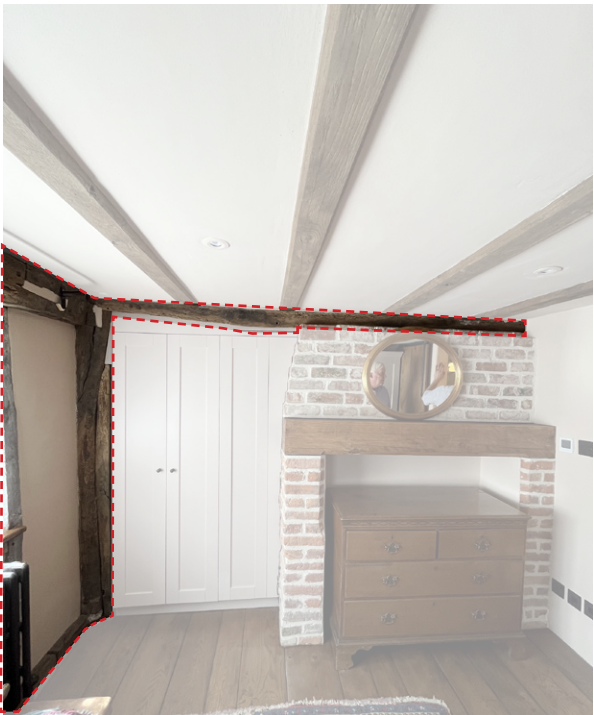
Figure 2. South wall

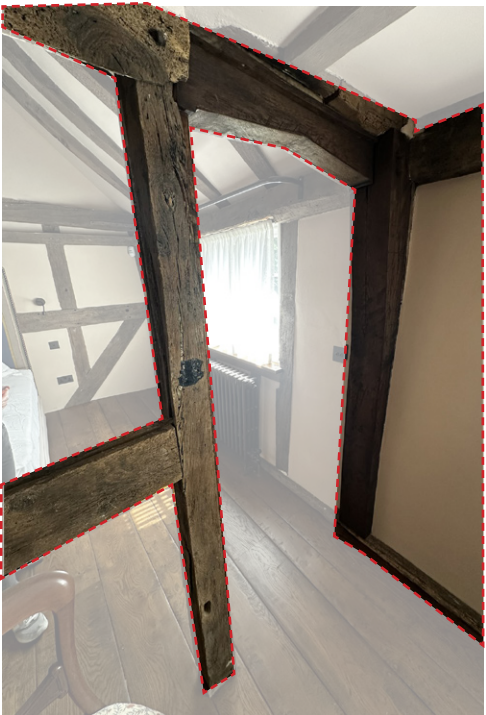
Figure 3. North wall

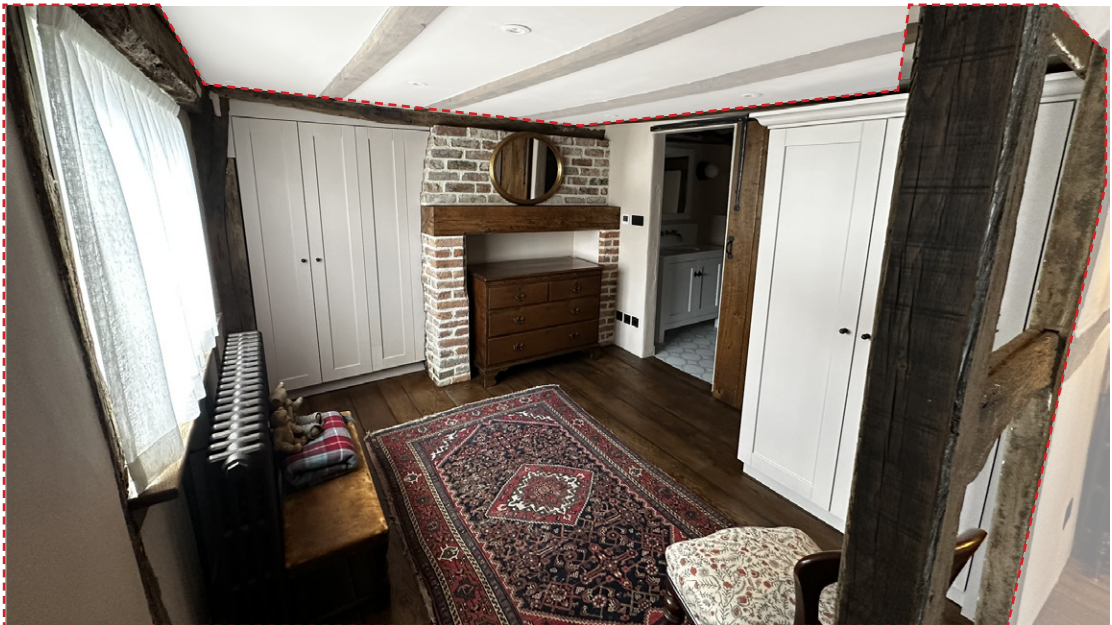
Figure 4. East, South and West Walls

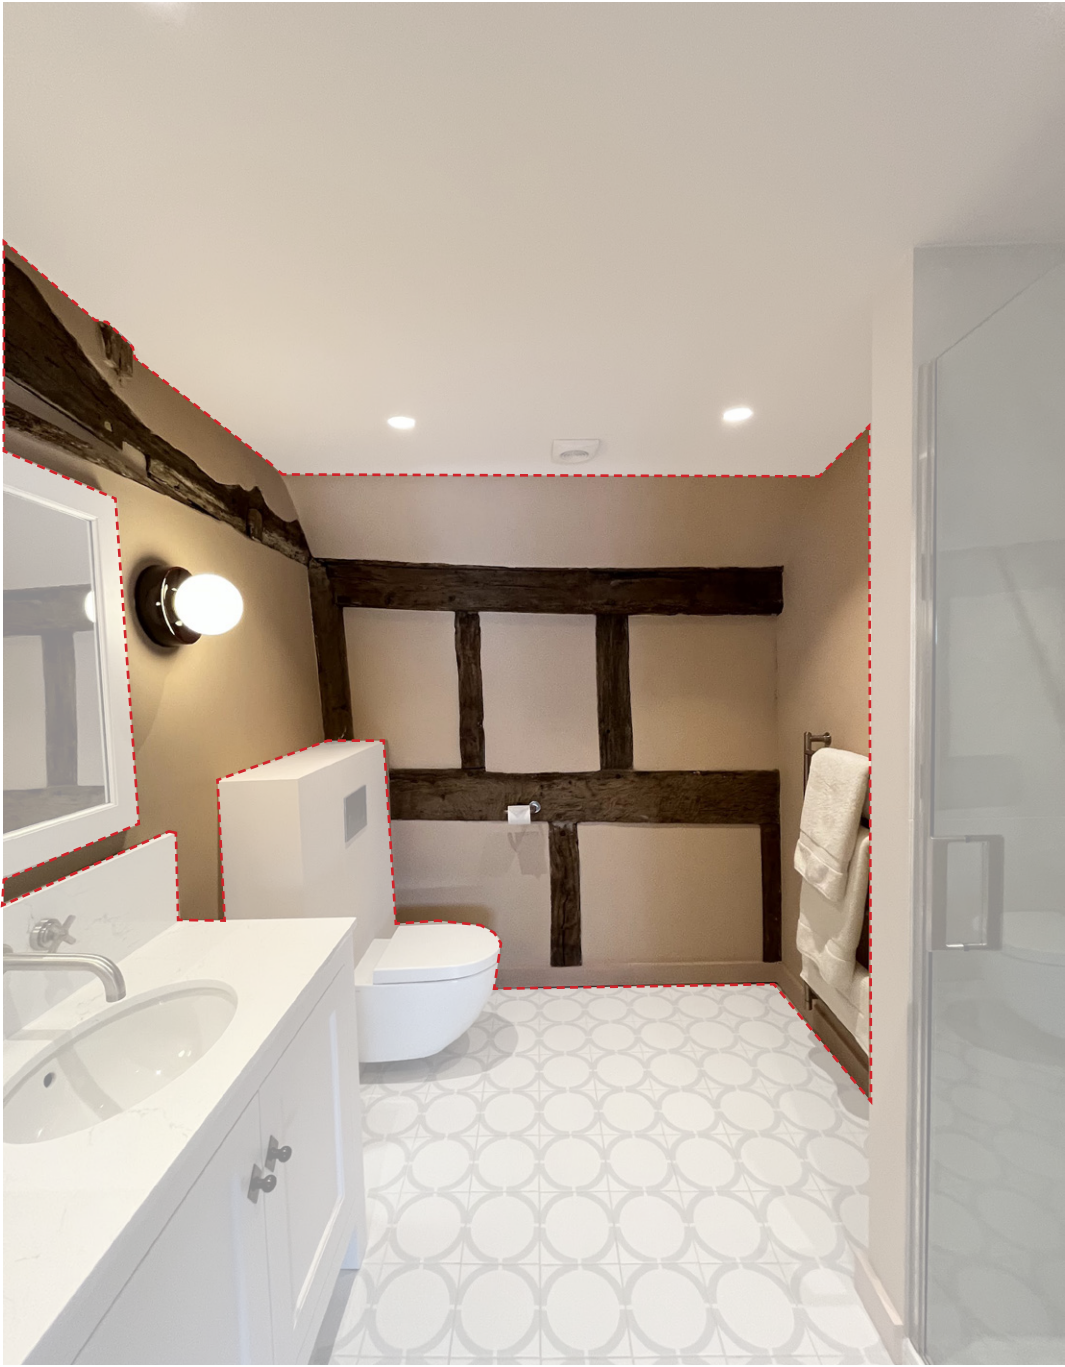
Figure 1. West wall

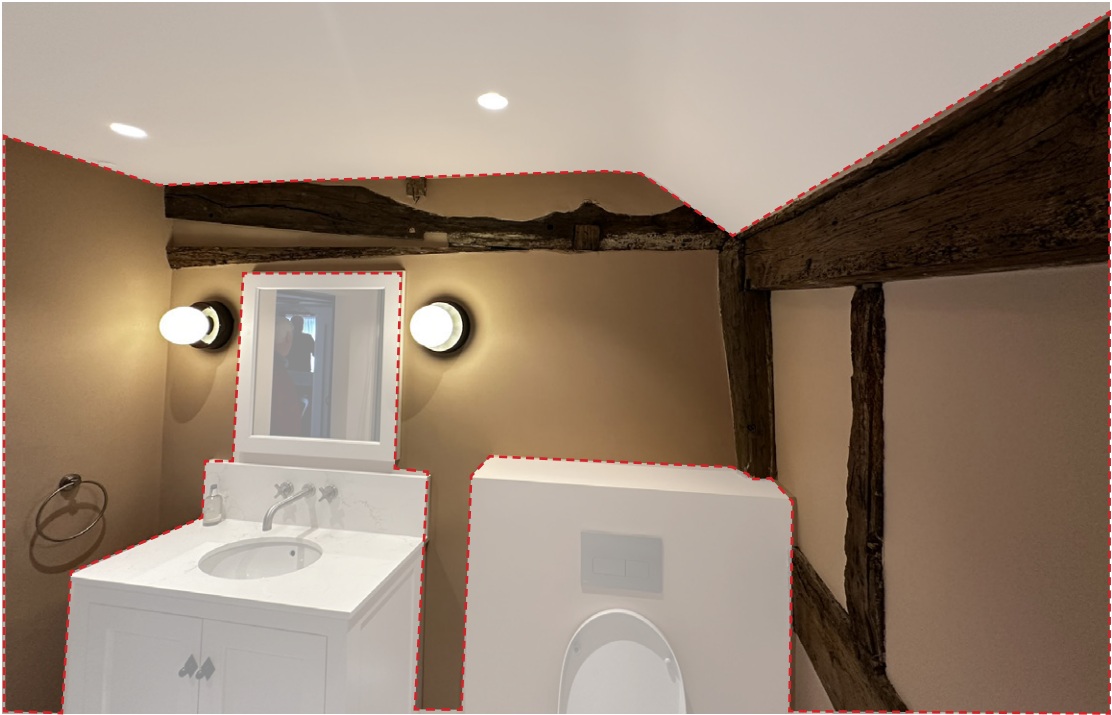
Figure 2. South wall

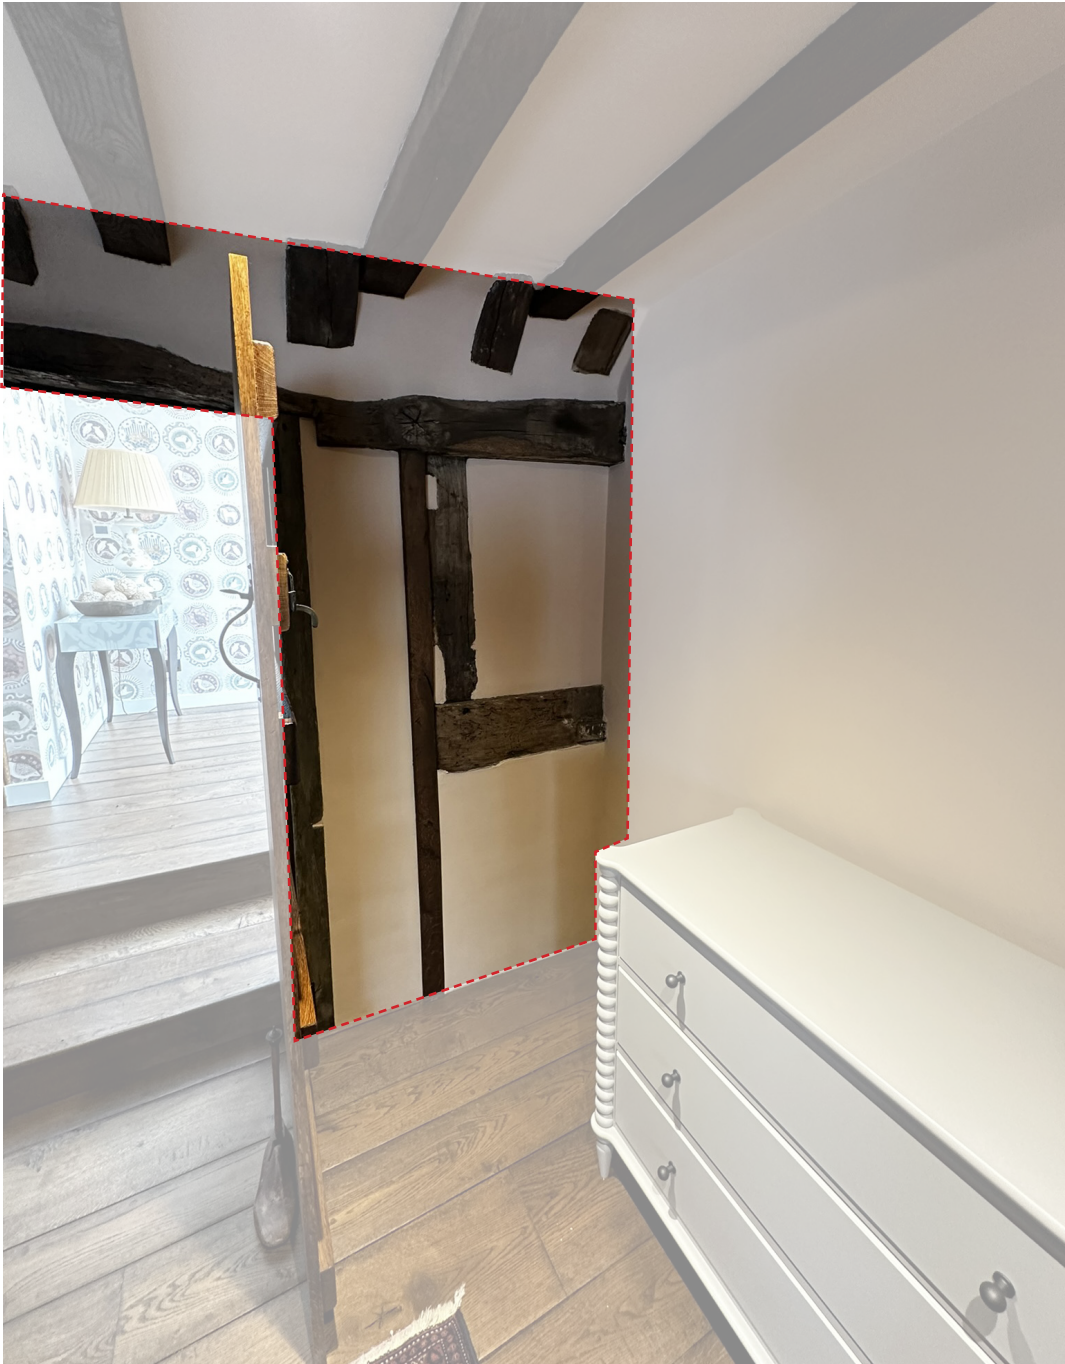
Figure 1. East wall

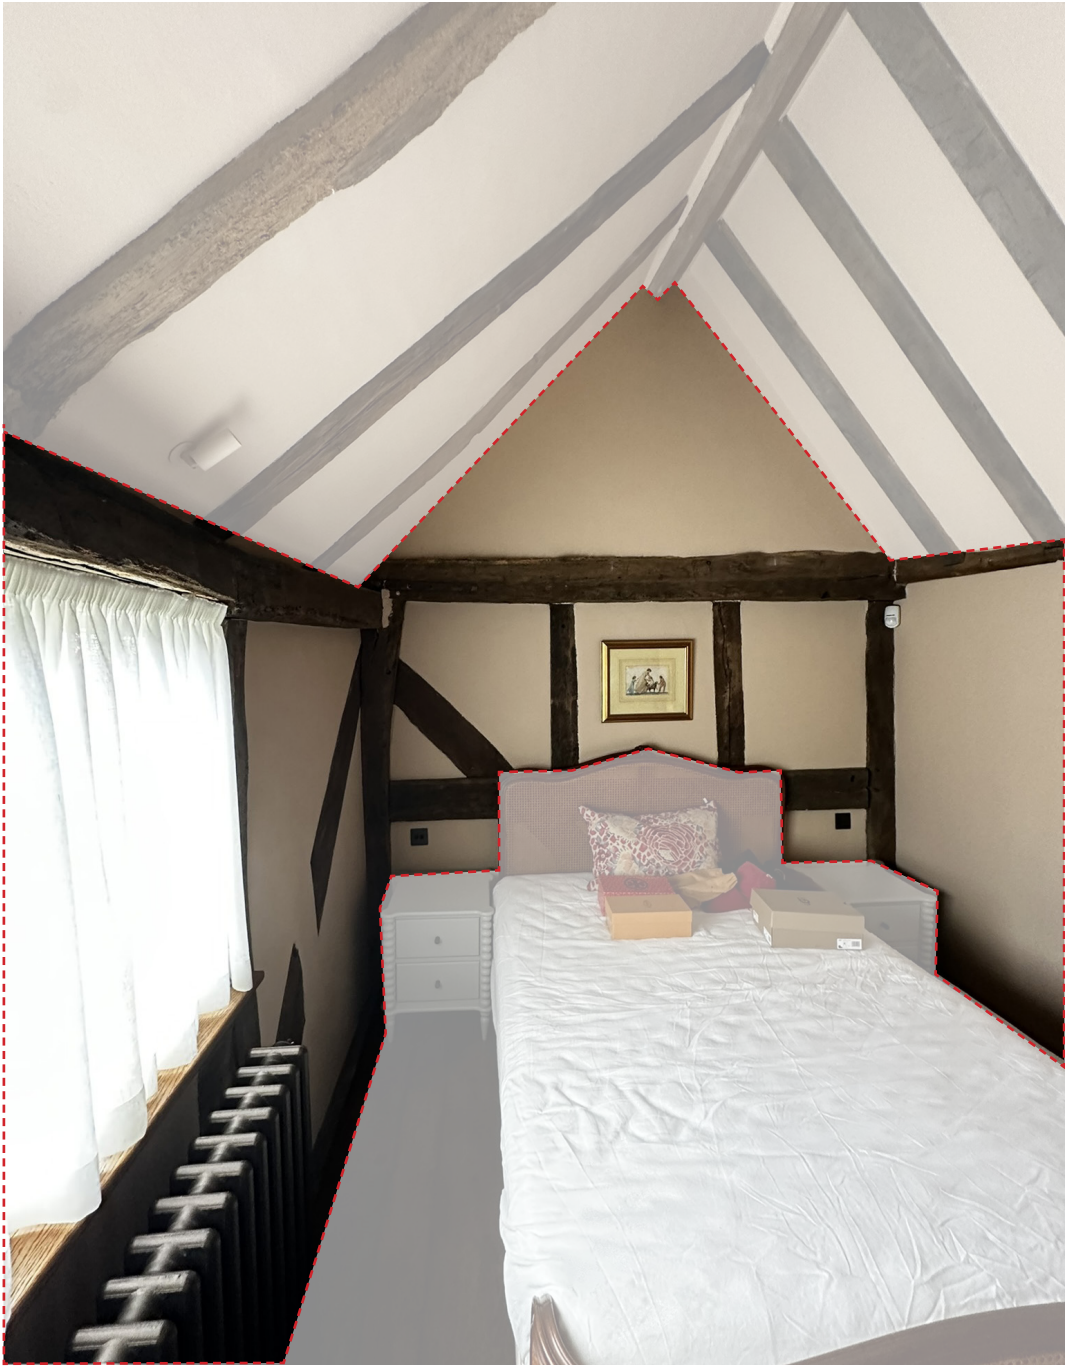
- Key
- Figure 1. East, South and West walls
  - Figure 2. South and West walls
  - Figure 3. East, South and West walls
  - Figure 4. North Wall
  - Figure 5. West Wall

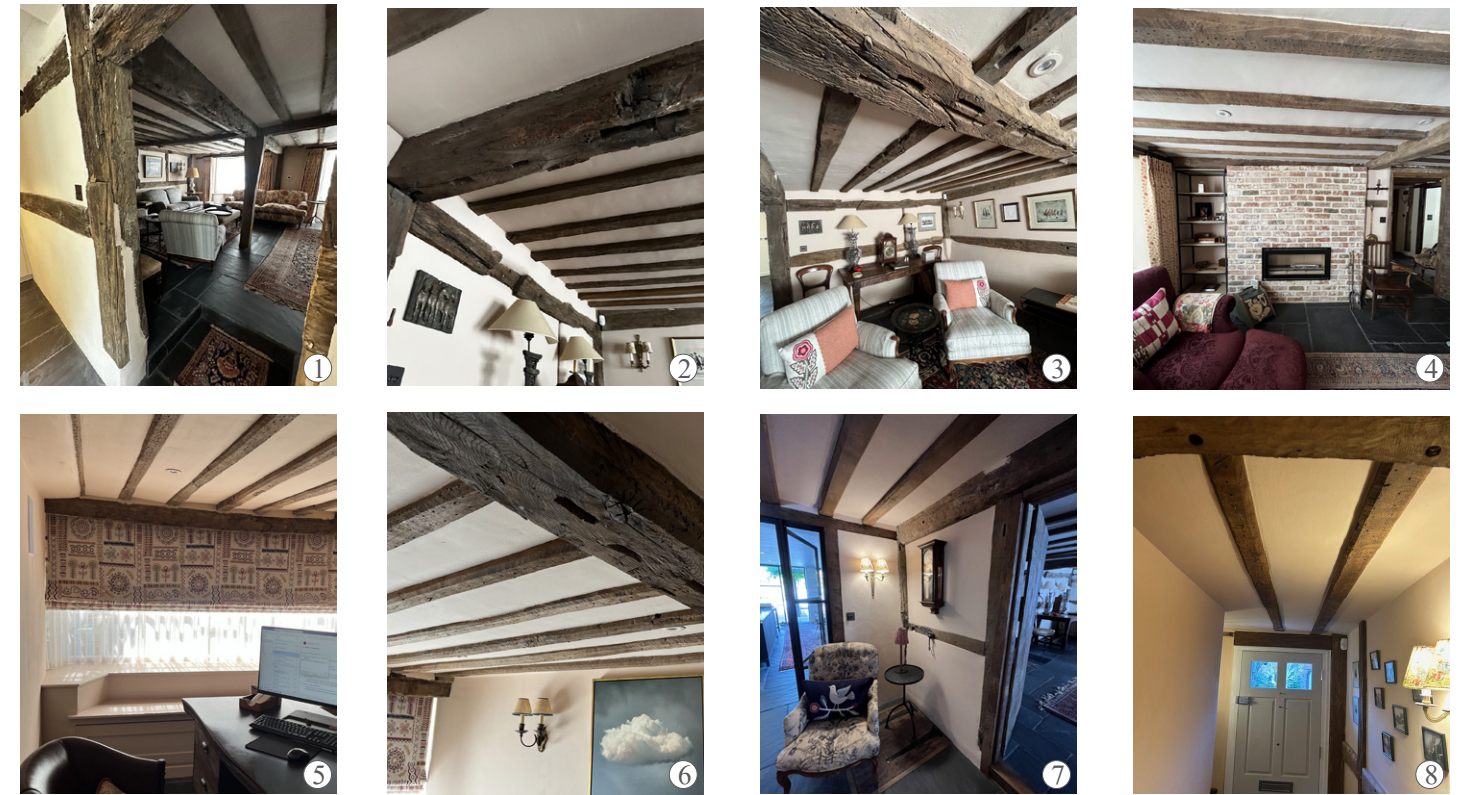
1. Living room South facing
2. Living Room East facing
3. Living Room North facing
4. Living Room West facing
5. Office South facing
6. Office exposed ceiling
7. Hallway North Facing
8. Entrance Hall South Facing

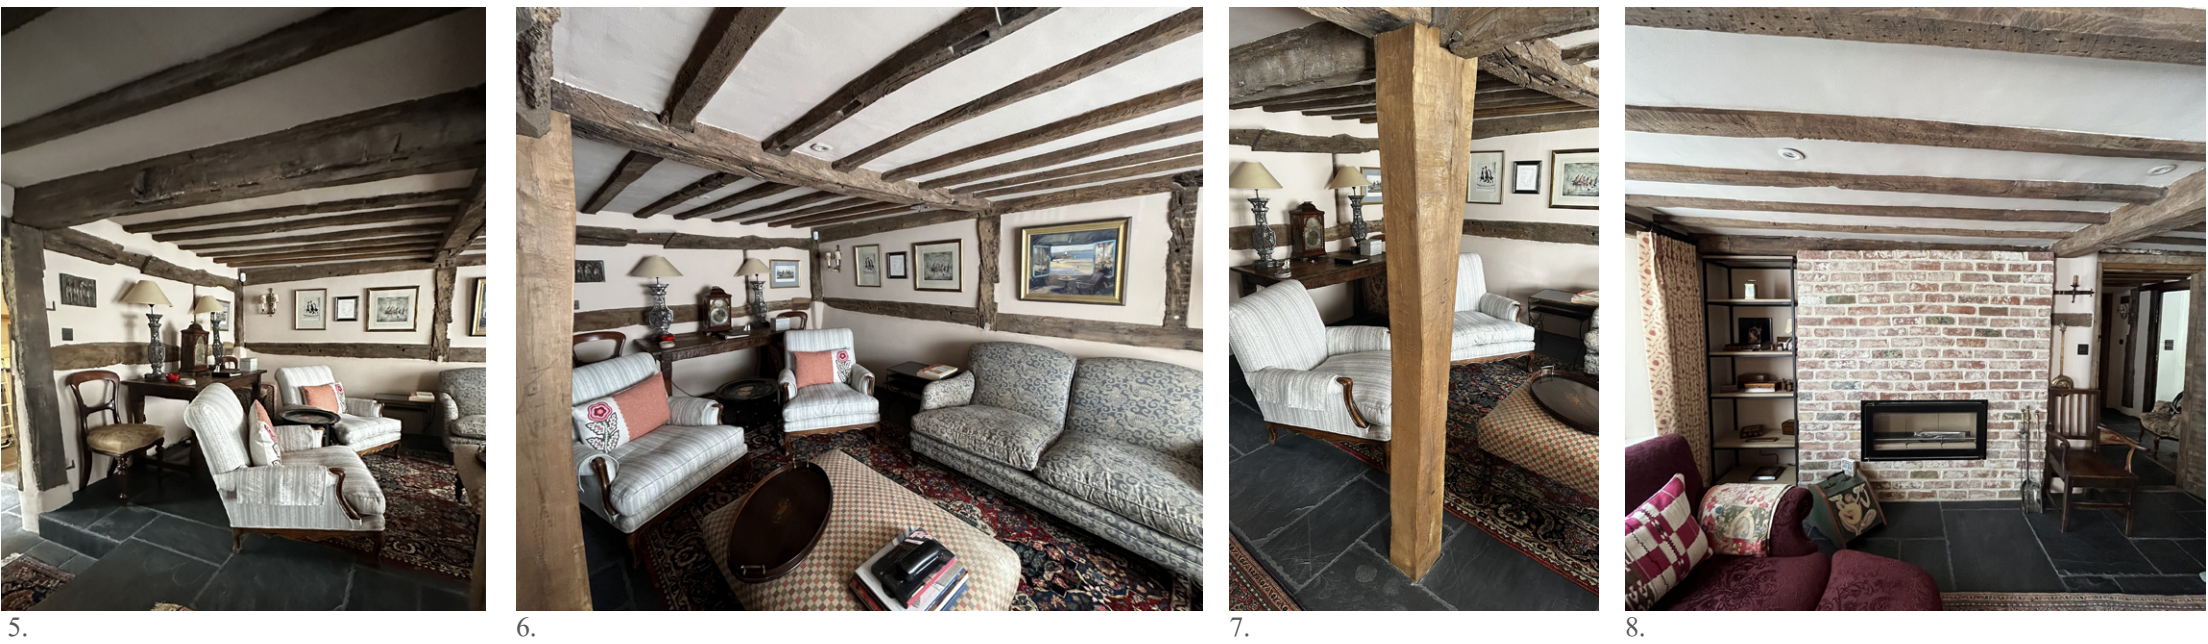
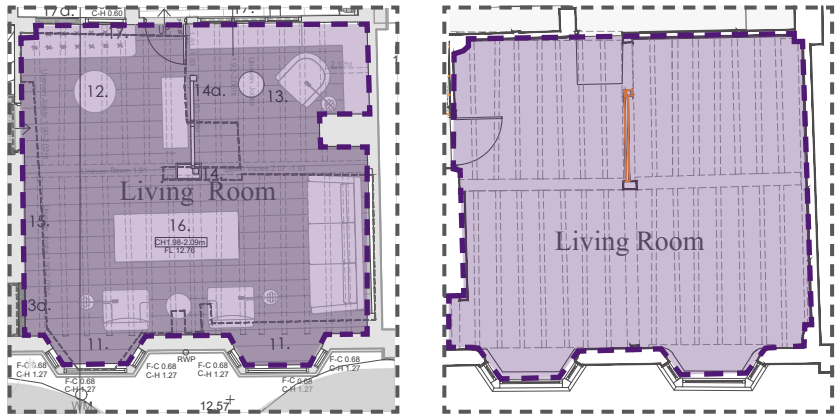
As a secondary intervention supporting these works, a later partition wall and steel post which previously interrupted the space have been removed and replaced with a crafted timber post designed to better integrate with the historic frame. This element is discussed earlier within this document and contributes to the improved readability of the ceiling structure without altering its historic character.

- Key
- Figure 1. Pre-construction view of the timber frame and plaster ceiling
  - Figure 2. Pre-construction steel post supporting timber frame ceiling
  - Figure 3. Pre-construction partition wall supporting timber frame ceiling
  - Figure 4. Under Construction Chimney original
  - Figure 5. Proposed / as-built Living room showing exposed timber frame and repaired ceiling
  - Figure 6. Proposed / as-built Living room showing exposed timber frame
  - Figure 7. Proposed / as-built Steel post replaced with traditional gunstock post in seasoned oak
  - Figure 8. Proposed / as-built View of chimney on west wall

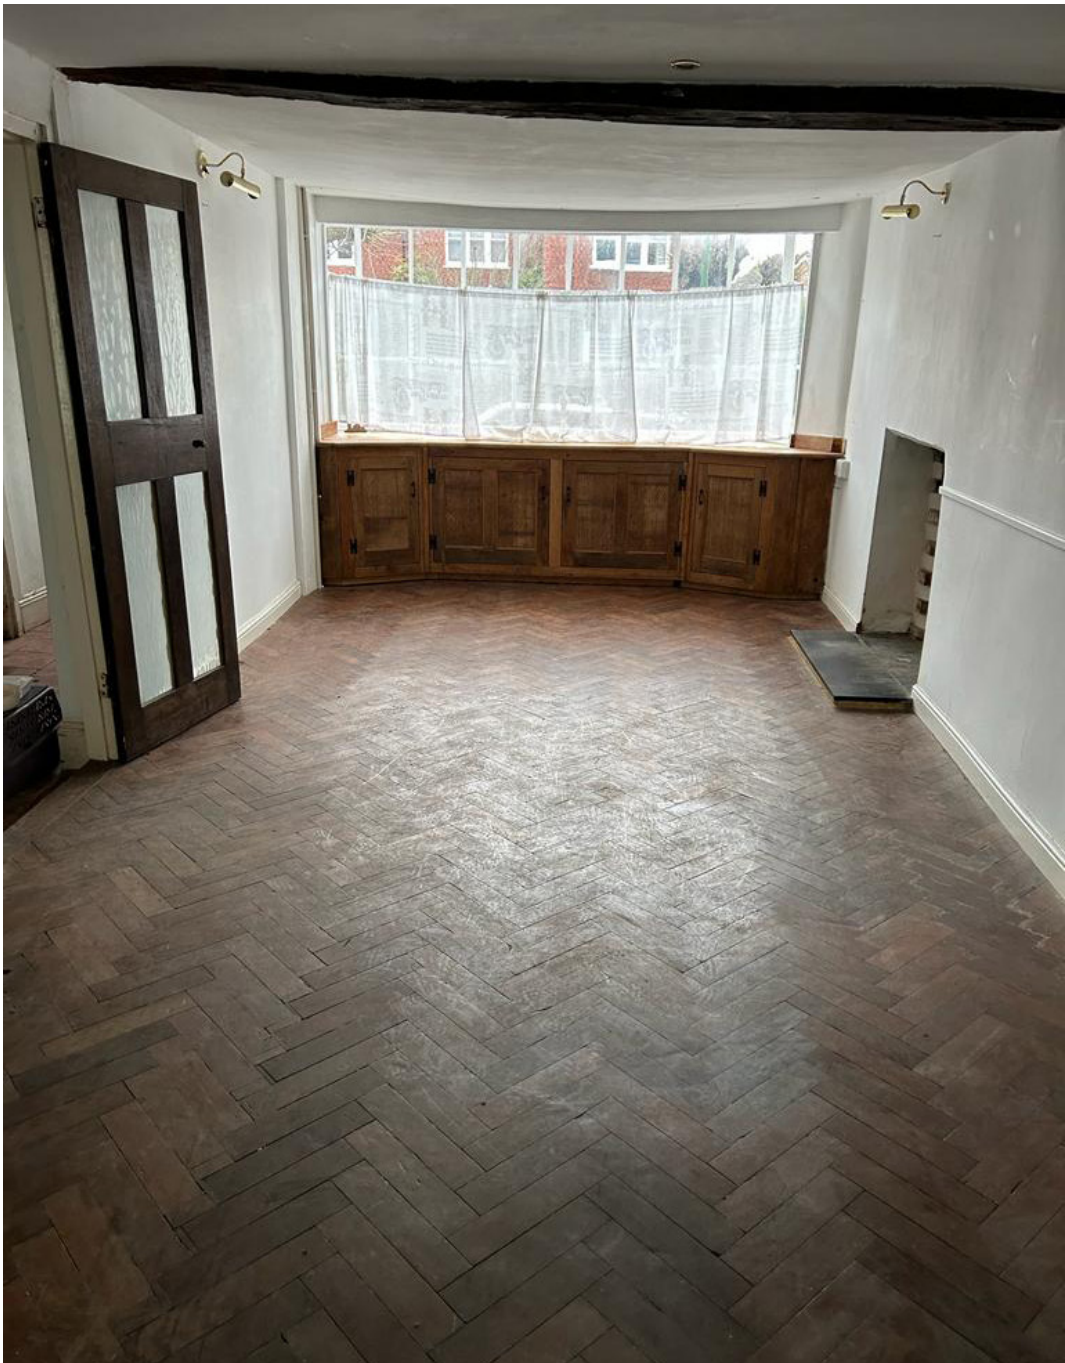
1.  
Key  
Figure 1. Pre-construction study space.  
Figure 2. Proposed / as-built study space.  
Figure 3. Exposed timber beam and ceiling detail.  
Figure 4. Exposed timber joists within the study ceiling.

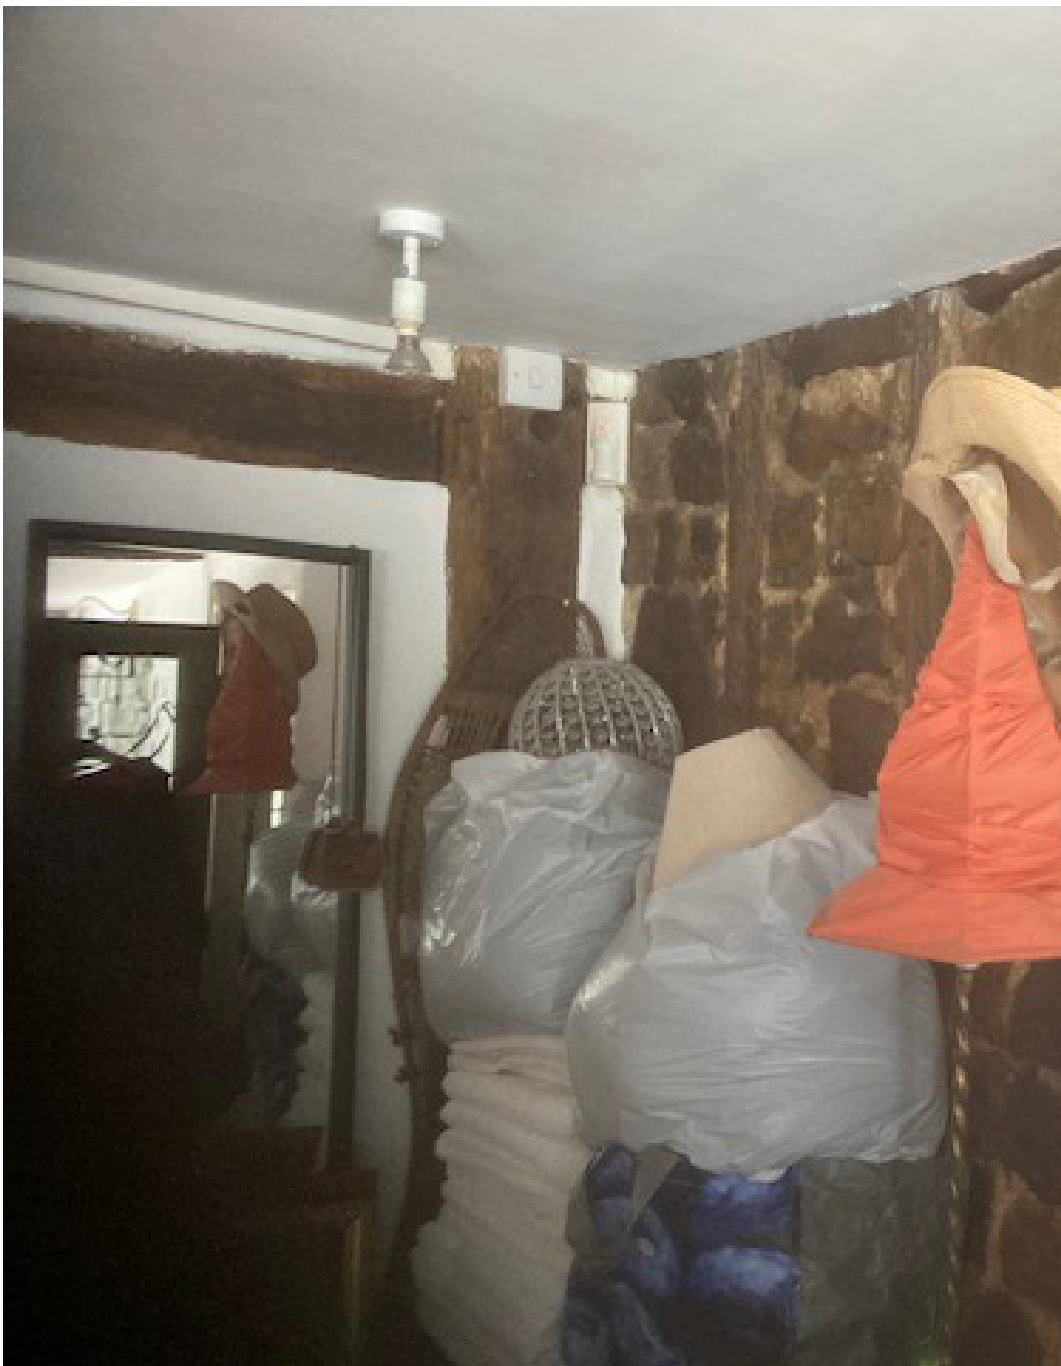
- Figure 1. Pre-construction hallway.
- Figure 2. Proposed / as-built entrance hall.
- Figure 3. Exposed timber beam and joists framework.
- Figure 4. Exposed timber beam and ceiling detail.

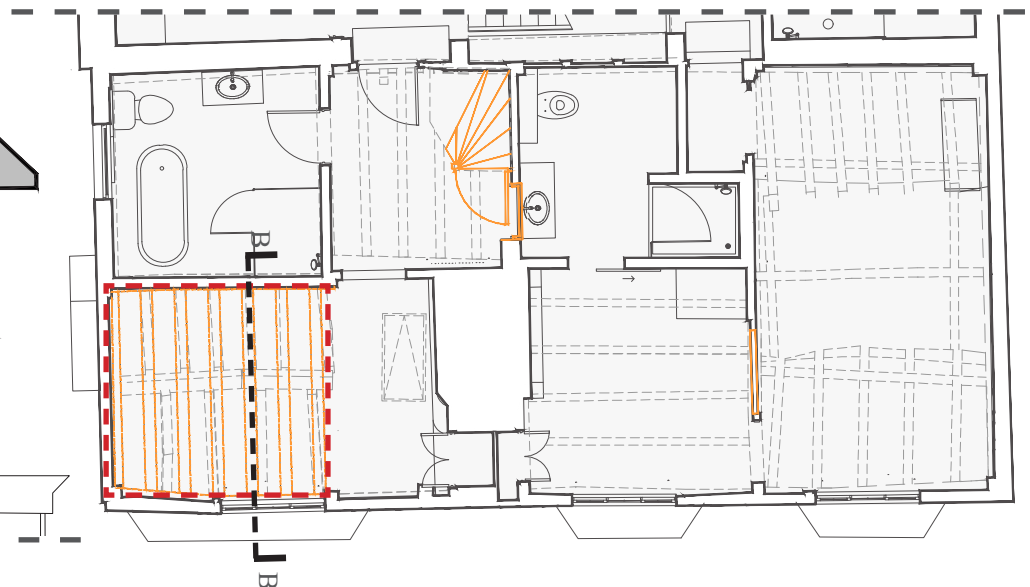
KEY PLAN Proposed First Floor

Highlighted area of deviation

Area of ceiling demolition above bedroom. Rotten, wood worm infested timber boards to non-original floor build-up removed. New vaulted ceiling introduced. Non-original timber ceiling joists to be reinstated.

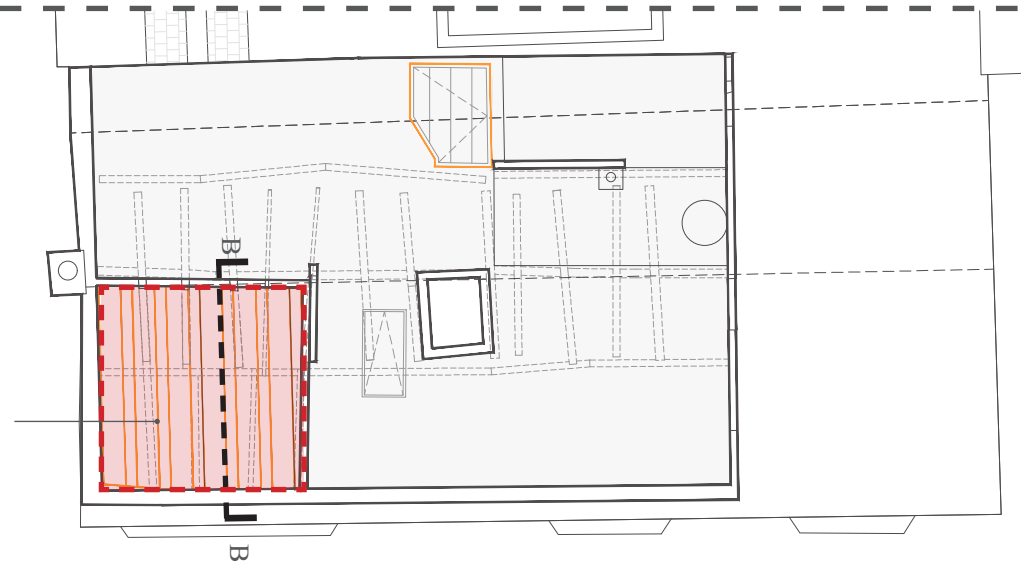
KEY PLAN  
As-Built Attic

Existing non-original ceiling removed. Limited information on build-up

- Gypsum plasterboard ceiling to bedroom side
- Modern timber joists
- 80mm insulation
- Loose laid oak floorboards to attic side, rotten and wood worm infested

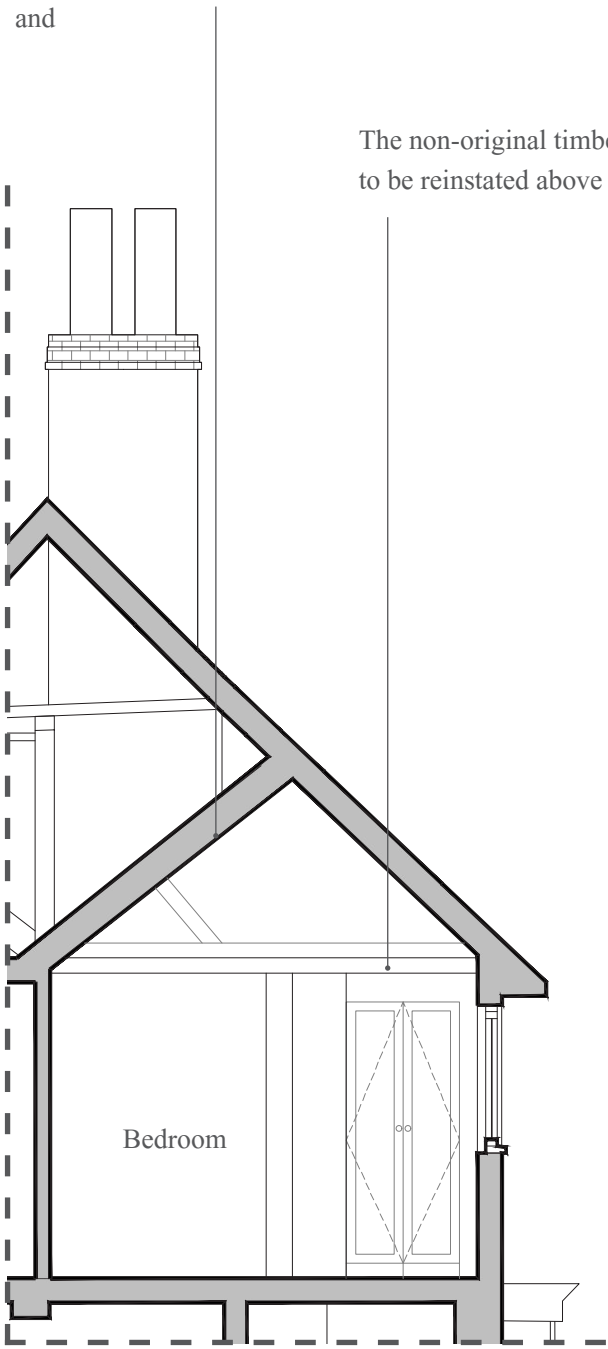
Extract of Proposed Section AA

New ceiling build up:

- Lime plaster to bedroom ceiling
- Hemp-Span Fibreboard, Hemp-span
- Insulation finished with Hemp-Span
- Fibreboard to attic side

The non-original timber joists to be reinstated above bedroom

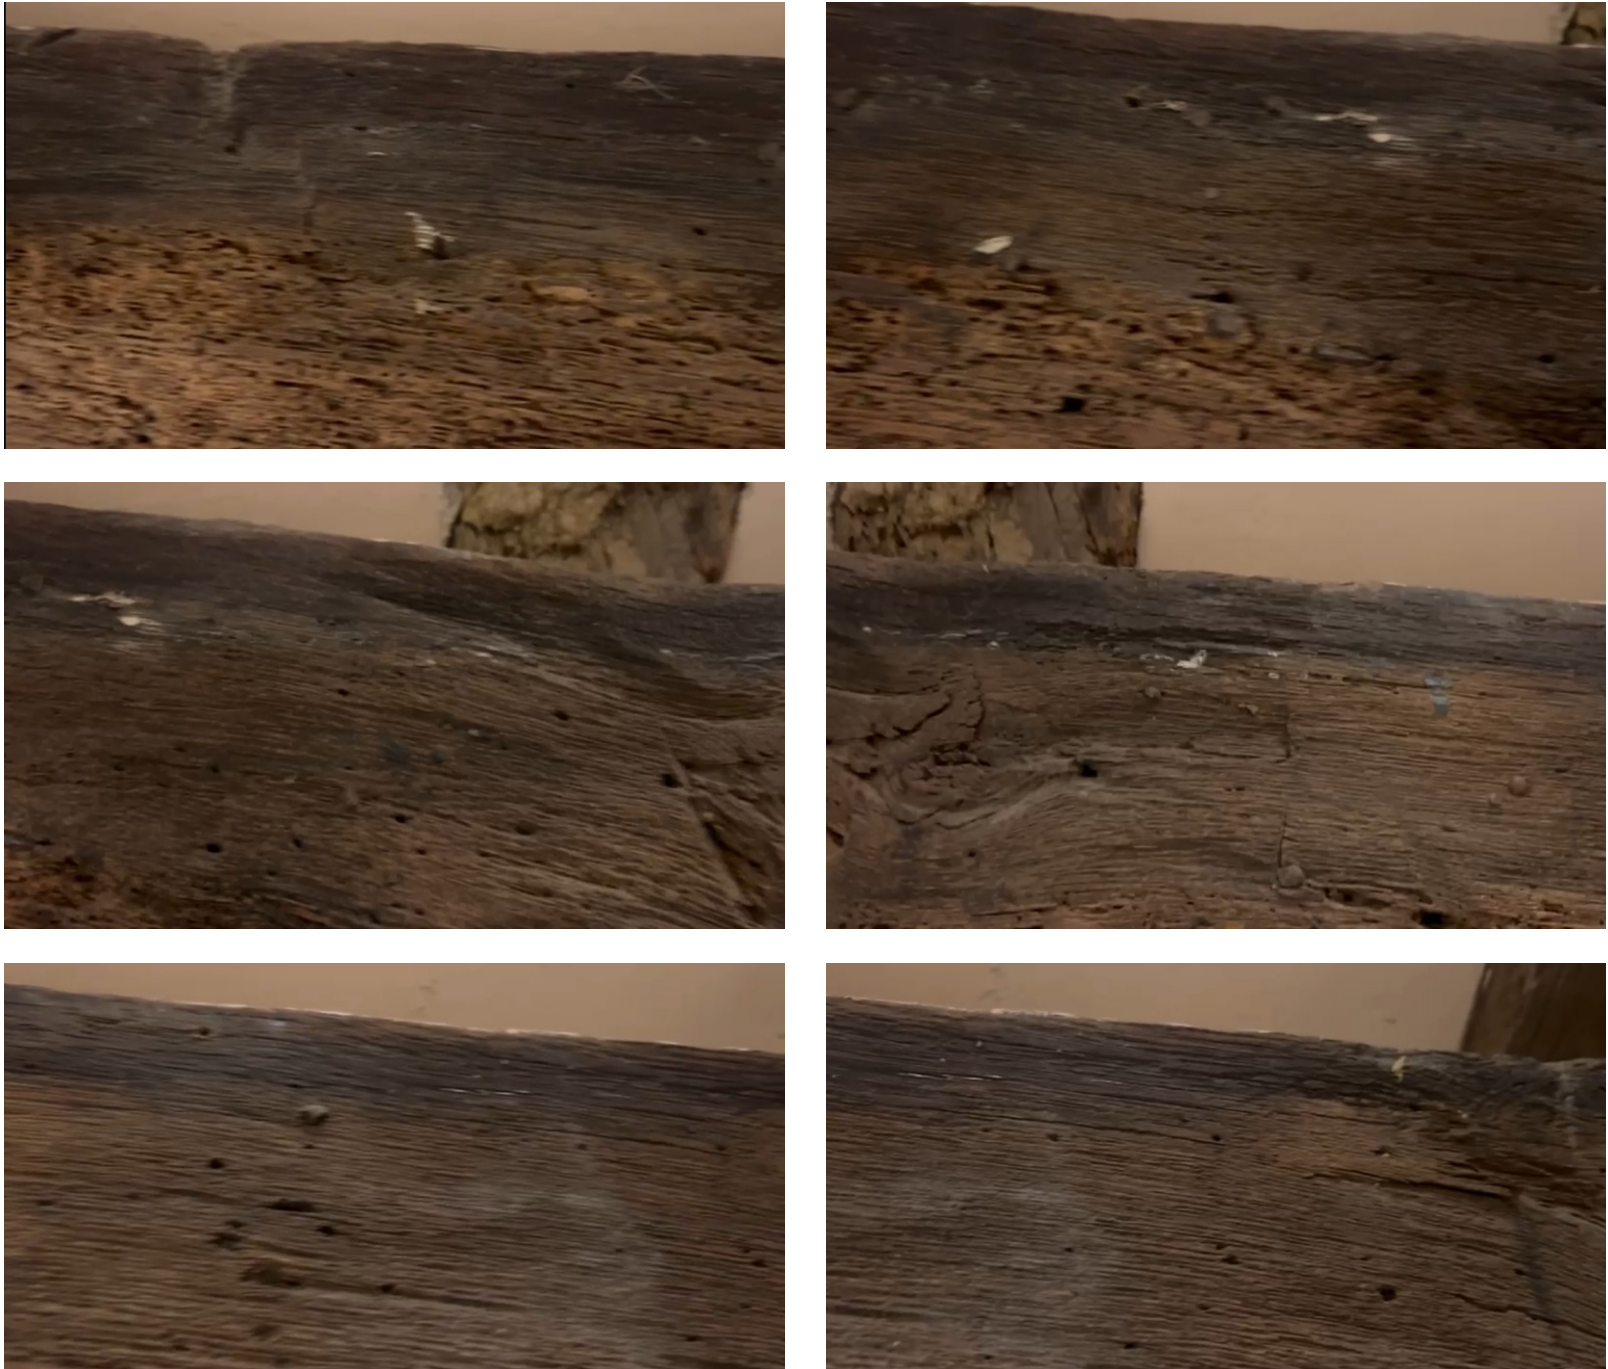
Following the submission of planning application DM/25/1103 further photographic evidence of historic frame soot blackening in the southern bedroom is provided, please see adjacent photographs.

South bedroom timber frame photographs, November 2025

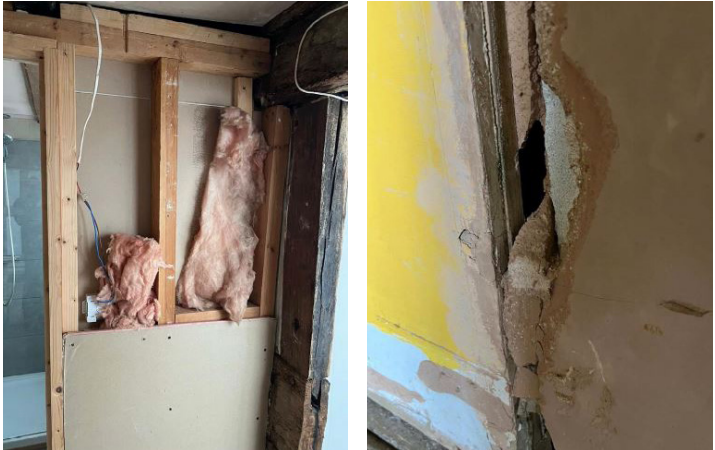
Removal of existing, poor quality wall and construction of new partition wall, reinstatement of sliding door to en-suite.

Poor quality bathroom wall build up exposed before demolition  
Poor quality bathroom wall before demolition

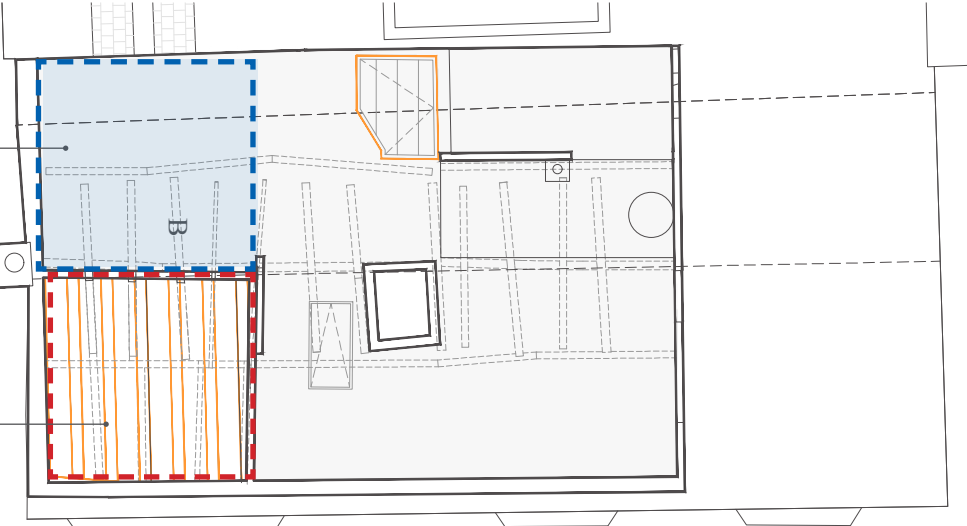
KEY PLAN  
Proposed Attic Floor

Area of reinstated aged oak timber boards to match the original ones

Area of ceiling demolition above bedroom. Rotten, wood worm infested timber boards to attic floor removed. New vaulted ceiling introduced. Non-original timber joists to be reinstated.

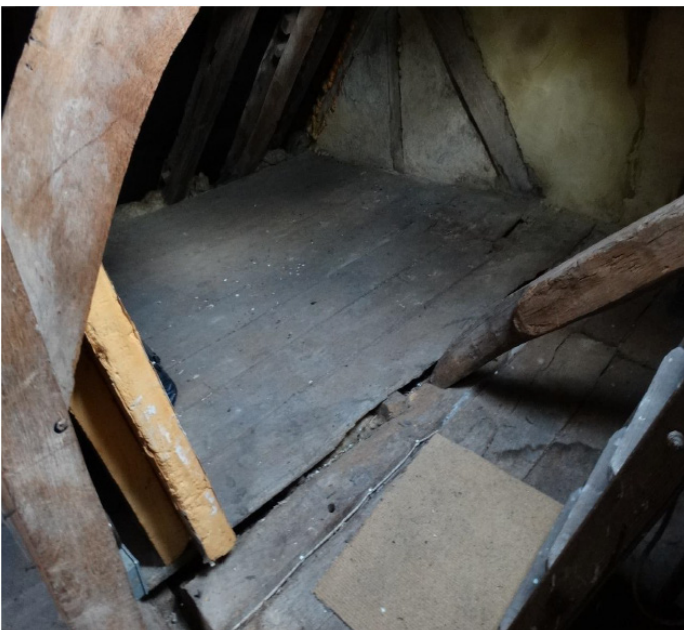
The 17th century floor boards above the south-east bedroom were excessively loose and instable located in the loft. The previous owner confirms many areas of the old flooring in the attic were in a very poor condition. A high percentage were badly stained and rotten. Furthermore, the Desbrulais report confirms in the photograph this attic area was already raised suggesting non-original elements being in place below the loose laid boards, perhaps the reason why they were loose laid in the first place.

Pre-construction photographs of attic floorboards in poor condition

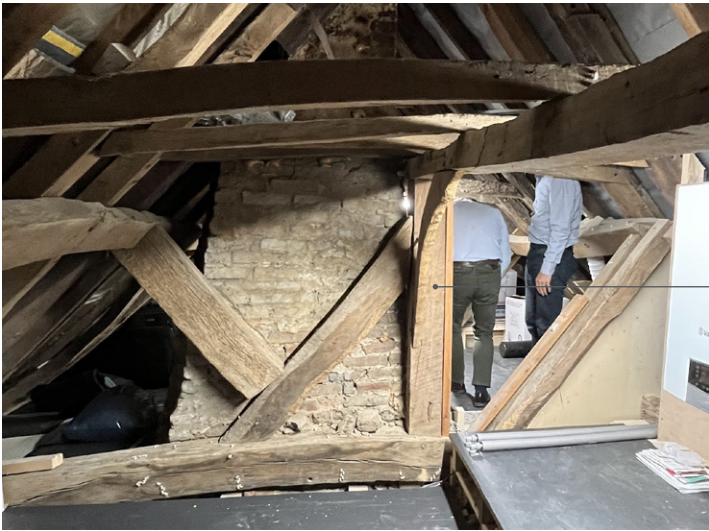
Recent photograph

It is illustrated on the photographs below that the crown post was not removed.

Existing crown post in its historic place
