EXPOSURE TIMBER FRAMES - FIRST FLOOR - WALLS - DRESSER

107 HIGH STREET, LINDFIELD, HAYWARDS HEATH, RH16 2HR

AS IMPLEMENTED PHOTOGRAPHIC DOCUMENTATION

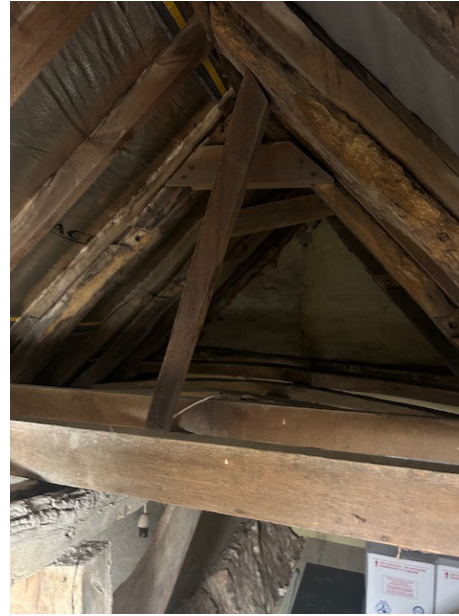
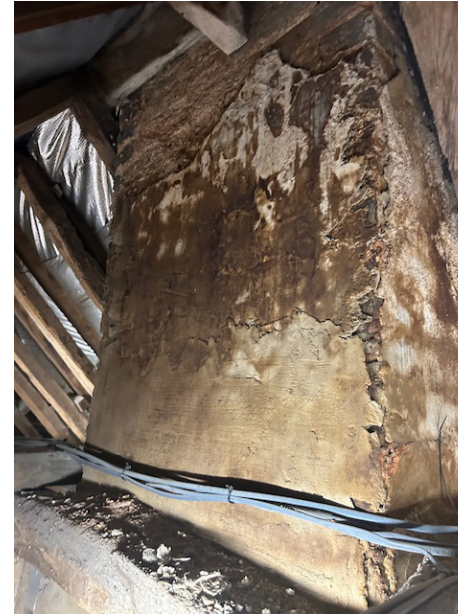
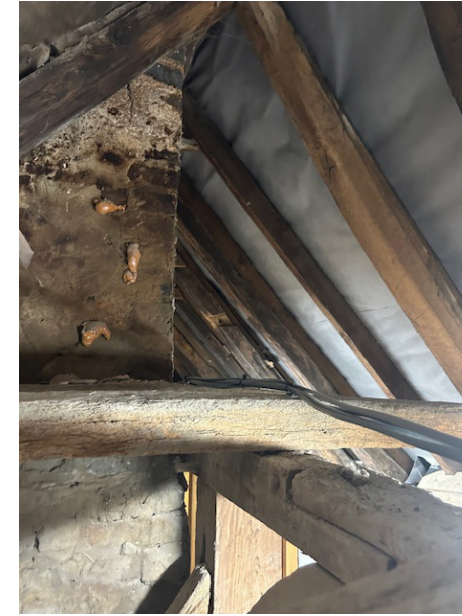
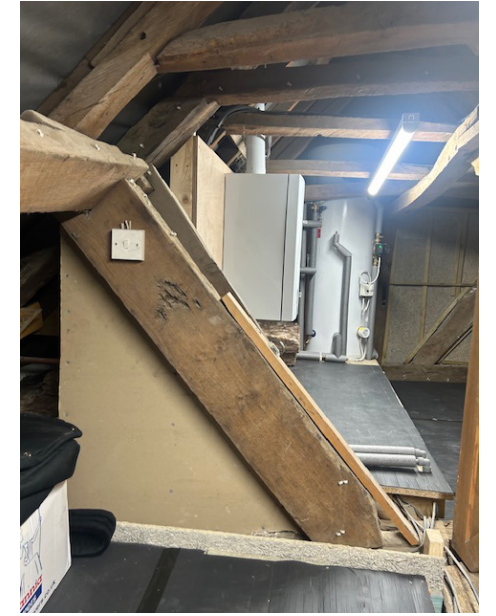
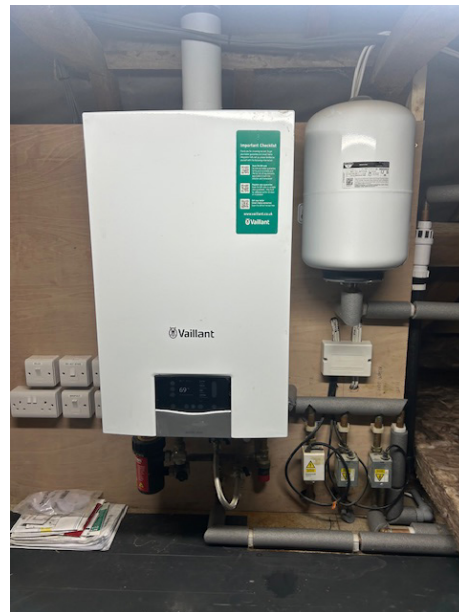
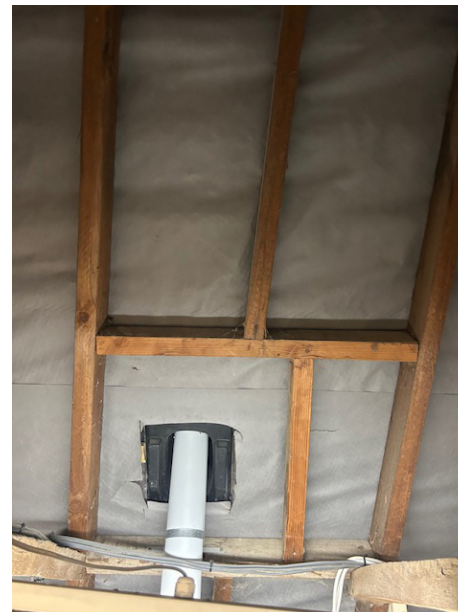
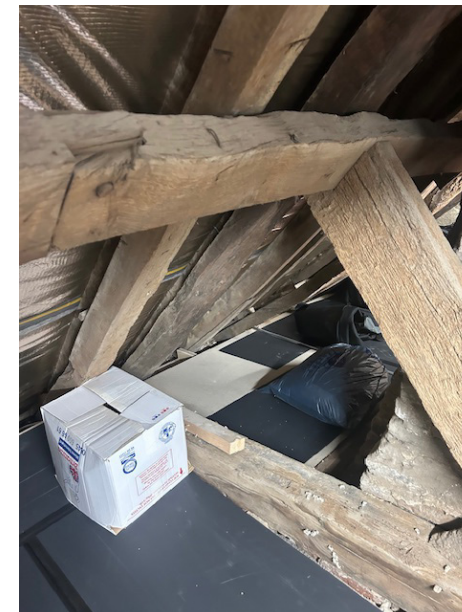
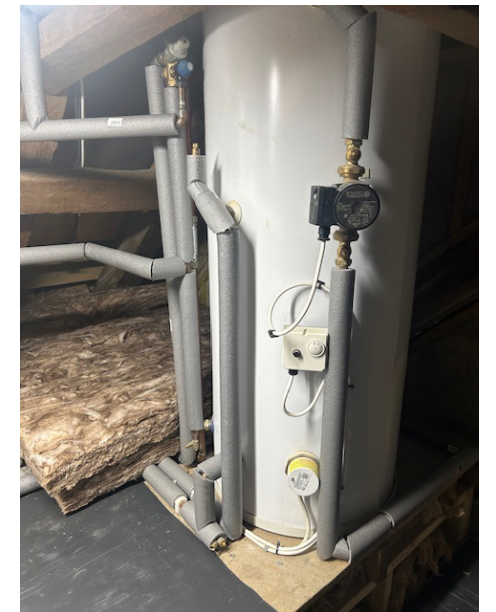
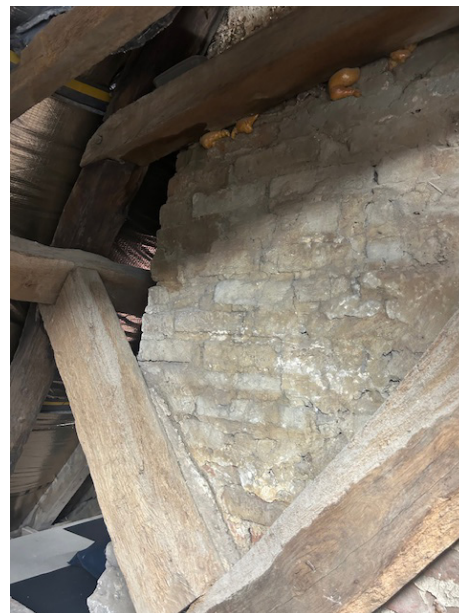
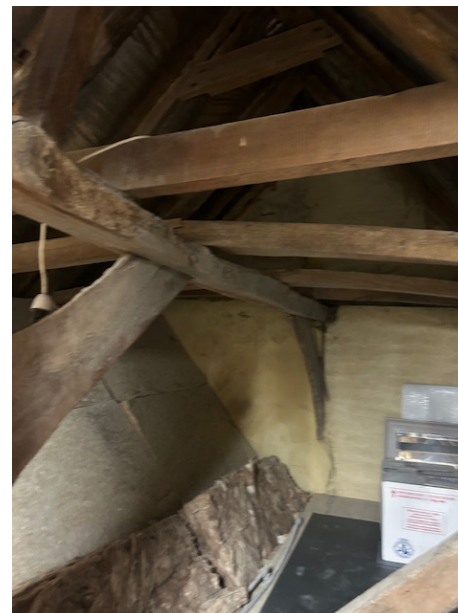
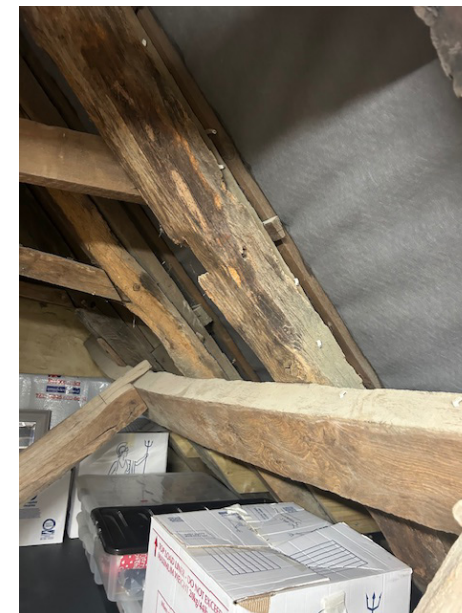
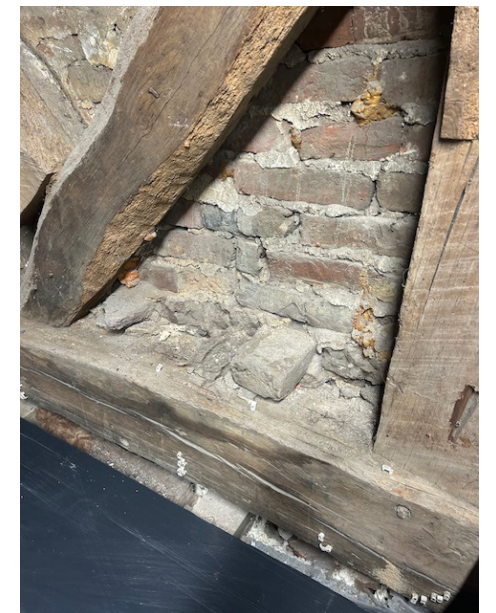
The adjacent photographs are of the current condition of the attic.

Timber frame was unaltered.

All roof structures of historical and national significance have been preserved, with loose floorboards carefully reused and modern materials removed, ensuring that the heritage value of the attic construction is maintained.

For comparison, the adjacent photographs are of the attic before any works were undertaken by the current owner.

It is noted that the timber frame was unaltered and untreated.

All roof structures of historical and national significance have been preserved, with loose floorboards carefully reused and modern materials removed, ensuring that the heritage value of the attic construction is maintained.

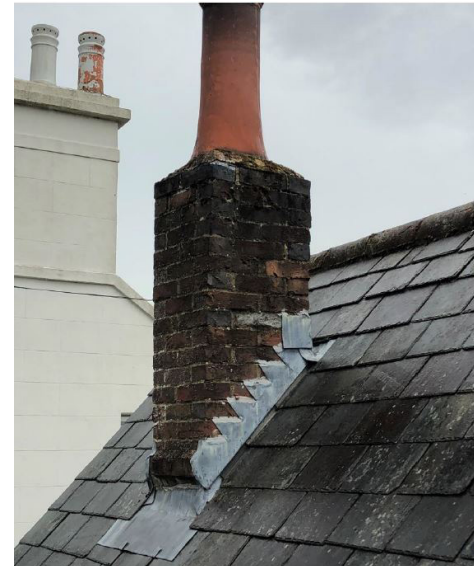
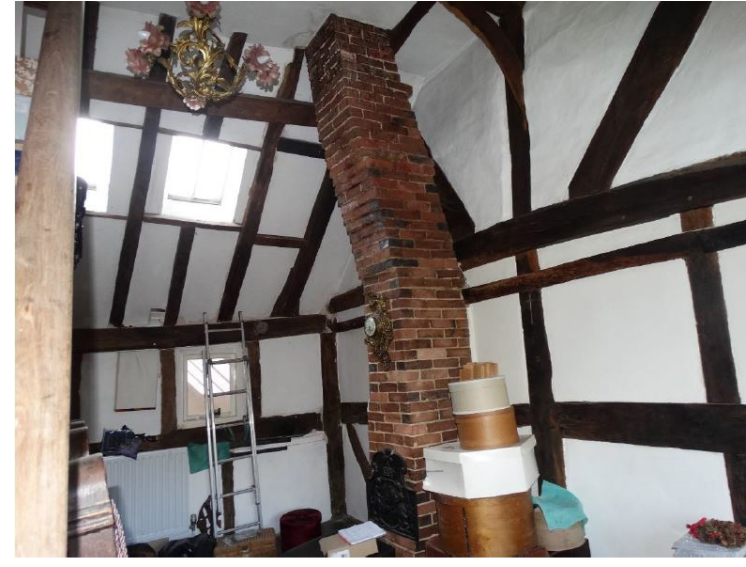
The existing chimney stack was in a poor structural condition, as quoted below from 'Condition Report' by Gould Baxter:

*1. In general terms the stack remains reasonably upright and plumb, although it is noted that where it penetrates the master bedroom below, it is raked to an angle.*

*6. The junction between the stack and roof slopes are weathered with lead flashing. From our vantage point the flashing appeared in serviceable condition, but the presence of damp staining internally would suggest current or historic damp penetration. Further investigation is required once high level access is provided but we would anticipate the flashing will require renewal. life expectancy, with cracking and surface spalling noted. The flaunching should be renewed, with high level access provided to facilitate works.*

External and internal photographs of the chimney stack prior to removal

The condition of the chimney stack was assessed by Structural Engineer McCarey Simmons. The adjacent Structural Report produced on the 29th of August 2023 highlights that the chimney within the north bedroom was structurally unsound due to excessive corbelling without adequate restraint. The upper brickwork and mortar was in poor condition, with areas of displacement noted, and there was evidence of water ingress from defective flashing. Given the extent of the corbel and lack of structural support, repair works would present a significant risk.

Additionally, the owner reported that when testing the chimney, smoke was leaking internally into the attic and bedroom, causing a health hazard for residents

Further to our review of the photographs of the existing chimney masonry within the north first floor bedroom, we confirm the existing chimney was significantly corbelled into the room (the corbelling was approximately 450mm, the full depth of the chimney) and away from the north timber framed gable wall with a lack of restraint to the gable wall. It would not be possible to justify this extent of corbelling given the lack of restraint to the chimney masonry. The mortar joints toward the top of the chimney were in a poor condition with some dislodge brickwork and there was also some damp staining to the ceiling indicating the flash over had been leaking. Carrying out repairs works on the chimney with such a significant corbel would be risky.

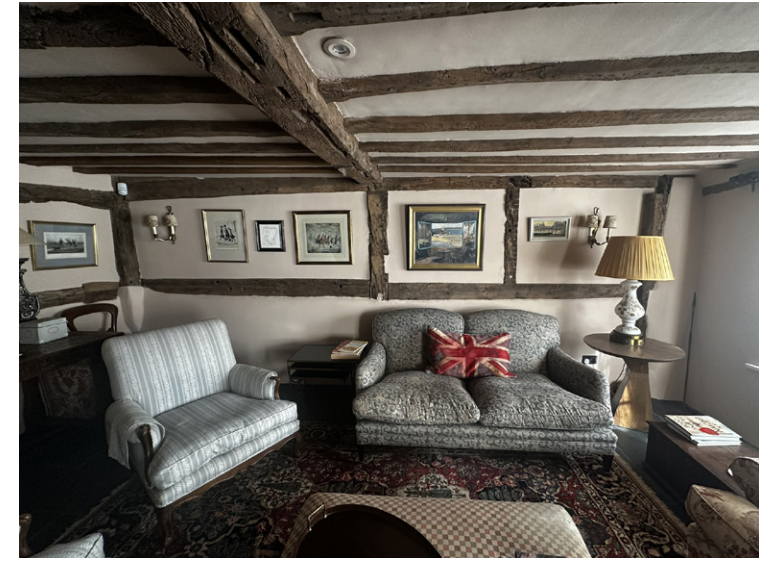
Ground floor living room - removed chimney breast and wall and ceiling made good

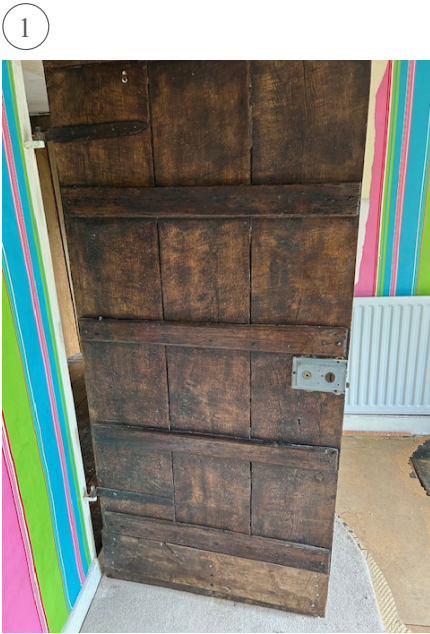
Existing timber door (to be reinstated and fixed shut)

On the first floor, an existing opening in the internal wall was blocked up. It is proposed for the doorway in question to be reinstated in the current bathroom wall, with door leaf fixed shut. As such, the legibility of horizontal movement on the first floor is still present. On the bathroom side, the doorway and associated architrave will be reinstated and current freestanding sink will be refitted in its current position. It should also be noted that the approved first floor plan has the sink located against an existing door that is to be locked shut, a measure that is now being proposed when reinstating the door to the opposite side (South side) of the en-suite in a revised sink position. The use of the sink in this position is reversible works and as such, should be agreeable on heritage terms.

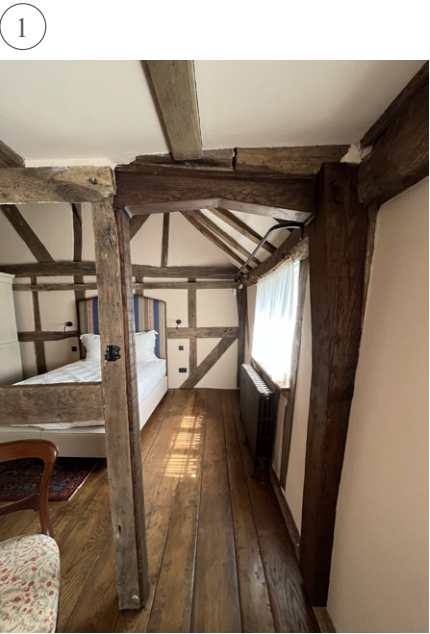
Photo of the doorway to the dressing room as implemented.

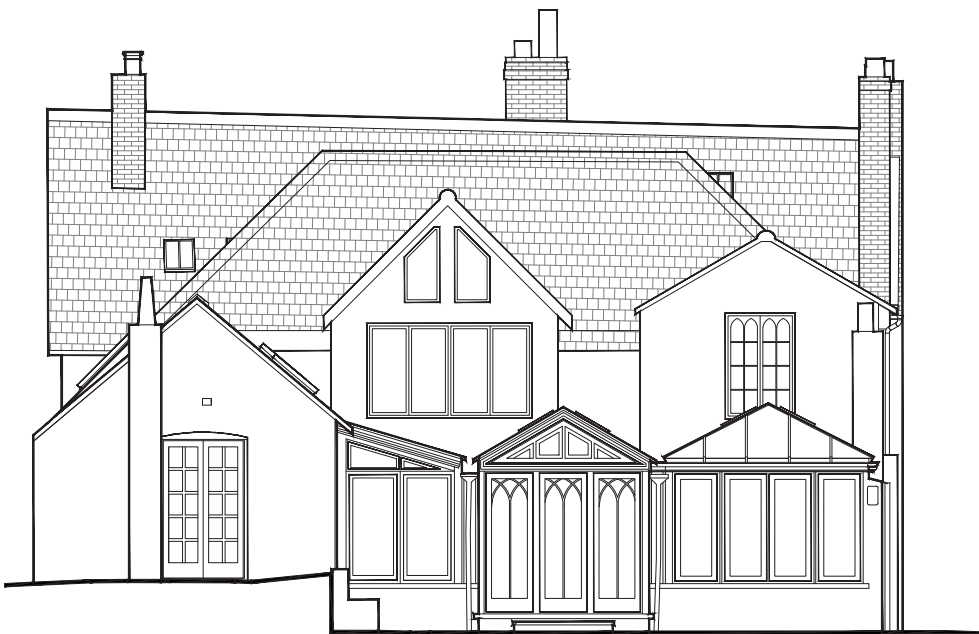
1. Rear elevation of the building prior to any works

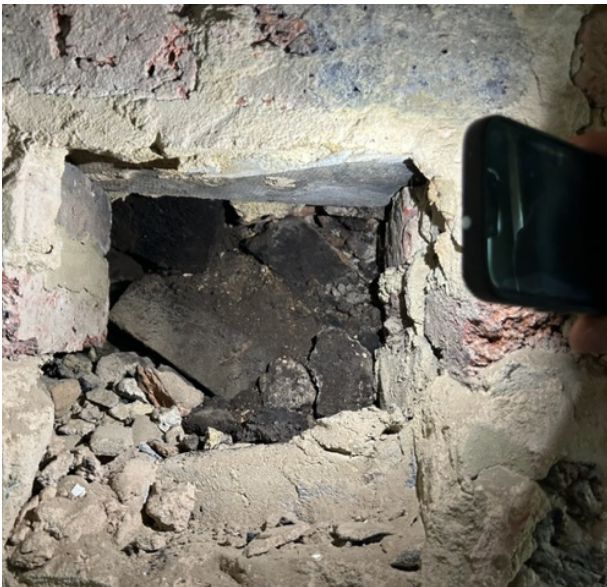
1. Initial, exploratory hole made on hallway side of chimney to visually investigate the construction of the chimney - blockwork was found to be located within the build ups

Ground floor living chimney breast assessment, opening from hall side. Chimney breast blocked up and not usable.

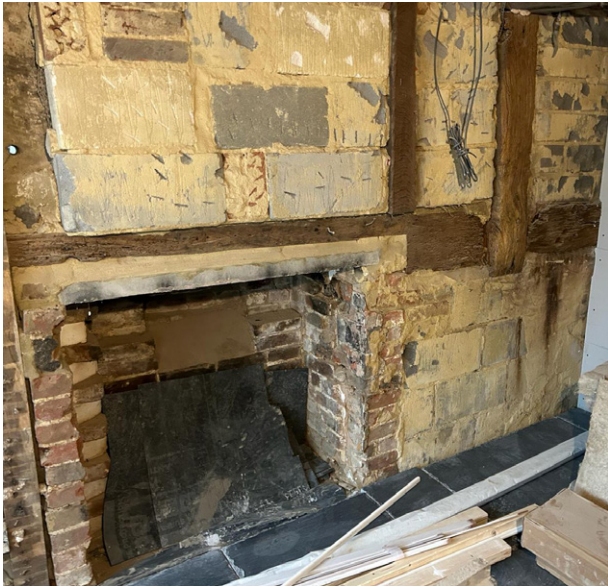
2. Existing blockwork removed from behind the existing hearth
3. Reclaimed brickwork cleaned where required across full extent of chimney prior to any repair works.

Ground floor living chimney breast under construction, prior to re-facing. Non-original blockwork wall infill exposed.

4. Any serious erosion from spalled brickwork removed, then cleaned out and infilled with new brickwork and mortar mix with colour, texture and pointing to match existing.

6. Any open mortar joints, if not found to be a consequence of structural defects, cleaned out and infilled with new mortar mix with colour, texture and pointing to match existing.

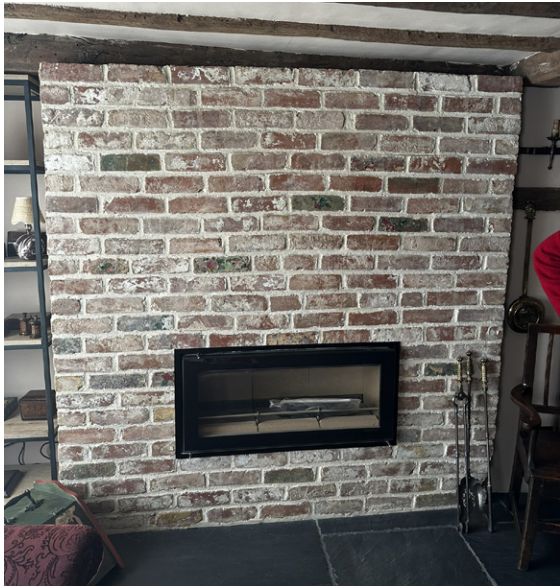
The condition of the ground floor main chimney breast has been significantly improved. The chimney breast has been re-faced in reclaimed brick using hydraulic lime mortar, with a new hearth being incorporated. This is considered an improvement to the listed house and a heritage benefit as outlined in the supporting HCUK heritage statement.

Ground floor living room re-faced chimney breast

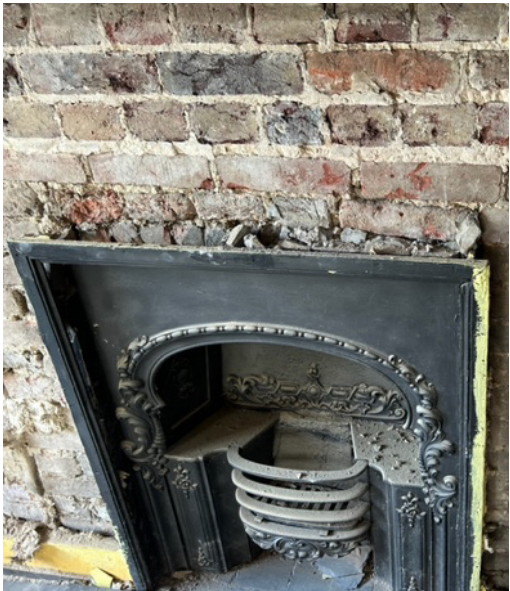
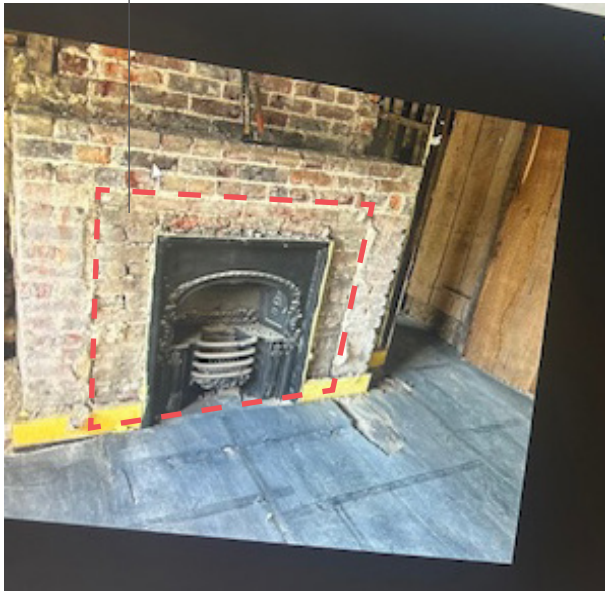
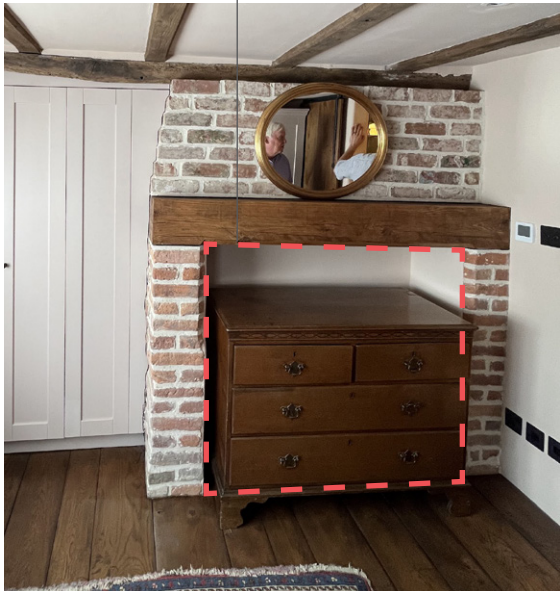
On the first floor, the fire place was modified to resemble the historic one by reinstating the hearth opening. The condition of the chimney breast has been significantly improved. The chimney breast brickwork has been cleaned and re-pointed. A new horizontal timber mantle was introduced for aesthetic reasons.

Original firebox blocked up

Original firebox retained

First floor bedroom fireplace and chimney breast before works

First floor bedroom re-faced chimney breast

1. Existing fireplace insert removed
2. Brickwork infill around inserted fireplace removed to reinstate the historic firebox
3. Reclaimed brickwork cleaned where required across full extent of chimney prior to any repair works.
4. Any serious erosion from spalled brickwork removed, then cleaned out and infilled with new brickwork and mortar mix with colour, texture and pointing to match existing.
5. Chipped or cement coated bricks removed, cleaned out and infilled with new brickwork and mortar mix with colour, texture and pointing to match existing.
6. Any open mortar joints, if not found to be a consequence of structural defects, cleaned out and infilled with new mortar mix with colour, texture and pointing to match existing.
7. New timber mantle by Nick Cane of Cruck Frame Carpentry installed above the opening. Timber treated to match the floorboards.

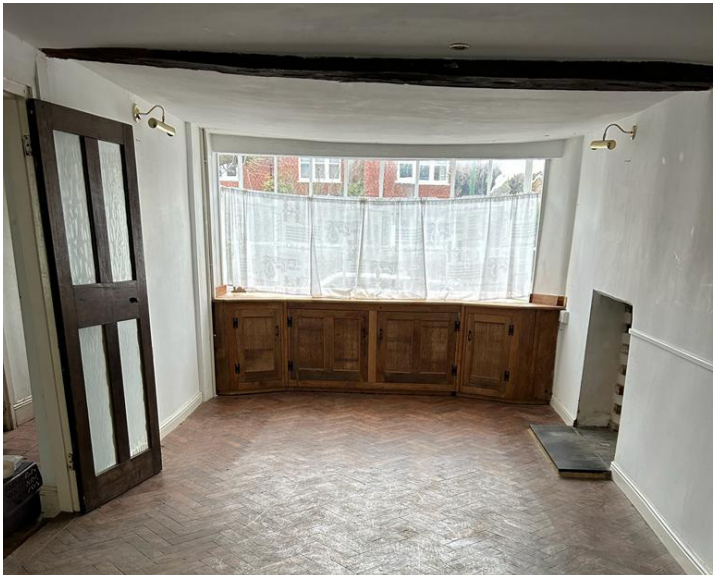
Further to the site visit that I have completed in September 2023 at Marlow House, according to my knowledge, taking into account the remains of what used to be an inglenook fireplace, that it is beyond economical repair to restore this fireplace. The reason for that is, the later construction reduced the size and layout of the original fireplace. Evidence is that the new corrugated cement flue pipe, that was built in when the latest repairs were done, is part of the modern structure/infield. This continues behind the fireplace upstairs which subsequently supports the chimney stack. So for this reason, your intentions to put the fireplace back to the original layout and to have it as an open fire will not be possible. The only option for a heating source will be to have a stove/wood burner installed in the current opening. I consider this option as a non permanent structure and should you need too, can be removed at later stages without disturbing the current layout of the fireplace.

Ground floor study fireplace before works- opening on the right side

- 1. Previously blocked up firebox opened up
- 2. Firebox cleaned up, debris removed
- 3. Opening decreased in height - using masonry infill with lime plaster covering, decorated to match surrounding wall finish
- 4. New electric fireplace insert installed

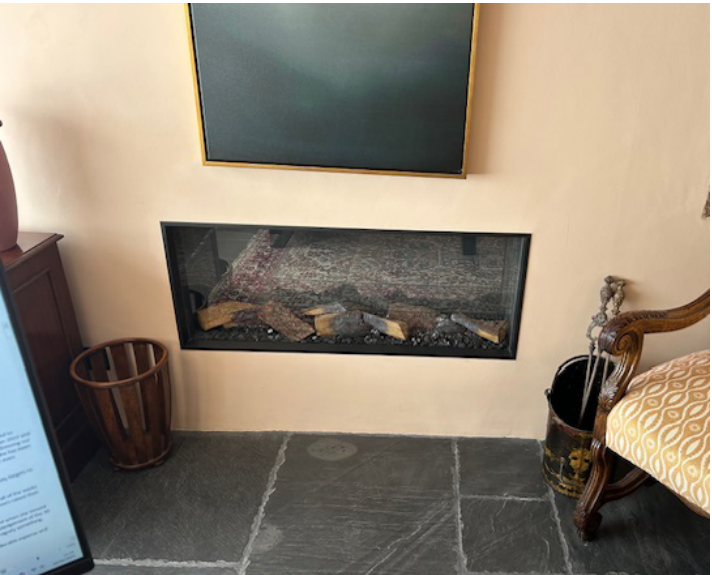
Ground floor study fireplace- electric fire place on the right side

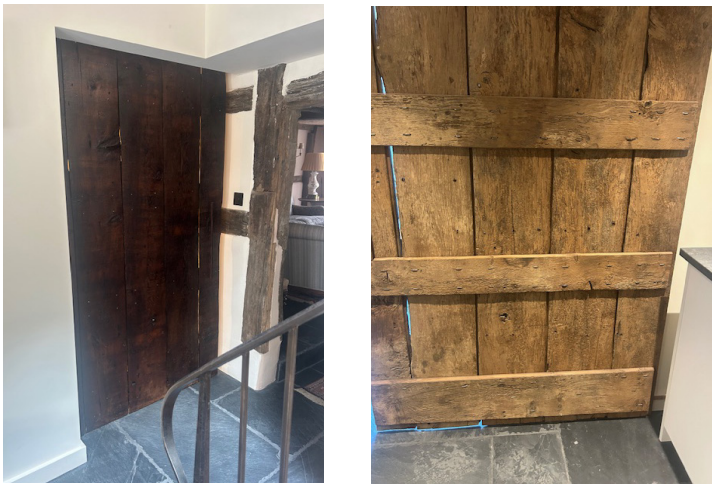
that is left in the open position. This door can be lifted off at any time it is not a permanent fixture, is (re)movable and should therefore be accepted as the perception of the rear elevation of the 15th century element of the house is still very much perceptible with the door in situ, both open or closed

Photographs of the sliding door

This is a minor deviation from the approved scheme and is considered to have neutral effect on the listed building significance in accordance with the supporting HCUK heritage statement.

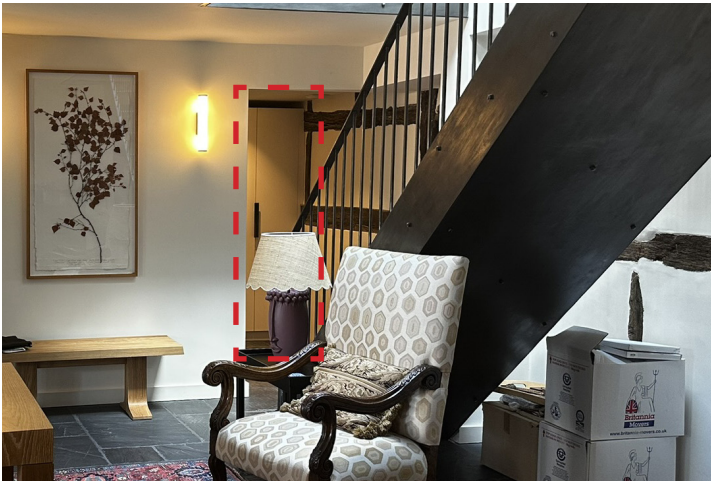
Photograph showing location of the door and exposed timber frame

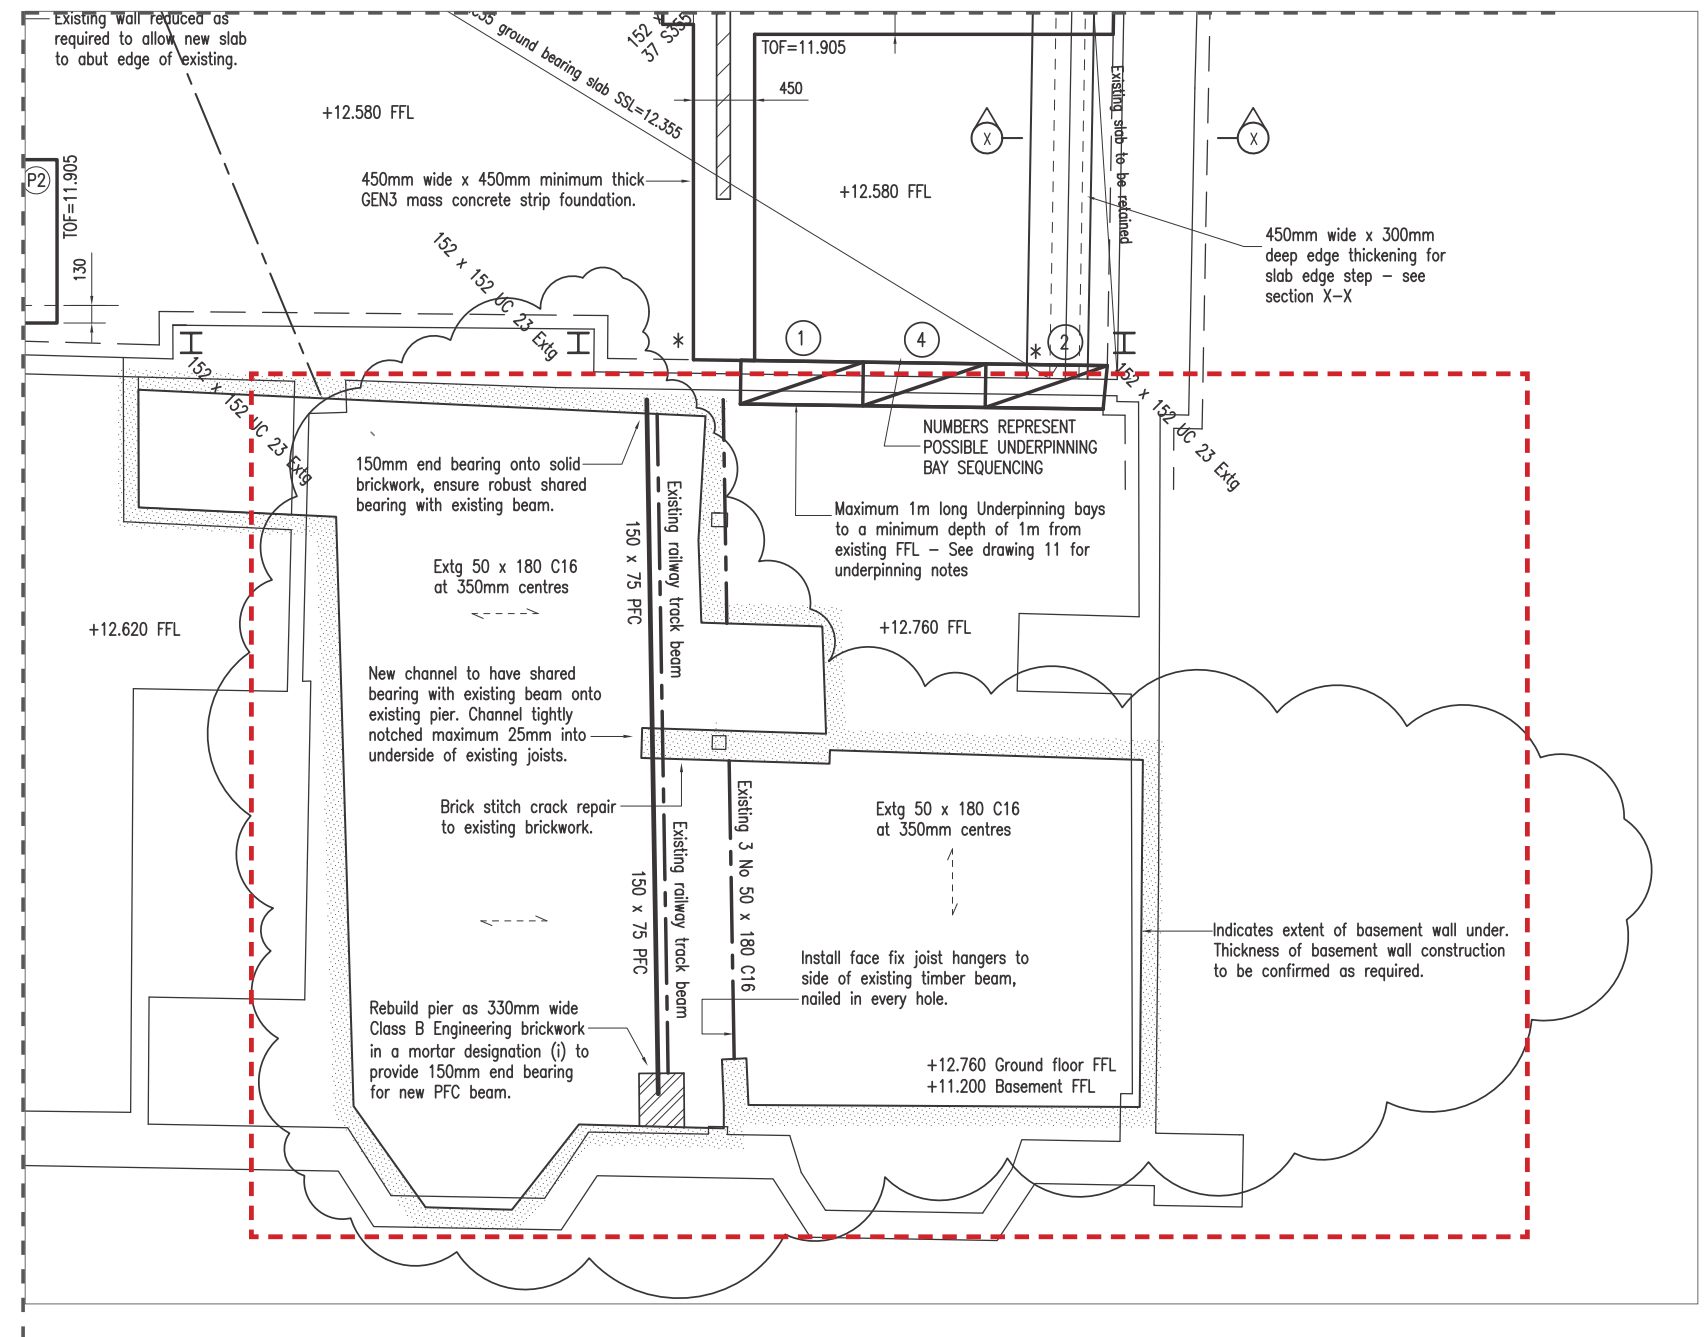
Foundation drawing by McCarey Simmonds Structural Engineers

When we first inspected the space, it was evident that the existing concrete slab had been in place for a considerable period. Its raised level had reduced the basement's natural ventilation, contributing to elevated humidity. This restricted ventilation, combined with moisture being forced up at the junctions between the slab and the walls, was the primary cause of the deterioration you observed in the masonry.

The walls showed characteristic signs of long-term salt-related damage and spalling, which is common when moisture has been trapped for many years behind impermeable tanking treatments. To help the structure dry in a controlled and gentle manner, we recommended a light coat of NHL 3.5 lime. This was not intended to block moisture but to regulate its release, allowing the wall to breathe and reducing further surface failure during the drying process.

The adjacent drawing developed and provided by the Structural Engineer, illustrates proposed strengthening works to the ground floor over the basement. The railway steel member used for structural support was replaced as per Structural Engineer proposal to ensure a suitable structural stability of the building to safeguard it for the years to come.

The appearance of the cellar is commensurate with what was present when the previous tenants were stewards of the property. The cellar walls have been lined with traditional material: lime plaster. This ensures the walls can breath and the moisture escapes from the building. This has been one of the issues encountered in the historic element of the building, which is demonstrable through the rotting of the modern floor joists that had to be removed due to rotting, with the underlying issue the extreme level of damp in the cellar. The application of lime plaster on the historic building is highly critical for the ongoing health of the building – it is highly breathable, avoids trapping moisture and allows moisture within the walls to evaporate naturally. This is critical in historic buildings, where walls are often constructed from stone or solid brick without a modern damp-proof course. It's worth noting that lime has been used in construction for centuries and is likely the original material used in the building's construction. Its use aligns with principles of conservation by preserving traditional methods and materials and it can be removed without damaging the underlying masonry, aligning with the conservation principle of reversibility. There were no alterations done to basement floor.

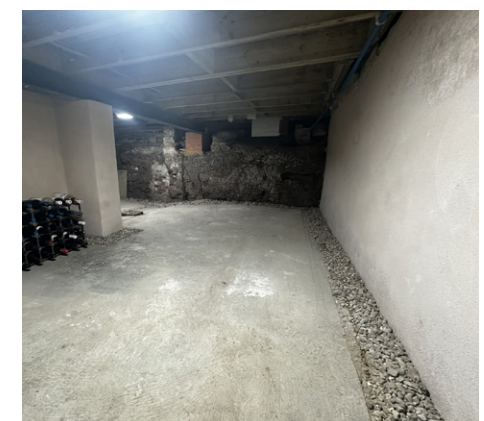
Basement, new softwood joists replacing rotten ones, brick wall finished with lime plaster, floor not altered.

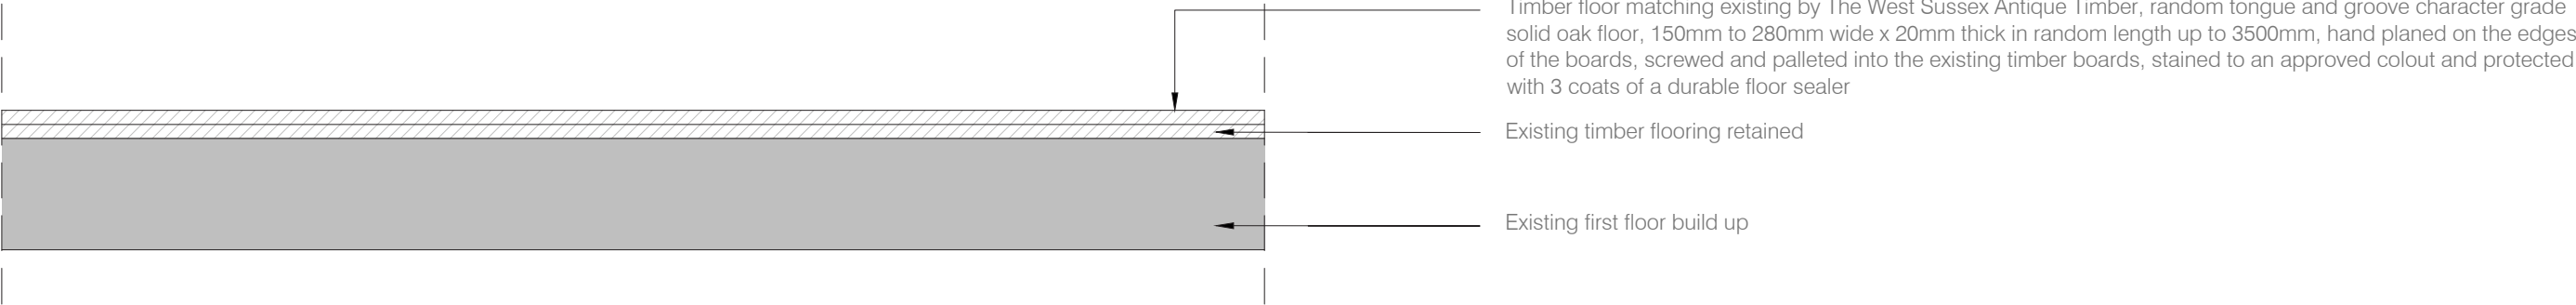
Technical section through first floor illustrating overlaid oak flooring

Upon inspection of the original floor boards we agreed that the flooring was beyond repair and refurbishment due to the degree of historic deterioration and damage. You therefore asked for a floor to replicate the original flooring as close as possible. We specialise in traditional random width solid oak flooring which we have been installing in historic buildings for over 30 years. Due to the extremely uneven surface the oak floor boards were secured using countersunk screws which are covered by oak dowels.

The first floor floorboards have been retained in-situ and have received new overlaid floor finish that very closely matches the existing timber floor finish found elsewhere in the house, specifically on the ground floor. High quality seasoned oak plants of varying widths and lengths have been supplied and installed by The West Sussex Antique Timber Co. Ltd. The boards are in-keeping with the character of the house and do not contribute or cause any loss of historic fabric. According to the supporting HCUK Heritage Statement, this change is considered to be of neutral impact to the significance of the listed building.
