# TREE RISK ASSESSMENT REPORT

**Of one oak tree in the front garden of  
Rutherford House, The Street, Bolney, West Sussex, RH17 5PG**

| <b>Document reference:</b> | MDJAC-DAS24105-TRAR-01 |

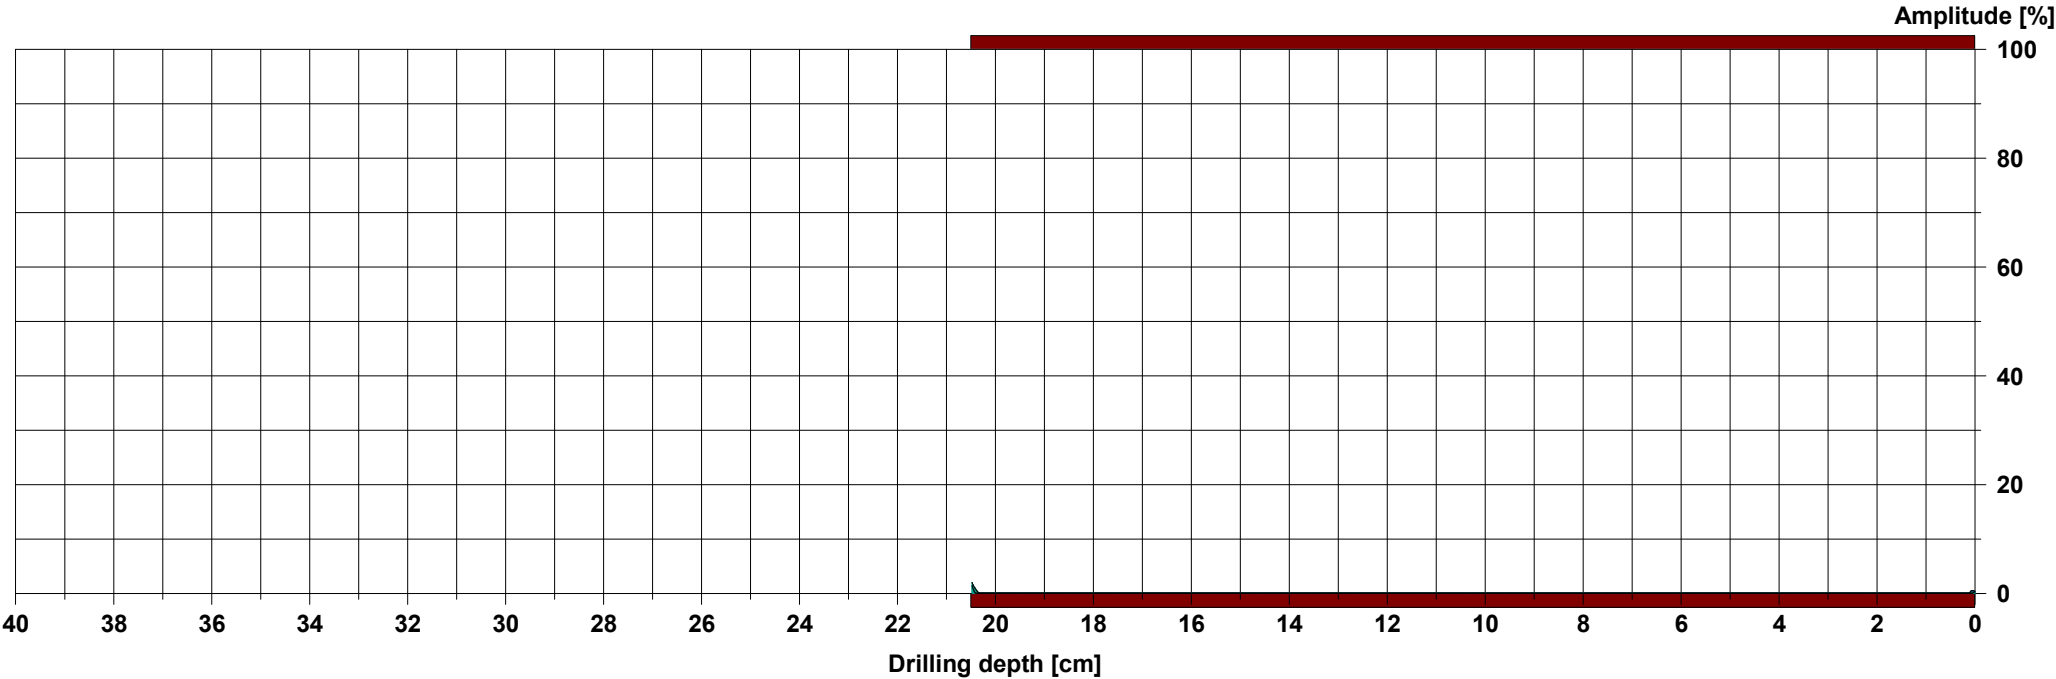
5.3.8. Whilst assessing the south and south-west aspect of the base, I noted a depression at the base of the buttress root on the west side with a small amount of exposed sapwood that was bright white in colour, consistent with extensive white rot. Upon drilling this section, north to south (perpendicular with the buttress root), no material resistance was noted.

5.3.9. These results are significant as they confirm that the decay is at an advanced level at the base of the trunk. As this fungus is known to also affect structural tree roots, I would expect the decay shown above to be the above ground section of an area of decay that affects many of the buttress roots that provide anchorage to the soil, particularly those on the west and east sides. Therefore, in my opinion it is foreseeable that a failure might arise from or close to ground level as a result of deterioration of the wood quality in this area.

■ From 0,00 cm to 20,50 cm : Ext.Decay/Hollow
